High Speed 2 - 1MC06 - Stage One C2 - MWCC –  
North Portal of Chiltern Tunnels to Brackley

## Aylesbury Embankment Landscape Earthworks Conceptual Site Model

**1MC06-CEK-EV-NOT-CS04\_CL18-000009**

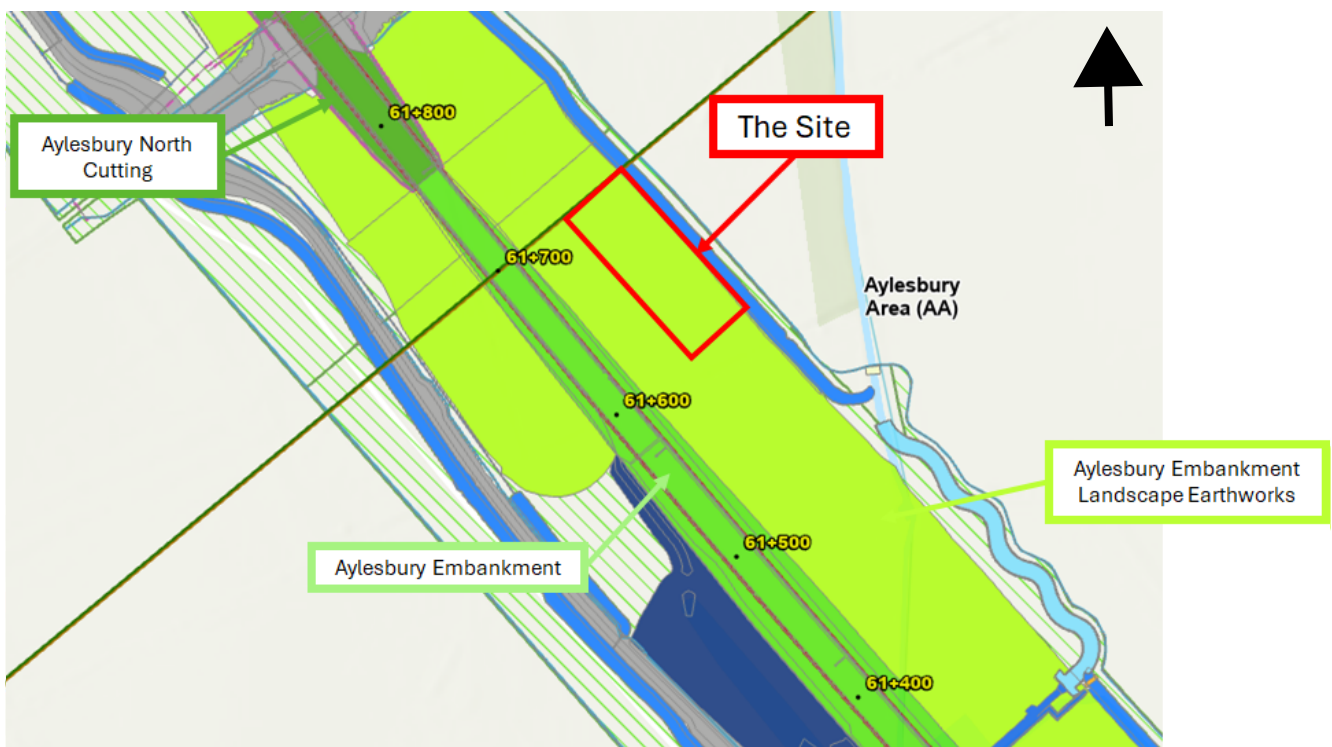
Figure 1-1 Site and HS2 Scheme Plan

The Arcadis/Setec and COWI Design Joint Venture (ASC) has been appointed by Eiffage/Kier/Ferrovial Agroman and BAM Nuttall (EKFB) to present a conceptual site model in support of a Deposit for Recovery Permit (DfR) application for the re-use of remediated waste within a portion of the Aylesbury Embankment Landscape Earthworks (the “Site”) within section C2, of the Phase 1 High Speed 2 (HS2) development, as shown in *Figure 1-1* below.

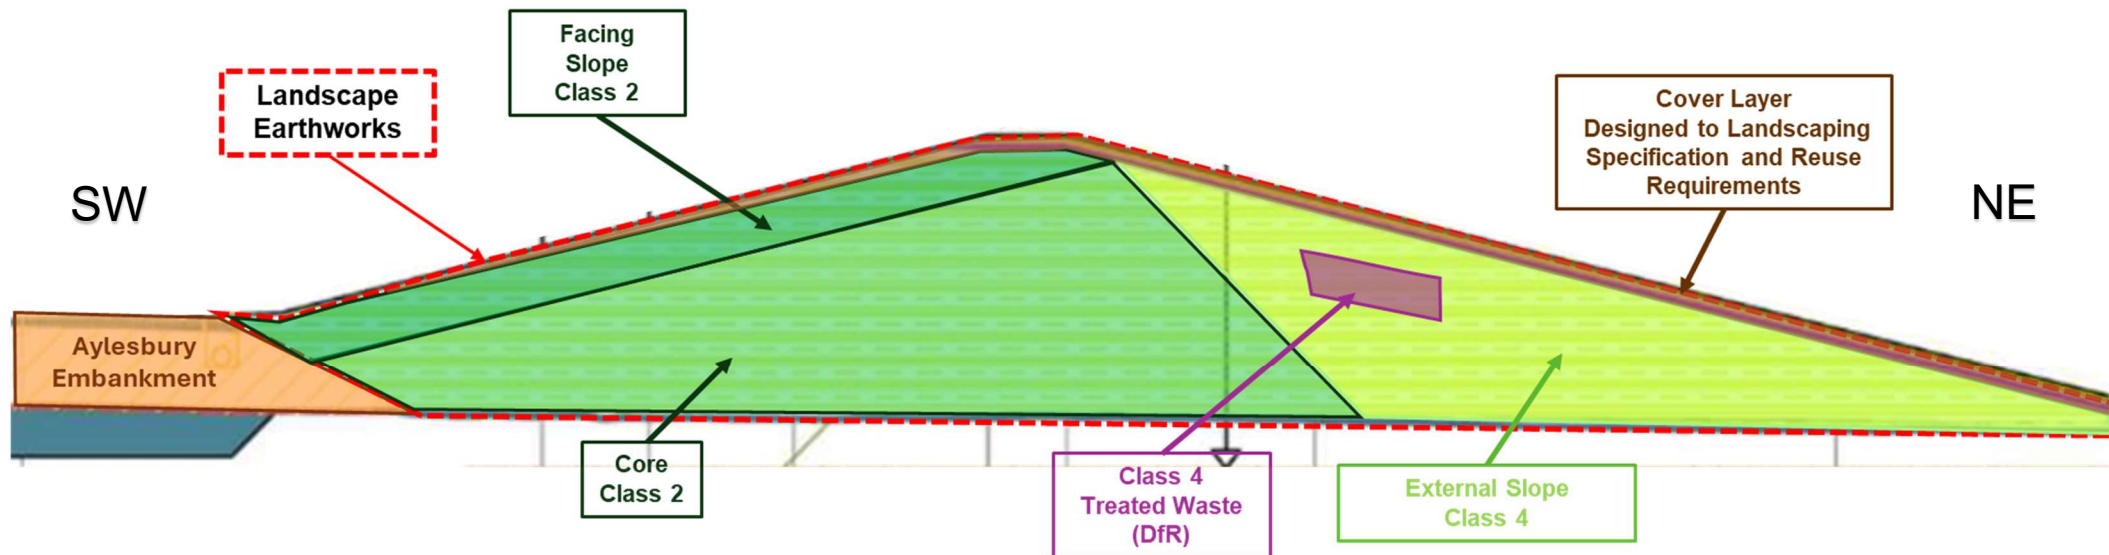
Figure 1-2 Annotated and Adapted Generalised Cross Section through Aylesbury Embankment and Landscape Earthworks

The AELE within the Site (ch.61+600- ch.61+700) will be constructed of treated waste (from LQ 11-03) and natural materials as follows which is on Figure 1-2 below (adapted from *the Asset Specific Cross Sections* [9] [12]).

- Class 2 (cohesive fill) material:
  - Kimmeridge Clay Formation (KC)
- Class 4 (landscape fill) material:
  - Kimmeridge Clay Formation (KC)
  - Post-remediation Treated Waste related to the DfR (Class U1B)

The internal slope and core of landscape earthworks is formed from Class 2 Kimmeridge Clay material and the external slope of landscape earthworks from Class 4 material. Compaction will be in 100-200 mm lifts, sufficient to remove large voids and to produce a coherent mass whilst avoiding over-compaction and build-up of excess pore pressures.

A cover layer as per the landscaping specification and the agreed reuse requirements will be in place above the core of the landscape earthworks which will contain the treated waste. An orange demarcation layer, or similar, will be placed between the treated waste and clean cover.

Not to Scale (for indicative purposes only)

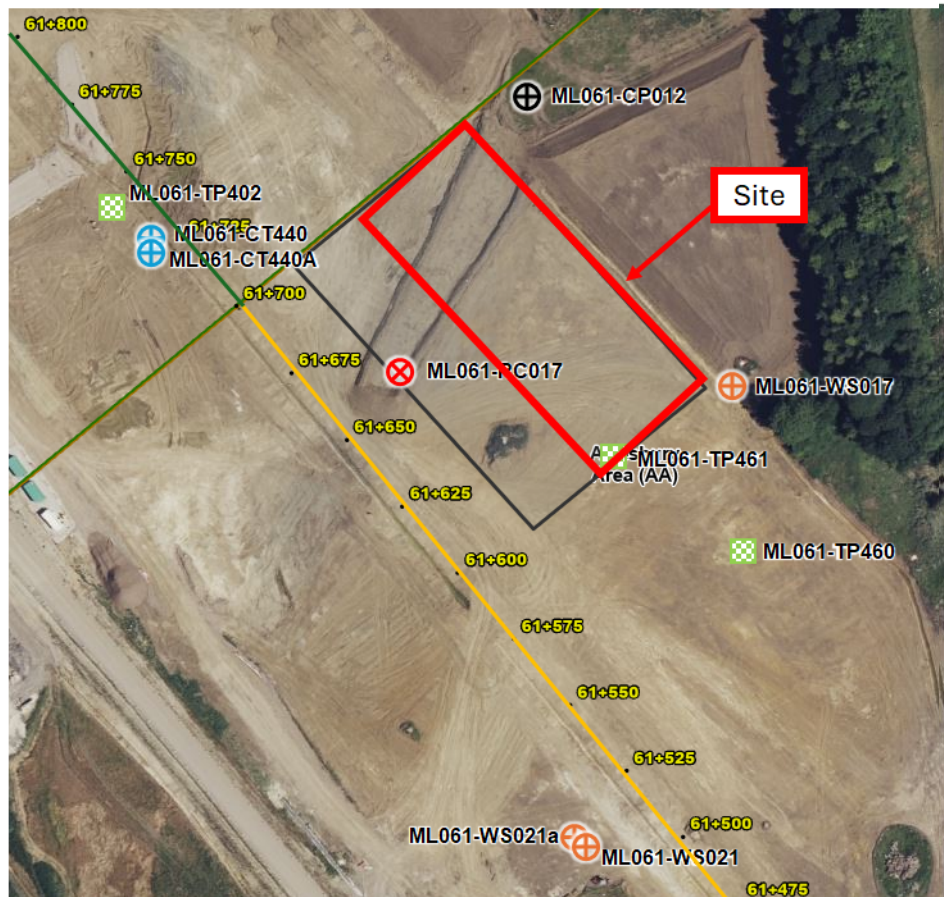
Figure 3-1 Exploratory Hole Location Plan (within 50m of the Site),

There is 1 exploratory hole within the footprint of the proposed re-use area (Site): ML061-TP461 and a further 9 exploratory hole locations within 50m of the Site (off-site) that have been reviewed. Ground conditions within the 10 exploratory holes on-site and off-site and considered to present similar ground conditions across the site. Ground conditions within the 10 exploratory holes are summarised in Table 2-5, and within the ground model in Section 3. Generalised geological cross sections and the exploratory hole logs are presented in Appendix II.
