Construction Quality Assurance Report (CQA) - Digestate Lagoon

The following is the CQA report for the digestate lagoon at Much Fawley Farm.

The report refers to the Digestate Storage lagoon at Much Fawley which is used to store digestate from the anaerobic digester and is the subject of a permit variation request.

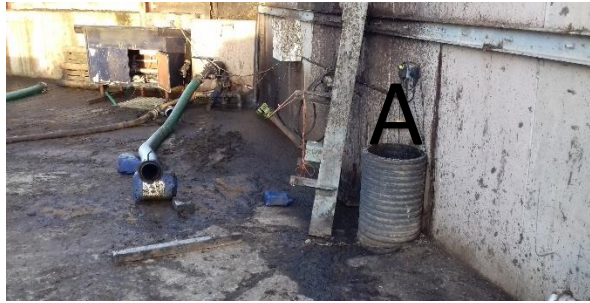
Leak detection has been installed as mitigation for the structure holding waste as per the attached plan. Installation as per Milbury Systems panels with perforated pipe behind membrane as stipulated. Leak detection is employed by groundwater testing from hydrostatic pressure outlet. Sample point located on southwest side of lagoon as indicated on drawing 01180-01-A-Construction Drawing "Digestate Lagoon" and capped to prevent contamination of the containment system. Design as per CIRIA 736. Location of leak detection sampling as in picture below – Marked as A.

Sampling as per maintenance section of Management System and as monitoring section above.

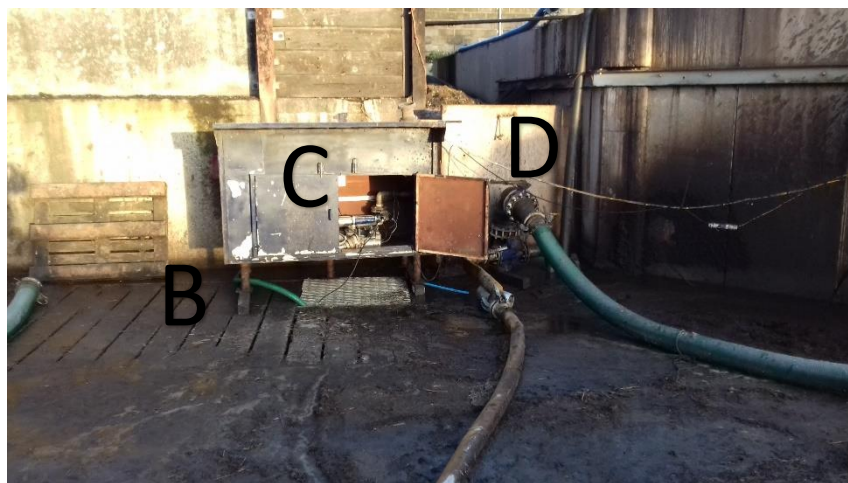
Picture below shows the reception pit for dirty water collection Marked B, Reception pit is automatically pumped over the top of the digestate store wall by the pump located in the central picture chest – marked as C. Pipe lengthened to reduce odours.

Digestate is removed from the store by the isolated extraction point right hand side of the chest – marked as D. Spills from the digestate extraction collected in reception pit and pumped back into store.
