## **Construction Quality Assurance Report (CQA) - Digestate Lagoon**

The following is the CQA report for the digestate lagoon at Much Fawley Farm.

The report refers to the Digestate Storage lagoon at Much Fawley which is used to store digestate from the anaerobic digester and is the subject of a permit variation request.

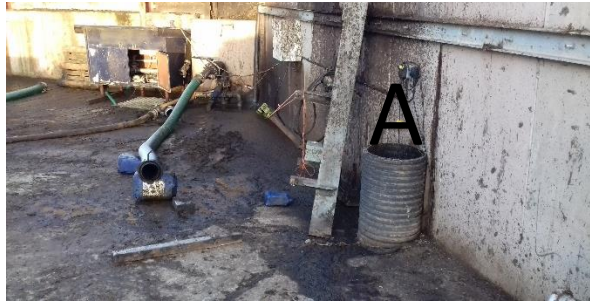
Leak detection has been installed as mitigation for the structure holding waste as per the attached plan. Installation as per Milbury Systems panels with perforated pipe behind membrane as stipulated. Leak detection is employed by groundwater testing from hydrostatic pressure outlet. Sample point located on southwest side of lagoon and capped to prevent contamination of the containment system. Design as per CIRIA 736. Location of leak detection sampling as in picture below – Marked as A.

Sampling as per maintenance section of Management System and as monitoring section above.

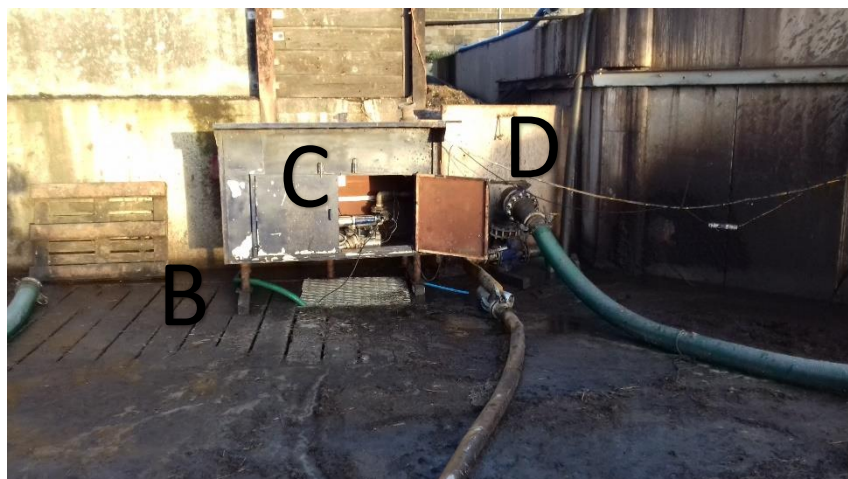
Picture below shows the reception pit for dirty water collection Marked B, Reception pit is automatically pumped over the top of the digestate store wall by the pump located in the central picture chest – marked as C. Pipe lengthened to reduce odours.

Digestate is removed from the store by the isolated extraction point right hand side of the chest – marked as D. Spills from the digestate extraction collected in reception pit and pumped back into store.
