Alkali Environmental Supplementary Information

Biowise Albion Lane Composting
Facility

Introduction

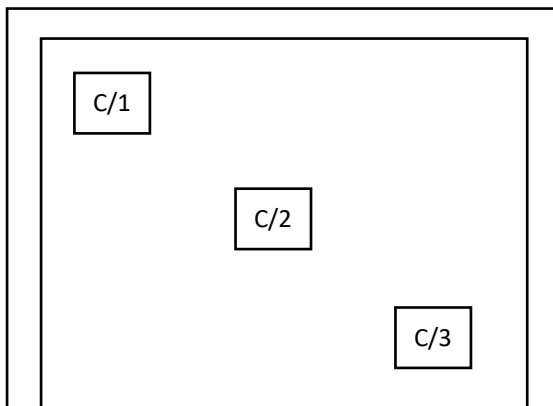
Diagram:

Fans Off

Samples in Order:

Odour: C/1, C/2, C/3

Ammonia, VOCs & Hydrogen Sulphide: C/2

- Fans off condition: a single air samples was taken from 3 of the 15 equal areas on a diagonal transect across each bay.
- Where possible the sample hood was positioned in the centre point of the grid area, however in some cases the hood position was moved slightly for technical and safety reasons:

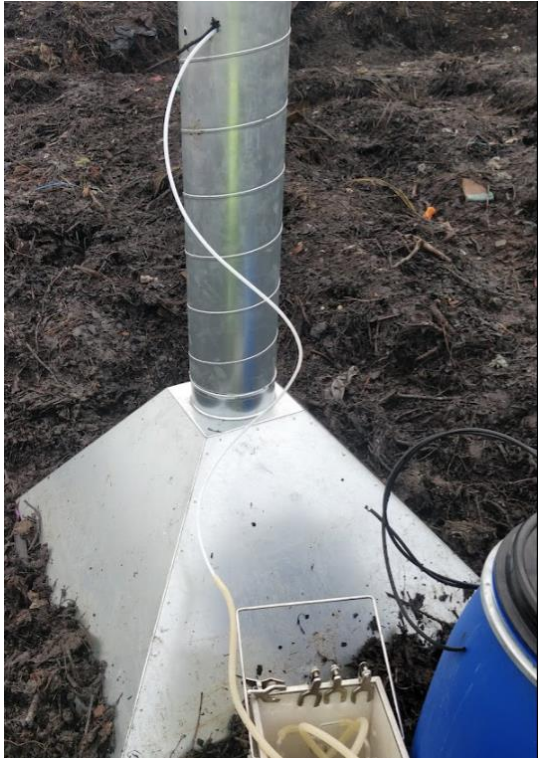
Sampling with the fans on was conducted using passive sampling hoods. Samples were taken from ports on the chimneys. Samples with the fans off were taken using ventilated sampling, samples were taken from the axis of the chimneys. Odour samples were taken using the lung principle from the respective hoods.

Sampling using a passive sampling hood
