Aldbrough 4z Borehole Support

Hydrogeological Impact Assessment

SSE Hornsea Ltd

SSE-5187736-200-RPT-003

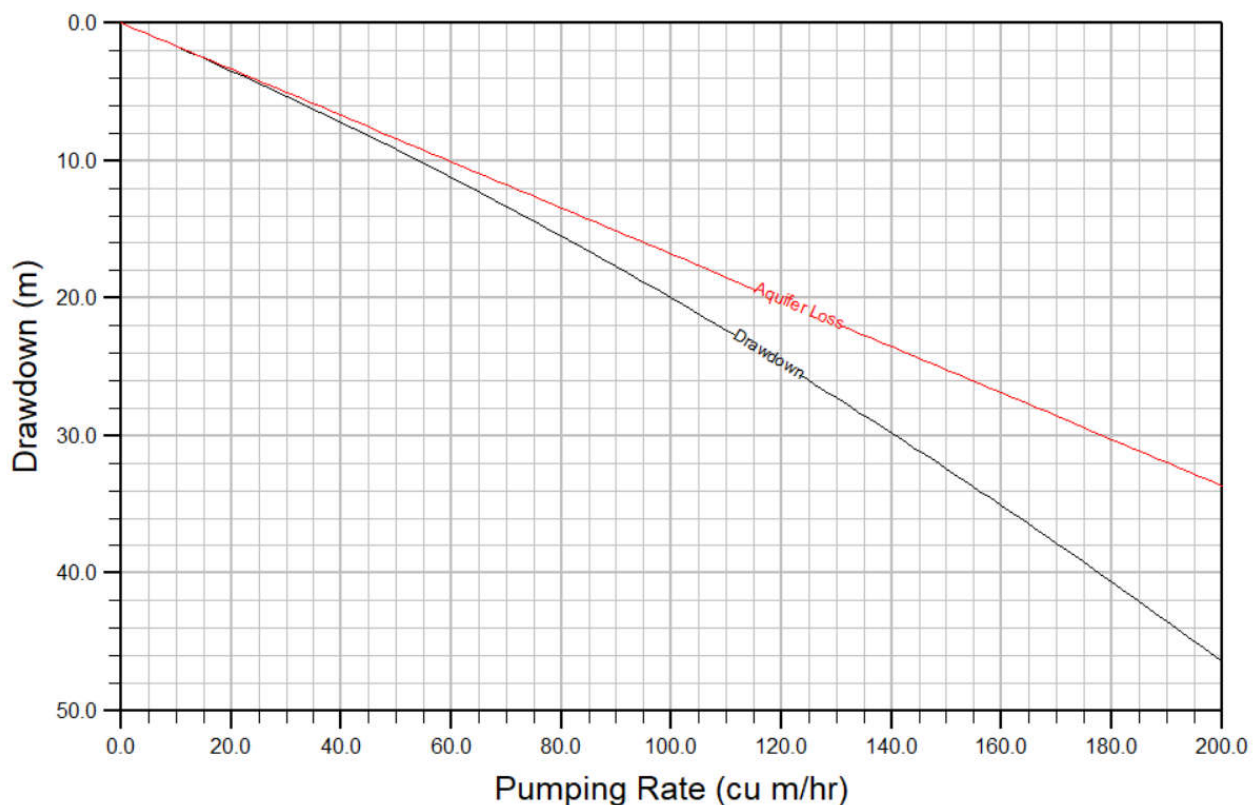
Figure 3-8 - Theoretical drawdown against pumping rate for 100 days of pumping

During the planned operation of the borehole it is likely to be pumped at periods of several weeks at a time, up to a maximum of 100 days. The predicted yield against drawdown for a pumping period of 100 days is shown in Figure 3-8. The likely maximum operational pumping rate is 125 m³/hr. At this flow rate, Figure 3-8 predicts approximately 26 m of drawdown for 100 days' pumping. Given that this method overestimated drawdown over a 7-day period compared to what was observed during the constant rate test, the 26 m estimate of drawdown will be an upper estimate.

Rest water levels in the borehole are generally between 0.85 m AOD and 1.05 m AOD. A drawdown of 26 m would take water levels to approximately -25 m AOD. The casing in the borehole extends to -33.07 m AOD (Table 2-3), so water levels are not expected to drop below the base of the casing.

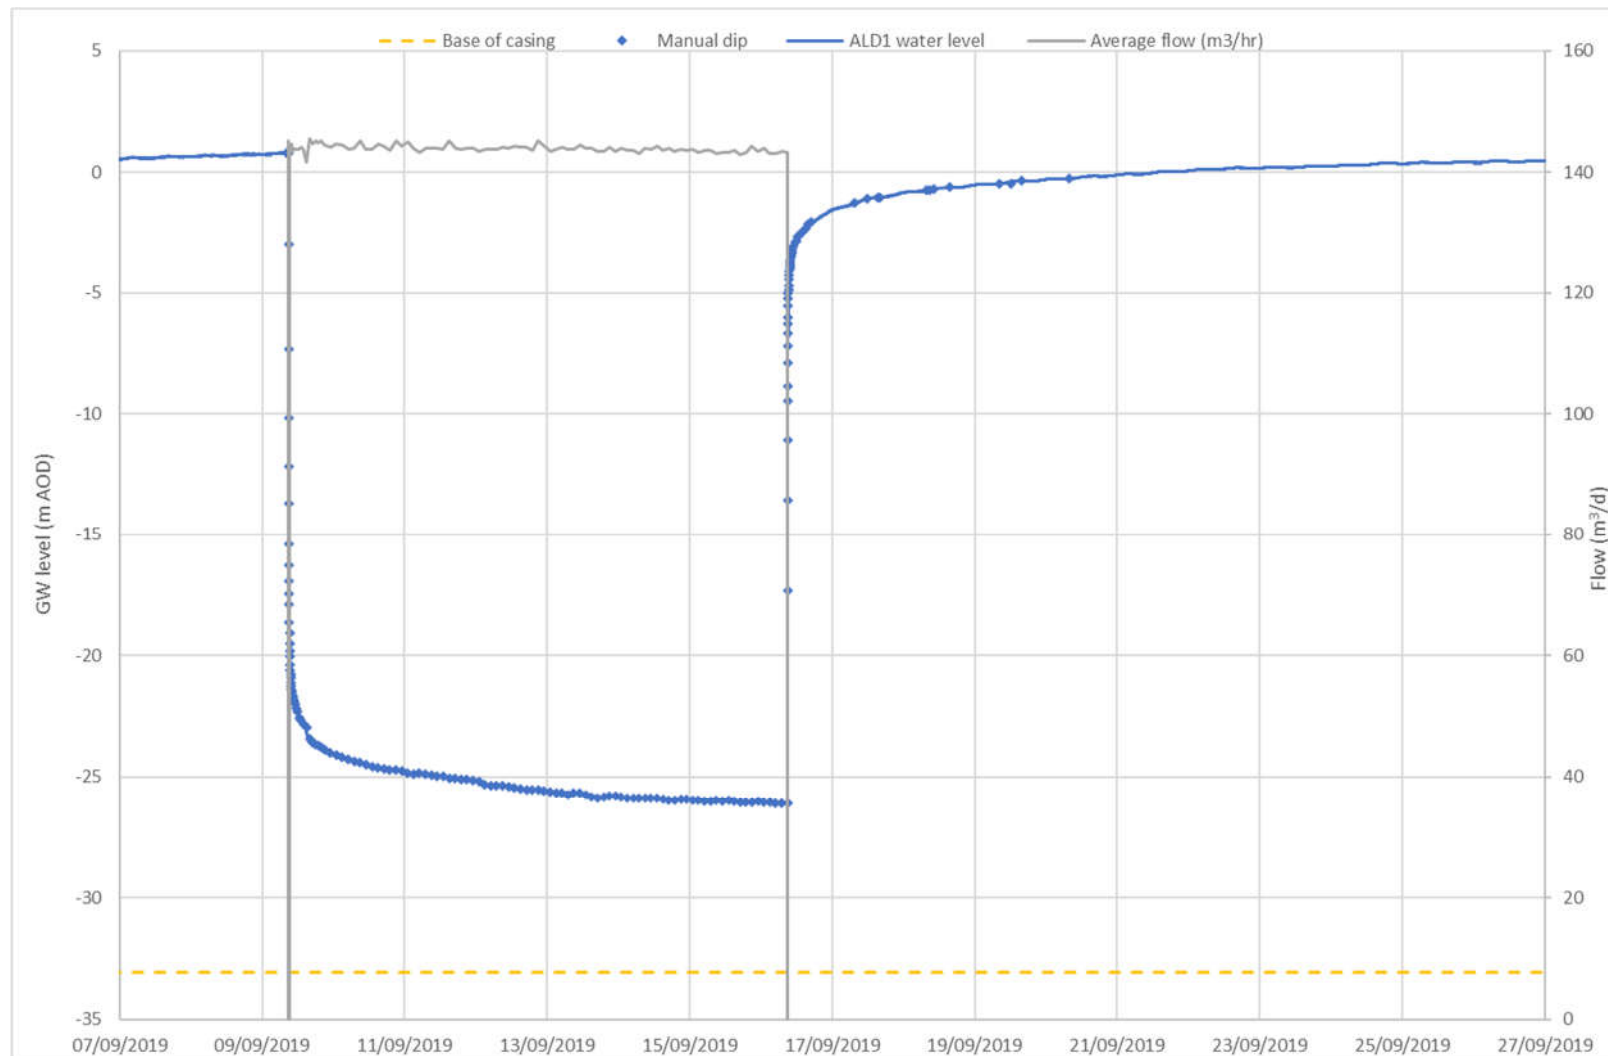
Figure 3-9 - Water levels at Aldbrough abstraction borehole during constant rate pumping test

Observed drawdown during the constant rate test at the pumping well is shown on Figure 3-9. Observed drawdown at Ringborough Farm is shown on Figure 3-10, and at Springfield Farm is shown on Figure 3-11. At both observation boreholes two loggers were installed in each well as a contingency measure, hence there are two water level lines on each chart. Maximum drawdown at each location is summarised in Table 3-1.

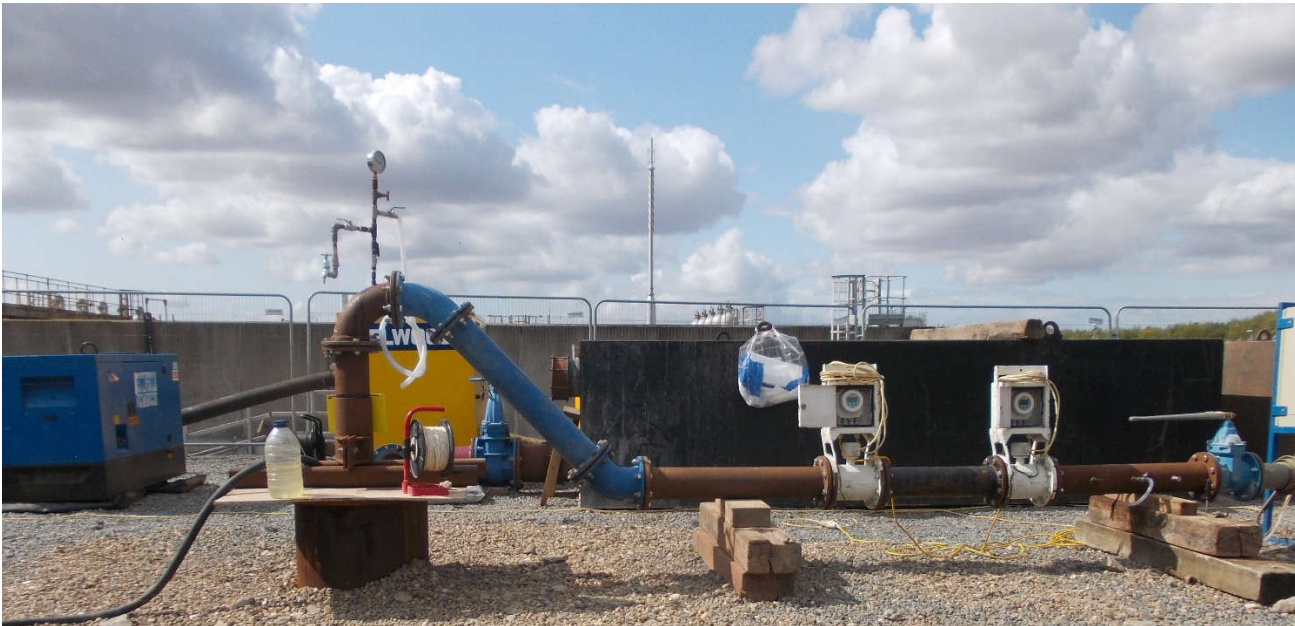
Photo 01: Abstraction borehole showing rising main and in-line flowmeters

Throughout the testing flows were monitored by two in-line electromagnetic flow meters. These were manually read throughout all phases of the testing, at the same time as manual dips for water levels were collected.

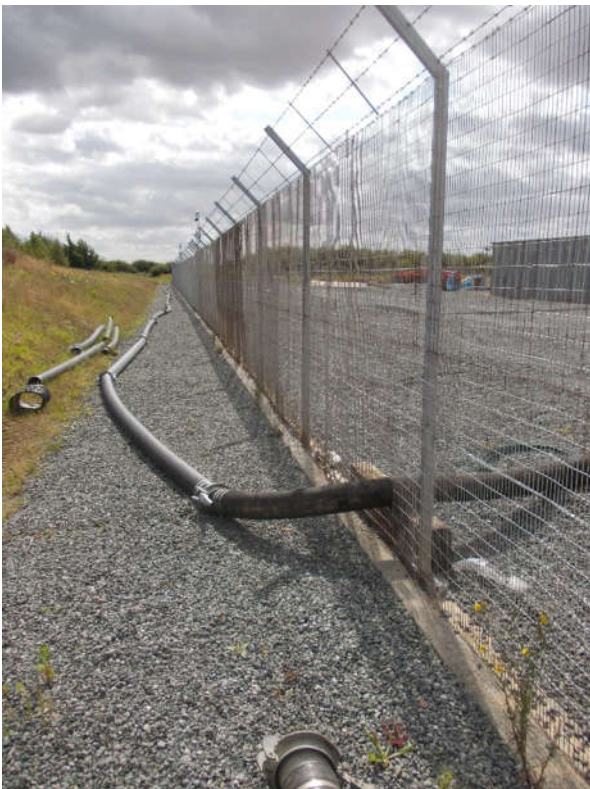
Photo 02: Discharge pipeline along compound boundary

Once the water being abstracted from the borehole was visibly clear and within acceptable limits for pH and EC it was pumped from the on-site tanks along a temporary discharge pipeline to a farm drainage ditch which flows into East Newton Drain, as shown on Figure 2-2. During the constant rate test the on-site tanks were removed and water was pumped directly to the discharge pipeline. SSE carried out daily checks at the discharge location during the test pumping to check that the water being discharged was visibly clear and that the receiving drain was not likely to flood.

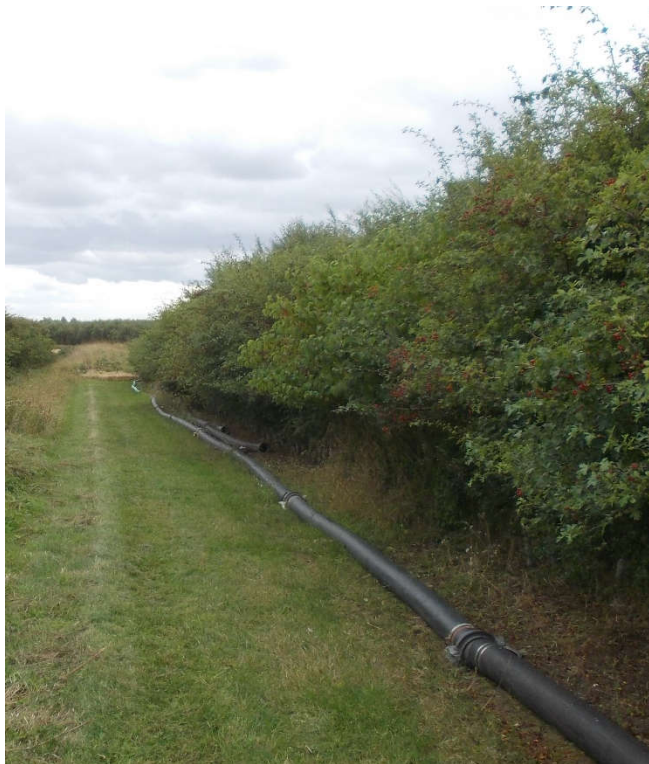
Photo 03: Discharge pipeline along compound boundary

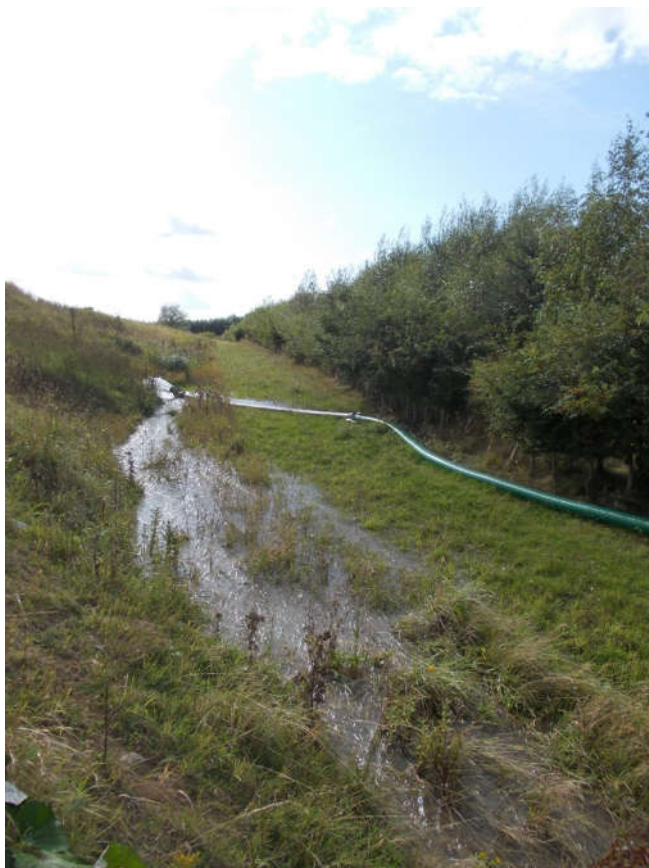
Photo 04: Discharge point

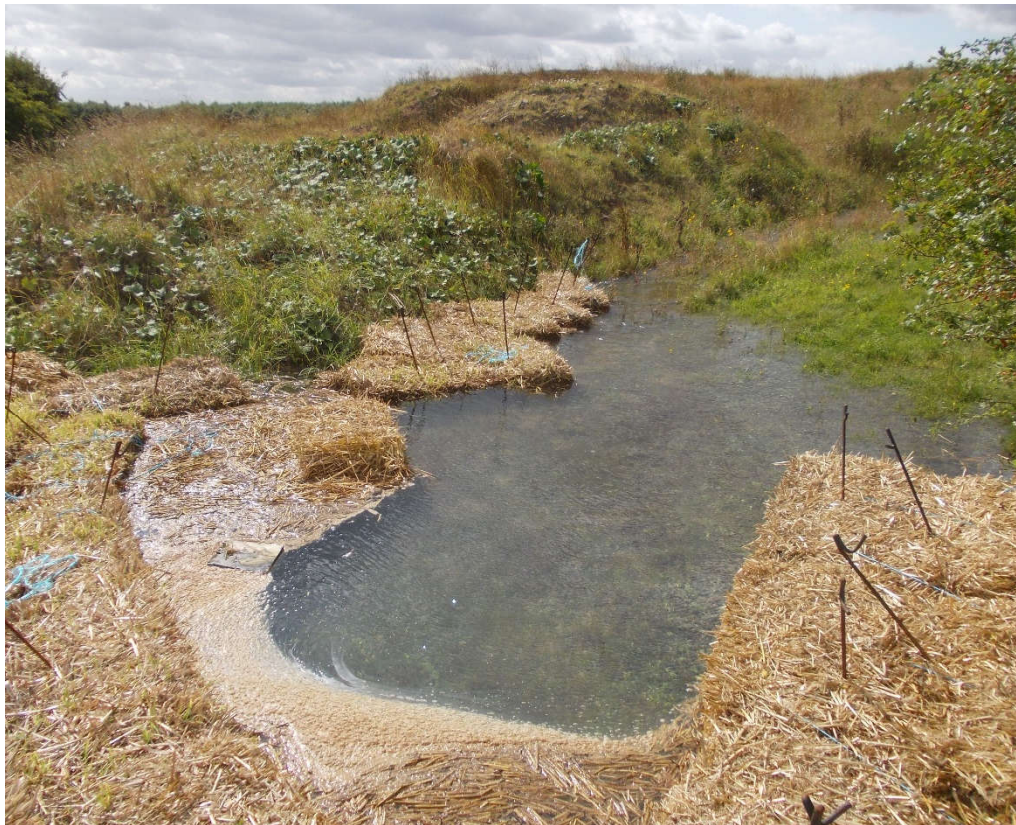
Photo 05: Straw bales dissipating water below discharge point

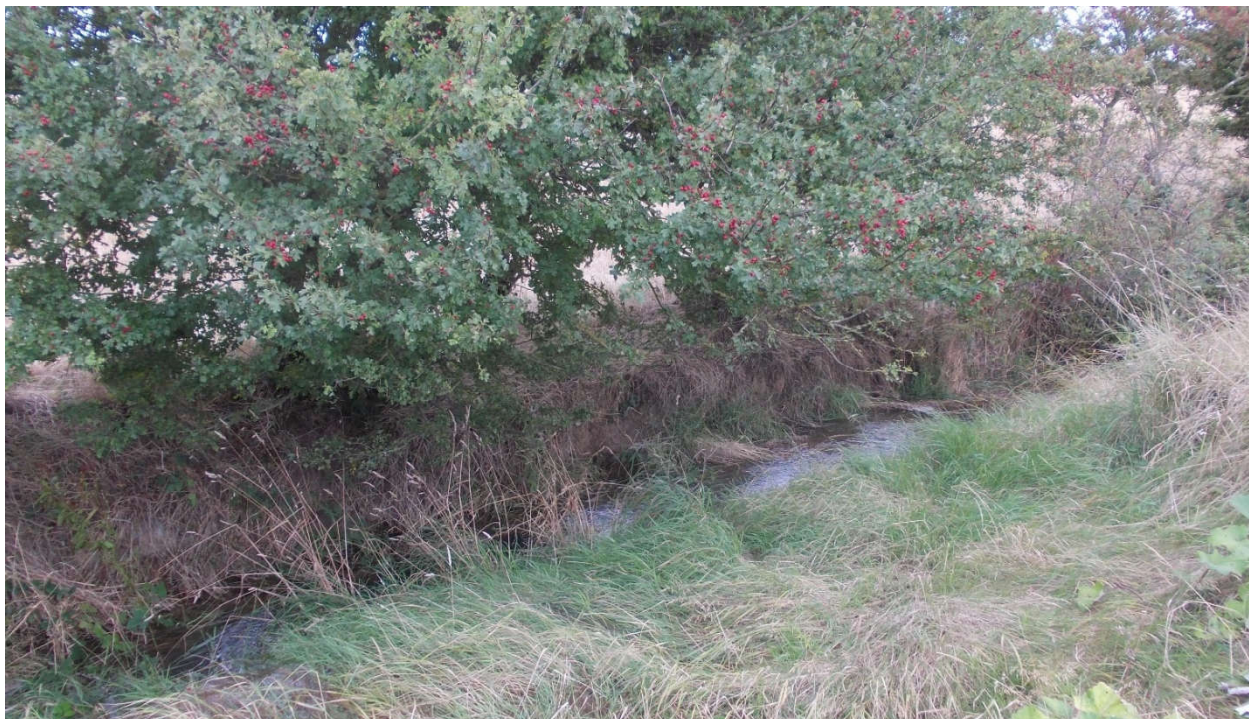
Photo 06: Receiving water course for discharge

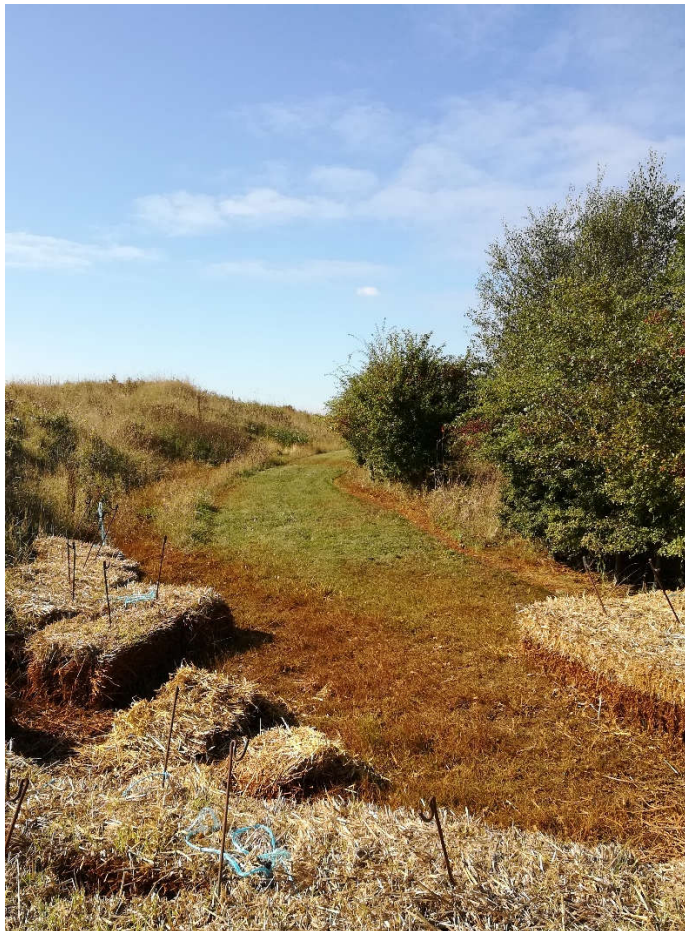
Photo 07: Orange staining in discharge area after pumping test is complete

Precipitation of iron and manganese may be accelerated if the top of the Chalk aquifer were dewatered around the borehole during pumping, due to oxygenation of the aquifer. The Eden- Hazel (1973) analysis indicates that the water level in the borehole would likely remain above the base of the casing throughout a 100-day pumped period, preventing dewatering of the Chalk, and therefore helping to reduce the amount of iron-manganese precipitation.
