**Geo-Environmental
Investigation & Assessment**

Barking Yard Redevelopment

Axion Polymers

Report Title:	Barking Yard Redevelopment Geo-environmental Investigation and Assessment
Report Reference:	8860G-WML-00-XX RP-G-001
Client:	Axion Polymers
Issue Date:	13th July 2020
Drafted By:	T P Booth

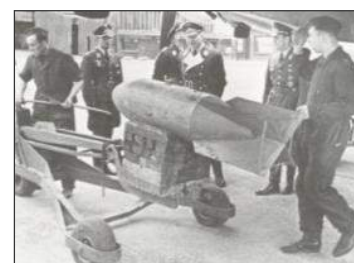
SC250 bomb being loaded onto German bomber

SC 250kg High Explosive Bomb

Bomb Weight	245-256kg (540-564lb)
Explosive Weight	125-130kg (276-287lb)
Fuze Type	Electrical impact/mechanical time delay fuze.
Bomb Dimensions	1640 x 512mm (64.57 x 20.16in)
Body Diameter	368mm (14.5in)
Use	Against railway installations, embankments, flyovers, underpasses, large buildings and below-ground installations.
Remarks	It could be carried by almost all German bomber aircraft, and was used to notable effect by the Junkers Ju-87 Stuka (Sturzkampfflugzeug or dive-bomber).

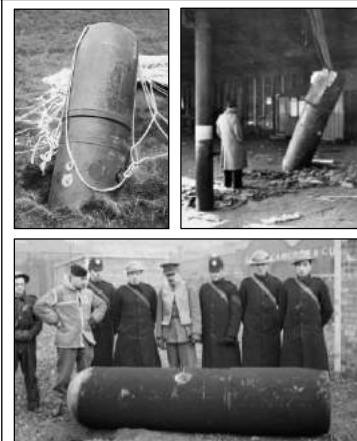
Parachute Mine (Luftmine B / LMB)

Bomb Weight	Approx. 990kg (2176lb)
Explosive Weight	Approx. 705kg (1,554lb)
Fuze Type	Impact/ Time delay / hydrostatic pressure fuze
Dimensions	2.64m x 0.64m (3.04m with parachute housing)
Use	Against civilian, military and industrial targets. Used as blast bombs and designed to detonate above ground level to maximise damage to a wider area.
Remarks	Deployed a parachute when dropped in order to control its descent. Had the potential to cause extensive damage in a 100m radius.

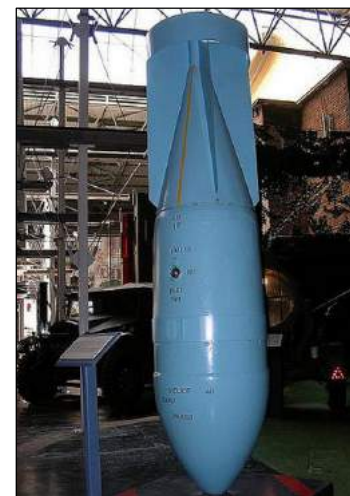
SC 1000kg

Bomb Weight	Approx. 993-1027kg (2,189-2,264lb)
Explosive Weight	Approx. 530-620kg (1168-1367lb)
Fuze Type	Electrical impact/mechanical time delay fuze.
Filling	Mixture of 40% amatol and 60% TNT, but when used as an anti-shipping bomb it was filled with Trialen 105, a mixture of 15% RDX, 70% TNT and 15% aluminium powder.
Bomb Dimensions	2800 x 654mm (110 x 25.8in)
Body Diameter	654mm (18.5in)
Use	SC type bombs are General Purpose Bombs used primarily for general demolition work. Constructed of parallel walls with comparatively heavy noses. They are usually of three piece welded construction

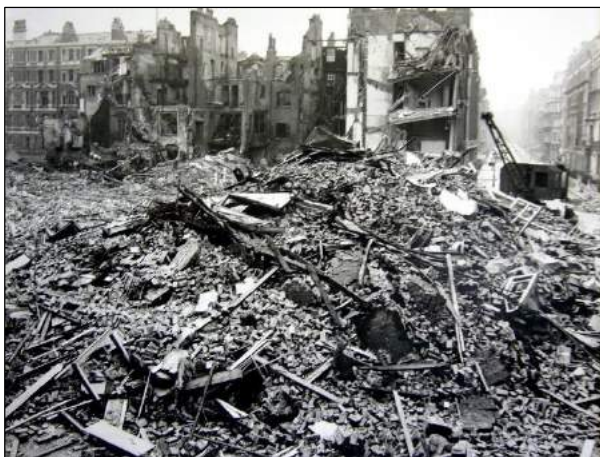
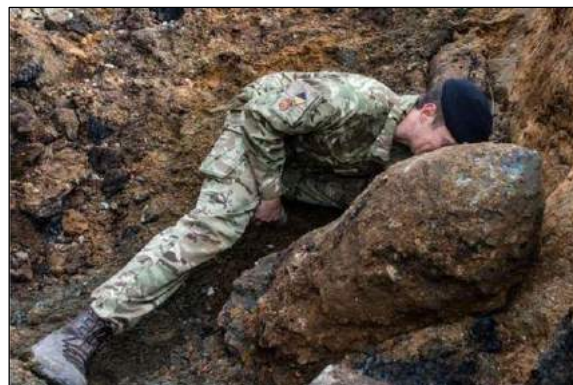
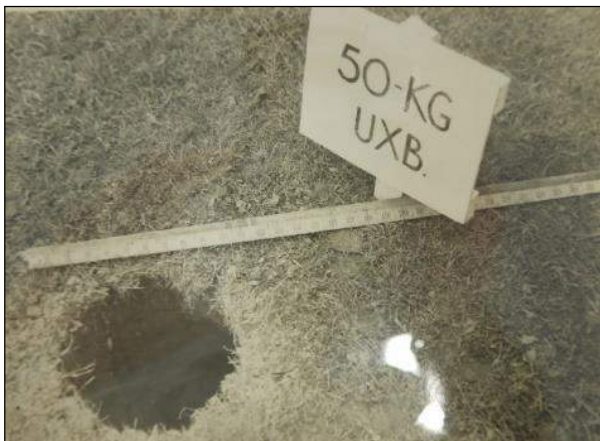
'J-Curve' Effect

Top: J-curve Effect - Due to angle of entry, unexploded bombs would often end their trajectory at a lateral offset from point of entry, often ending up beneath adjacent extant structures/sites. The photograph above shows 250kg bomb found in Bermondsey pointing upwards, demonstrating 'J-curve'

One of the most common scenarios for UXO going unnoticed was when a UXB fell into a 'bomb site' (such as the area shown **Top Left**), the entry hole of the bomb obscured by any debris and rubble present. Note that the entry hole of a 50kg UXB could be as little as 20cm in diameter (**Left**).

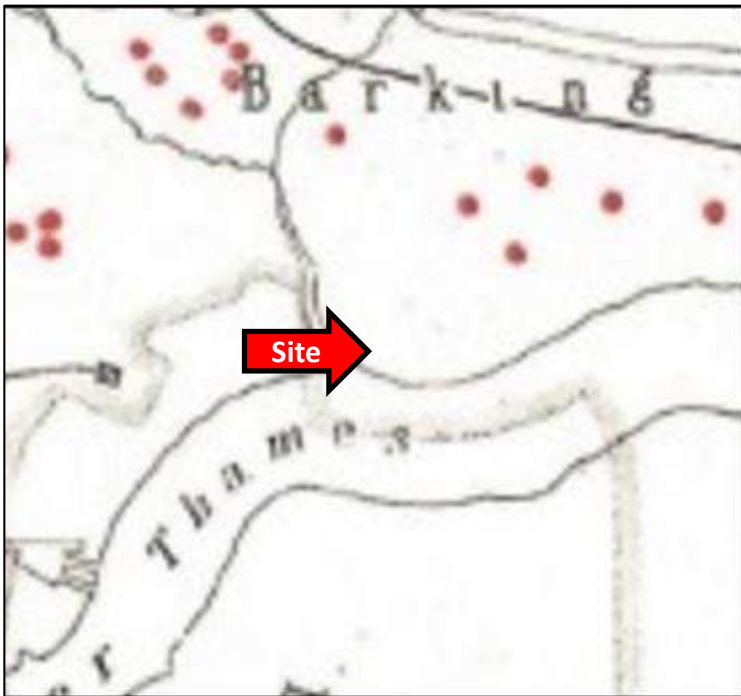
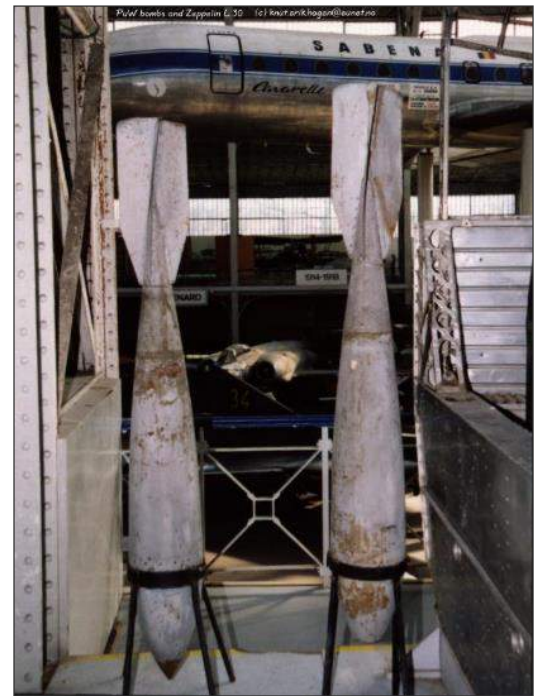
Examples of 50 and 100kg German WWI bombs

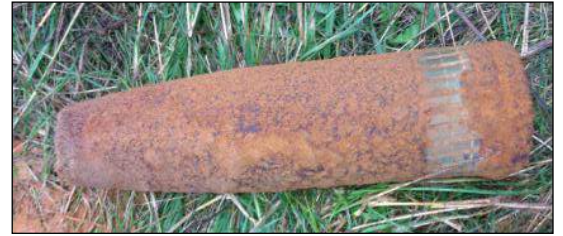
3.7 Inch QF Anti-Aircraft Projectile

Projectile Weight	28lb (12.6 kg)
Explosive Weight	2.52lbs
Fuze Type	Mechanical Time Fuze
Dimensions	3.7in x 14.7in (94mm x 360mm)
Rate of Fire	10 to 20 rounds per minute
Use	The 3.7in AA Mks 1-3 were the standard Heavy Anti-Aircraft guns of the British Army.
Ceiling	30,000ft to 59,000ft

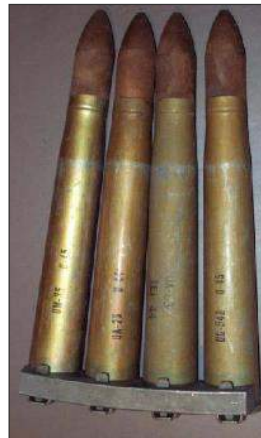
40mm Bofors Projectile

Projectile Weight	1.96lb (0.86kg)
Explosive Weight	300g (0.6lb)
Fuze Type	Impact Fuze
Rate of Fire	120 rounds per minute
Projectile Dimensions	40 x 180mm
Ceiling	23,000ft (7000m)
Remarks	Light quick fire high explosive anti-aircraft projectile. Each projectile fitted with small tracer element. If no target hit, shell would explode when tracer burnt out. Designed to engage aircraft flying below 2,000ft

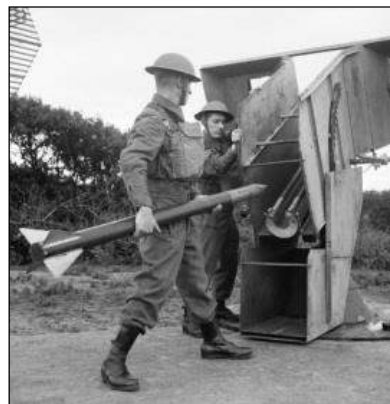
3in Unrotated Projectile (UP) Anti-Aircraft Rocket ("Z" Battery)

HE Projectile Weight	3.4kg (7.6lb)
Explosive Weight	0.96kg (2.13lb)
Filling	High Explosive – TNT. Fitted with aerial burst fuzing
Dimensions of projectile	236 x 83mm (9.29 x 3.25in)
Remarks	As a short range rocket-firing anti-aircraft weapon developed for the Royal Navy. It was used extensively by British ships during the early days of World War II. The UP was also used in ground-based single and 128-round launchers known as Z Batteries. Shell consists of a steel cylinder reduced in diameter at the base and threaded externally to screw into the shell ring of the rocket motor
