Detailed Unexploded Ordnance (UXO) Risk Assessment

Project Name	S. Norton & Sons, River Road, Barking
Client	WML Consulting
Site Address	River Road, Barking, London, IG11 0DS
Report Reference	DA10683-00
Date	1 st April 2020
Originator	CB

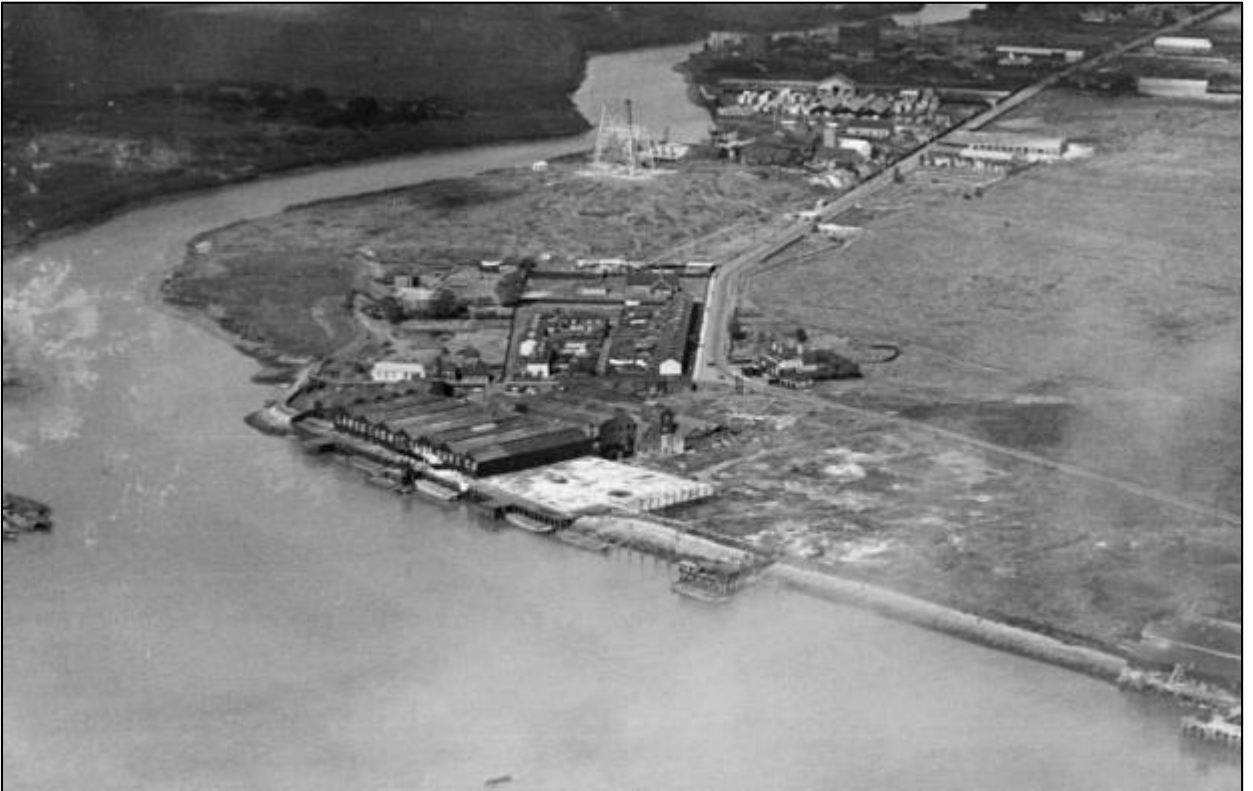
EPW036779 – The Lawes Chemical Co Works, the Barking Guano Works and environs, Creekmouth, from the south-east, 1931

During WWII, the site was occupied by the Lawes Chemical Company. Founded in 1857, the main factory and workmen's cottages were built at Barking Creek, Essex at some point prior to 1875. The business was purchased from Lawes in 1872 and incorporated as Lawes Chemical Manure Co. Ltd, to manufacture artificial fertilisers, sulphuric acid and other chemical fertilisers. The company became Lawes Chemical Co. Ltd. in 1935 and went into liquidation in 1969, the business continuing to trade under the name of Seabright Chemicals Ltd.

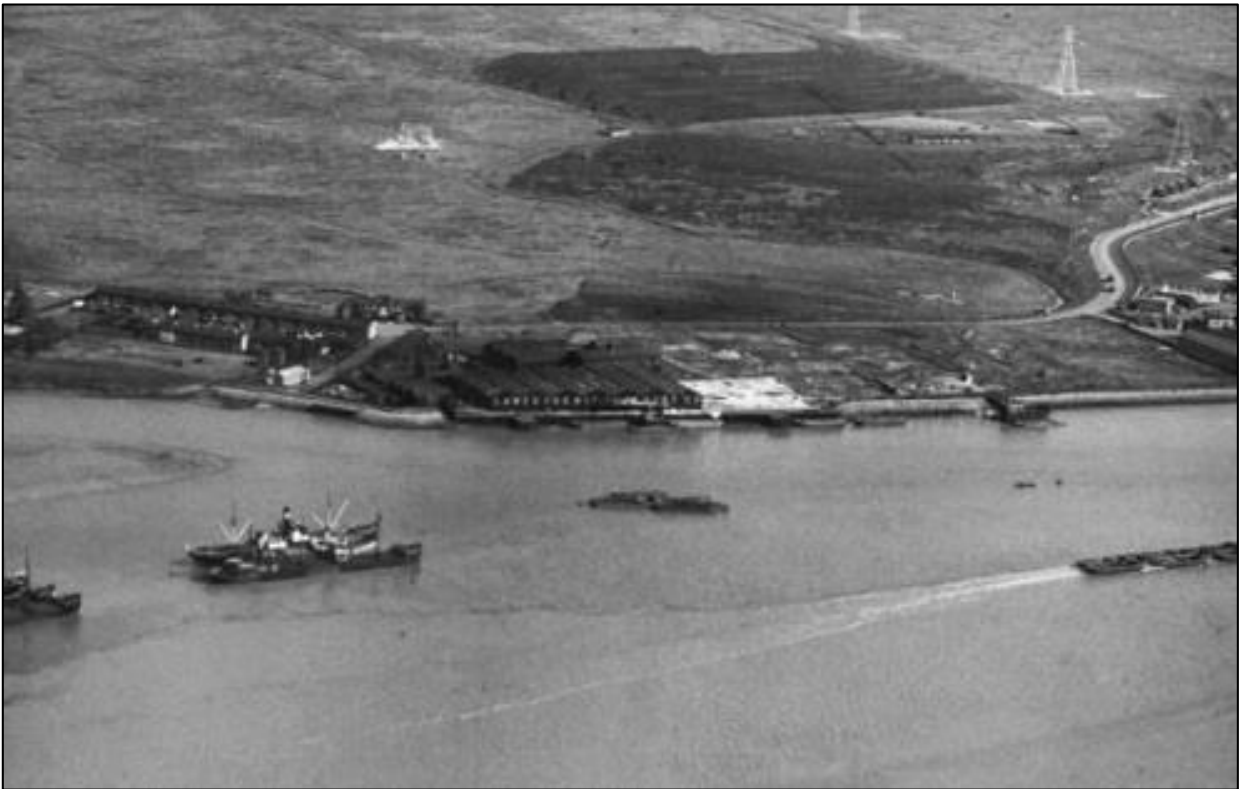
EPW036783 – The Lawes Chemical Co Works, pylons running across the Dagenham Marshes and environs, Creekmouth, from the south-west, 1931

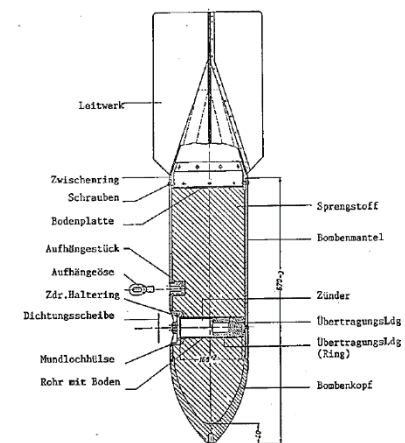
Bomb Weight	40-54kg (88-119lb)
Explosive Weight	25kg (55lb)
Fuze Type	Impact fuze/electro-mechanical time delay fuze
Bomb Dimensions	1,090 x 280mm (42.9 x 11.0in)
Body Diameter	200mm (7.87in)
Use	Against lightly damageable materials, hangars, railway rolling stock, ammunition depots, light bridges and buildings up to three stories.
Remarks	The smallest and most common conventional German bomb. Nearly 70% of bombs dropped on the UK were 50kg.

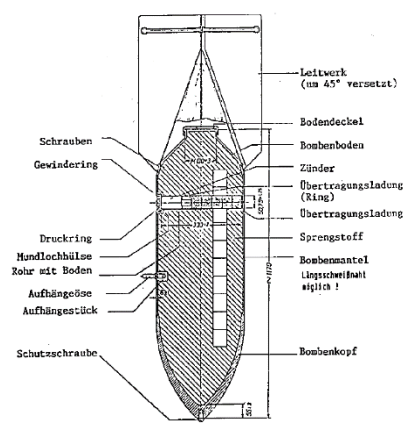
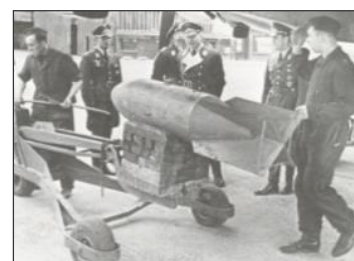
SC 250kg High Explosive Bomb

Bomb Weight	245-256kg (540-564lb)
Explosive Weight	125-130kg (276-287lb)
Fuze Type	Electrical impact/mechanical time delay fuze.
Bomb Dimensions	1640 x 512mm (64.57 x 20.16in)
Body Diameter	368mm (14.5in)
Use	Against railway installations, embankments, flyovers, underpasses, large buildings and below-ground installations.
Remarks	It could be carried by almost all German bomber aircraft, and was used to notable effect by the Junkers Ju-87 Stuka (Sturzkampfflugzeug or dive-bomber).

SC250 bomb being loaded onto German bomber

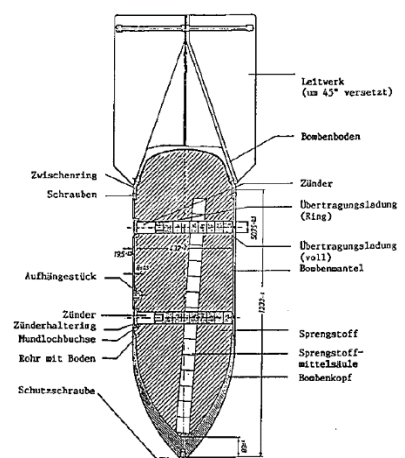
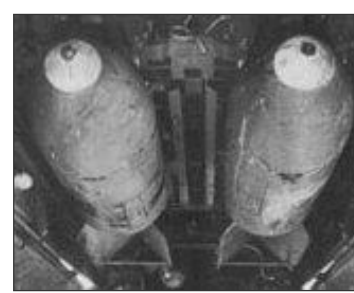
Bomb Weight	480-520kg (1,058-1,146lb)
Explosive Weight	250-260kg (551-573lb)
Fuze Type	Electrical impact/mechanical time delay fuze.
Bomb Dimensions	1957 x 640mm (77 x 25.2in)
Body Diameter	470mm (18.5in)
Use	Against fixed airfield installations, hangars, assembly halls, flyovers, underpasses, high-rise buildings and below-ground installations.
Remarks	40/60 or 50/50 Amatol TNT, trionalene. Bombs recovered with Trialen filling have cylindrical paper wrapped pellets 1-15/16 in. in length and diameter forming

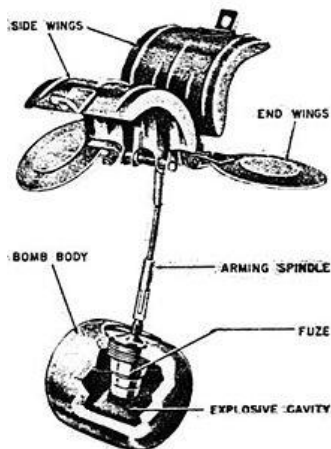
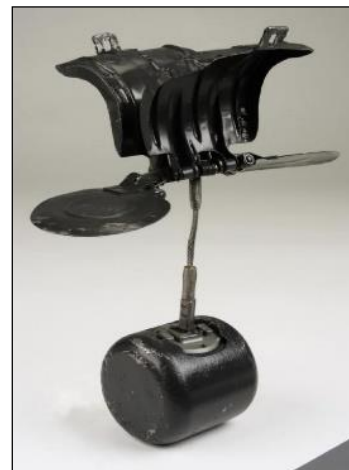
Bomb Weight	Approx. 2kg (4.41lb)
Explosive Weight	Approx. 7.5oz (225 grams) of Amatol surrounded by a layer of bituminous composition.
Fuze Type	41 fuze (time) , 67 fuze (clockwork time delay) or 70 fuze (anti-handling device)
Body Diameter	3in (7.62 cm) diameter, 3.1in (7.874) long
Use	Designed as an anti-personnel/ fragmentation weapon. They were delivered by air, being dropped in containers of 23-144 sub-munitions that opened at a predetermined height, thus scattering the bombs.
Remarks	Very rare. First used against Ipswich in 1940, but were also dropped on Kingston upon Hull, Grimsby and Cleethorpes in June 1943, amongst various other targets in UK. As the bombs fell the outer case flicked open by springs which caused four light metal drogues with a protruding 5 inch steel cable to deploy in the form of a parachute & wind vane which armed the device as it span.

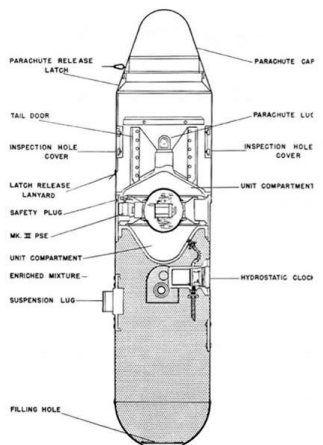
Parachute Mine (Luftmine B / LMB)

Bomb Weight	Approx. 990kg (2176lb)
Explosive Weight	Approx. 705kg (1,554lb)
Fuze Type	Impact/ Time delay / hydrostatic pressure fuze
Dimensions	2.64m x 0.64m (3.04m with parachute housing)
Use	Against civilian, military and industrial targets. Used as blast bombs and designed to detonate above ground level to maximise damage to a wider area.
Remarks	Deployed a parachute when dropped in order to control its descent. Had the potential to cause extensive damage in a 100m radius.

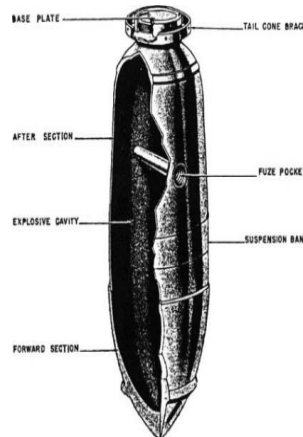
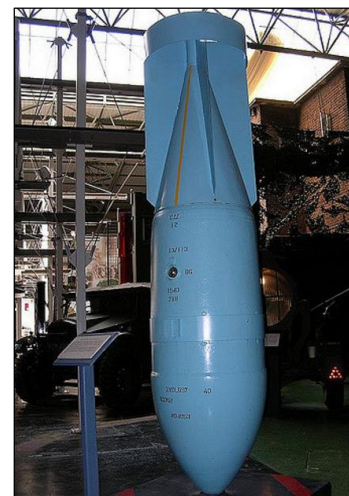
SC 1000kg

Bomb Weight	Approx. 993-1027kg (2,189-2,264lb)
Explosive Weight	Approx. 530-620kg (1168-1367lb)
Fuze Type	Electrical impact/mechanical time delay fuze.
Filling	Mixture of 40% amatol and 60% TNT, but when used as an anti-shiping bomb it was filled with Trialen 105, a mixture of 15% RDX, 70% TNT and 15% aluminium powder.
Bomb Dimensions	2800 x 654mm (110 x 25.8in)
Body Diameter	654mm (18.5in)
Use	SC type bombs are General Purpose Bombs used primarily for general demolition work. Constructed of parallel walls with comparatively heavy noses. They are usually of three piece welded construction

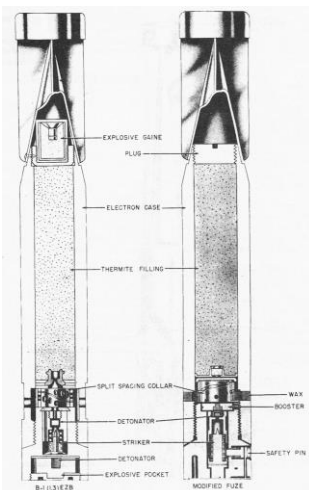
Bomb Weight	Approx. 1.0 - 1.3kg (2.2 and 2.9lb)
Explosive Weight	Approx. 680g (1.5lb) Thermite 8-15gm Explosive Nitropenta
Fuze Type	Impact fuze
Bomb Dimensions	350 x 50mm (13.8 x 1.97in)
Body Diameter	50mm (1.97in)
Use	As incendiary – dropped in clusters on towns and industrial complexes
Remarks	Magnesium alloy case. Sometimes fitted with high explosive charge. The body is a cylindrical alloy casting threaded internally at the nose to receive the fuze holder and fuze.

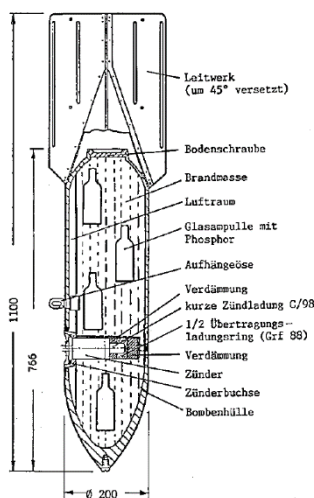
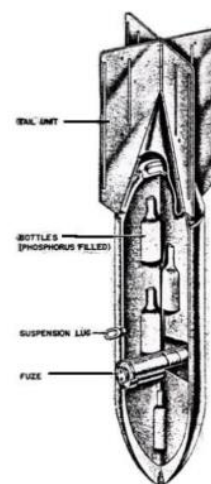
C50 A Incendiary Bomb

Bomb Weight	Approx. 41kg (90.4lb)
Explosive Weight	Approx. 0.03kg (0.066lb)
Incendiary Filling	12kg (25.5lb) liquid filling with phosphor igniters in glass phials. Benzine 85%; Phosphorus 4%; Pure Rubber 10%
Fuze Type	Electrical impact fuze
Bomb Dimensions	1,100 x 280mm (43.2 x 8in)
Use	Against any targets where an incendiary effect is required
Remarks	Early fill was a phosphorus/carbon disulphide incendiary mixture

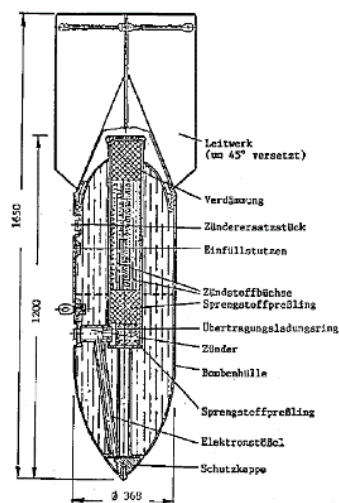
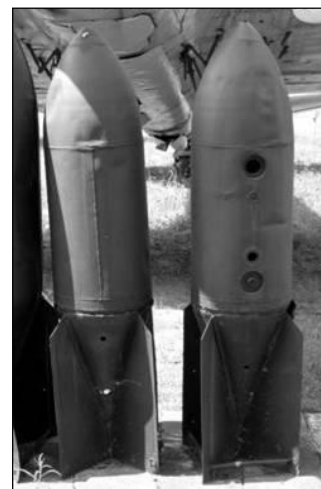
Flam C-250 Oil Bomb

Bomb Weight	Approx. 125kg (276lb)
Explosive Weight	Approx. 1kg (2.2lb)
Fuze Type	Super-fast electrical impact fuze
Filling	Mixture of 30% petrol and 70% crude oil
Bomb Dimensions	1,650 x 512.2mm (65 x 20.2in)
Body Diameter	368mm (14.5in)
Use	Often used for surprise attacks on ground troops, against troop barracks and industrial installations. Thin casing – not designed for ground penetration

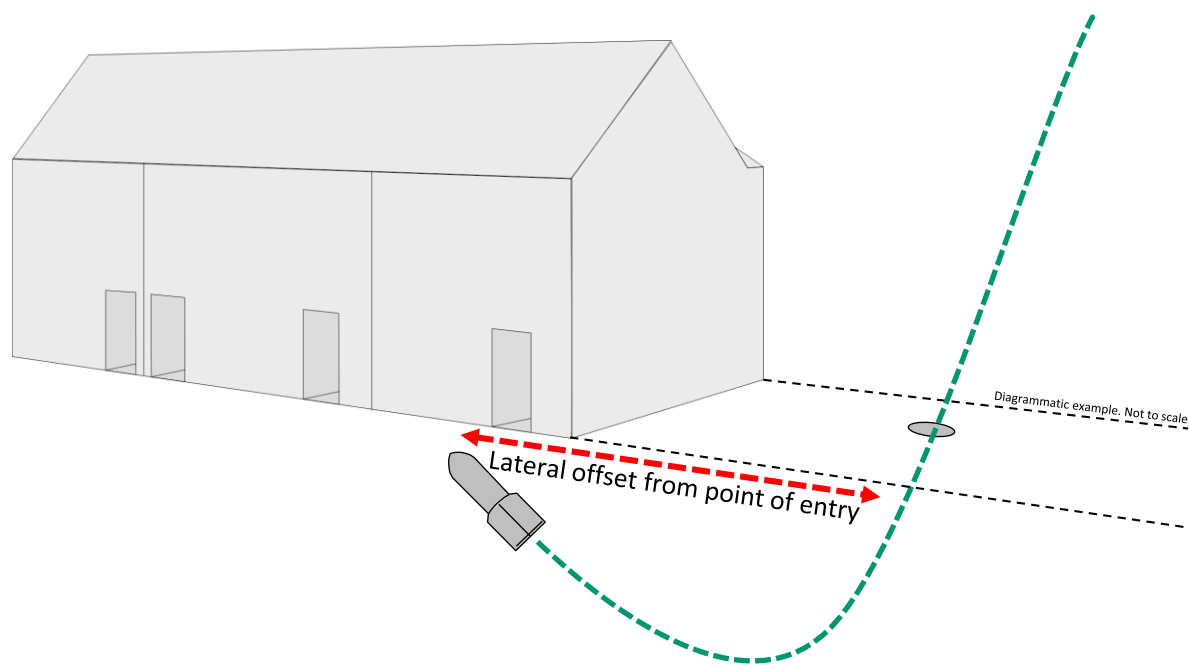
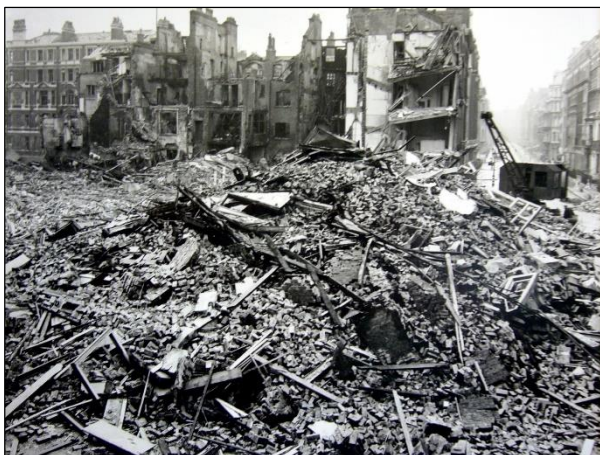
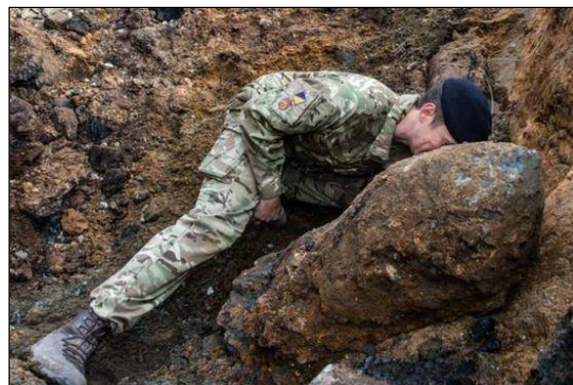
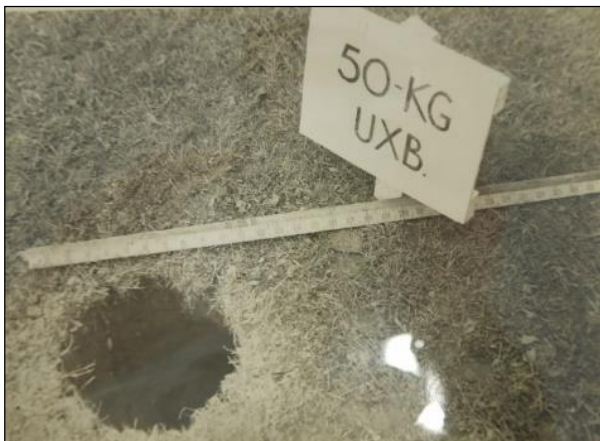
'J-Curve' Effect

Top: J-curve Effect - Due to angle of entry, unexploded bombs would often end their trajectory at a lateral offset from point of entry, often ending up beneath adjacent extant structures/sites. The photograph above shows 250kg bomb found in Bermondsey pointing upwards, demonstrating 'J-curve'

One of the most common scenarios for UXO going unnoticed was when a UXB fell into a 'bomb site' (such as the area shown **Top Left**), the entry hole of the bomb obscured by any debris and rubble present. Note that the entry hole of a 50kg UXB could be as little as 20cm in diameter (**Left**).

J-curve is the term used to describe the characteristic curve commonly followed by an aerial delivered bomb dropped from height after it penetrates the ground. Typically, as the bomb is slowed by its passage through underlying soils, its trajectory curves towards the surface. Many UXBs are found with their nose cone pointing upwards as a result of this effect. More importantly, however, is the resulting horizontal offset from the point of entry. This is typically a distance of about one third of the bomb's penetration depth, but can be higher in certain conditions (see **Annex G**).

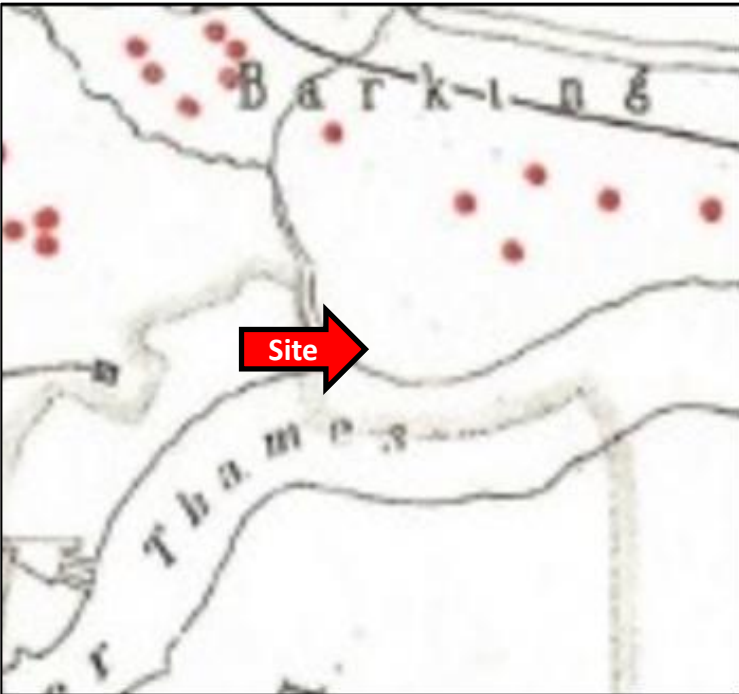
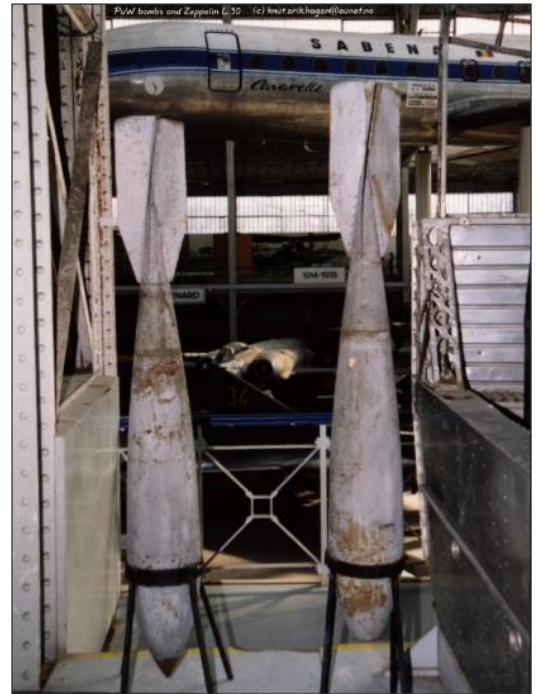
Examples of 50 and 100kg German WWI bombs

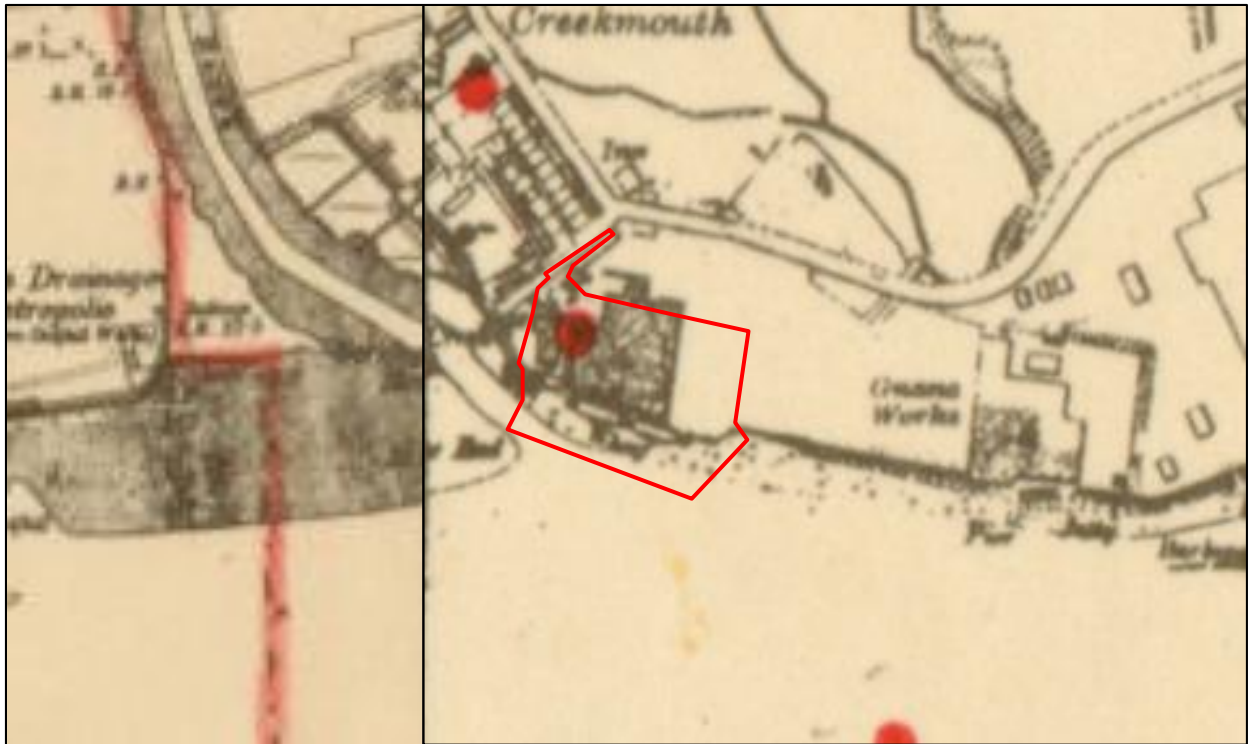
Night Bombing up to 7th October 1940

●● Recorded bomb strike

- London bomb census mapping and local bomb plot mapping both record incidents within and immediately adjacent to the site area, including HE bomb strikes in the centre of the boundary and to the immediate north and north-west. An anti-aircraft shell is also recorded on the north-western border. However, whilst analysing available written records, no references to incidents occurring within the site area were found. It should be noted that the available written records were often ambiguous regarding the locations of incidents.

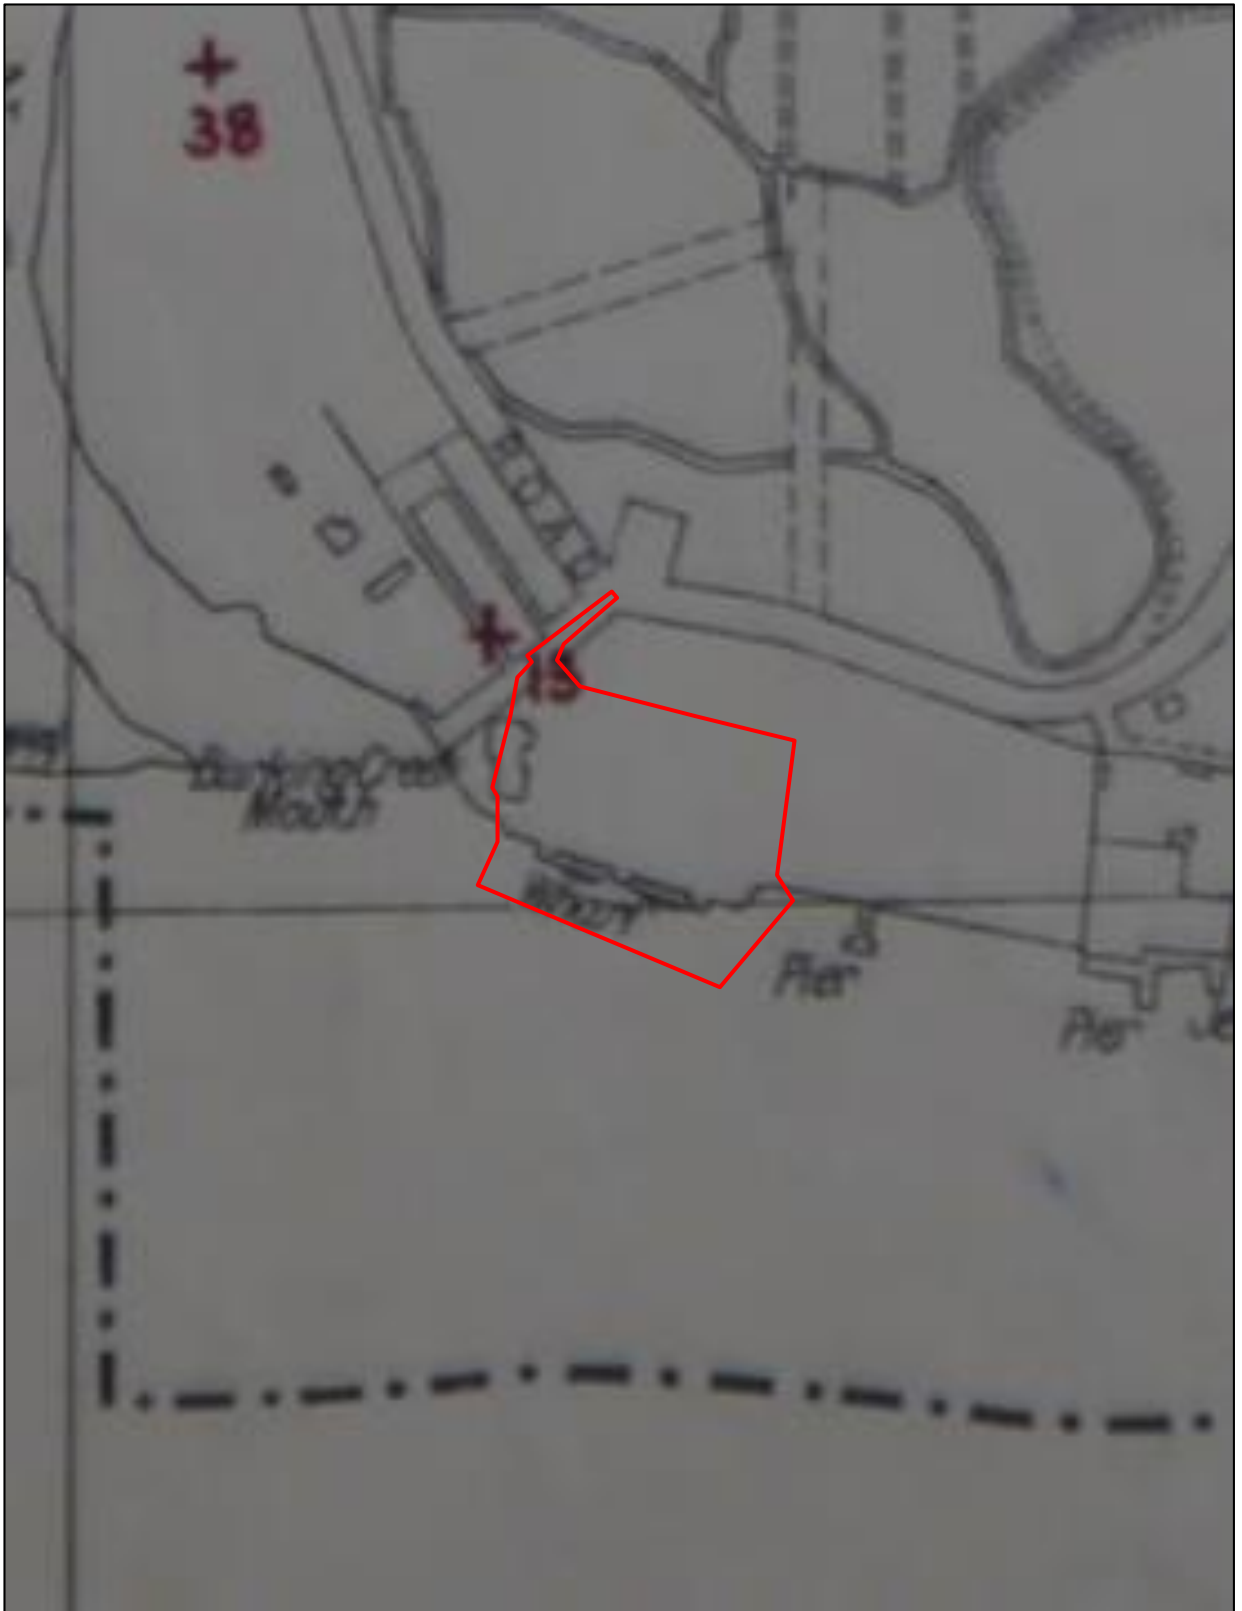
Recorded AA Shell

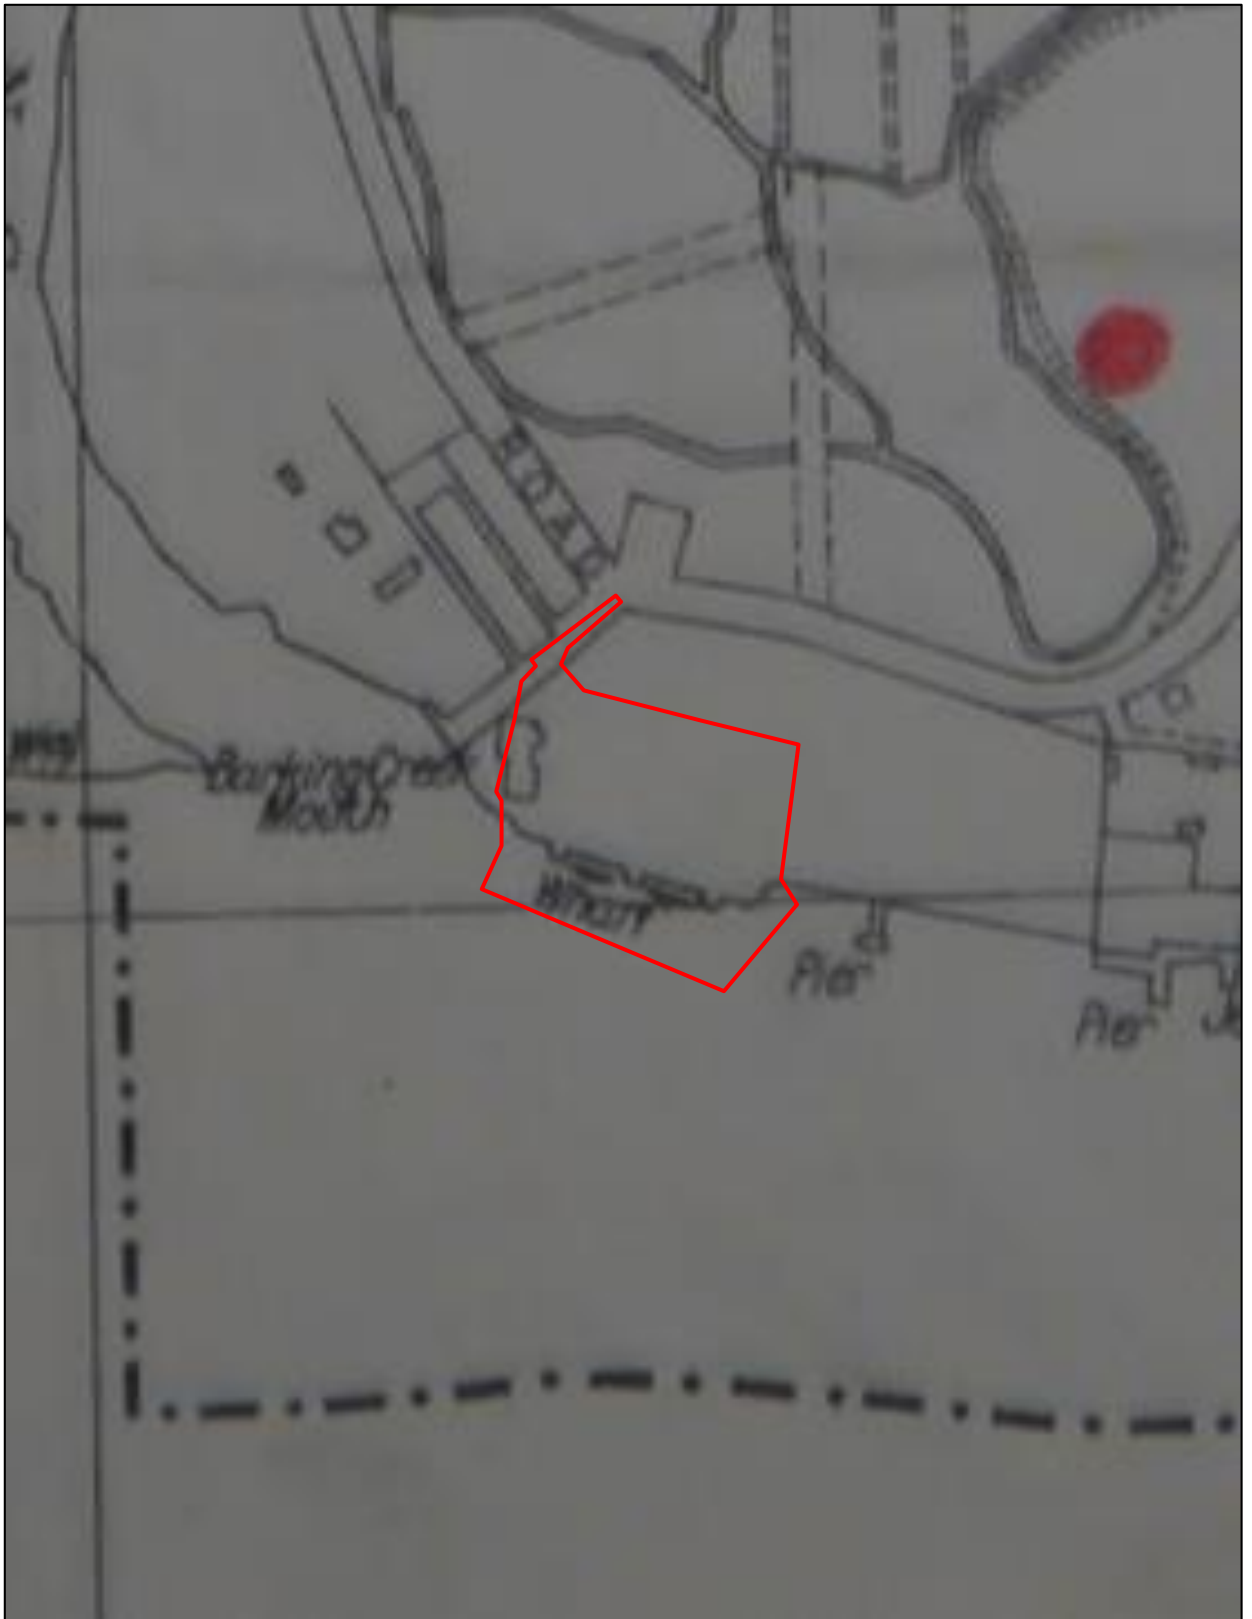
● Recorded V-1 Pilotless Aircraft strike

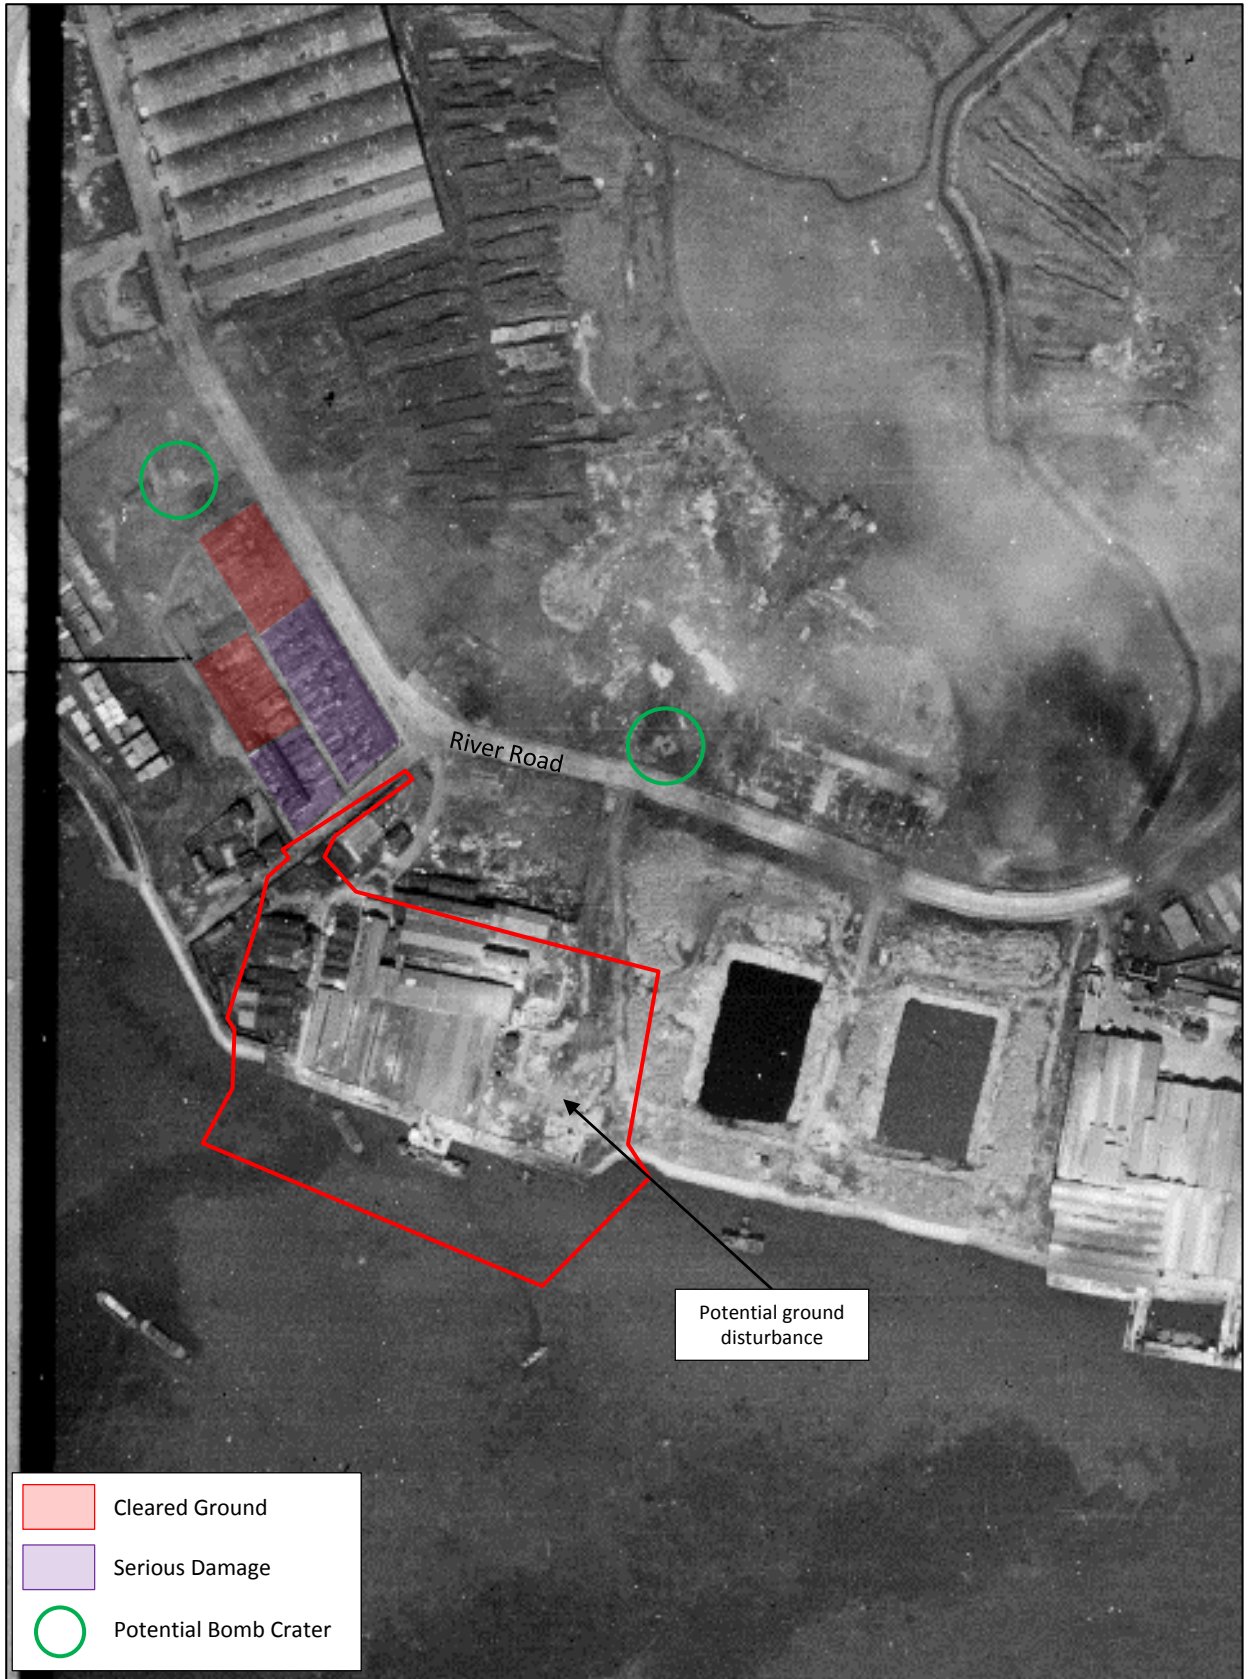
Source: National Monuments Record Office (Historic England)

Cleared Ground
	Serious Damage
	Potential Bomb Crater

- Aerial photography taken in 1941 does not identify any obvious areas of structural clearance or significant damage within the site footprint. However, when comparing with post-WWII photography taken in 1946, whilst the general composition of the site area does not alter, there is evidence suggesting that structures present on site sustained bomb damage i.e. repairs to roofing. However, given the limitations of the available record set, the exact extent of any damage is unknown.

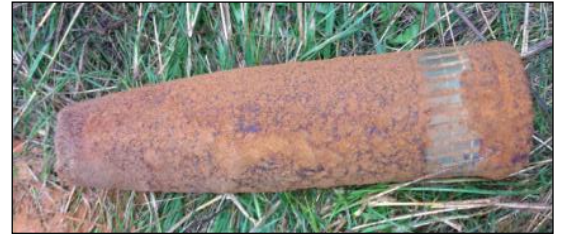
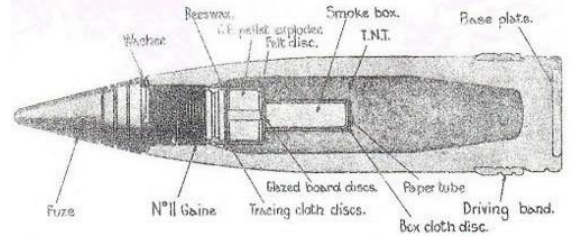
Projectile Weight	28lb (12.6 kg)
Explosive Weight	2.52lbs
Fuze Type	Mechanical Time Fuze
Dimensions	3.7in x 14.7in (94mm x 360mm)
Rate of Fire	10 to 20 rounds per minute
Use	The 3.7in AA Mks 1-3 were the standard Heavy Anti-Aircraft guns of the British Army.
Ceiling	30,000ft to 59,000ft

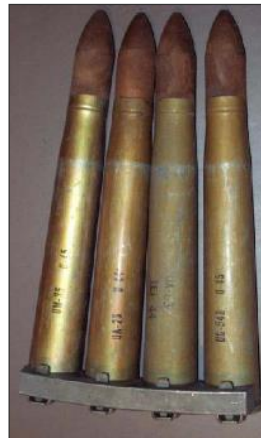
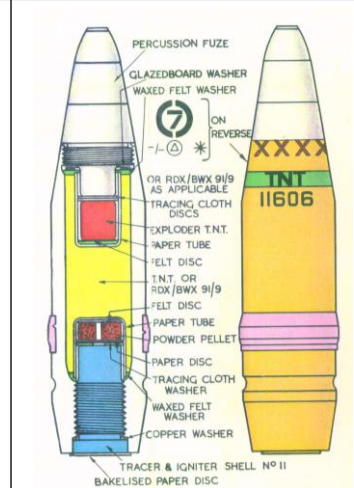
40mm Bofors Projectile

Projectile Weight	1.96lb (0.86kg)
Explosive Weight	300g (0.6lb)
Fuze Type	Impact Fuze
Rate of Fire	120 rounds per minute
Projectile Dimensions	40 x 180mm
Ceiling	23,000ft (7000m)
Remarks	Light quick fire high explosive anti-aircraft projectile. Each projectile fitted with small tracer element. If no target hit, shell would explode when tracer burnt out. Designed to engage aircraft flying below 2,000ft

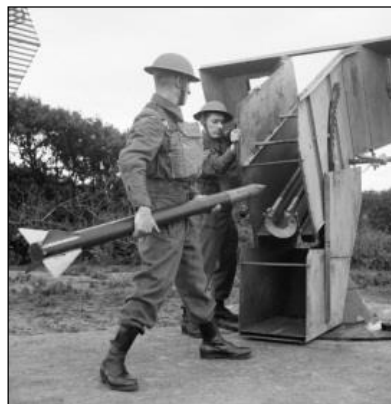
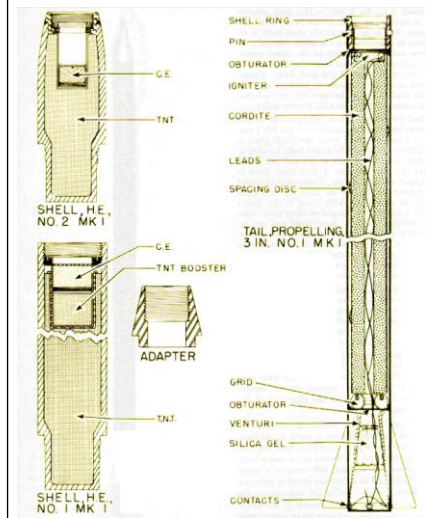
3in Unrotated Projectile (UP) Anti-Aircraft Rocket ("Z" Battery)

HE Projectile Weight	3.4kg (7.6lb)
Explosive Weight	0.96kg (2.13lb)
Filling	High Explosive – TNT. Fitted with aerial burst fuzing
Dimensions of projectile	236 x 83mm (9.29 x 3.25in)
Remarks	As a short range rocket-firing anti-aircraft weapon developed for the Royal Navy. It was used extensively by British ships during the early days of World War II. The UP was also used in ground-based single and 128-round launchers known as Z Batteries. Shell consists of a steel cylinder reduced in diameter at the base and threaded externally to screw into the shell ring of the rocket motor
