# **SITE CONDITION REPORT**

## **West Lay Ltd**

| <b>1.0 SITE DETAILS</b> | |
|---|---|
| Document reference and dates for Site Condition Report at permit application and surrender | 321890 Site Condition report (May 26, 1.0). |

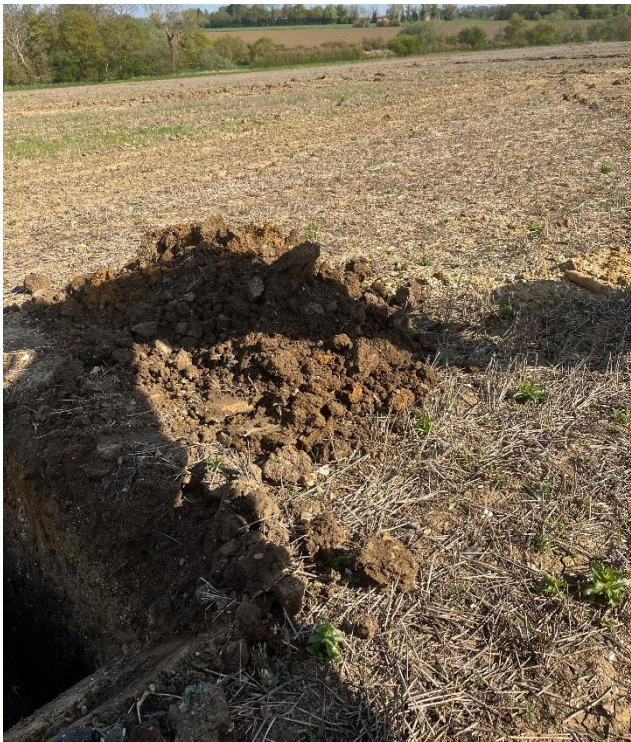
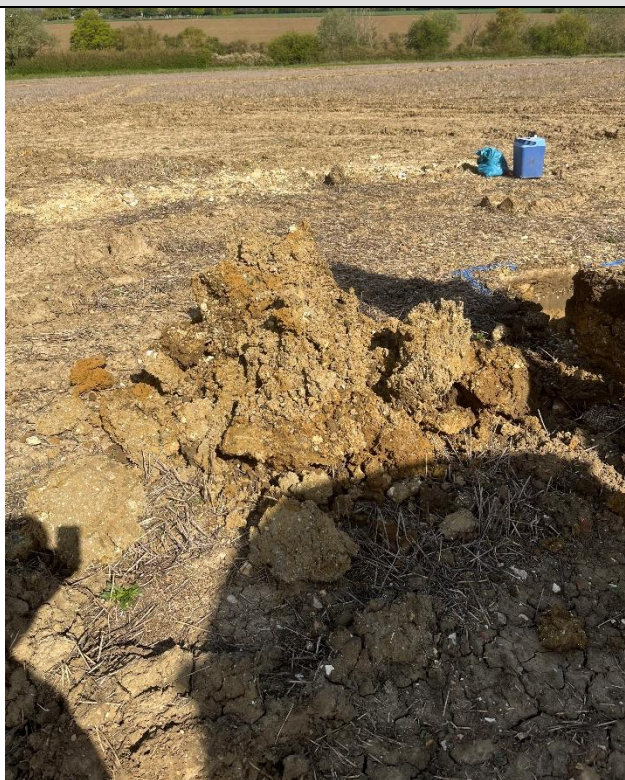
| 2.0 Condition of the land at permit issue | |
|---|---|
| | <p>strata can support local water supplies and may form an important source of base flow to rivers.</p> <p>The site is in a total catchment Source Protection Zone (MAGIC, 260326). This is the area around a supply source within which all the groundwater ends up at the abstraction point.</p> <p>The site is in an area mapped as being of medium groundwater vulnerability (MAGIC, 250326) i.e. at medium risk to a pollutant discharged at ground level. These are areas that offer some groundwater protection. Intermediate between high and low vulnerability.</p> <p>The nearest watercourse is the River Deben that flows parallel to the northern site boundary approximately 25 m from the site.</p> <p>The site is just located in a Flood Zone 2 or Flood Zone 3 recorded area (Gov.UK, accessed 250326) along the northern boundary of the site. These are lands with a medium to high risk of flooding from rivers or the sea.</p> <p>The site is just located in an area (along the northern site boundary) noted to be at risk from surface water flooding i.e. where rainfall overwhelms local drainage infrastructure (1:30 year risk).</p> <p>We have included some images of the site captured during the ground investigation (April 2026) below.</p> |

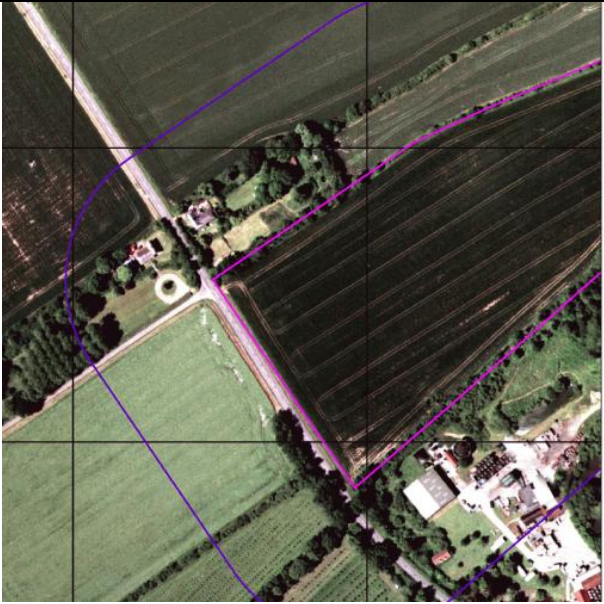
The 1999 aerial photograph taken from the Envirocheck (see below) shows the eastern part of the site as it was at that time: agricultural land. The western part not shown is the same.
