Site Investigation Report

Longcross Film Studios, Chobham Lane, Longcross, Chertsey, KT16 0EE

FOR AND ON BEHALF OF ARK DATA CENTRES LTD C/O HURLEY PALMER FLATT

Issue Date: 14 December 2020

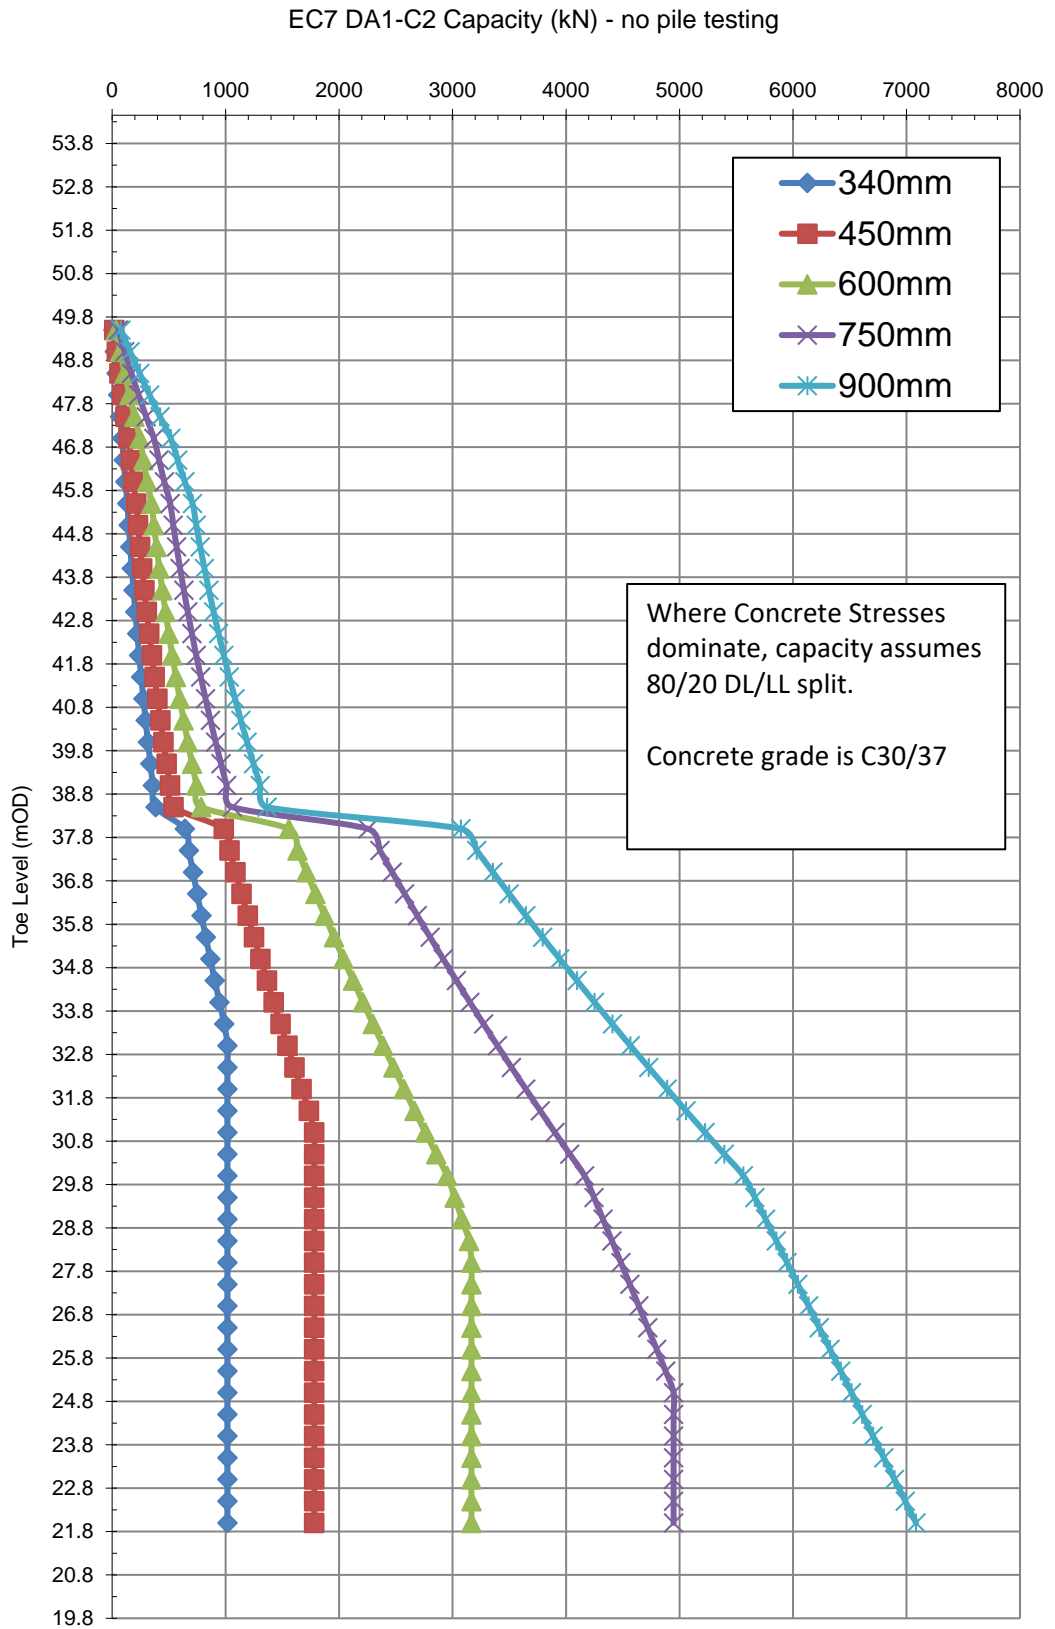
Graph 2. Preliminary pile design

9. Should the magnitude of the structural loads of the proposed development preclude the use of economical shallow foundation options, pile foundations are considered feasible. It is recommended that piles are formed using either Continuous Flight Auger (CFA) or bored piling methods. It is also recommended that the toe of all piles should be terminate below 37mOD to avoid bearing onto bands of variable and predominately silty material within the upper region of the Bagshot Formation. A preliminary pile capacity design for a range of pile diameters are provided.
