Site Investigation Report

Longcross Film Studios, Chobham Lane, Longcross, Chertsey, KT16 0EE

REFERENCE: 19.0415/CB/LSG

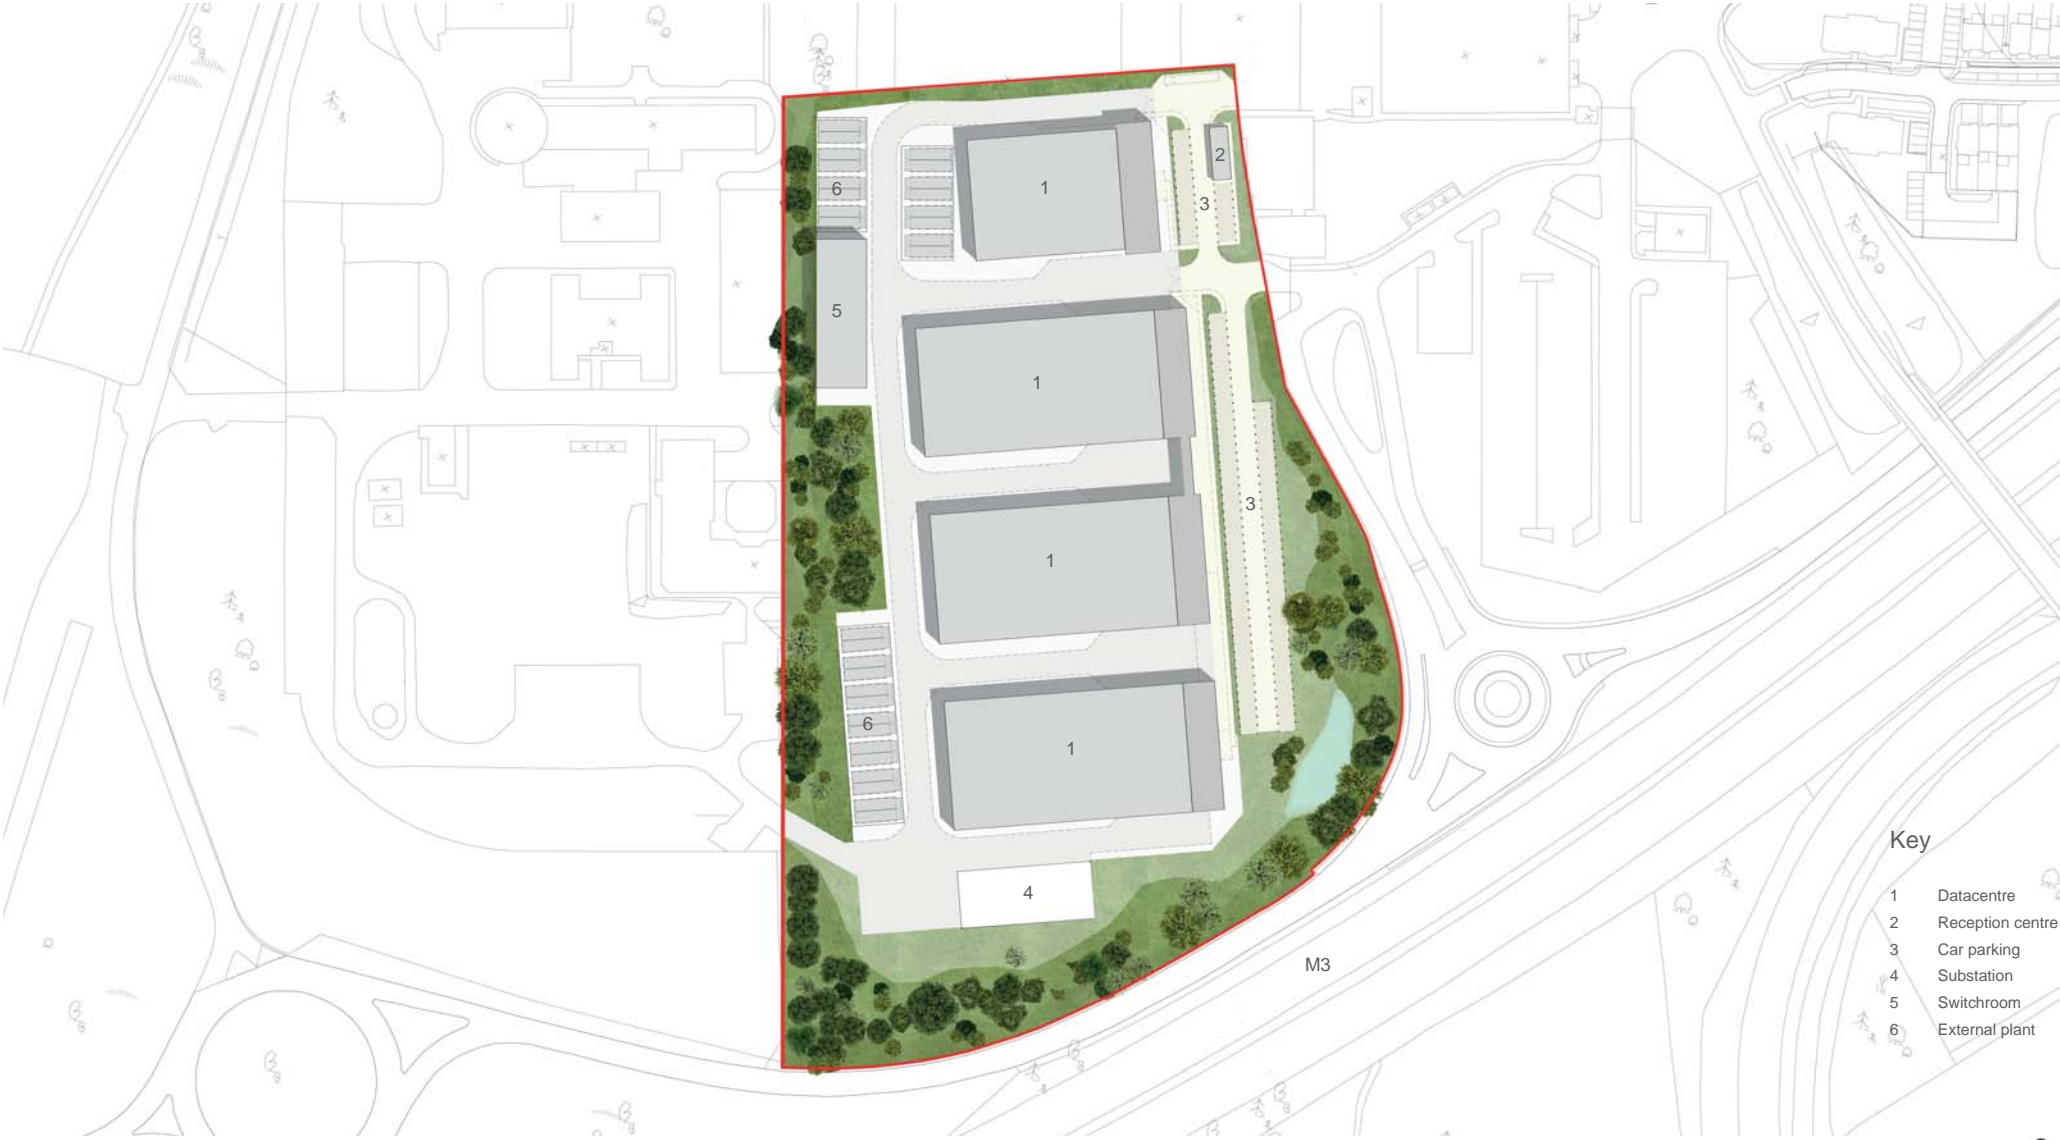
Figure 2

- Key
- 1 Datacentre
 - 2 Reception centre
 - 3 Car parking
 - 4 Substation
 - 5 Switchroom
 - 6 External plant

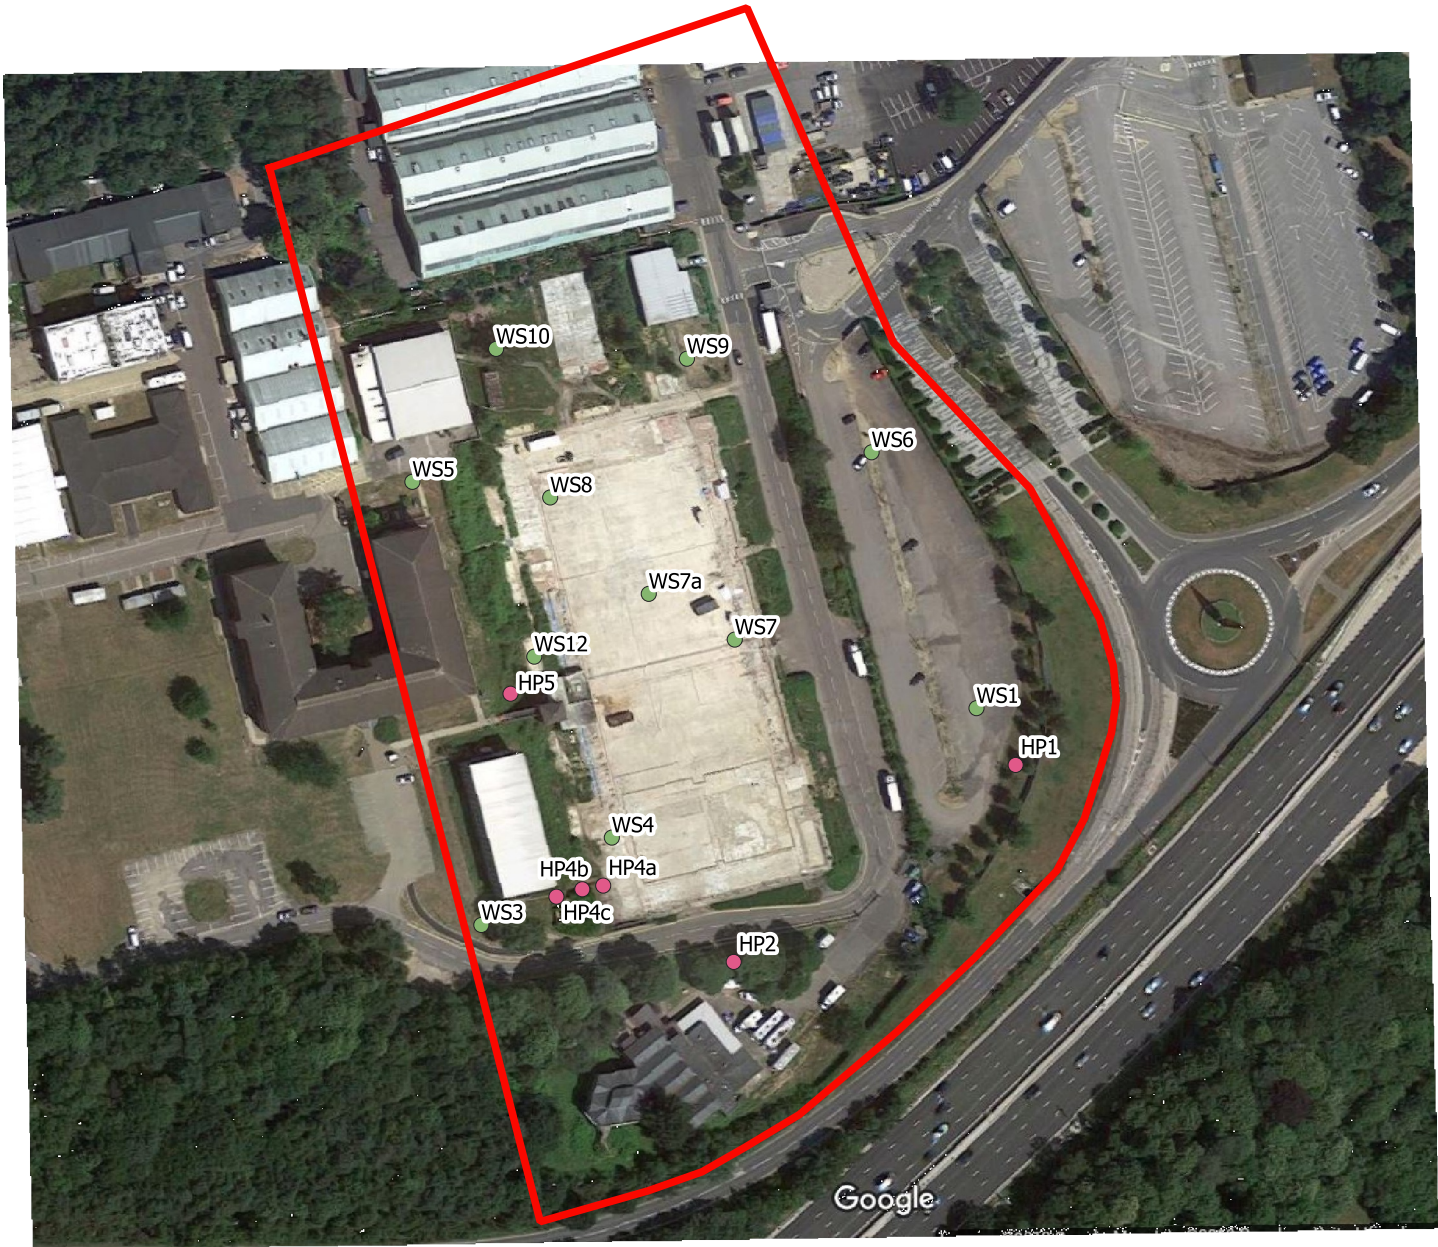
Project Longcross Studios	Scale not to scale
	Drawn by CB
	Approved By CK
Title Borehole Location Plan	Drawing Number 4
	Date 3 July 2019

- WS (Windowless Sample Borehole)
- HP (Hand Excavated Pit)

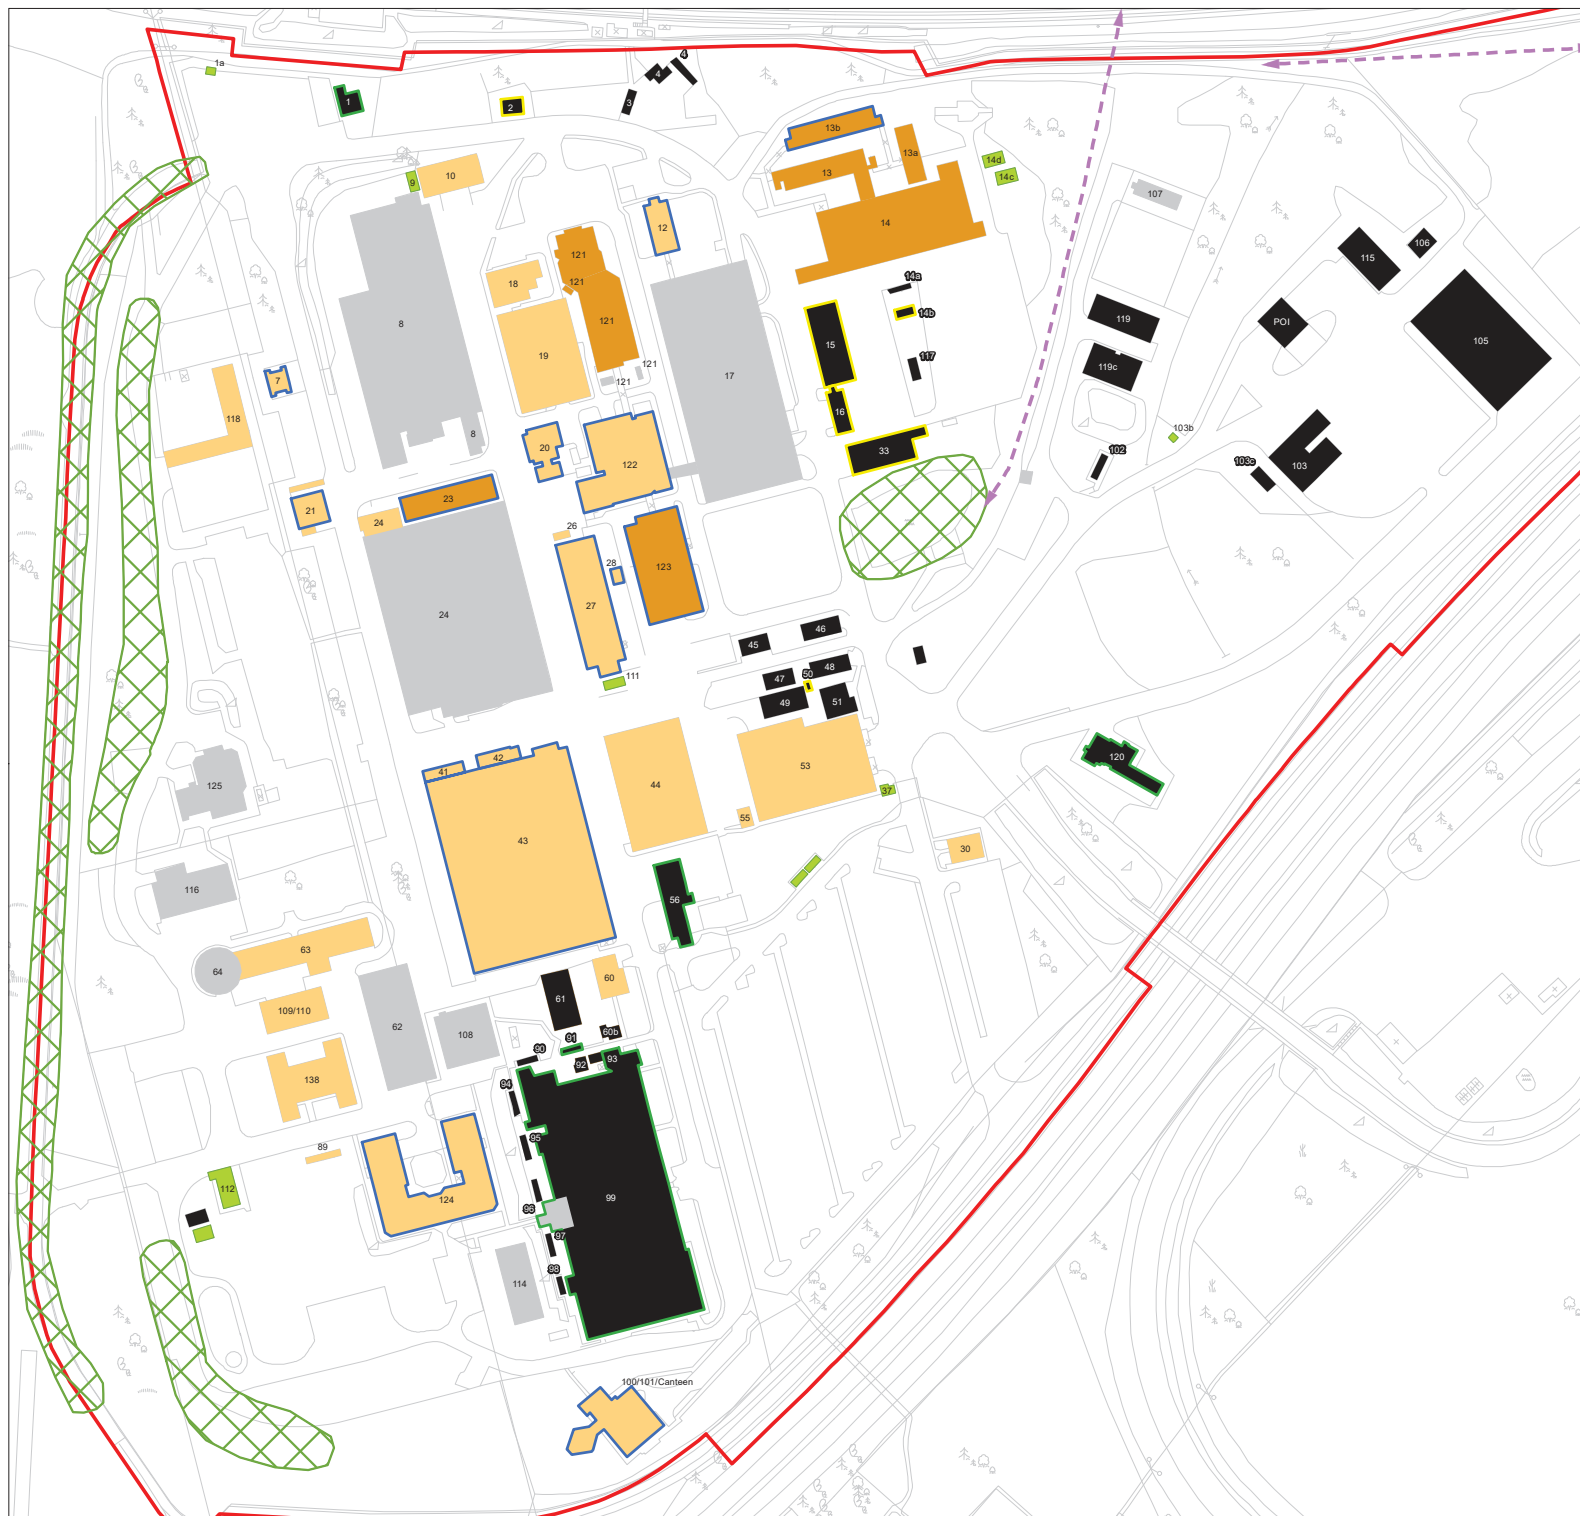
MAP 2 Bat Constraints

12.5.3	The information provided by Crest Nicholson on bat constraints suggests two buildings onsite were found to previously have bat roosts (Figure 6), and an up to date survey and licence would be required prior to demolition. In addition, the record shows buildings with no up to date information. As such, an additional survey is required prior to demolition.
