## Site Condition Report

Longcross Data Centre: SP3004SB

**Reference:** 10274458

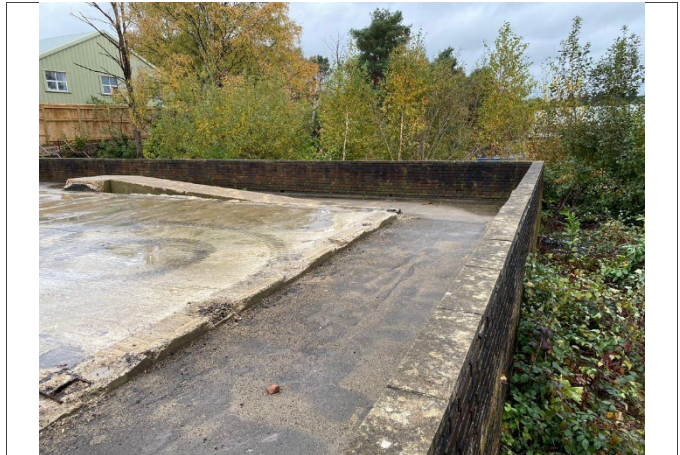
04: Raised concrete foundations
