ENVIRONMENTAL RISK ASSESSMENT

Unit 25B, Sefton Lane Industrial Estate, Maghull, Liverpool, L31 8BX

Darren Sinners T/A Knowsley Waste Services

Version:	1.0	Date:	13 January 2022		
Doc. Ref:	SEF-2138-D	Author(s):	CP	Checked:	--
Client No:	2138	Job No:	002

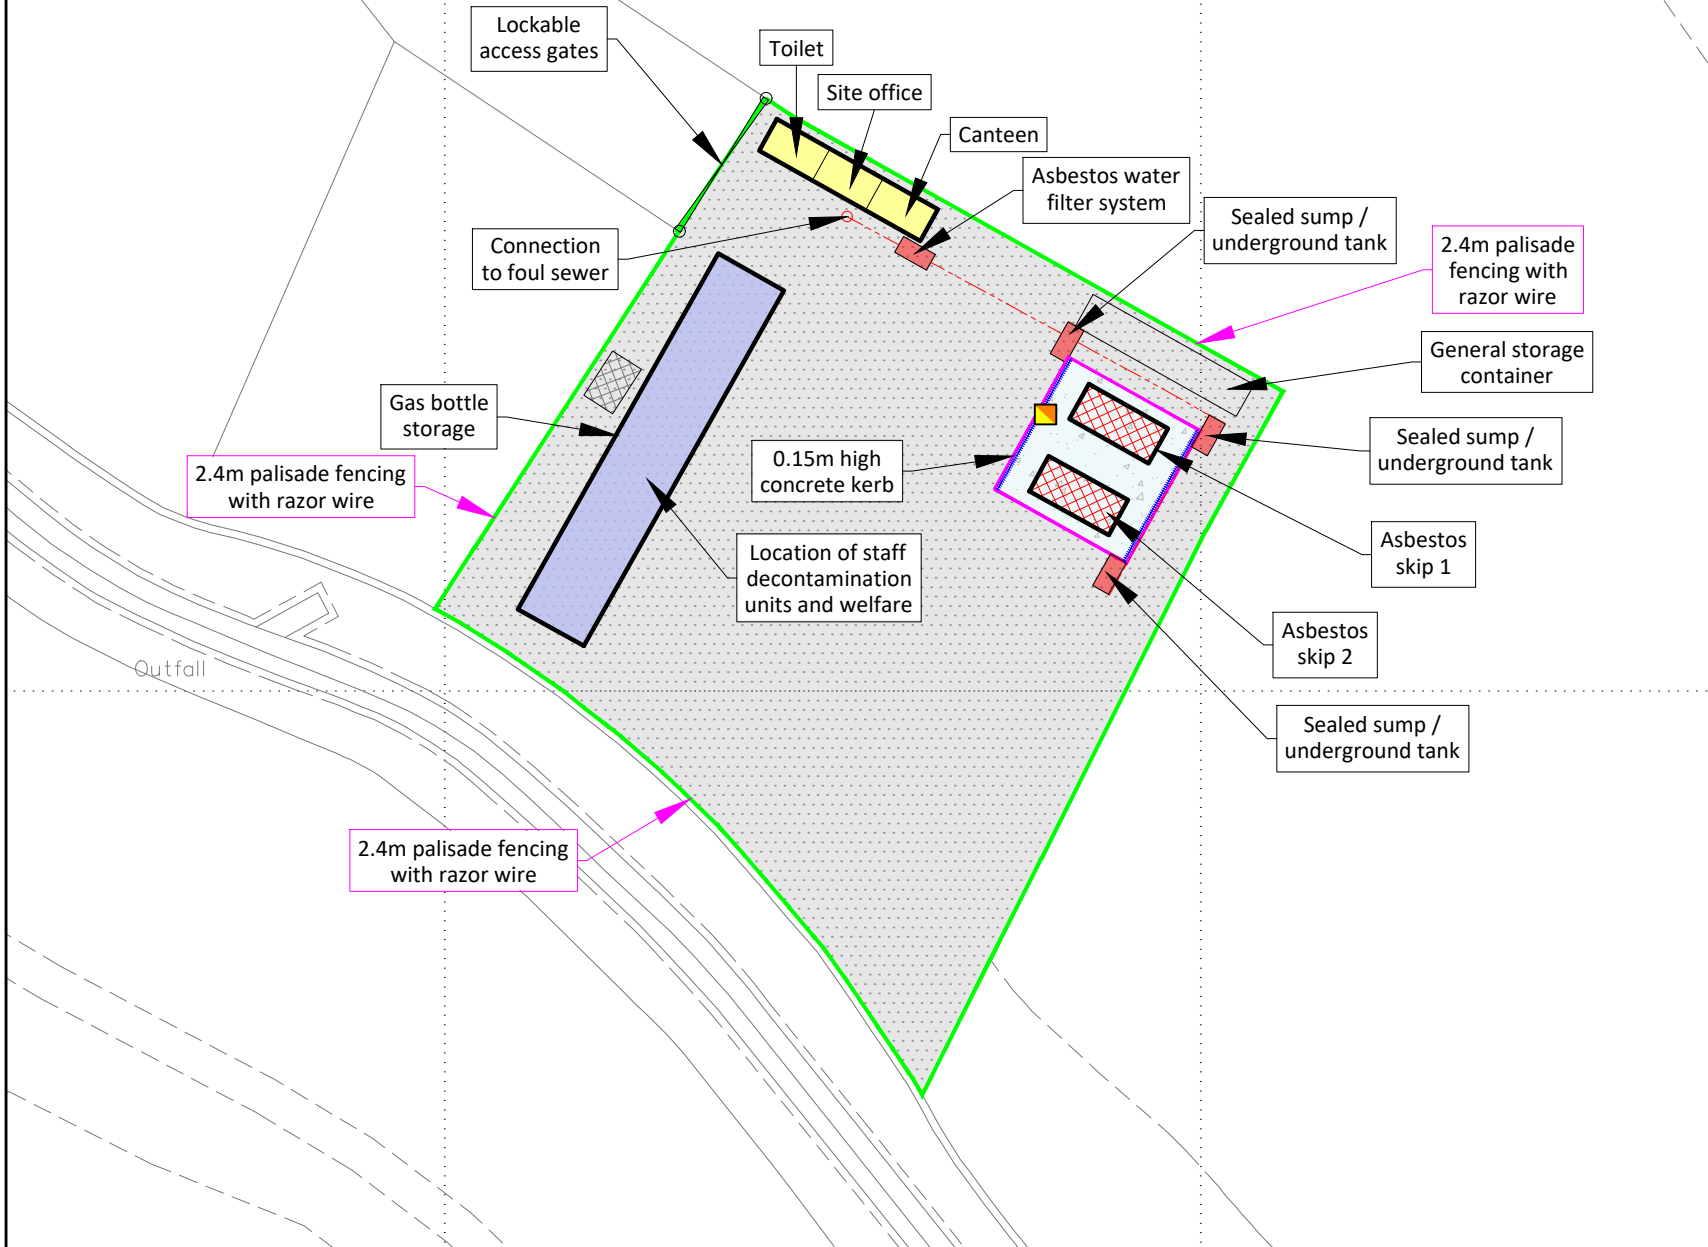
Title: SITE LAYOUT PLAN

- Permit boundary
- Spill kit
- Sealed concrete pad
- Hardstanding area
- Buildings/offices
- - - Underground drainage

2.1 A Sensitive Receptors Plan has been provided Appendix II of this document.

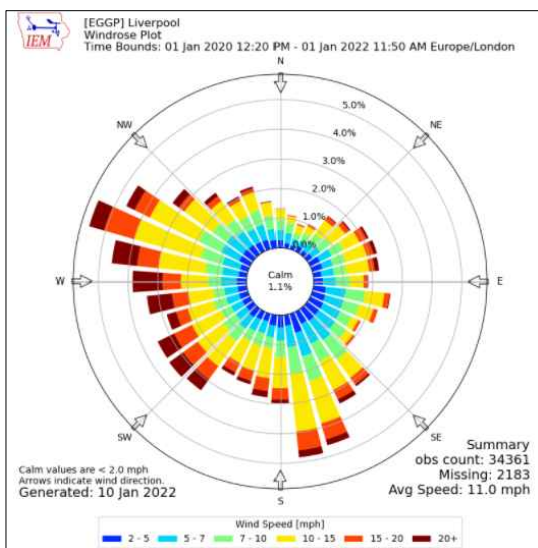
Compass Wind Rose for Liverpool (EGGP)
Period 2020-2022
- source: Iowa State University

1. Boundaries are shown indicatively.
2. Wind rose data shows the prevailing wind direction to be blowing westerly from the east.
