**FOYLE MEATS
MELTON RD
SIX HILLS
MELTON MOWBRAY
LE14 3PR**

Bund Integrity Assessment

Document Ref: Attachment C.3

BUND INTEGRITY ASSESSMENT REPORT
FOYLE MEATS, SIX HILLS, MELTON MOWBRAY, UK

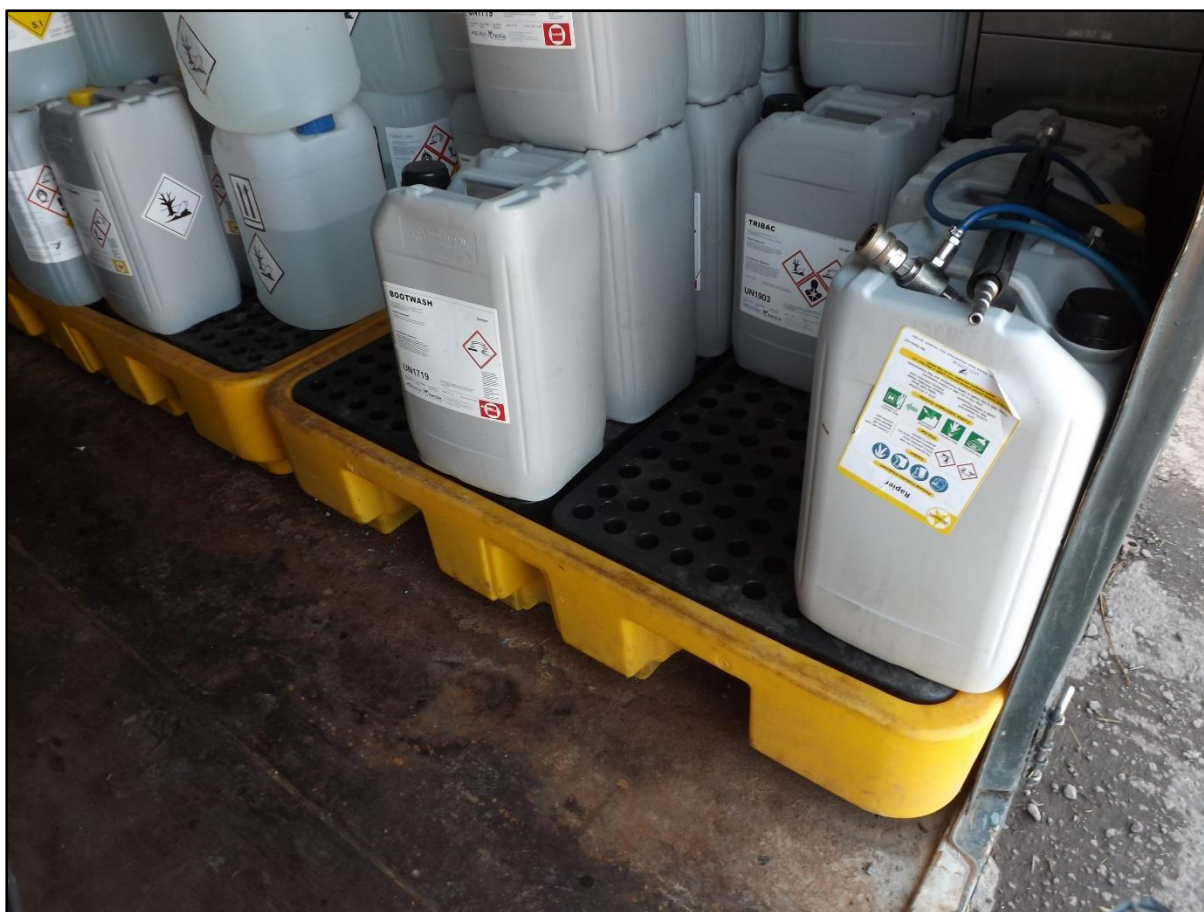
Figure 1: Quad Drum Bund

Bund No.1, located within the site COSHH Store, was found to provide containment for 2 x 25-litre drums of Rapier, 5 x 25-litre drums of Tribac, 9 x 25-litre drums of Bootwash, 8 x 25-litre drums of Causdeta and 1 x 25-litre drum of Excel Extra.

The bund is made of high-density polyethylene, is of a "one-piece" construction and features removable gratings.

This bund has a capacity of 245-litres, which provides in excess of 110% capacity of the largest container and in excess of 25% of the total volume of the combined containers.

The structural integrity of this bund is sound and shows no evidence of plastic fatigue, distress, or major corrosion.

Result (Pass/Fail)	Pass													
Recommendation(s): The bund should be re-inspected in October 2024 as per Guidance.														
Signed: Nial Ryan Paul McShane	Qualification: MSc BEng (HONS) MIEI	Date: 21st October 2021 21st October 2021

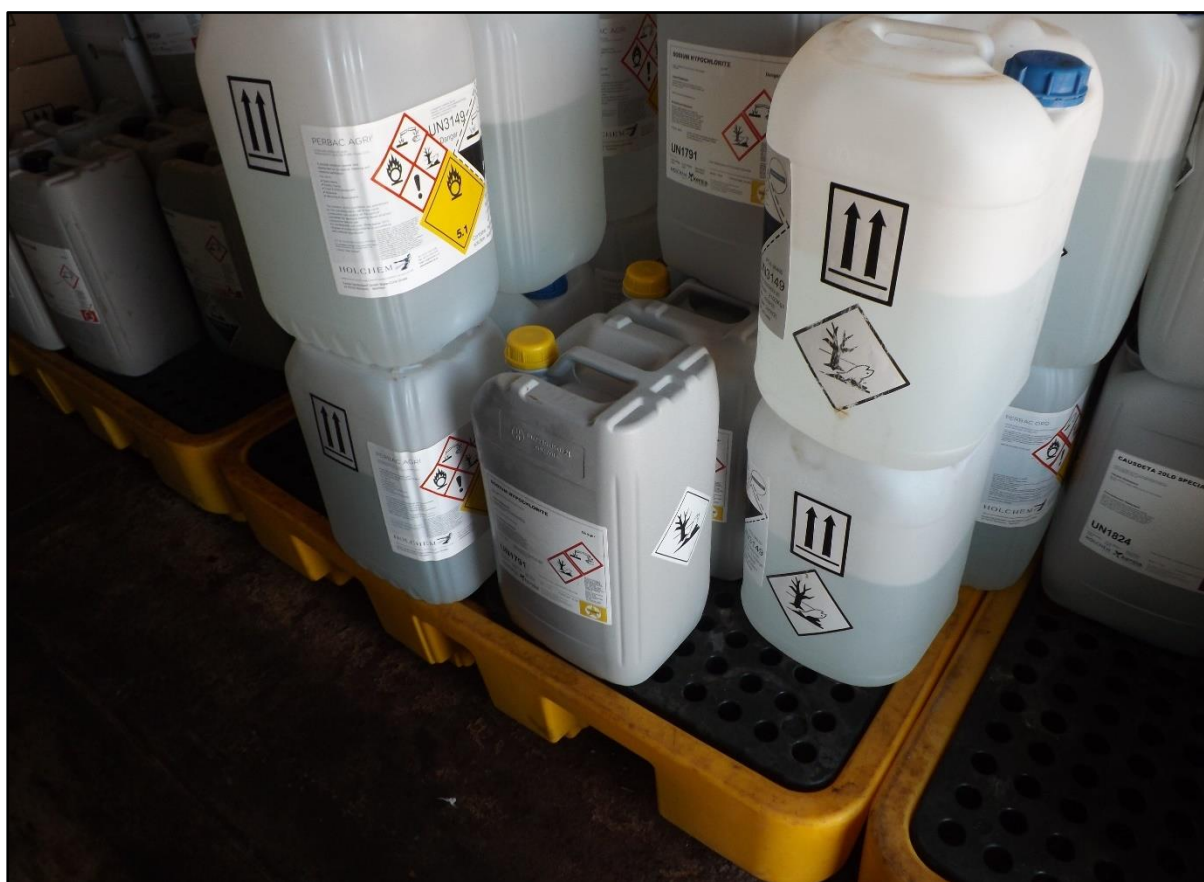
Figure 2: Quad Drum Bund

Bund No.2, located within the site COSHH Store, was found to provide containment for 8 x 25-litre drums of Perbac OPD, 6 x 25-litre drums of Sodium Hypochlorite, 10 x 25-litre drums of Perbac Agri, 5 x 25-litre drums of Nipac and 10 x 10-litre drums of Bio-Drain Cleaner.

This bund has a capacity of 245-litres, which provides in excess of 110% capacity of the largest container and in excess of 25% of the total volume of the combined containers.

The structural integrity of this bund is sound and shows no evidence of plastic fatigue, distress, or major corrosion.

Result (Pass/Fail)	Pass												
Recommendation(s): <ul style="list-style-type: none"> It is recommended that 100% of the storage vessel be located within the bund area. The bund should be re-inspected in October 2024 as per Guidance. 													
Signed: Nial Ryan Paul McShane	Qualification: MSc BEng (HONS) MIEI	Date: 21st October 2021 21st October 2021

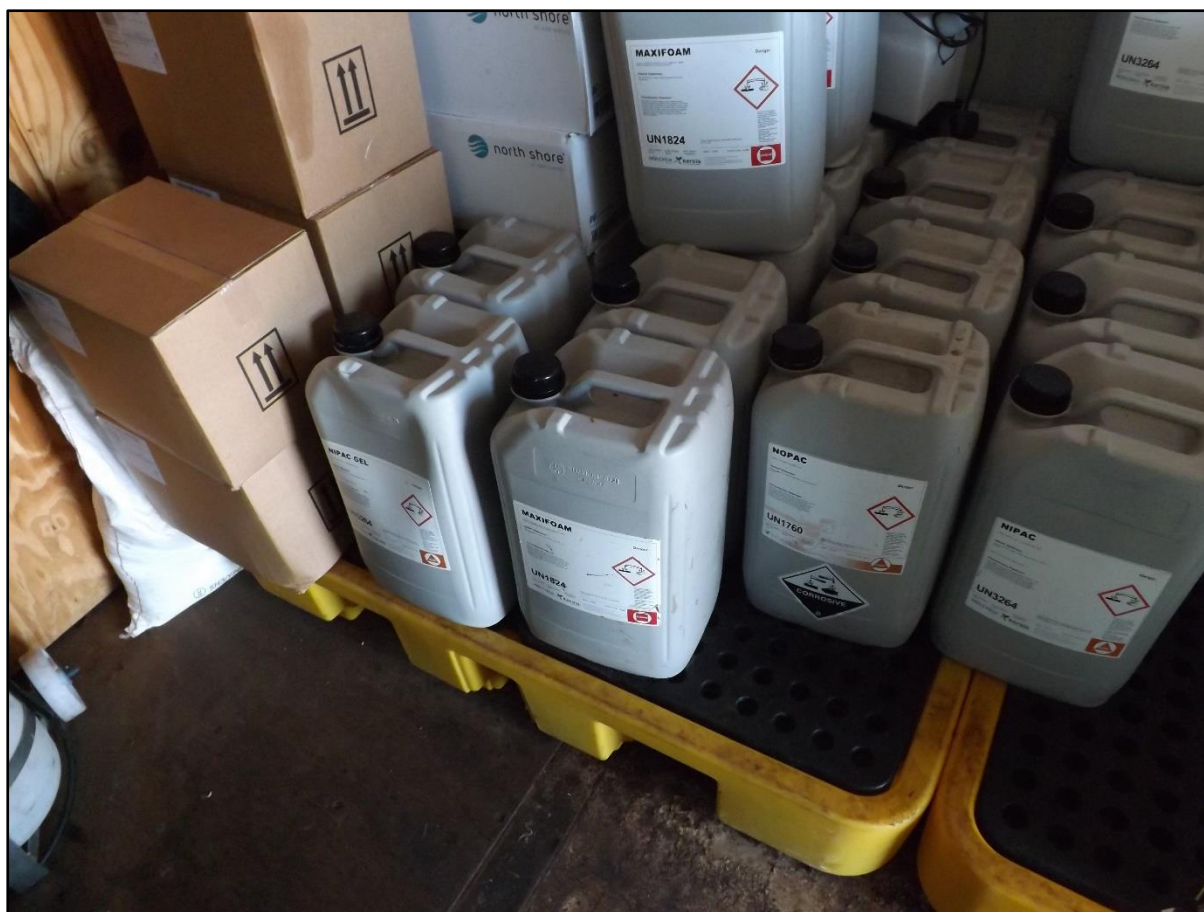
Figure 3: Quad Drum Bund

A number of drums on the bund were found to be stored partially outside of the catchment area, overlapping upon the adjacent Bund No.3 (see Figure 3). It is recommended that 100% of the storage vessel be located within the bund area.

Bund No.3, located within the site COSHH Store, was found to provide containment for 5 x 25-litre drums of Nipac, 5 x 25-litre drums of Nopac, 7 x 25-litre drums of Maxifoam, 2 x 25-litre drums of Nipac Gel and 19 x 5-litre drum of M7 Hand Soap.

This bund has a capacity of 245-litres, which provides in excess of 110% capacity of the largest container and in excess of 25% of the total volume of the combined containers.

The structural integrity of this bund is sound and shows no evidence of plastic fatigue, distress, or major corrosion.

A number of drums on the bund were found to be stored partially outside of the catchment area, overlapping upon the adjacent Bund No.3 (see Figure 3).

It is recommended that 100% of the storage vessel be located within the bund area.

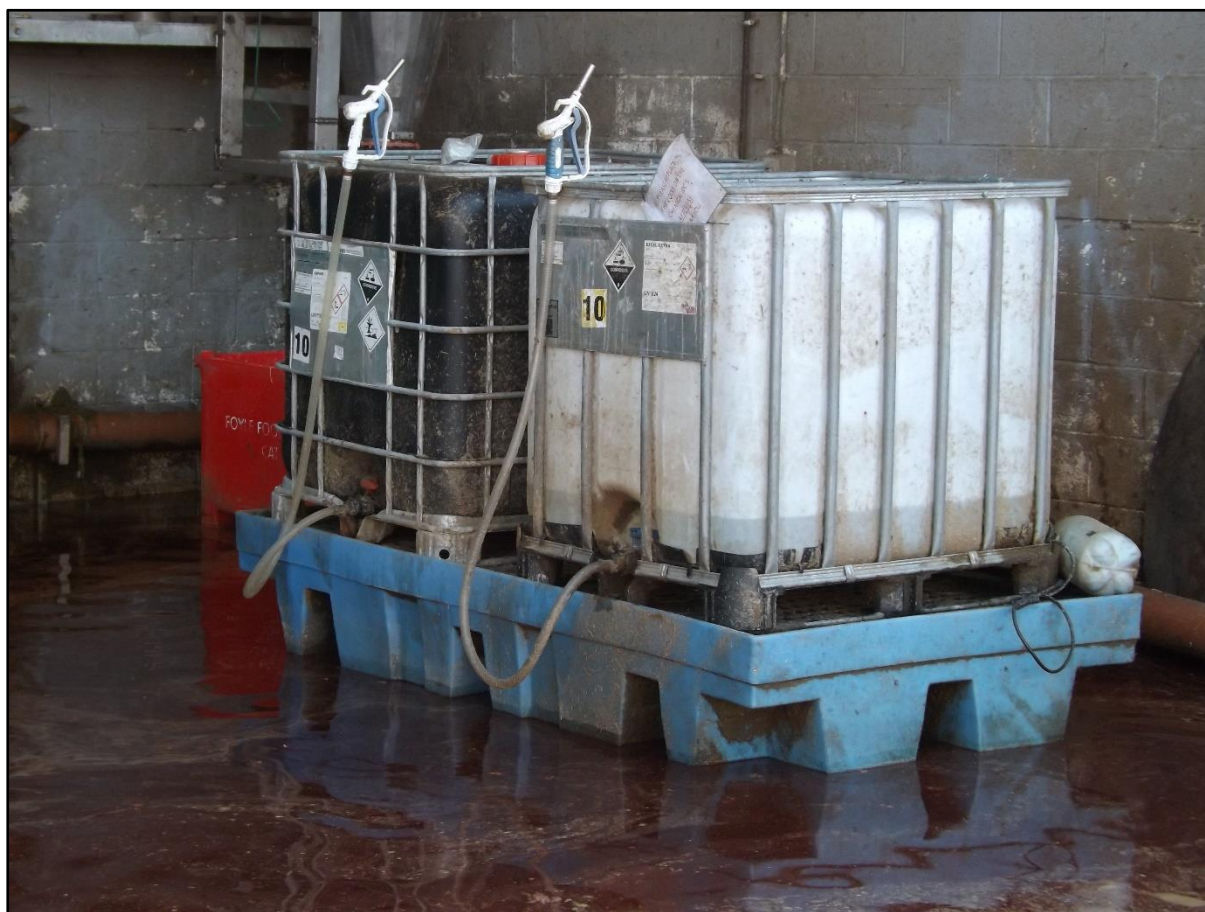
Figure 4: Double IBC Bund

Bund No.4, located within the site Animal-By-Product handling area, was found to provide containment for 1 x 1,000-litre IBC of Rapier and 1 x 1,000-litre IBC of Excel Extra.

This bund has a capacity of 1,140-litres, which provides in excess of 110% capacity of the largest container and in excess of 25% of the total volume of the combined containers.

The structural integrity of this bund is sound and shows no evidence of plastic fatigue, distress, or major corrosion.

Result (Pass/Fail)	Pass													
Recommendation(s): The bund should be re-inspected in October 2024 as per Guidance.														
Signed: Nial Ryan Paul McShane	Qualification: MSc BEng (HONS) MIEI	Date: 21st October 2021 21st October 2021

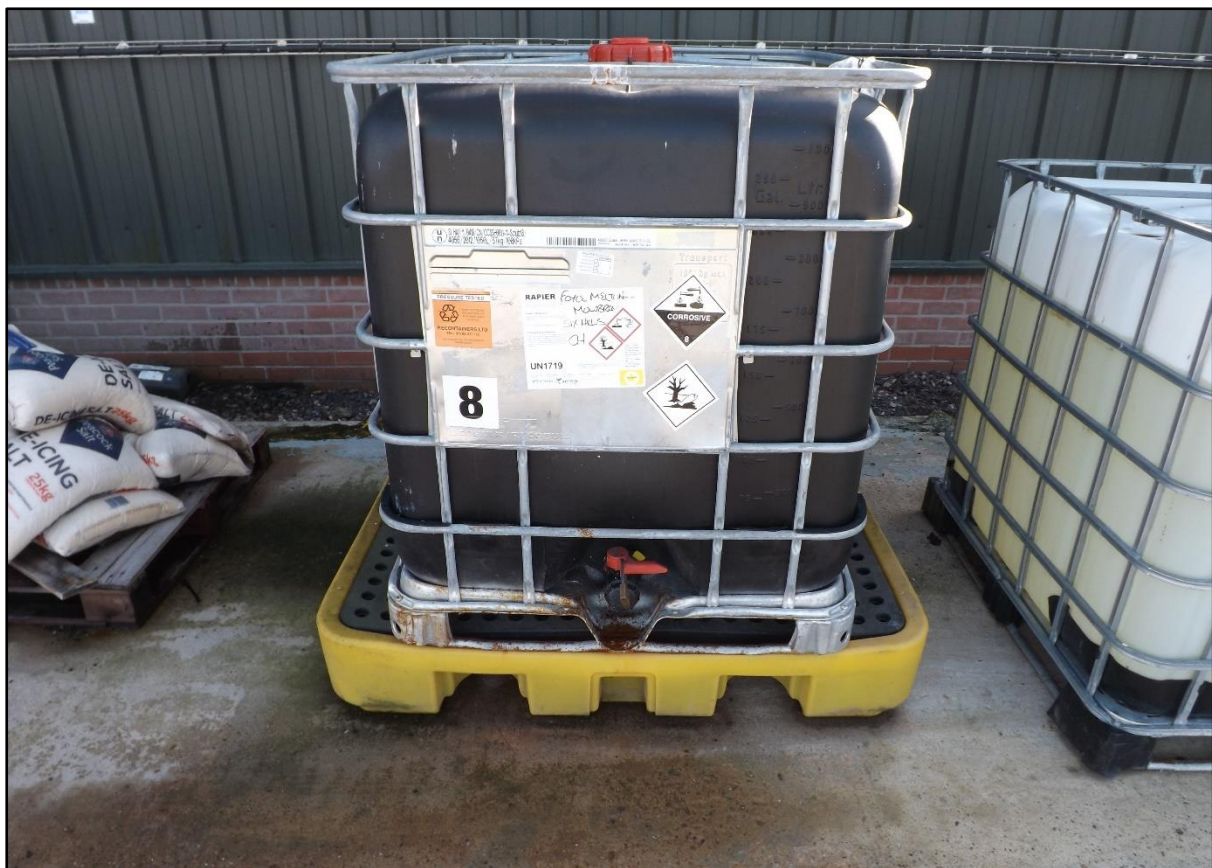
Figure 5: Quad Drum Bund

Bund No.5, located within the rear yard area, was found to provide containment for 1 x 1,000-litre IBC of Rapier.

This bund has a capacity of 245-litres, which does not provide in excess of 110% capacity of the largest container.

The structural integrity of this bund is sound and shows no evidence of plastic fatigue, distress, or major corrosion. This structure has a max load rating of 2700kg and has not been damaged by the 1000kg IBC.

It is recommended that this bund be replaced with one of sufficient storage capacity ($\geq 1,000$ -litre).

It is recommended that this bund be replaced with one of sufficient storage capacity (\geq 1,000-litre).

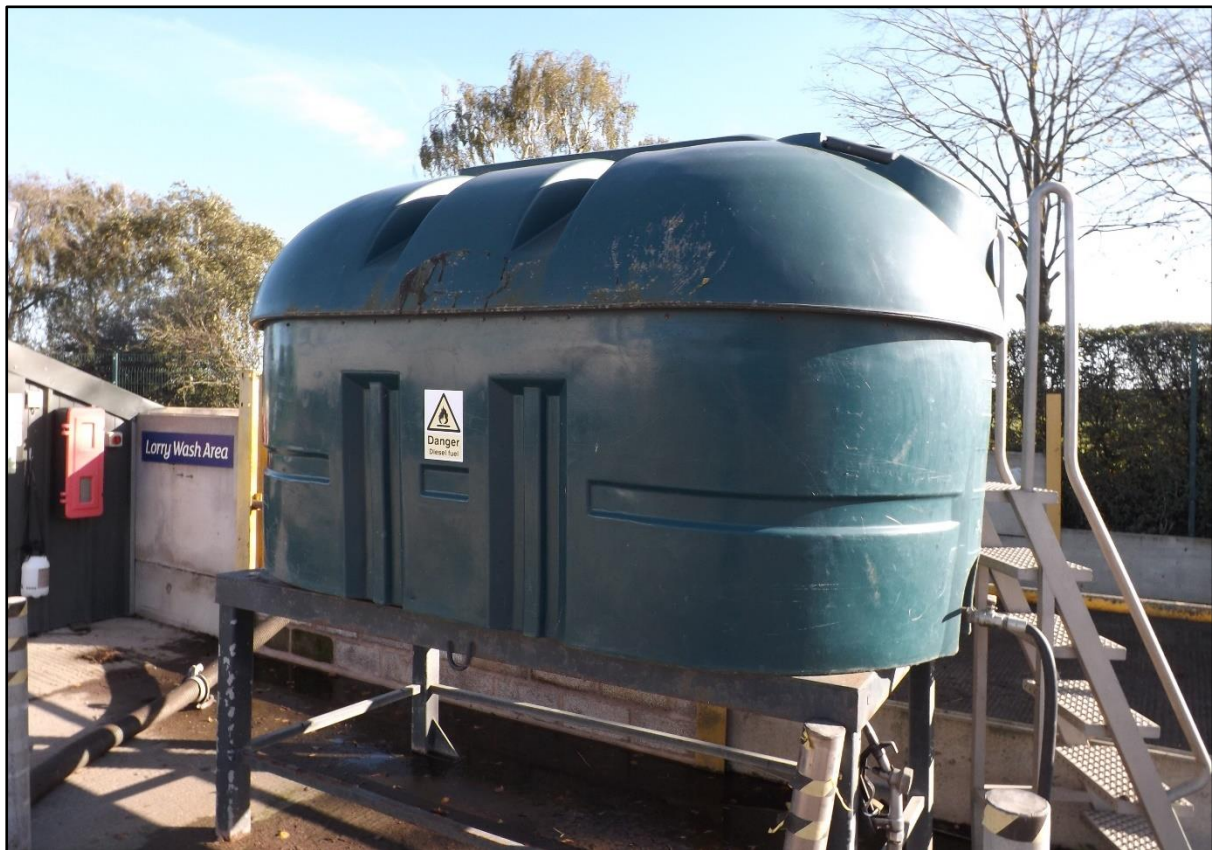
Figure 6.1: Double Skinned Tank

Bund No.6, located adjacent to the Truck-Wash, is a Balmoral HB2500 Bunded Fuel Tank, which provides storage capacity for red diesel, used by the site shunter truck and two forklifts.

This double-skinned diesel tank is a high-density polyethylene structure tank and consist of a 'tank within a tank'. Oil is stored in the inner tank, whilst the outer tank acts as a failsafe in case of a spill.

This bund has a capacity of 2,750 litres, which provides in excess of 110% capacity of its primary 2,500-litre vessel contained within.

This bund was found to be in a good condition. The structural integrity of this bund is sound and shows no evidence of distress, plastic fatigue or major corrosion.

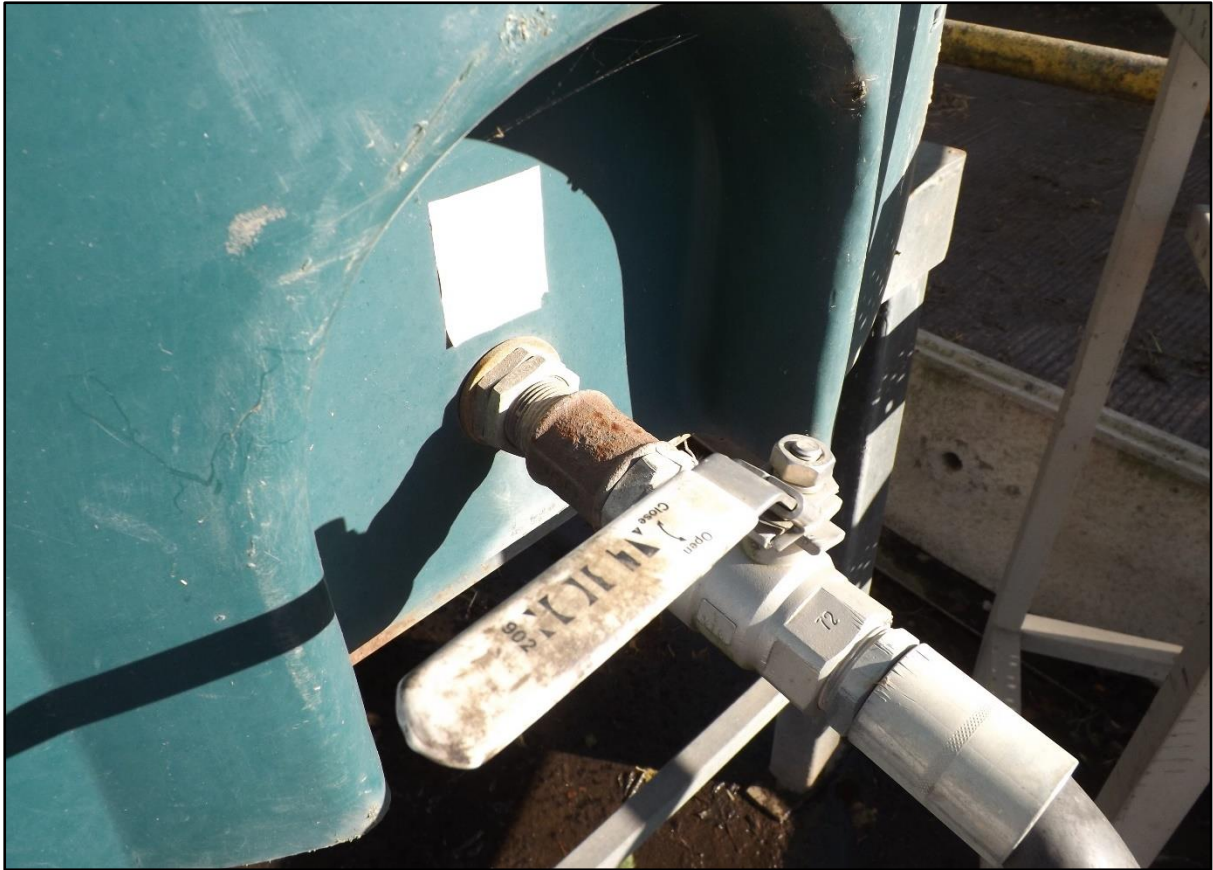
Figure 6.2: Tank Outlet Pipe and Valve

The tank outlet pipe, valve and hose were found to be in good condition, while the fuel nozzle was locked when not in use.

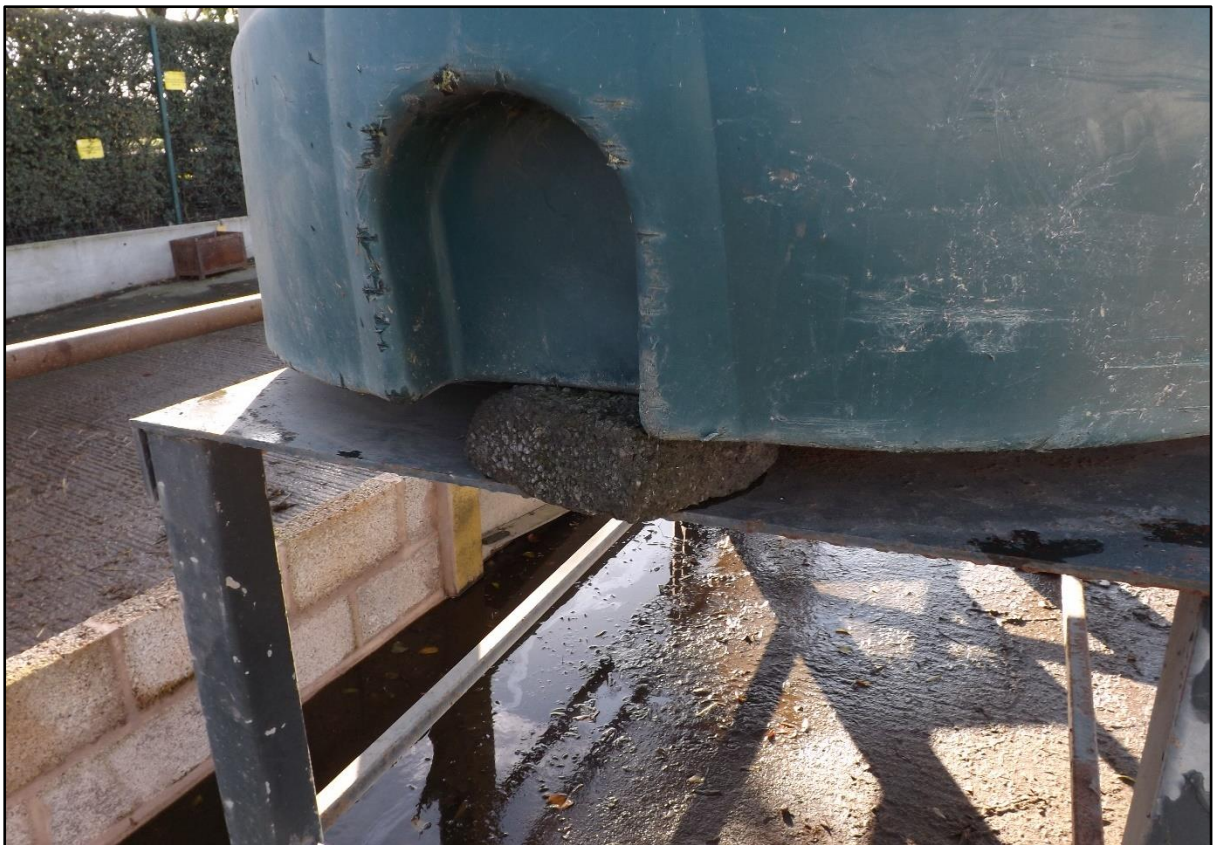
Figure 6.3: Concrete Block Beneath Eastern End of Structure

A concrete block was discovered beneath the eastern end of the structure, designed to elevate the tank directing fuel to the outlet. It is recommended that this block be removed, as the structure is designed to dispersed weight through the entire flat base and not via a reduced surface area, which would damage the tank surface over time, while also increasing the overall stability of the tank.

It is recommended that this block be removed, as the structure is designed to dispersed weight through the entire flat base and not via a reduced surface area, which would damage the tank surface over time, while also increasing the overall stability of the tank.
