**Environmental Setting and
Site Design Report
For
Woolfox Quarry Southern Landfill,
near Greetham,
Rutland**

**For:
Bullimores
(Sand and Gravel)
Limited**

Date of report: 3rd February 2021

Document reference: WEDS21-001

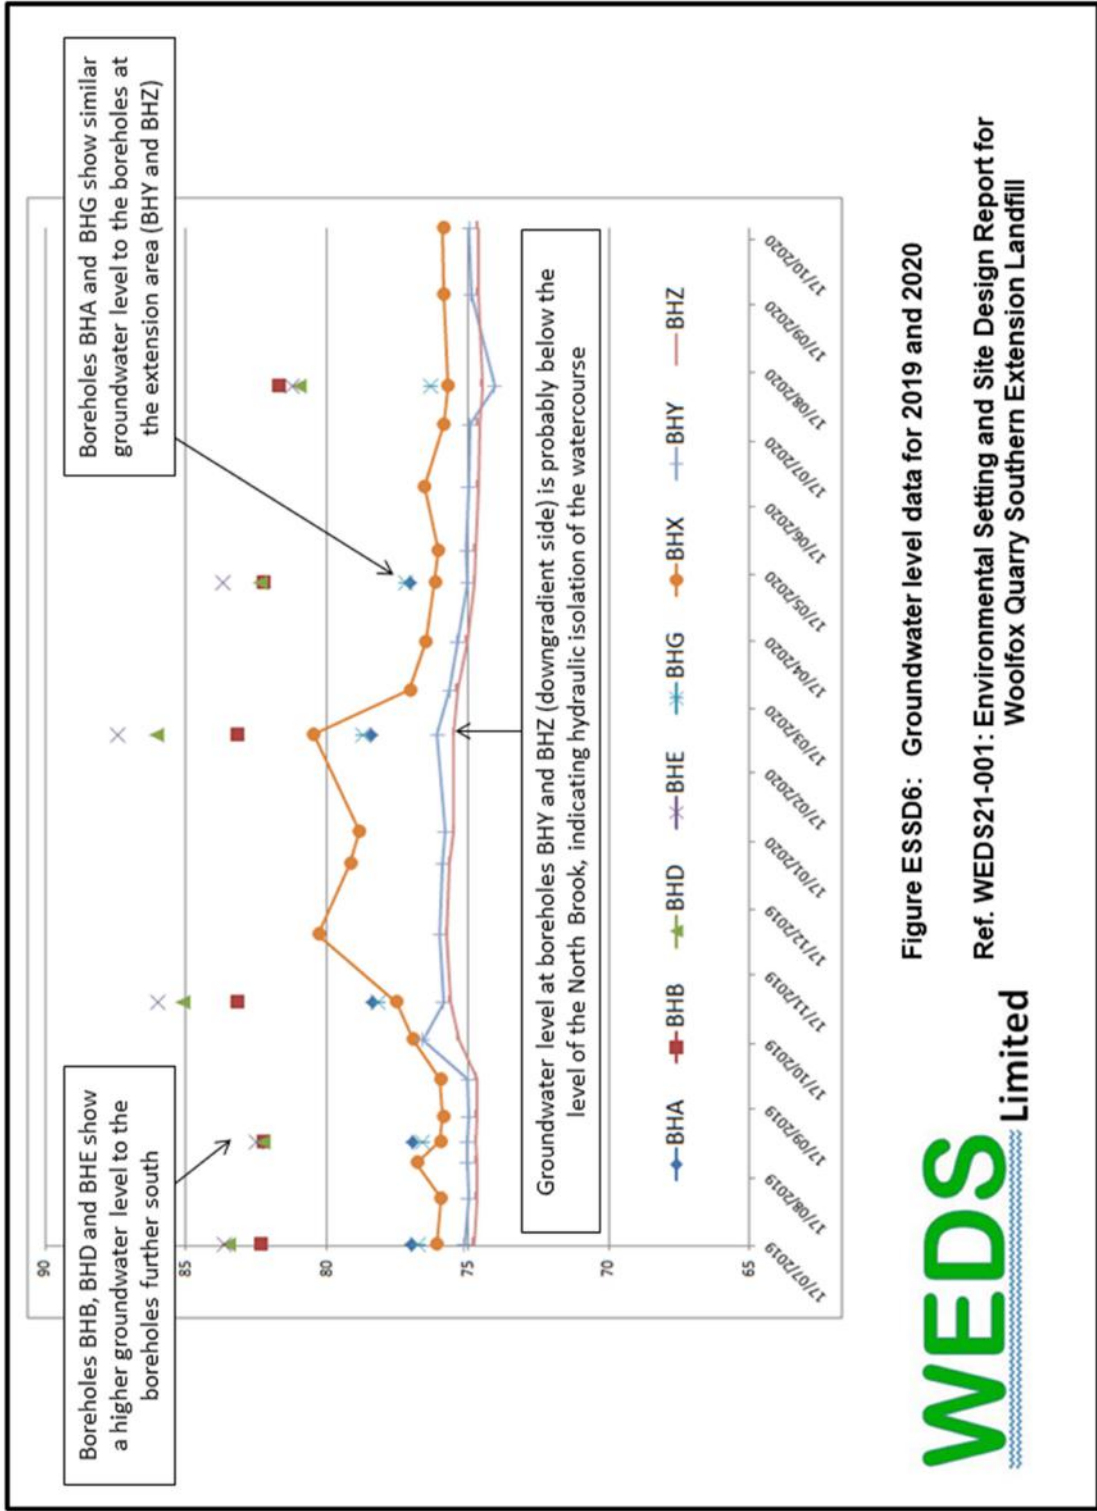
Figure ESSD6: Groundwater level data for 2019 and 2020
 Ref. WEDS21-001: Environmental Setting and Site Design Report for Woolfox Quarry Southern Extension Landfill

The observed groundwater levels indicate a hydraulic gradient of approx. 0.013 in a westward/southwestward direction.

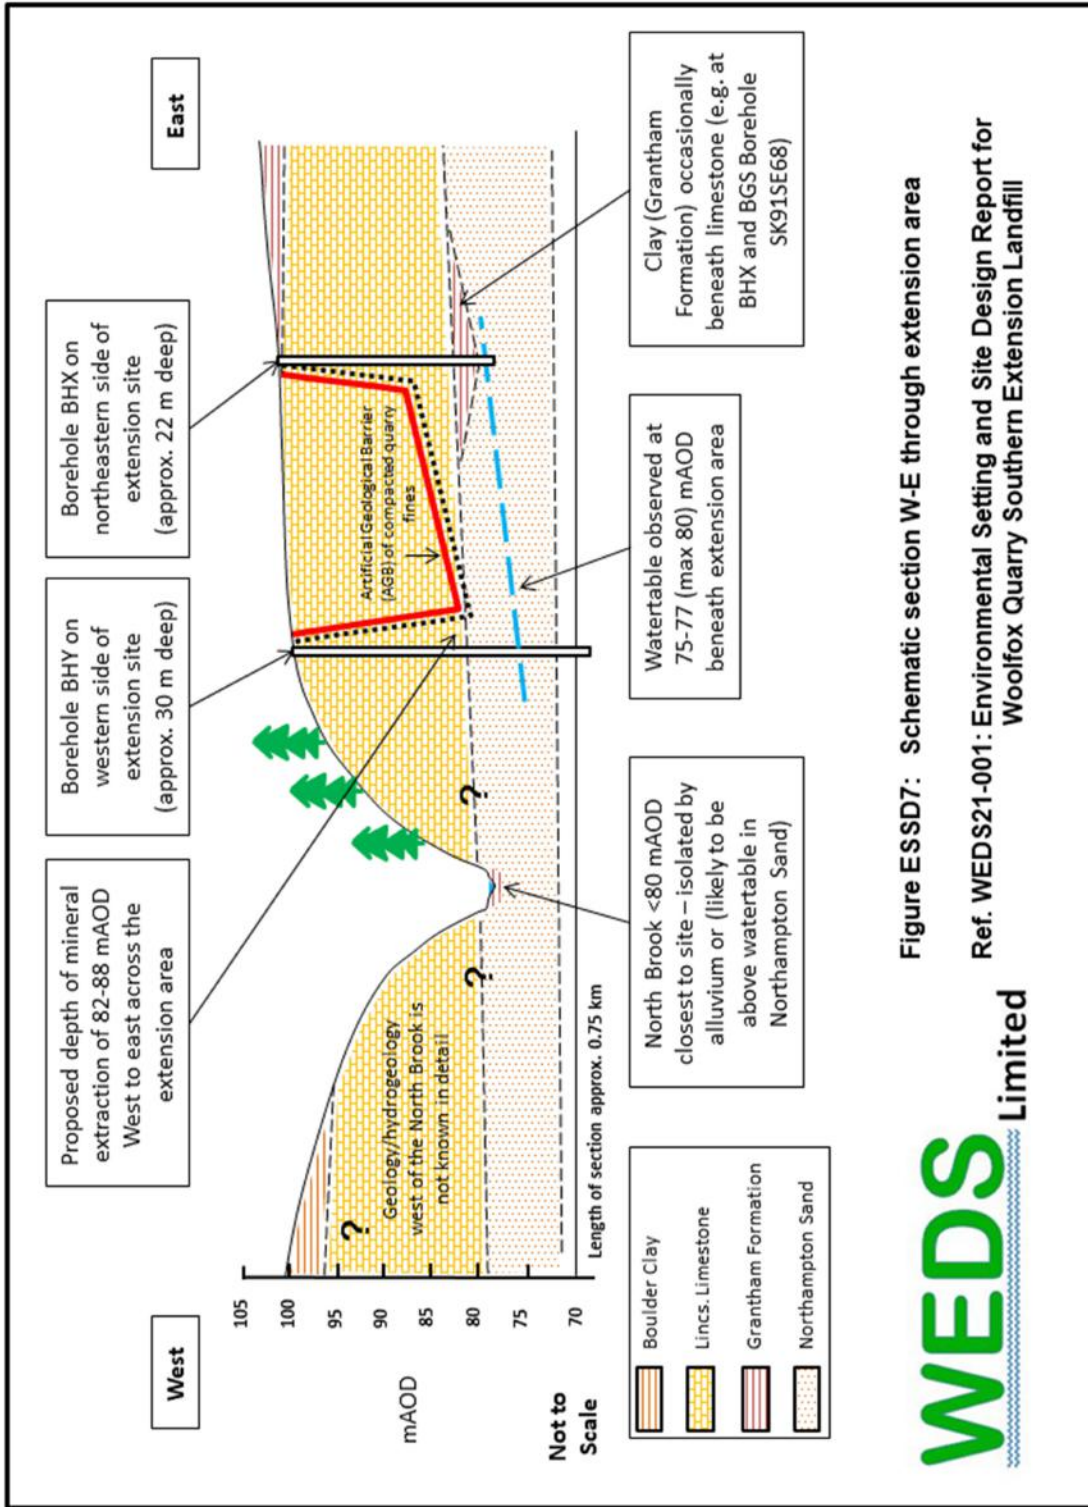
Figure ESSD7: Schematic section W-E through extension area

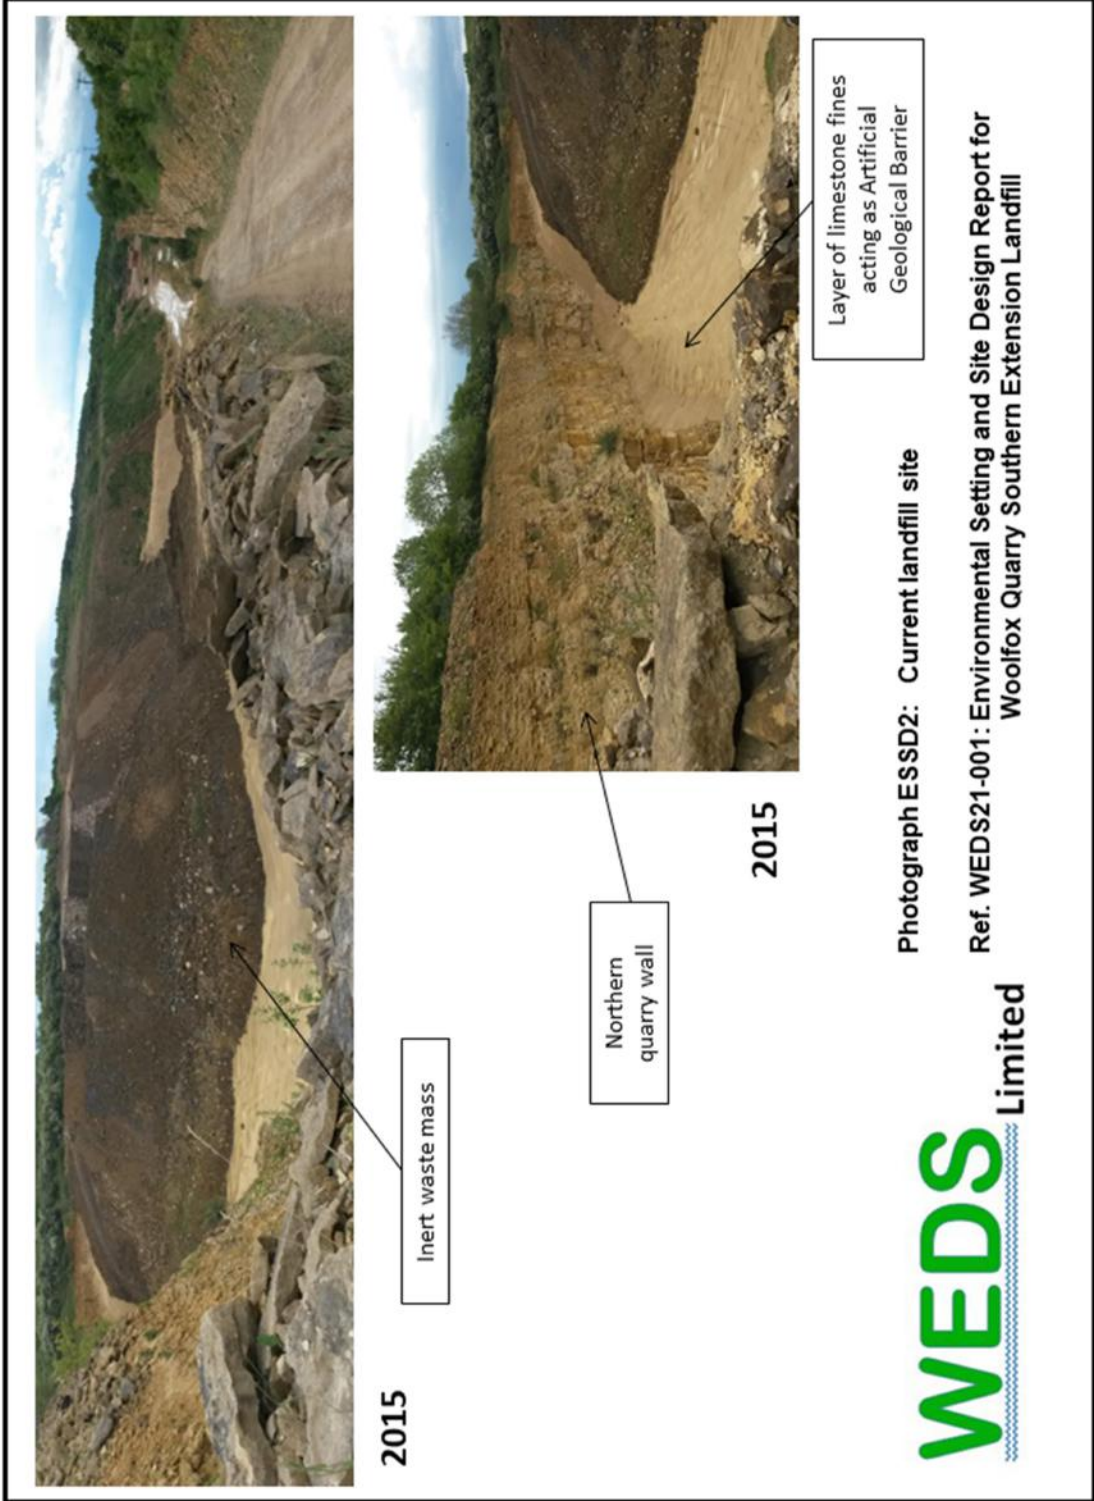
2015

Inert waste mass

- Existing landfill within formerly-quarried area (see Photograph ESSD2), approx. 11 Ha in area. Partial restoration has taken place in the southern part of this area, east of the site office and weighbridge and adjacent to the central restored zone.
- Central restored zone (former workings), currently woodland, approx. 3.5 Ha in area (see Photograph ESSD3). This area is currently only used for access into the southern quarry extension area.
- Southern extension area (the subject of this report), an active limestone quarry currently being worked in a generally southward direction, approx. 8.6 Ha in area (see Photograph ESSD4).

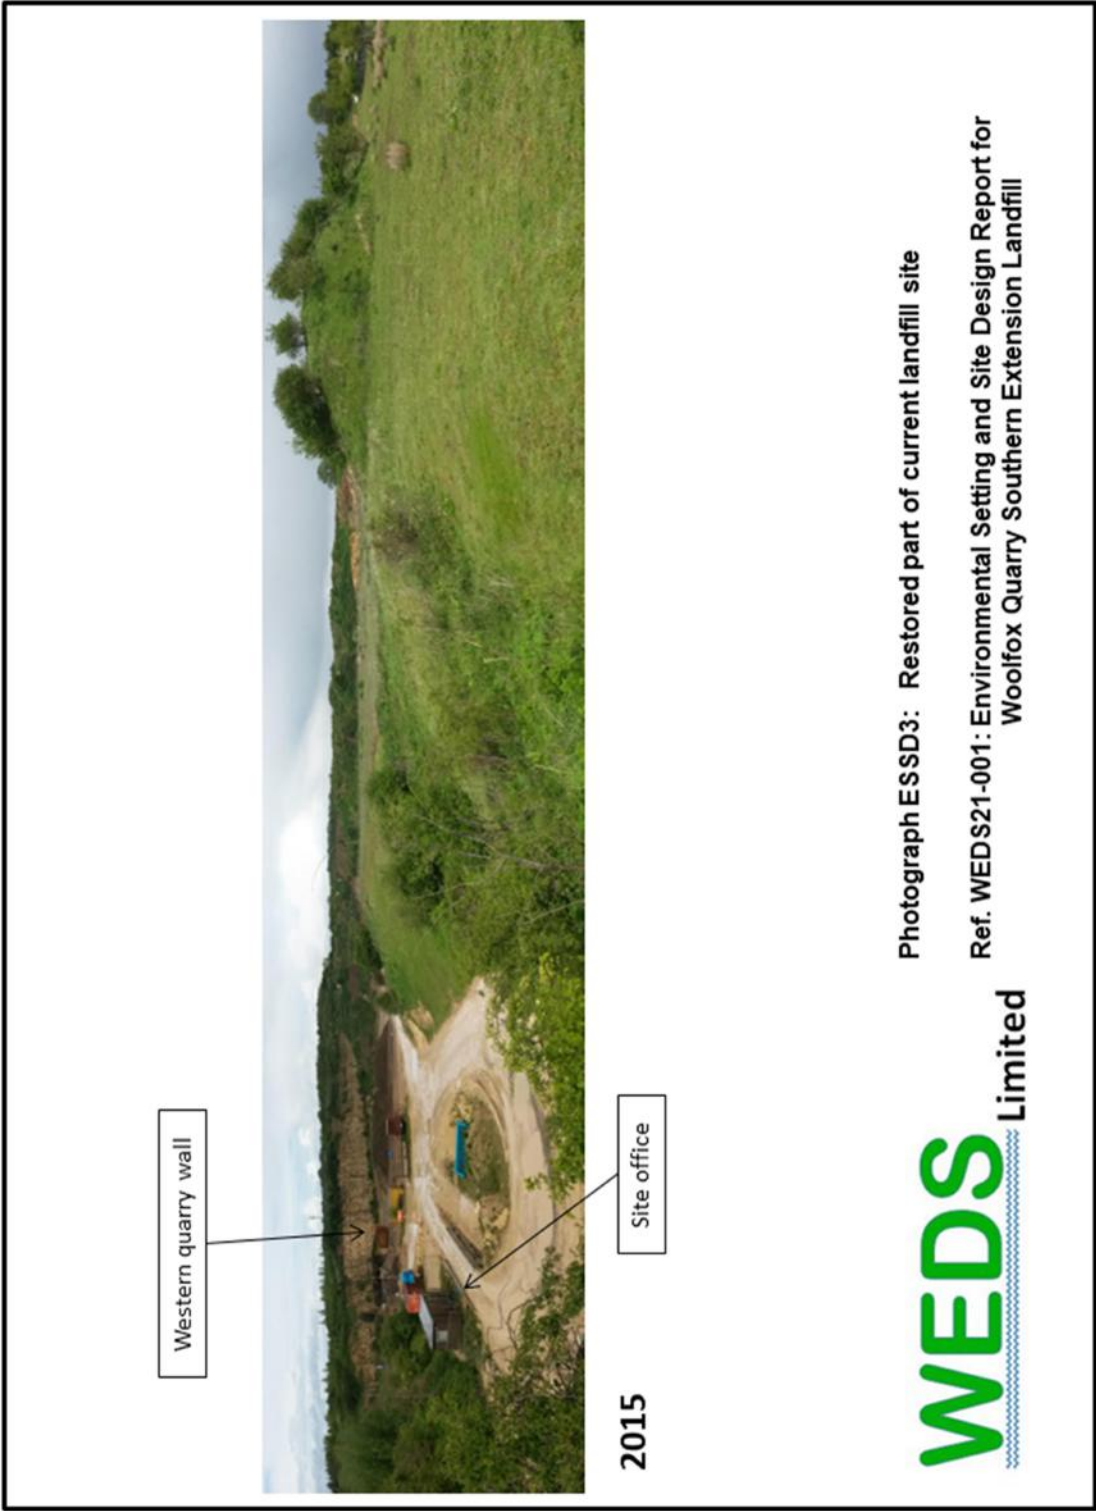
Photograph ESSD3: Restored part of current landfill site
Ref. WEDS21-001: Environmental Setting and Site Design Report for
Woolfox Quarry Southern Extension Landfill
