LANDFILL CAP AND WASTE EXCAVATION REMEDATION METHOD STATEMENT (RMS) AND VERIFICATION PLAN

SITE: Leicester County Council (LCC),
Kibworth Household Waste and Recycling Centre (HWRC)

DATE: 6th April 2021

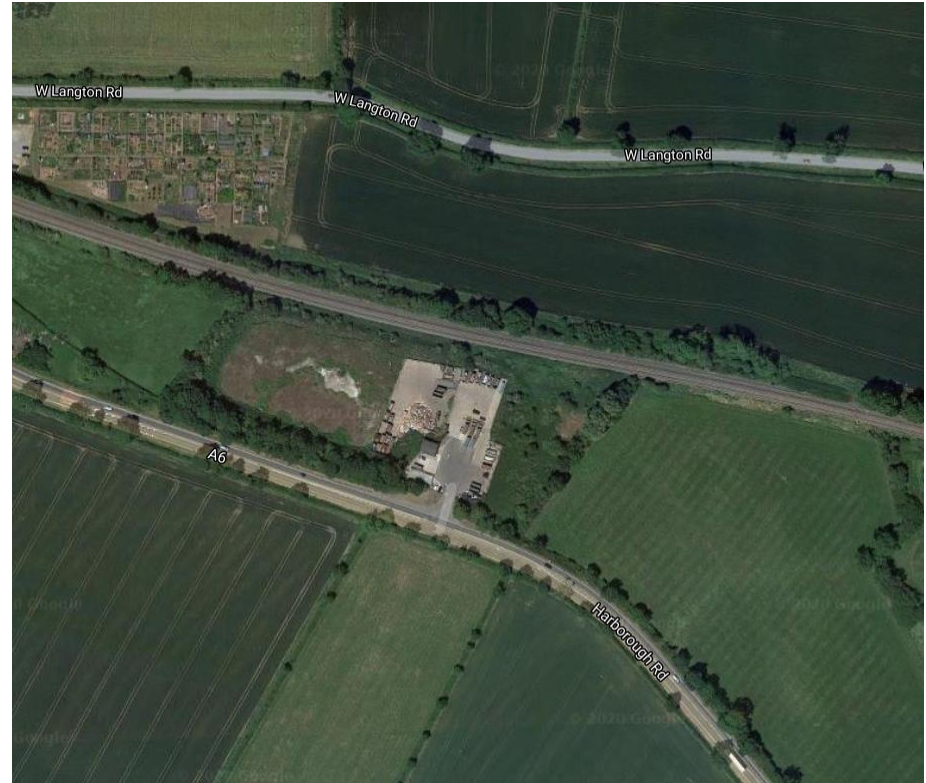
Figure 1

INTRODUCTION: The site is located approximately 1km south-east of Kibworth village centre, comprising an area of approximately 2.0 Ha. The National Grid Reference (NGR) for the approximate centre of the site is SP 697 932. The site location, and development proposal are shown in **Appendix A**.
