**ENVIRONMENTAL PERMIT VARIATION APPLICATION –
STABILITY RISK ASSESSMENT**

**CROFT QUARRY
MARION'S WAY
CROFT
LEICESTERSHIRE
LE9 3GP**

**Document Reference: AI1009/09.R0
June 2024**

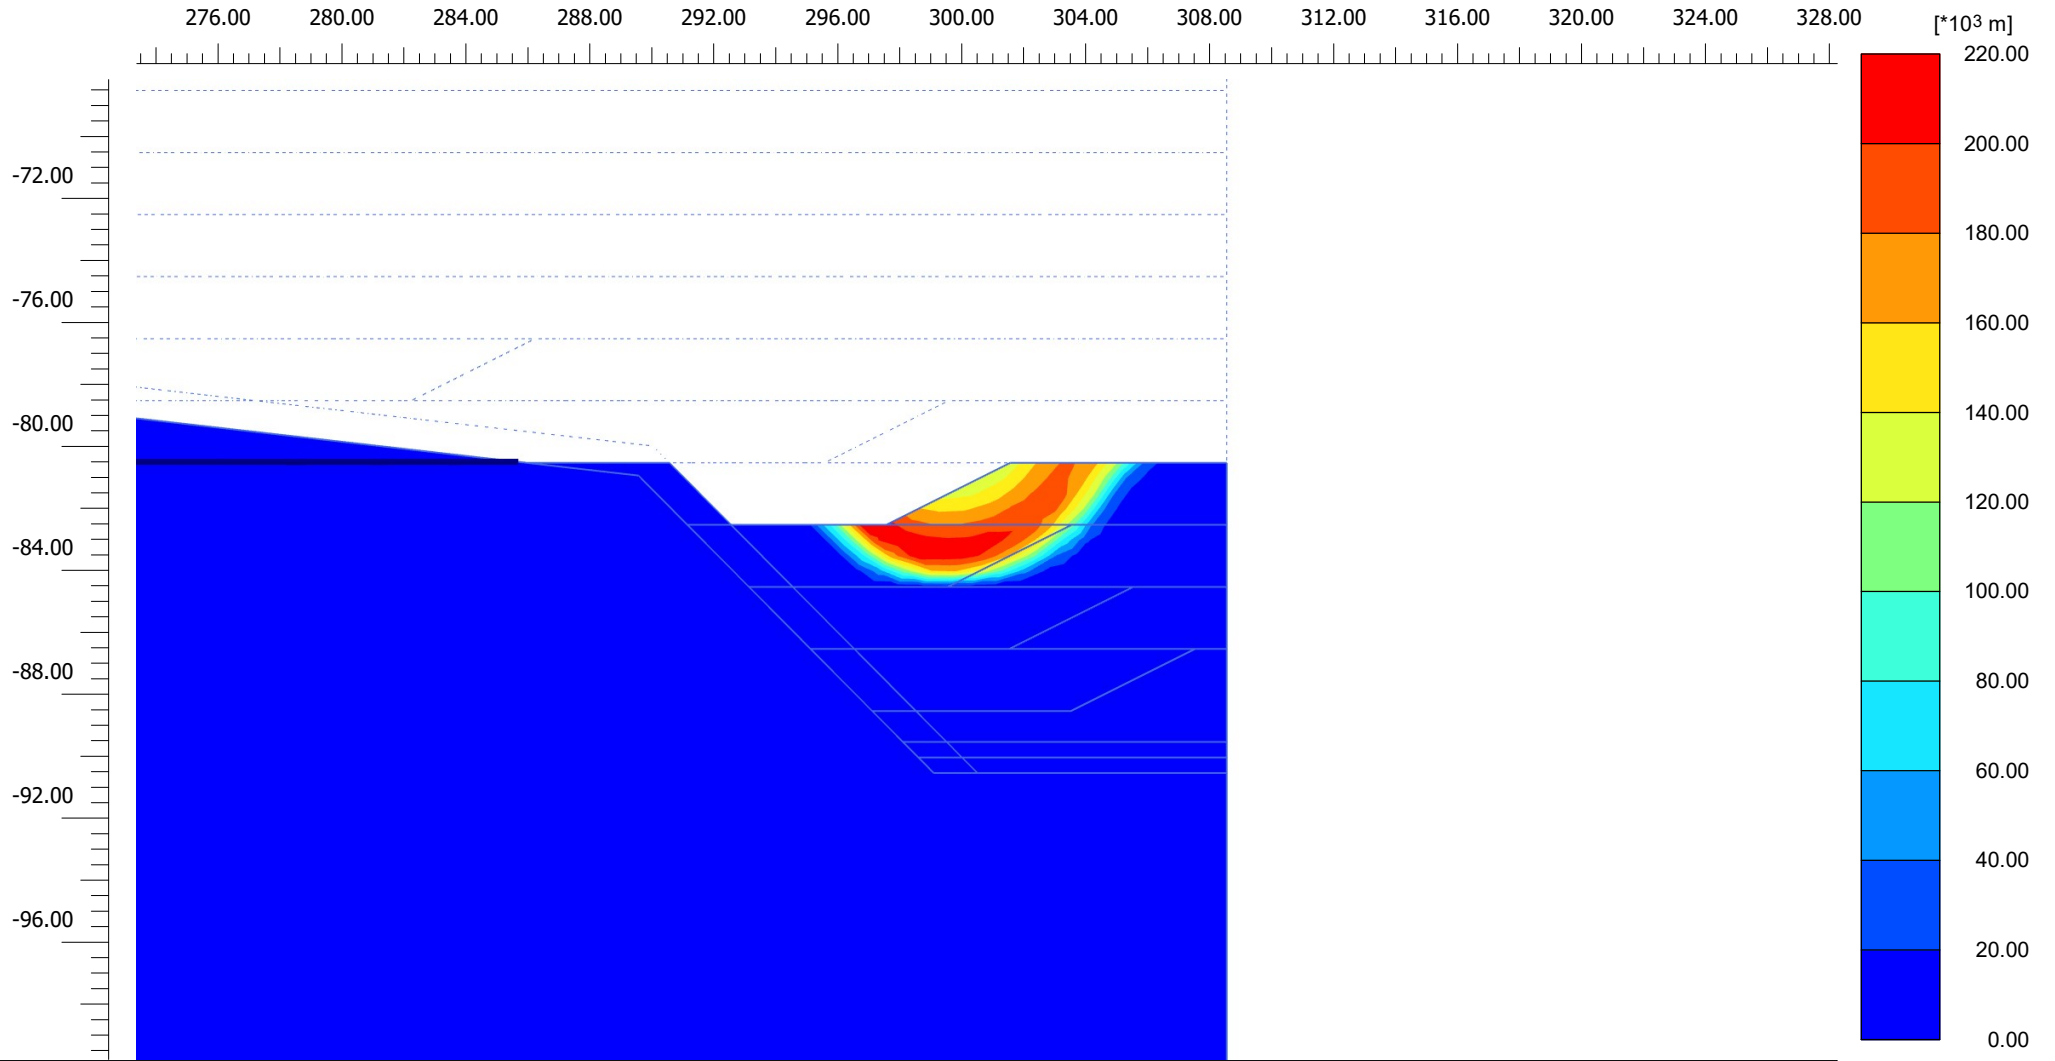
Incremental displacements $|\Delta u|$ (scaled up $0.0500 \cdot 10^{-3}$ times)

Maximum value = $218.0 \cdot 10^3$ m (Element 5659 at Node 27057)

3.2.1 A summary of the factors of safety from the PLAXIS Phi-C reduction runs for the stability model are presented in **Table SRA11, Table SRA12, Table SRA13** and **Table SRA14** below. These tables represent the results for side-slope AEGB construction lifts 1-15 (1st year), 16-23 (2nd year), 24-35 (3rd-5th years), 36-50 (final years), respectively. The results include the stability of each side-slope AEGB construction phase, and each buttressing of the AEGB with waste phase. Graphical representations of the analyses (including failure modes) for every 5th lift of the lining system / waste buttressing are shown in **Appendix SRA2**.

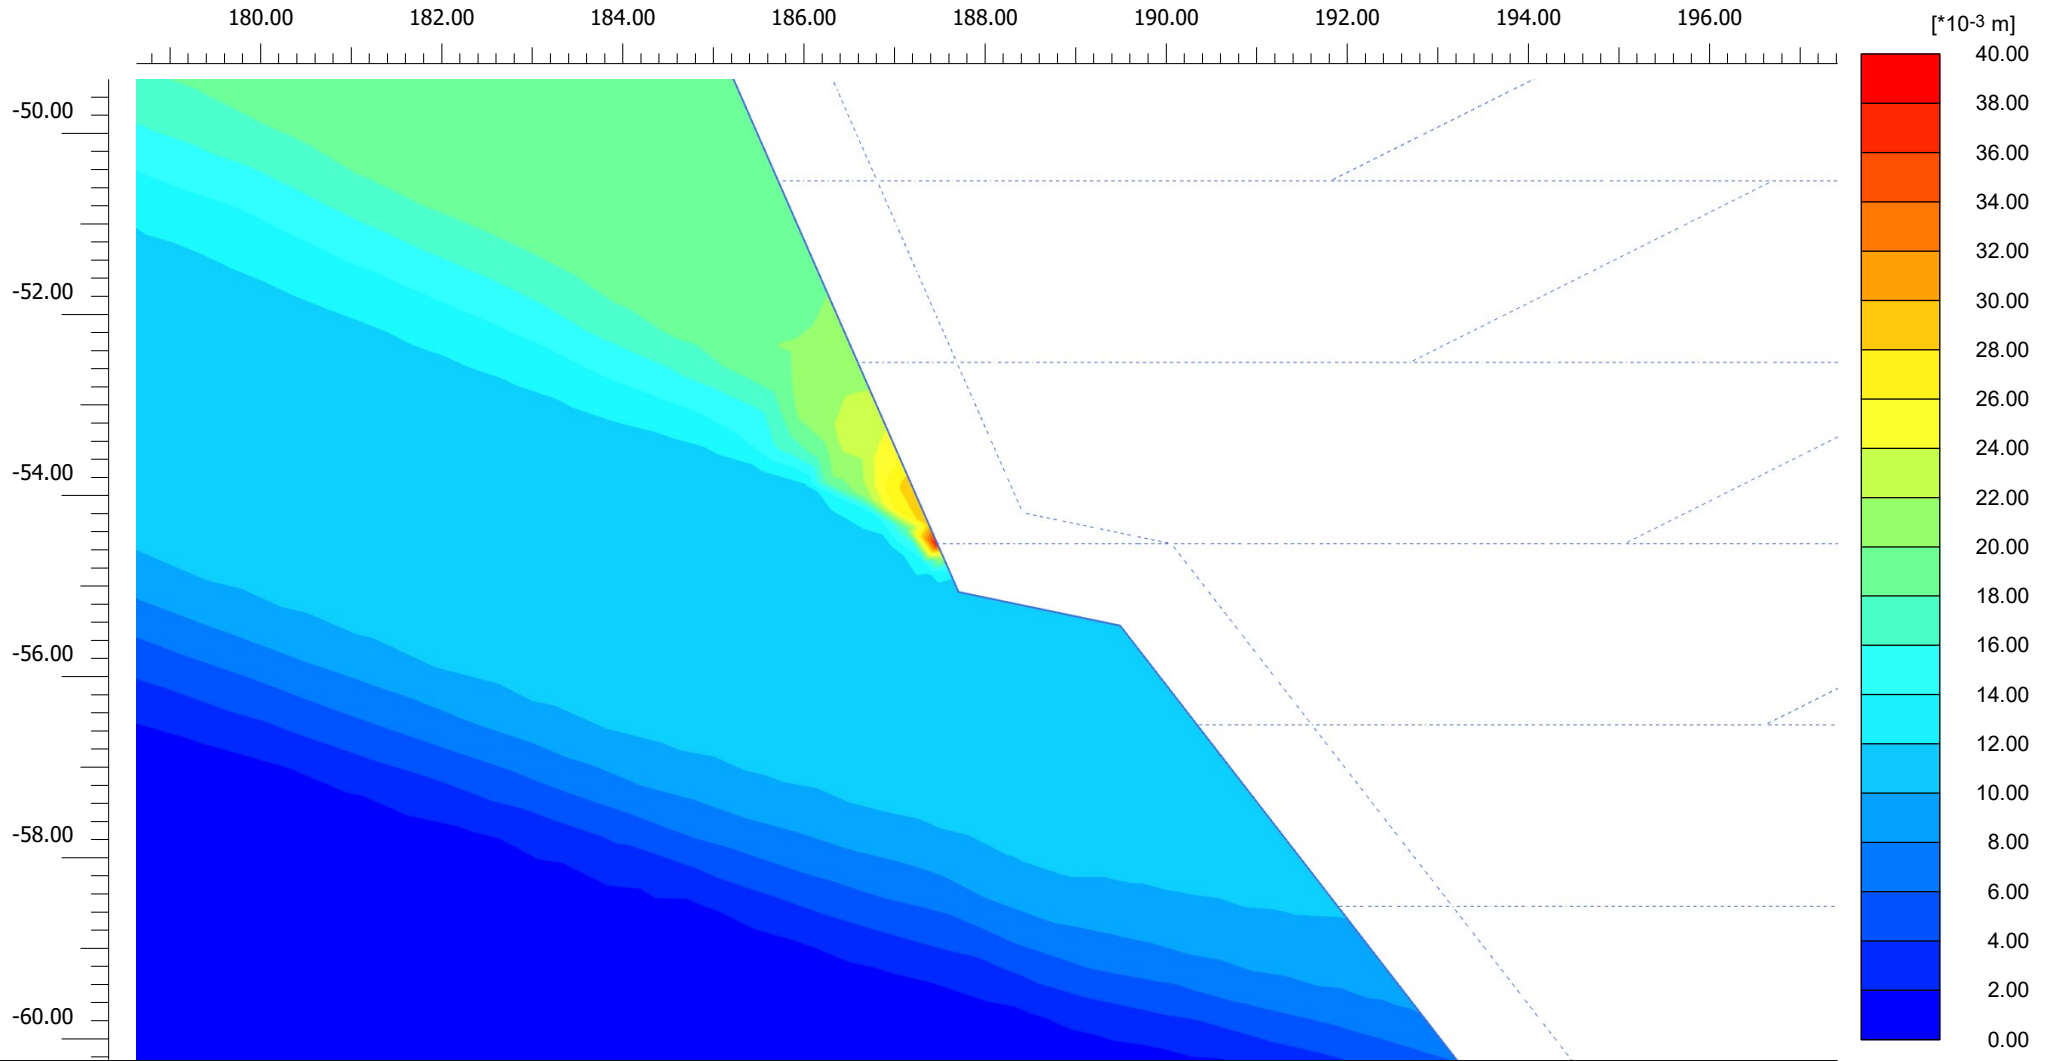
Incremental displacements $|\Delta u|$ (scaled up 200 times)
 Maximum value = 0.03889 m (Element 4266 at Node 10491)

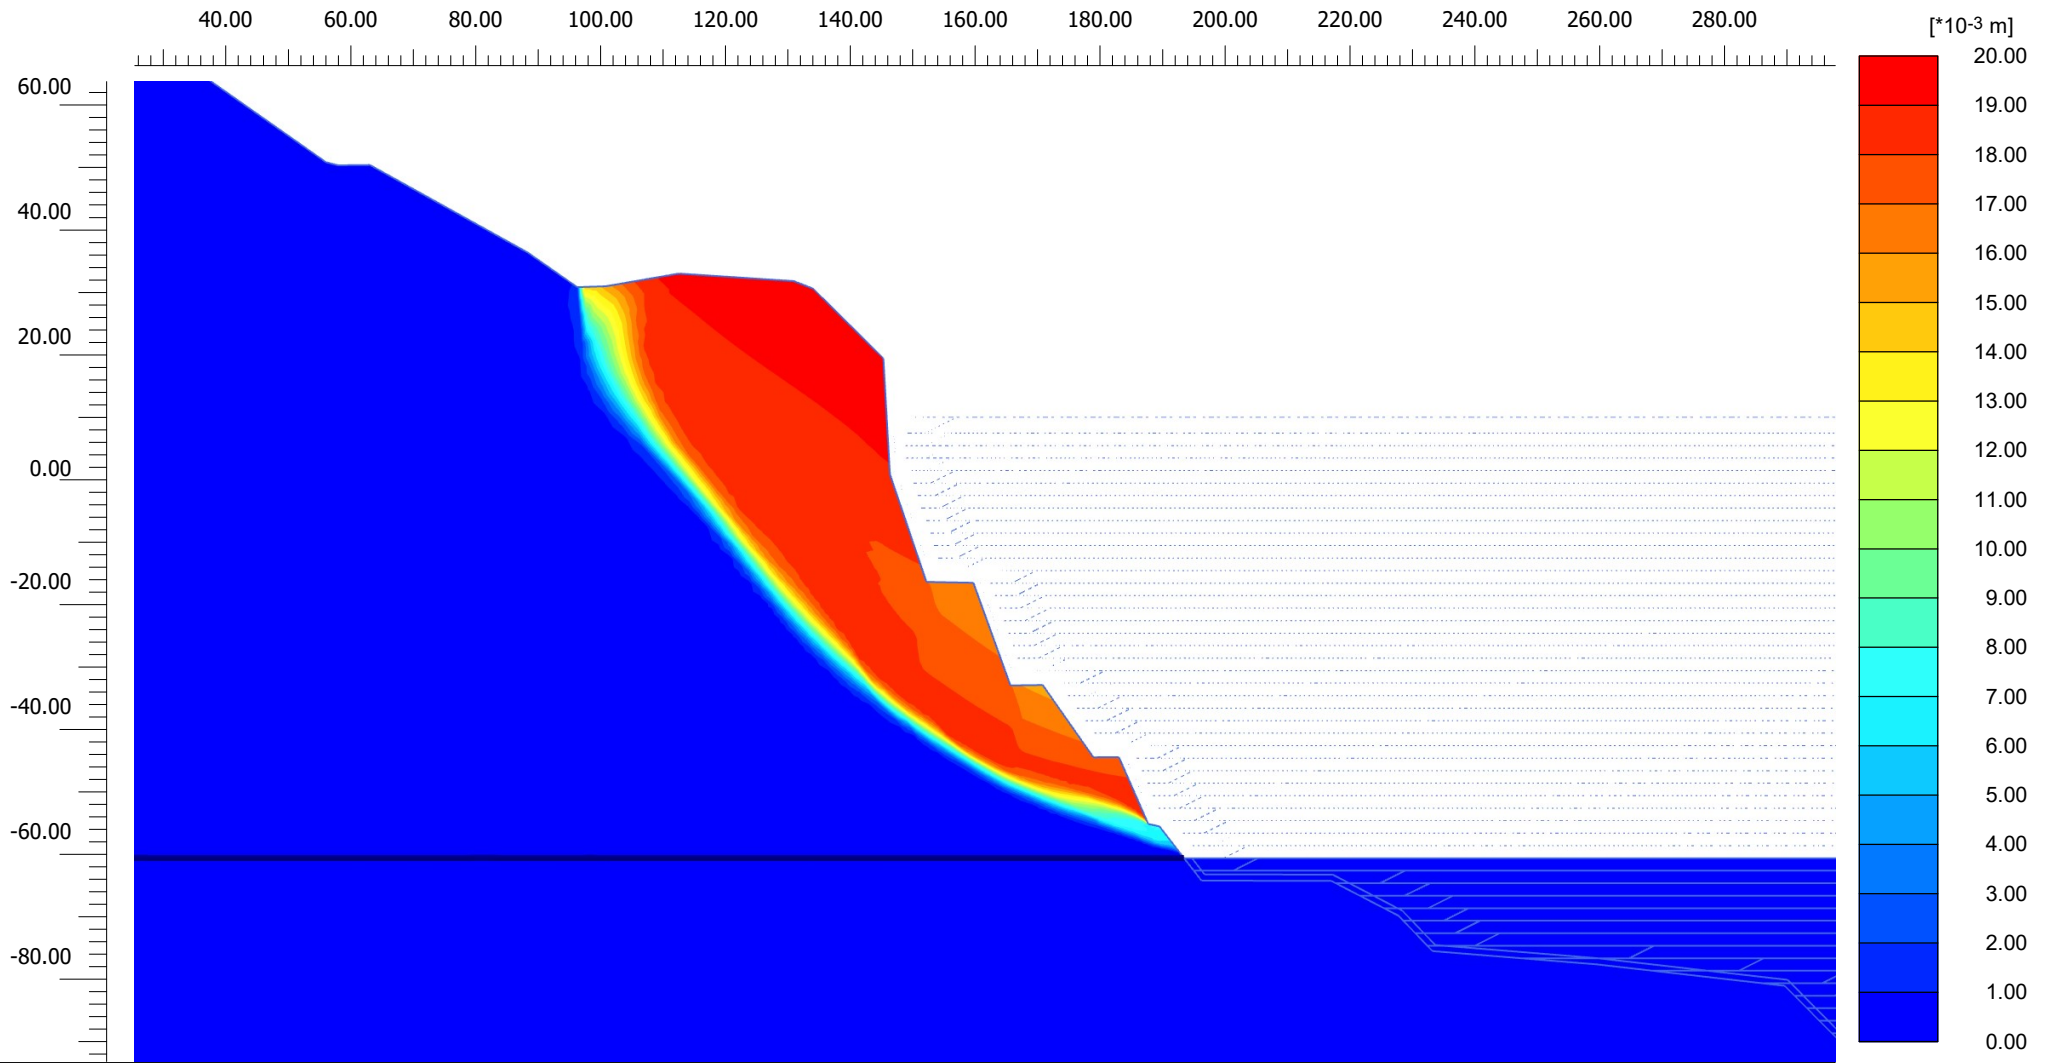
Incremental displacements $|\Delta u|$ (scaled up 500 times)
 Maximum value = 0.01965 m (Element 3506 at Node 2243)

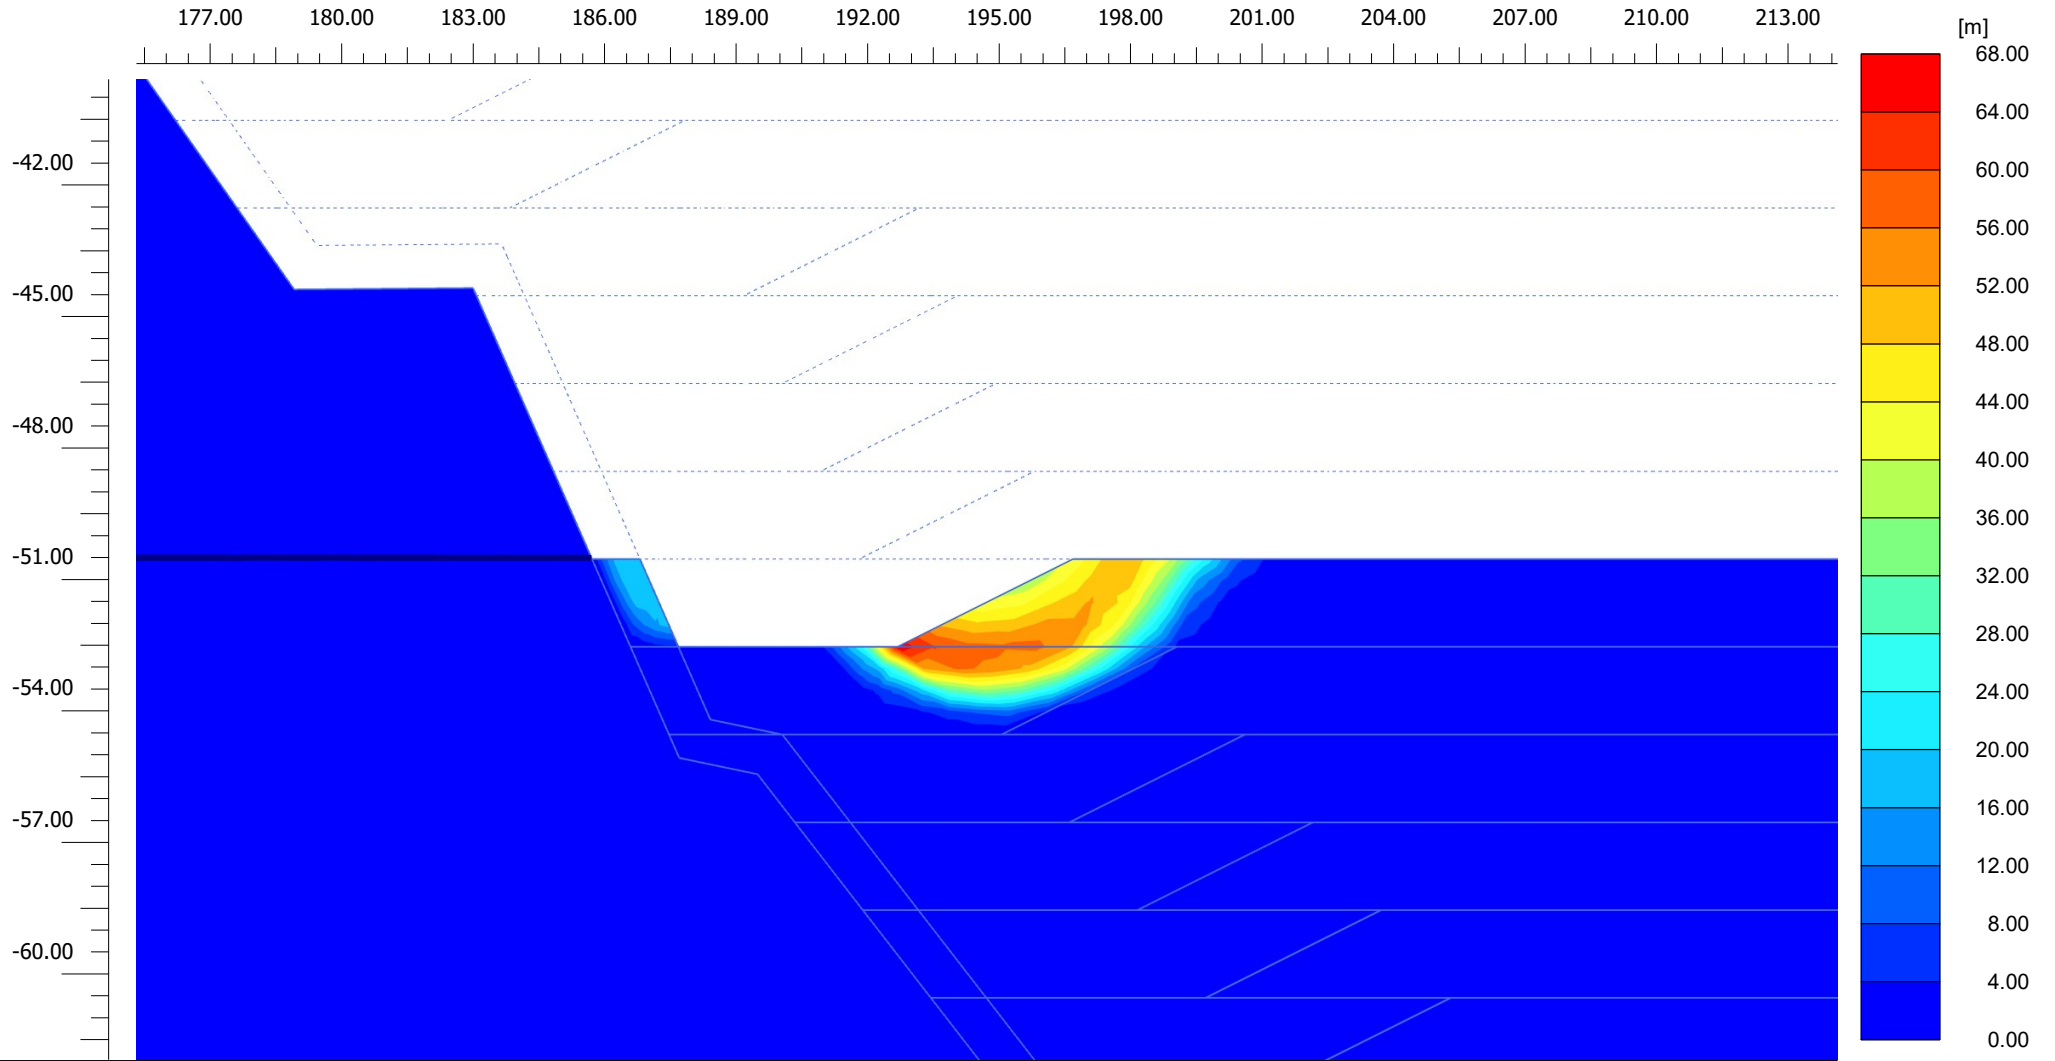
Incremental displacements $|\Delta u|$ (scaled up 0.200 times)

Maximum value = 67.09 m (Element 4374 at Node 14645)

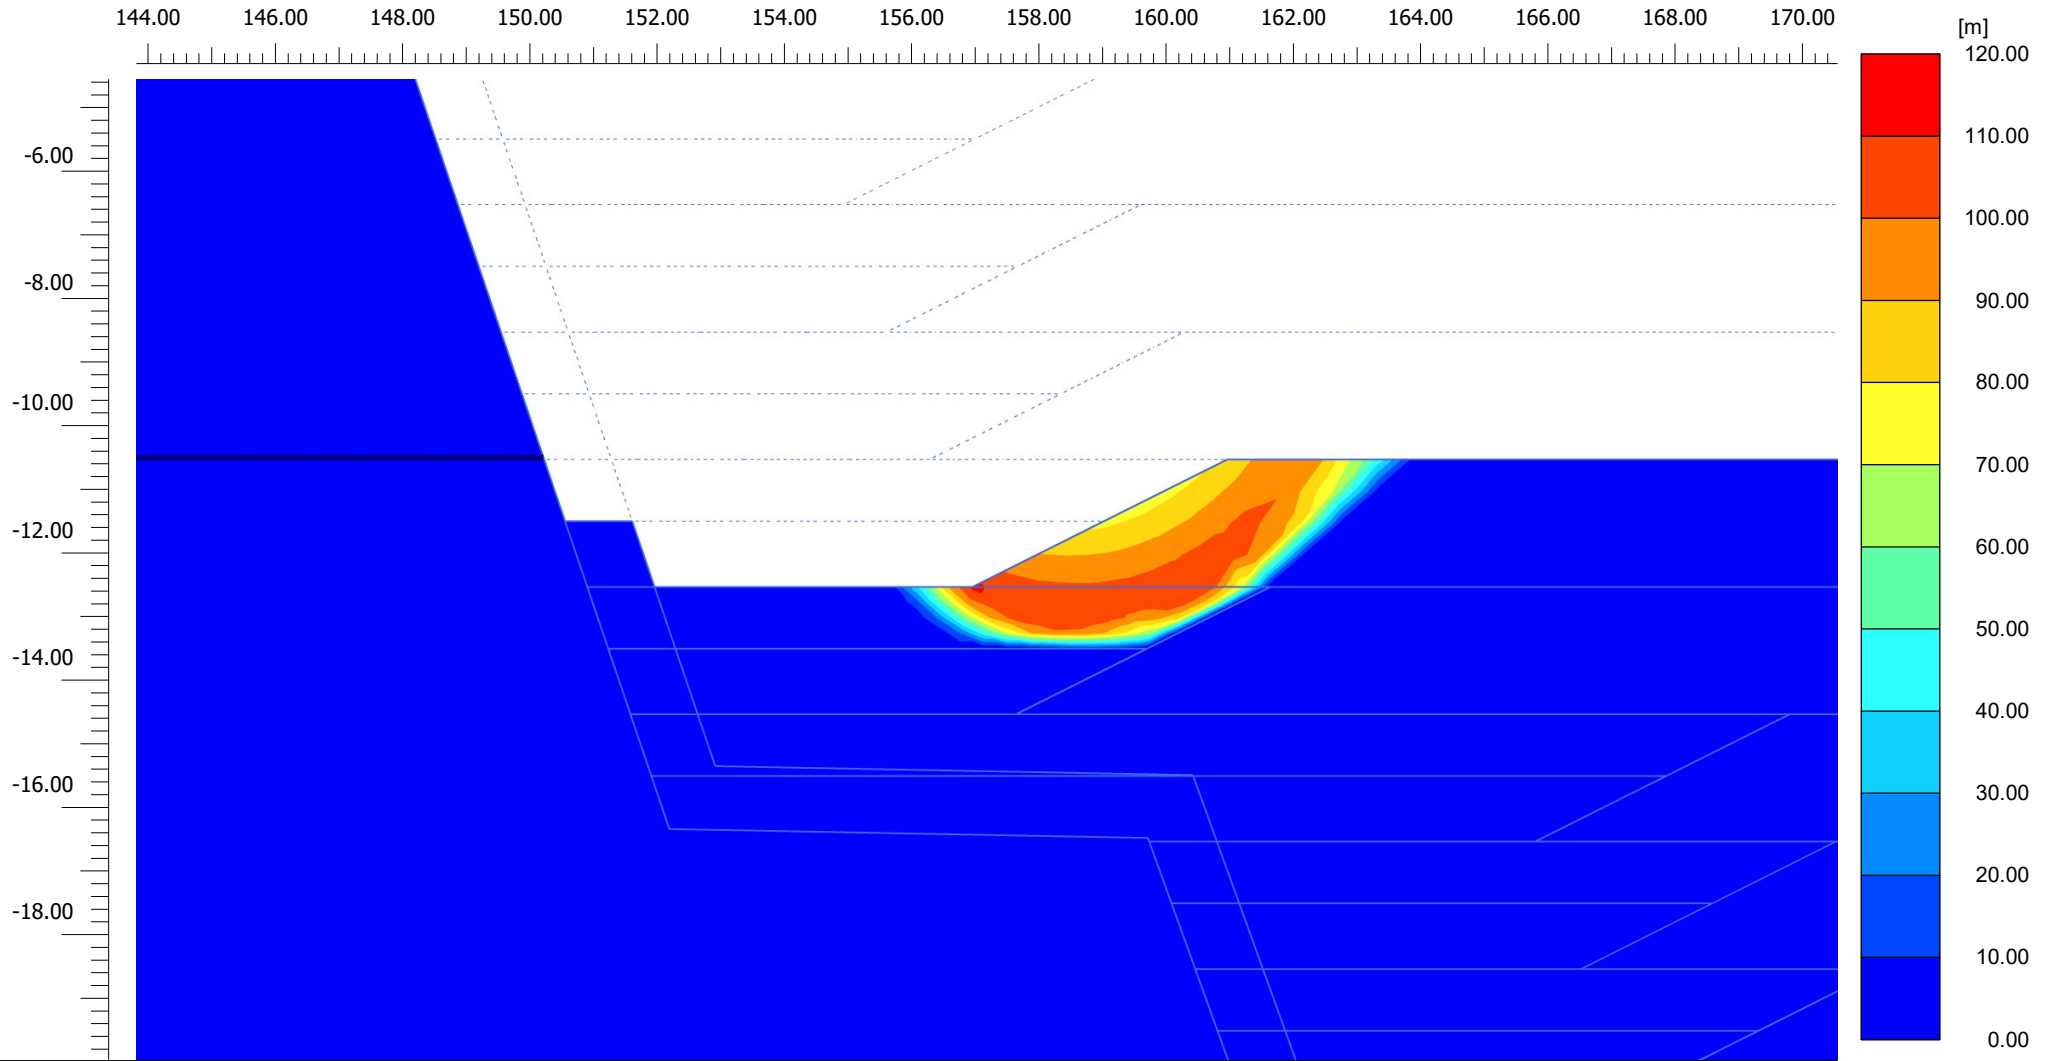
Incremental displacements $|\Delta u|$ (scaled up 0.0500 times)

Maximum value = 113.4 m (Element 1415 at Node 2039)

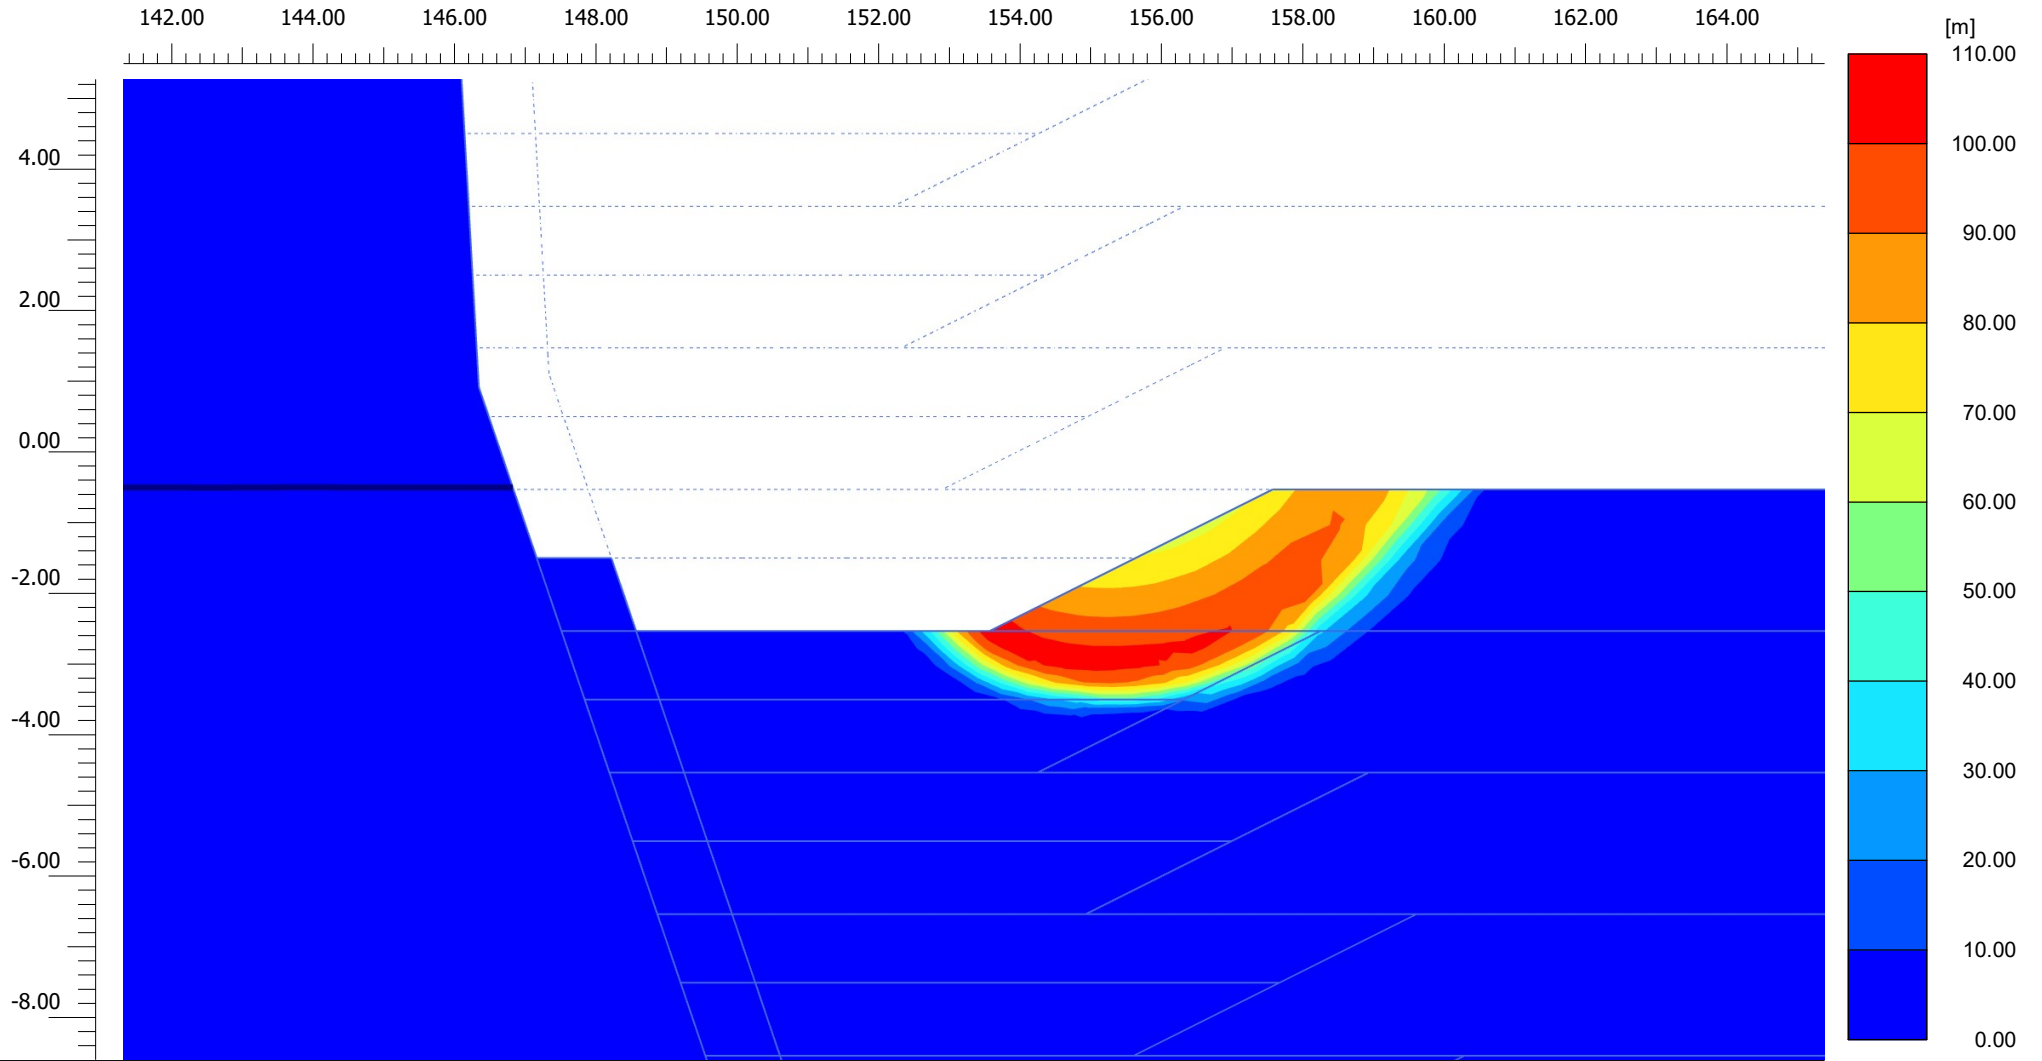
Incremental displacements $|\Delta u|$ (scaled up 0.100 times)

Maximum value = 108.6 m (Element 775 at Node 304)

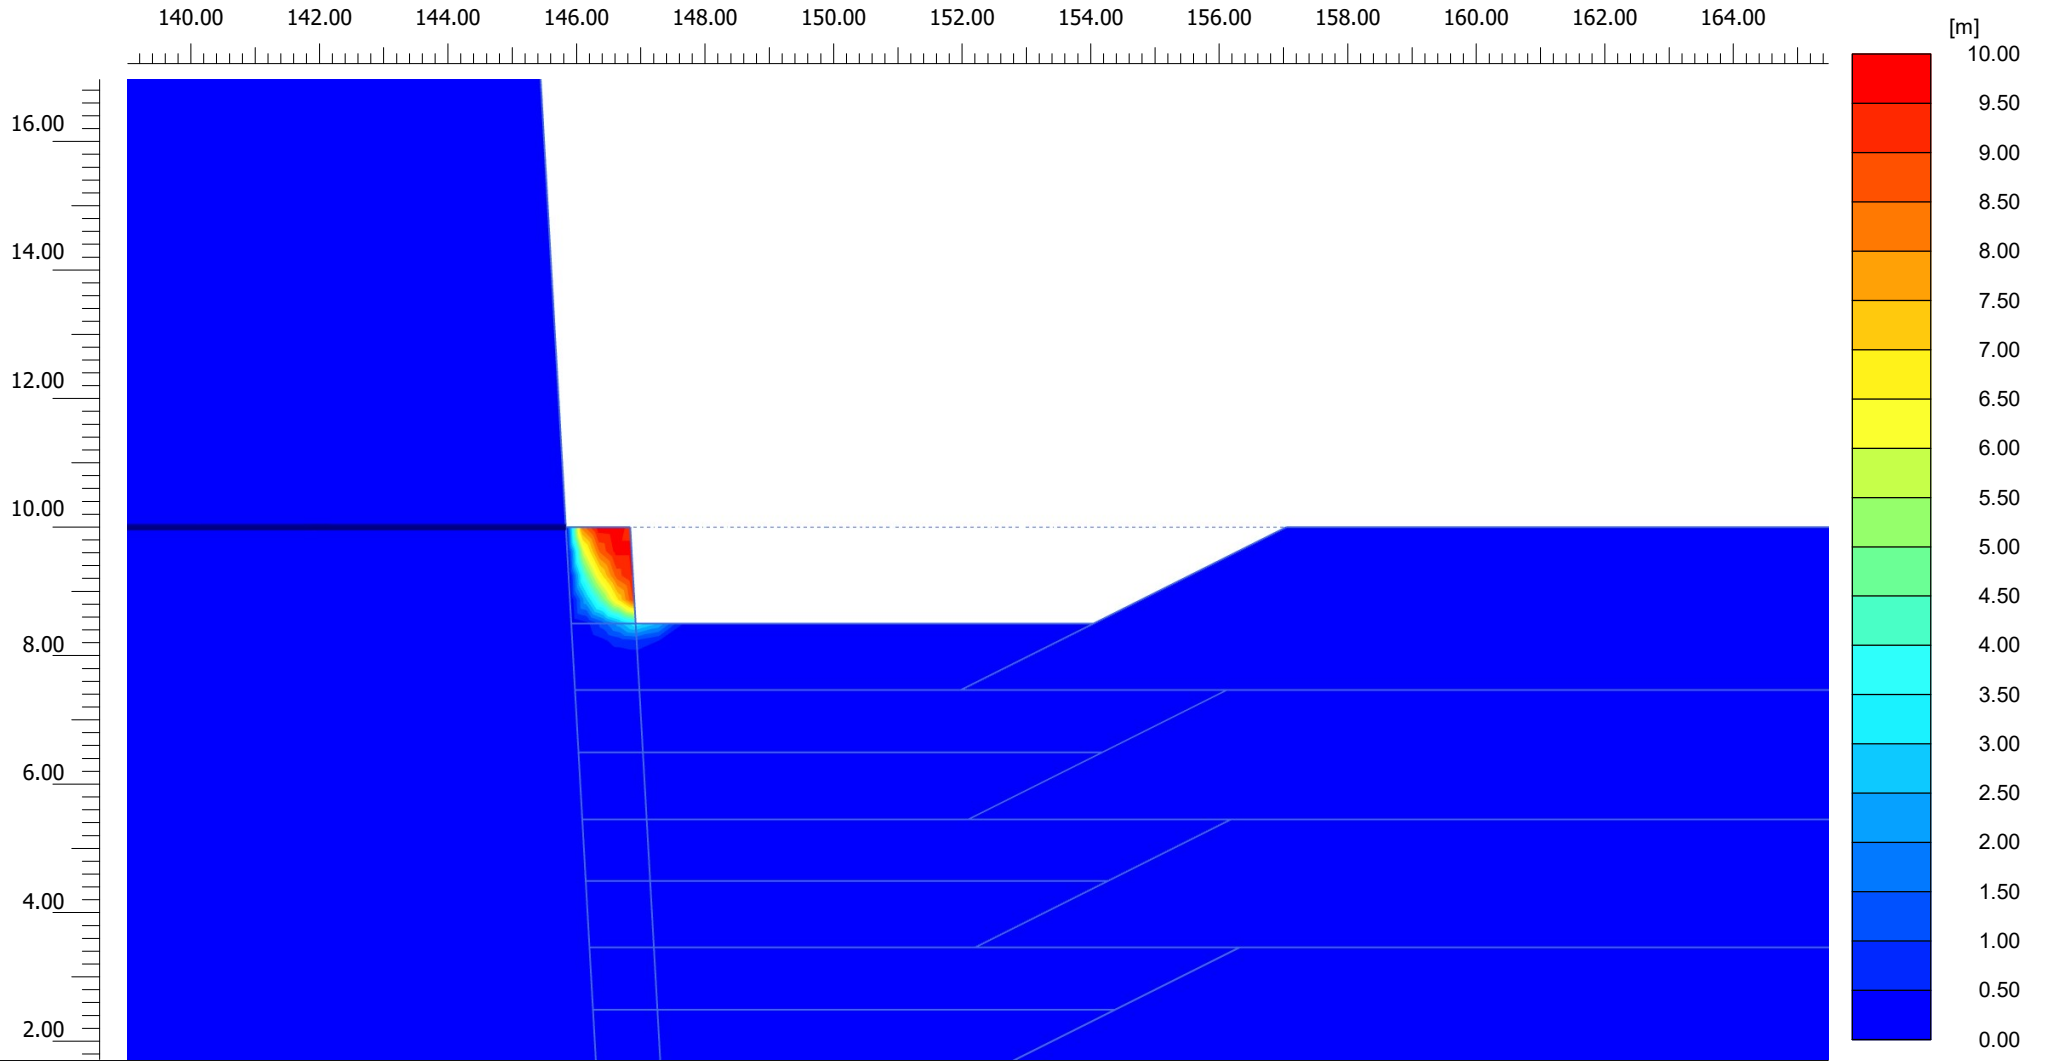
Incremental displacements $|\Delta u|$ (scaled up 5.00 times)

Maximum value = 9.885 m (Element 12 at Node 1957)

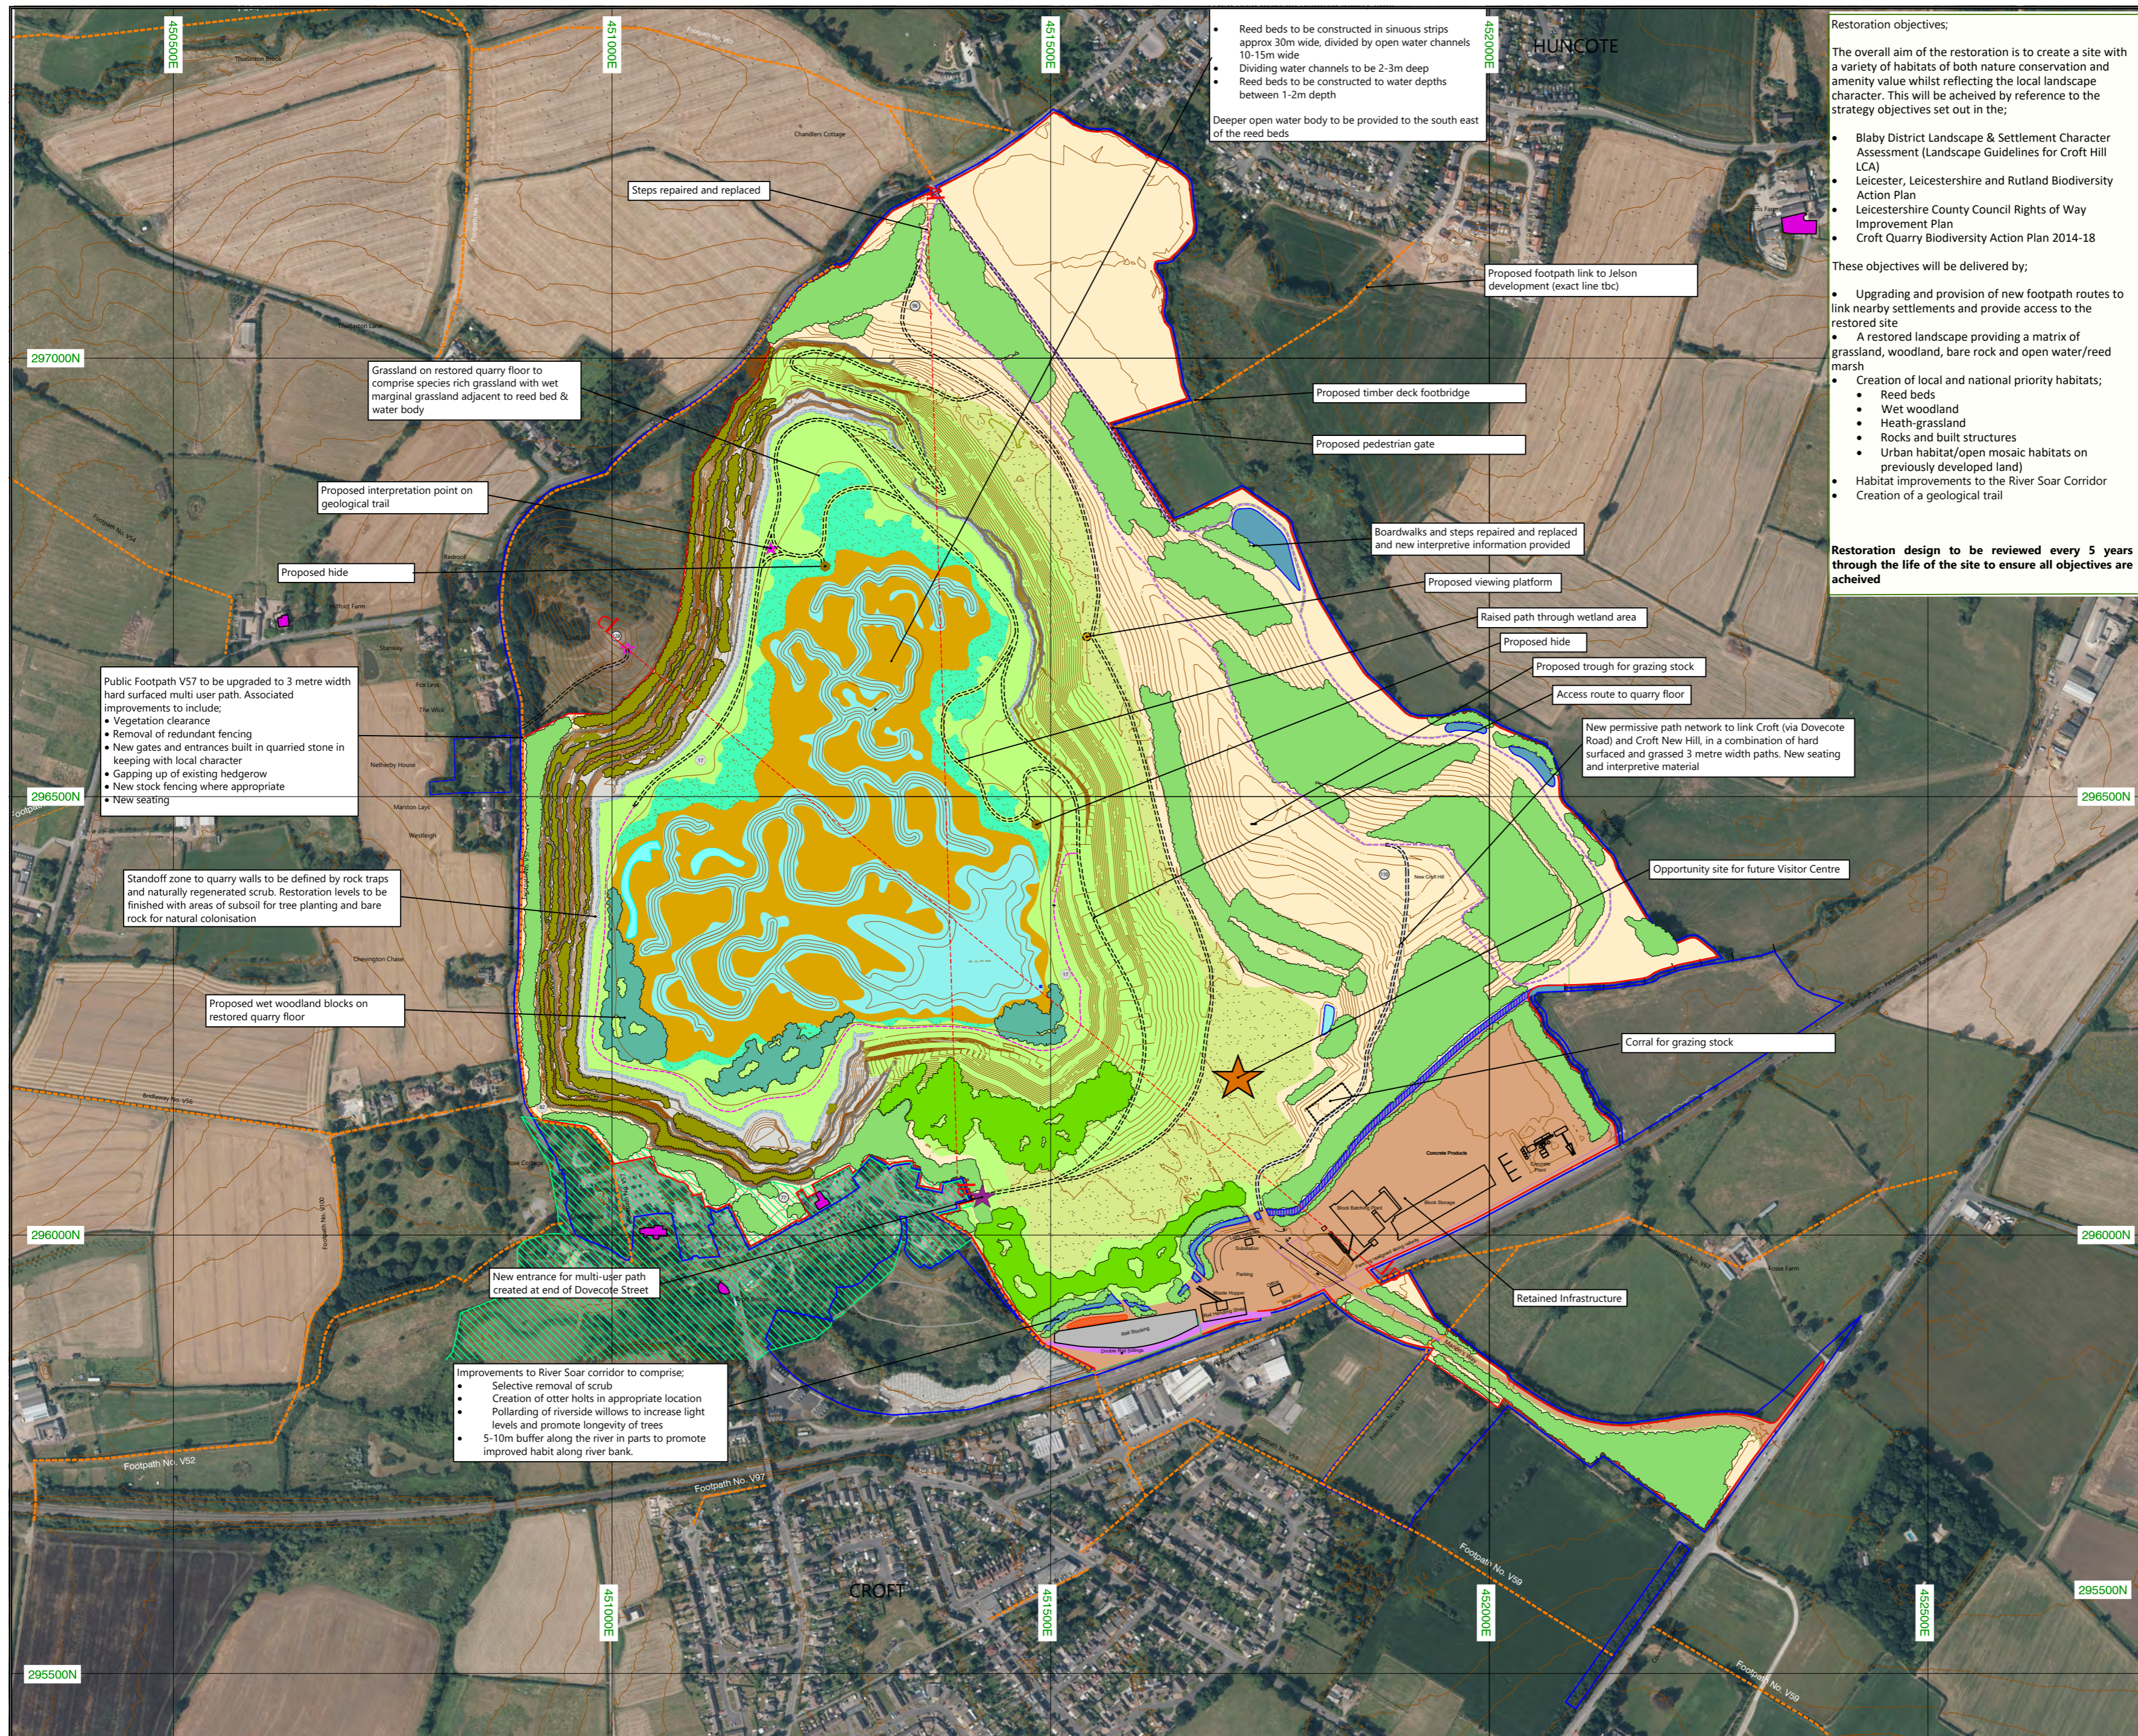
DRAWING NUMBER: C14_LAN_035 REV: D Feb 20

- Reed beds to be constructed in sinuous strips approx 30m wide, divided by open water channels 10-15m wide
- Dividing water channels to be 2-3m deep
- Reed beds to be constructed to water depths between 1-2m depth

Deeper open water body to be provided to the south east of the reed beds
