Whisby Landfill Site – IBA Processing Facility

Environmental Permit Variation Application

Environmental Setting & Installation Design Report - Addendum

Document Reference: 5671-CAU-XX-XX-RP-V-0303.A0.C1

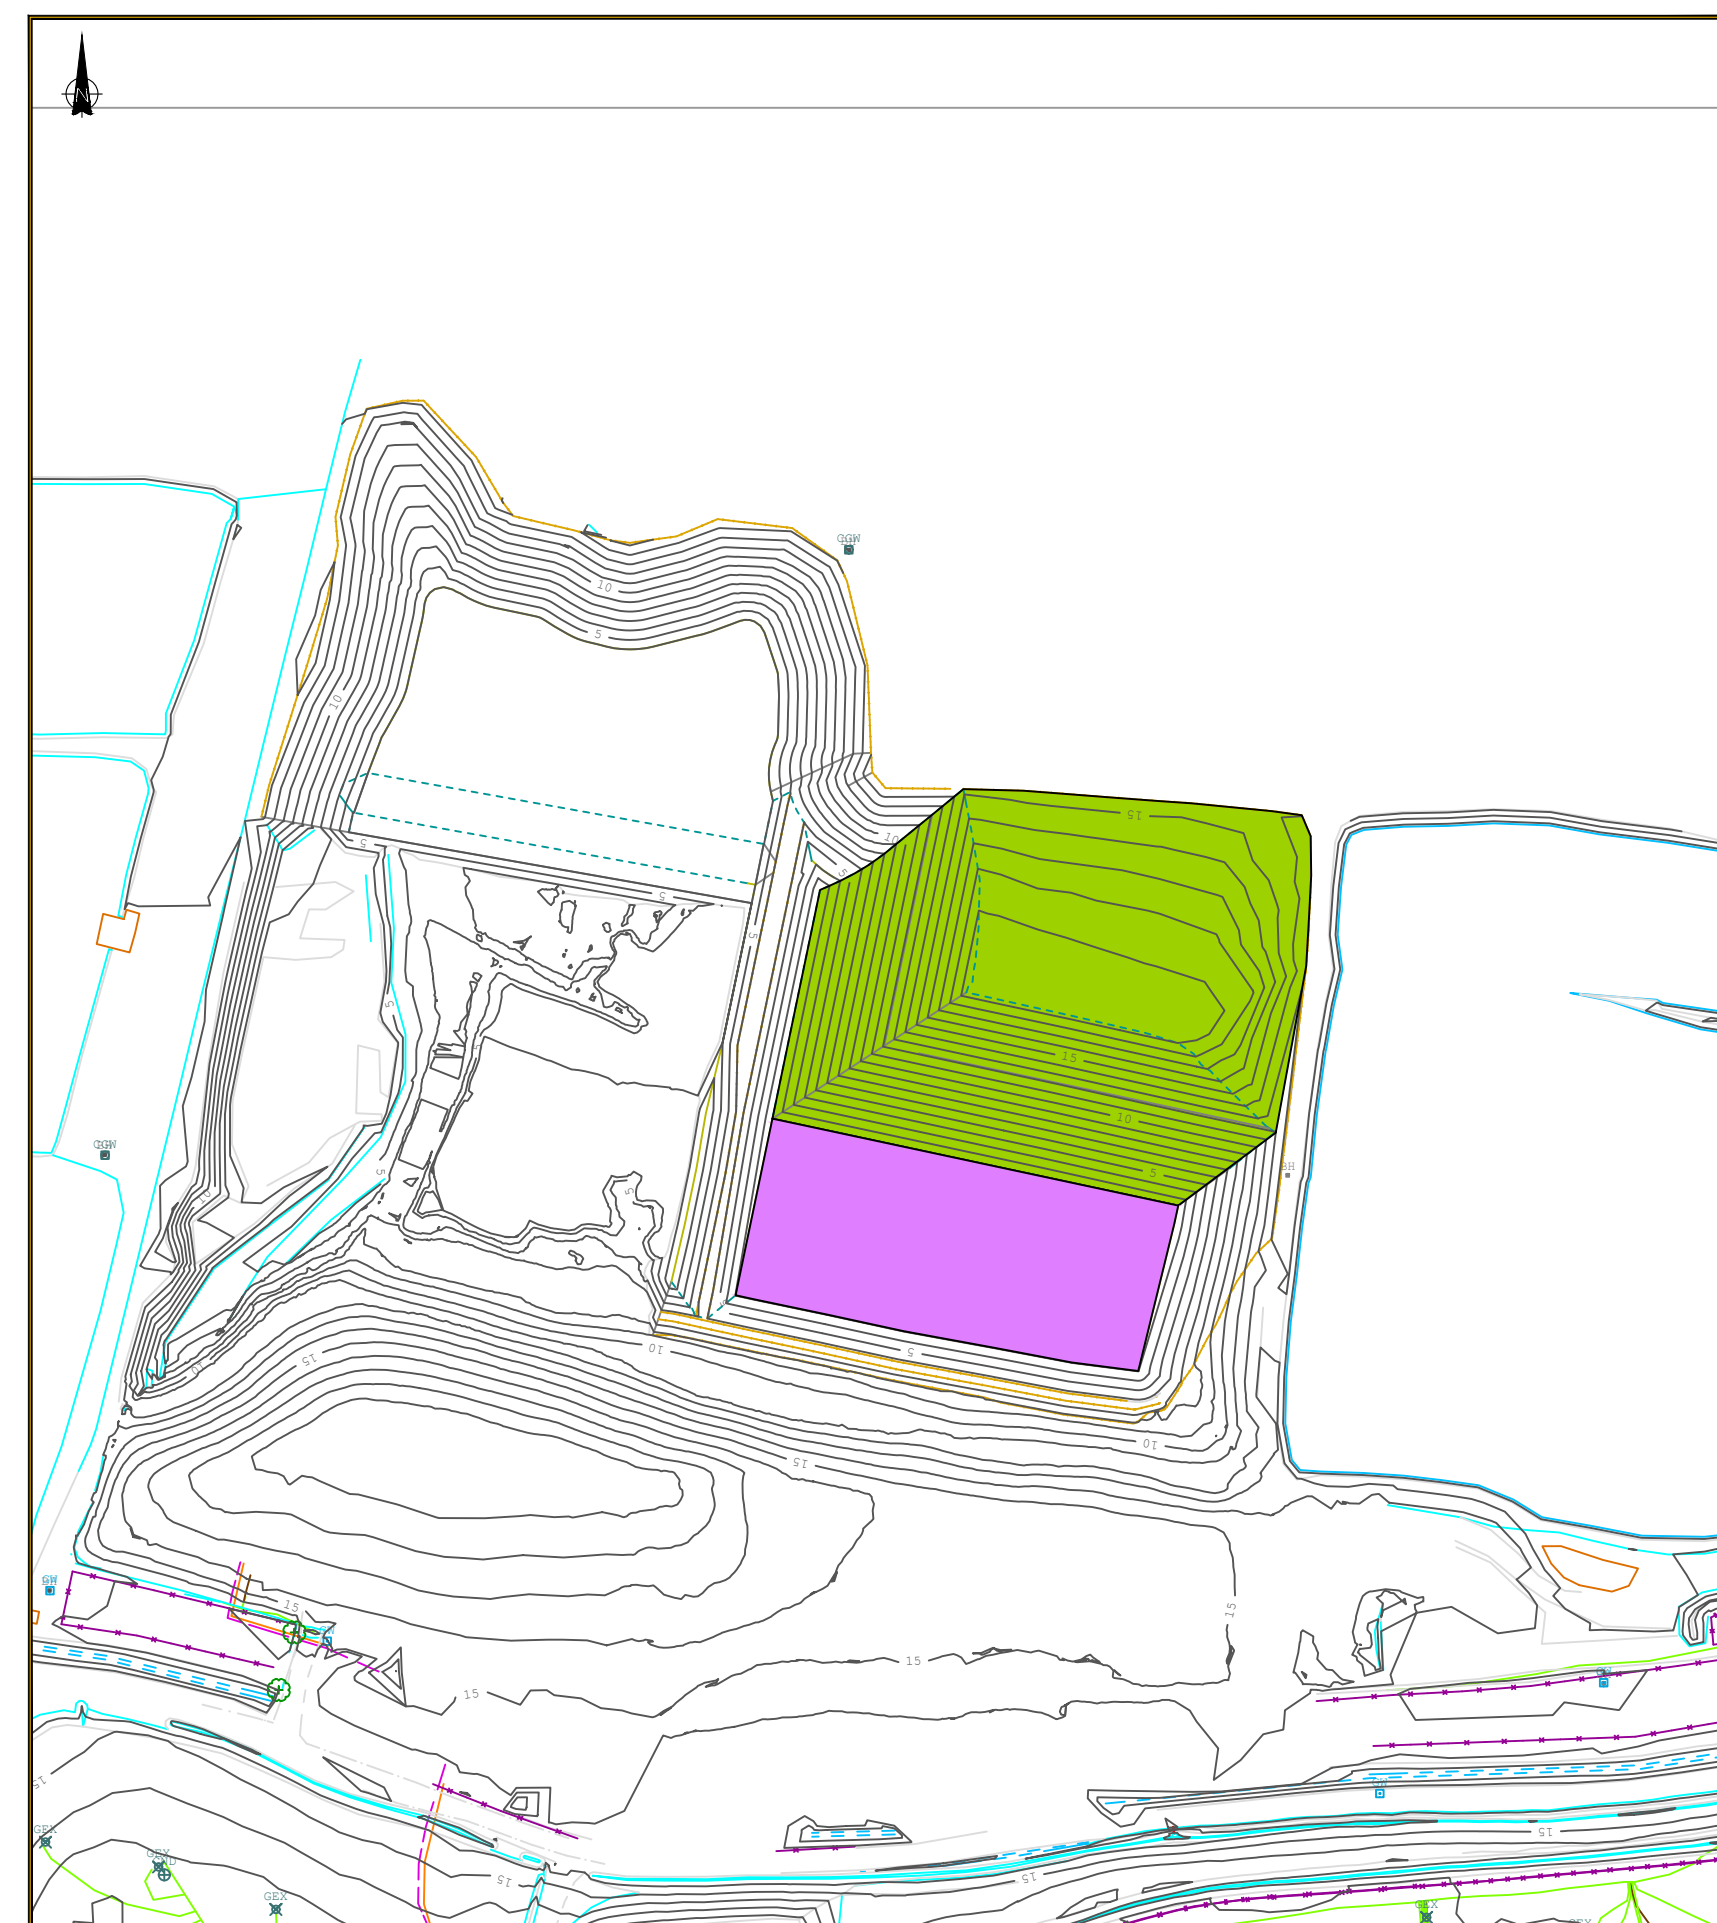
PROPOSED CELL 1 FILLED, CELL 2 ENGINEERED
SCALE 1:1250

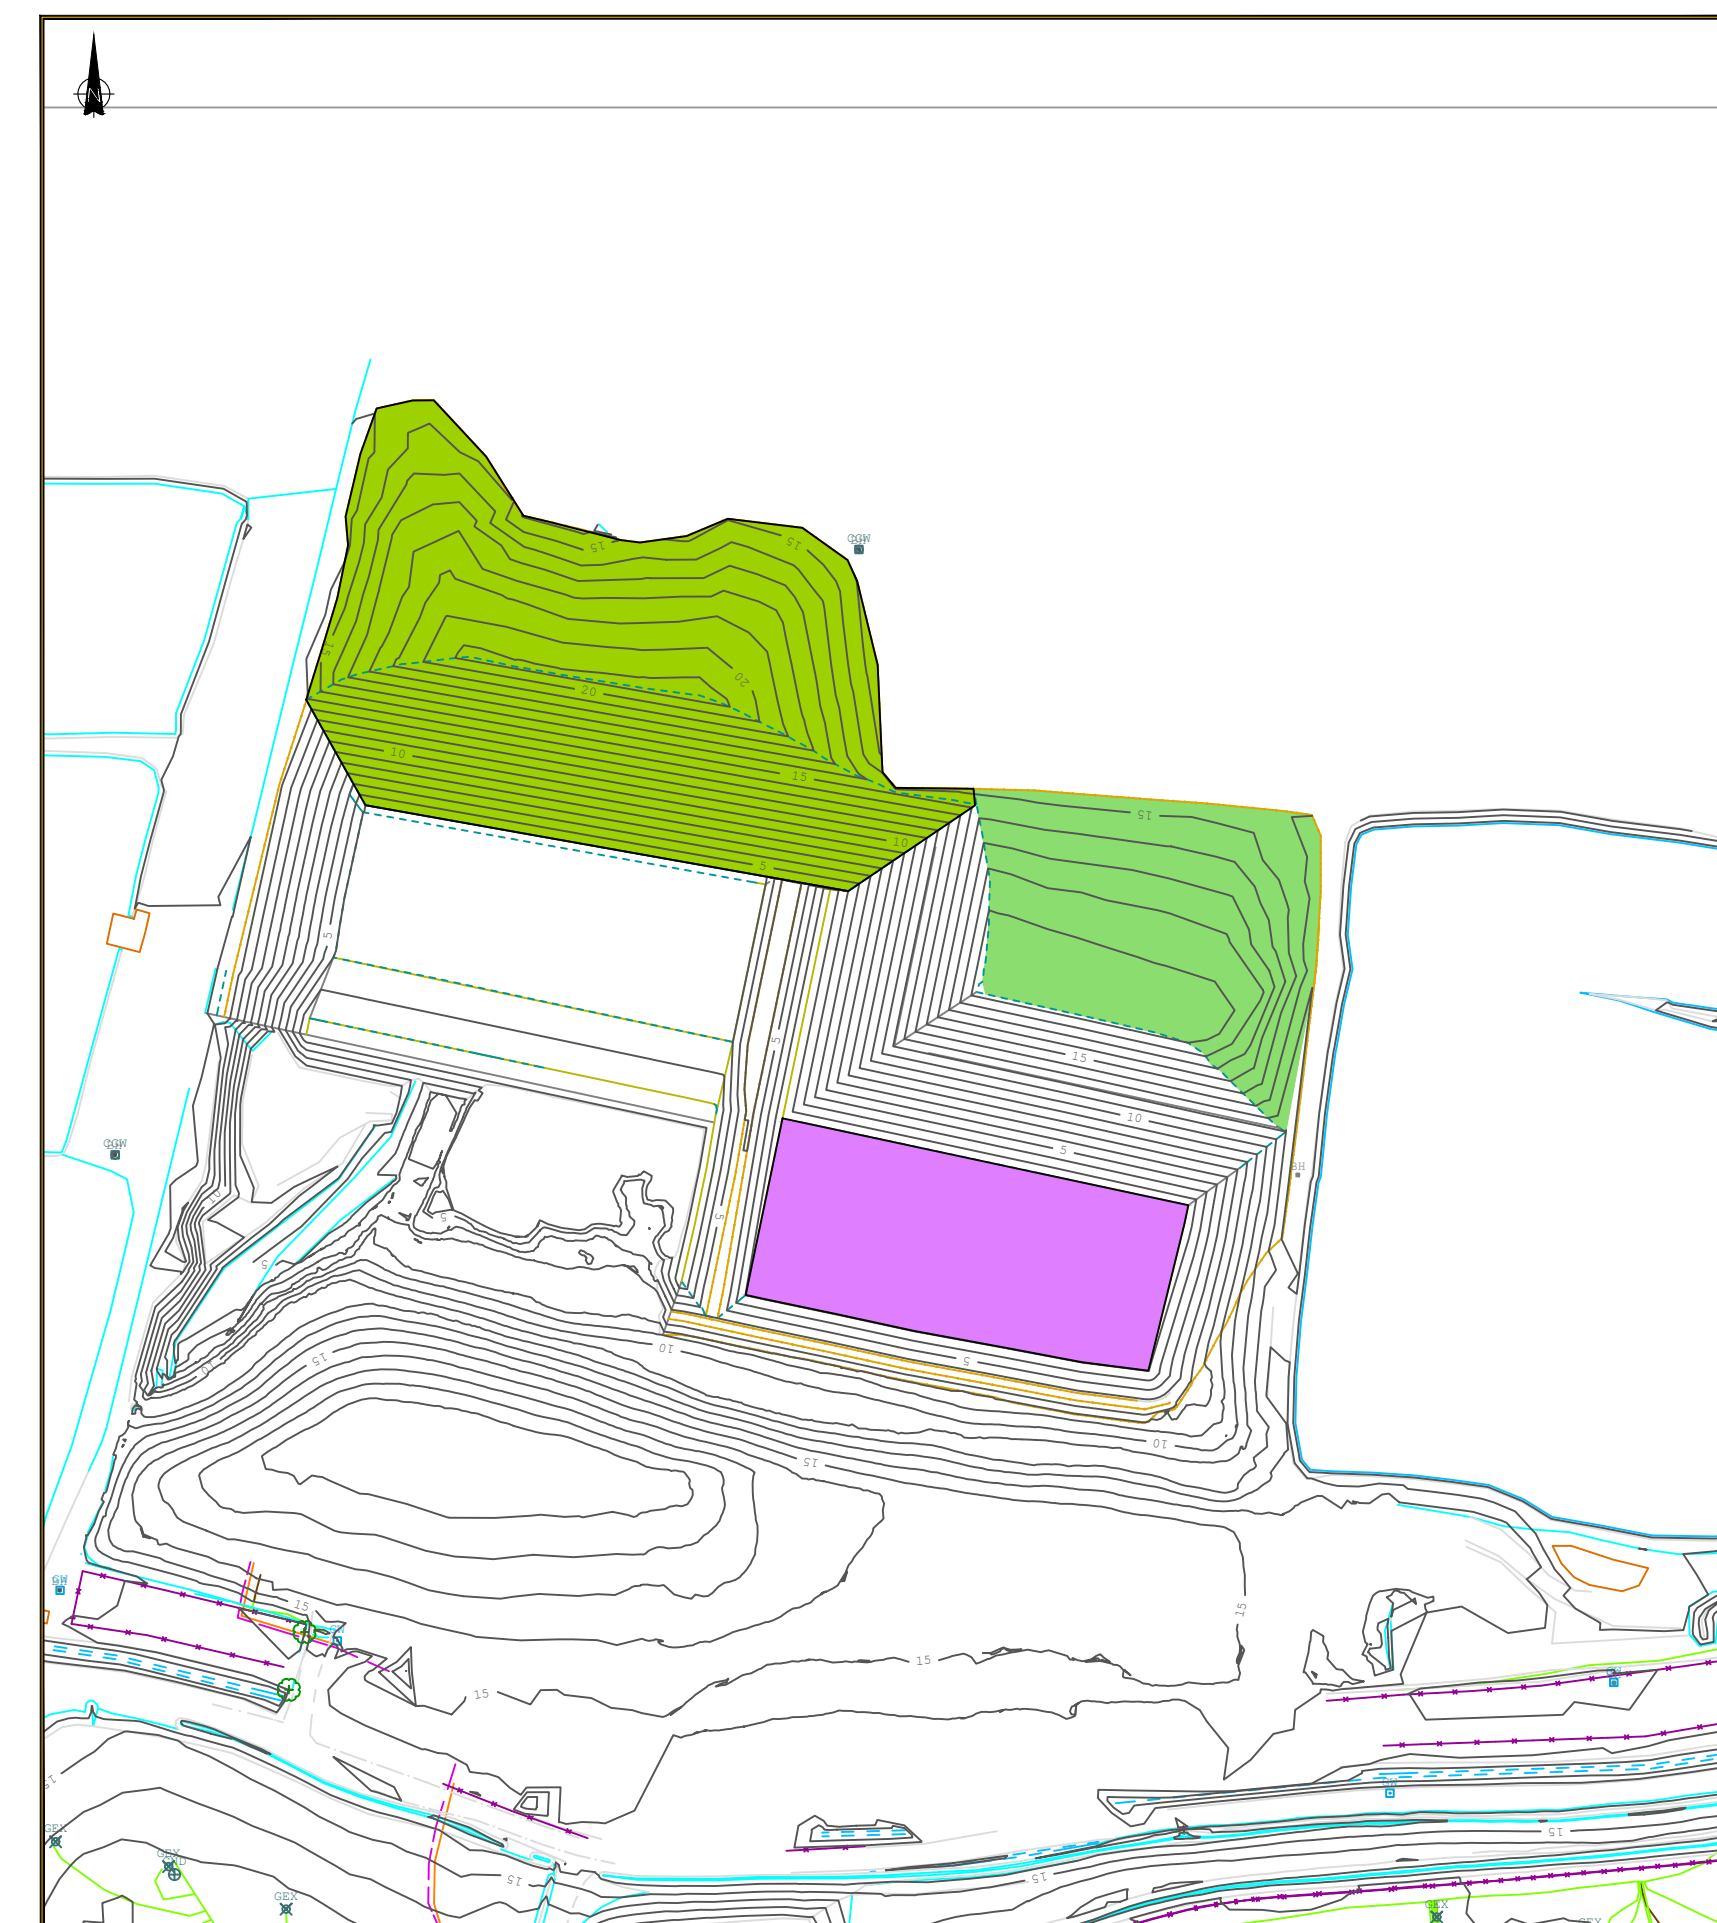
PROPOSED CELL 1 RESTORED, CELL 2 FILLED & CELL 3 ENGINEERED
SCALE 1:1250

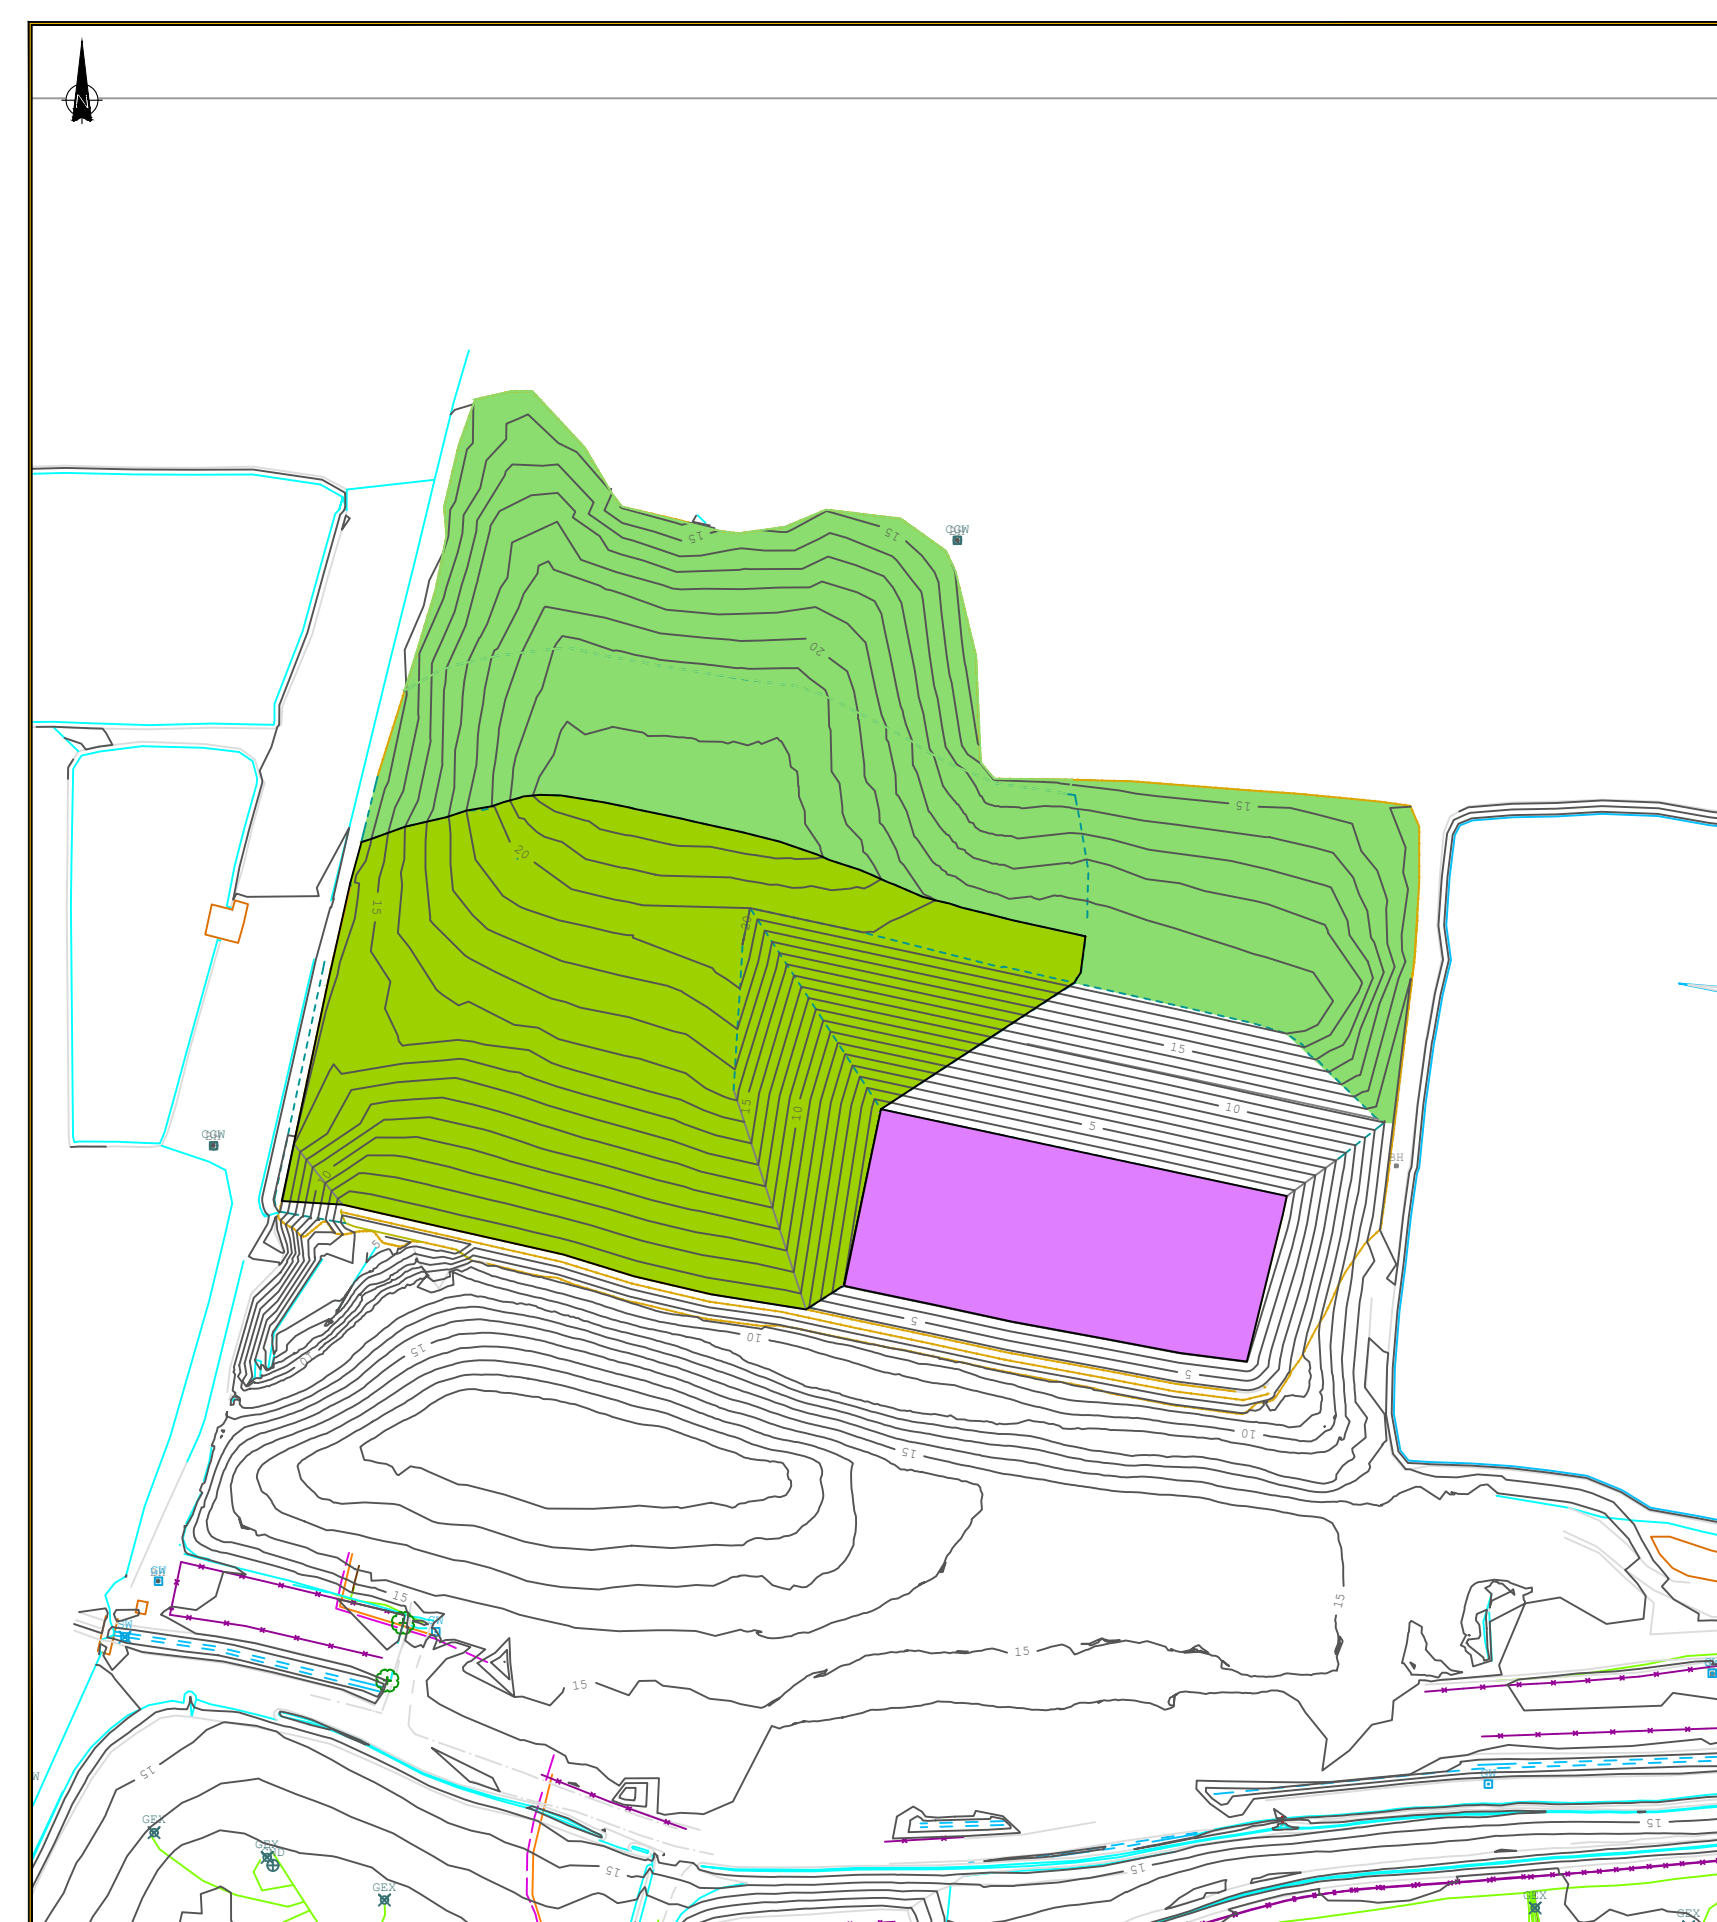
PROPOSED CELL 1, 2 & 3 RESTORED, CELL 4 FILLED - IBA PAD IN CELL 1 RE-PURPOSED
SCALE 1:1250

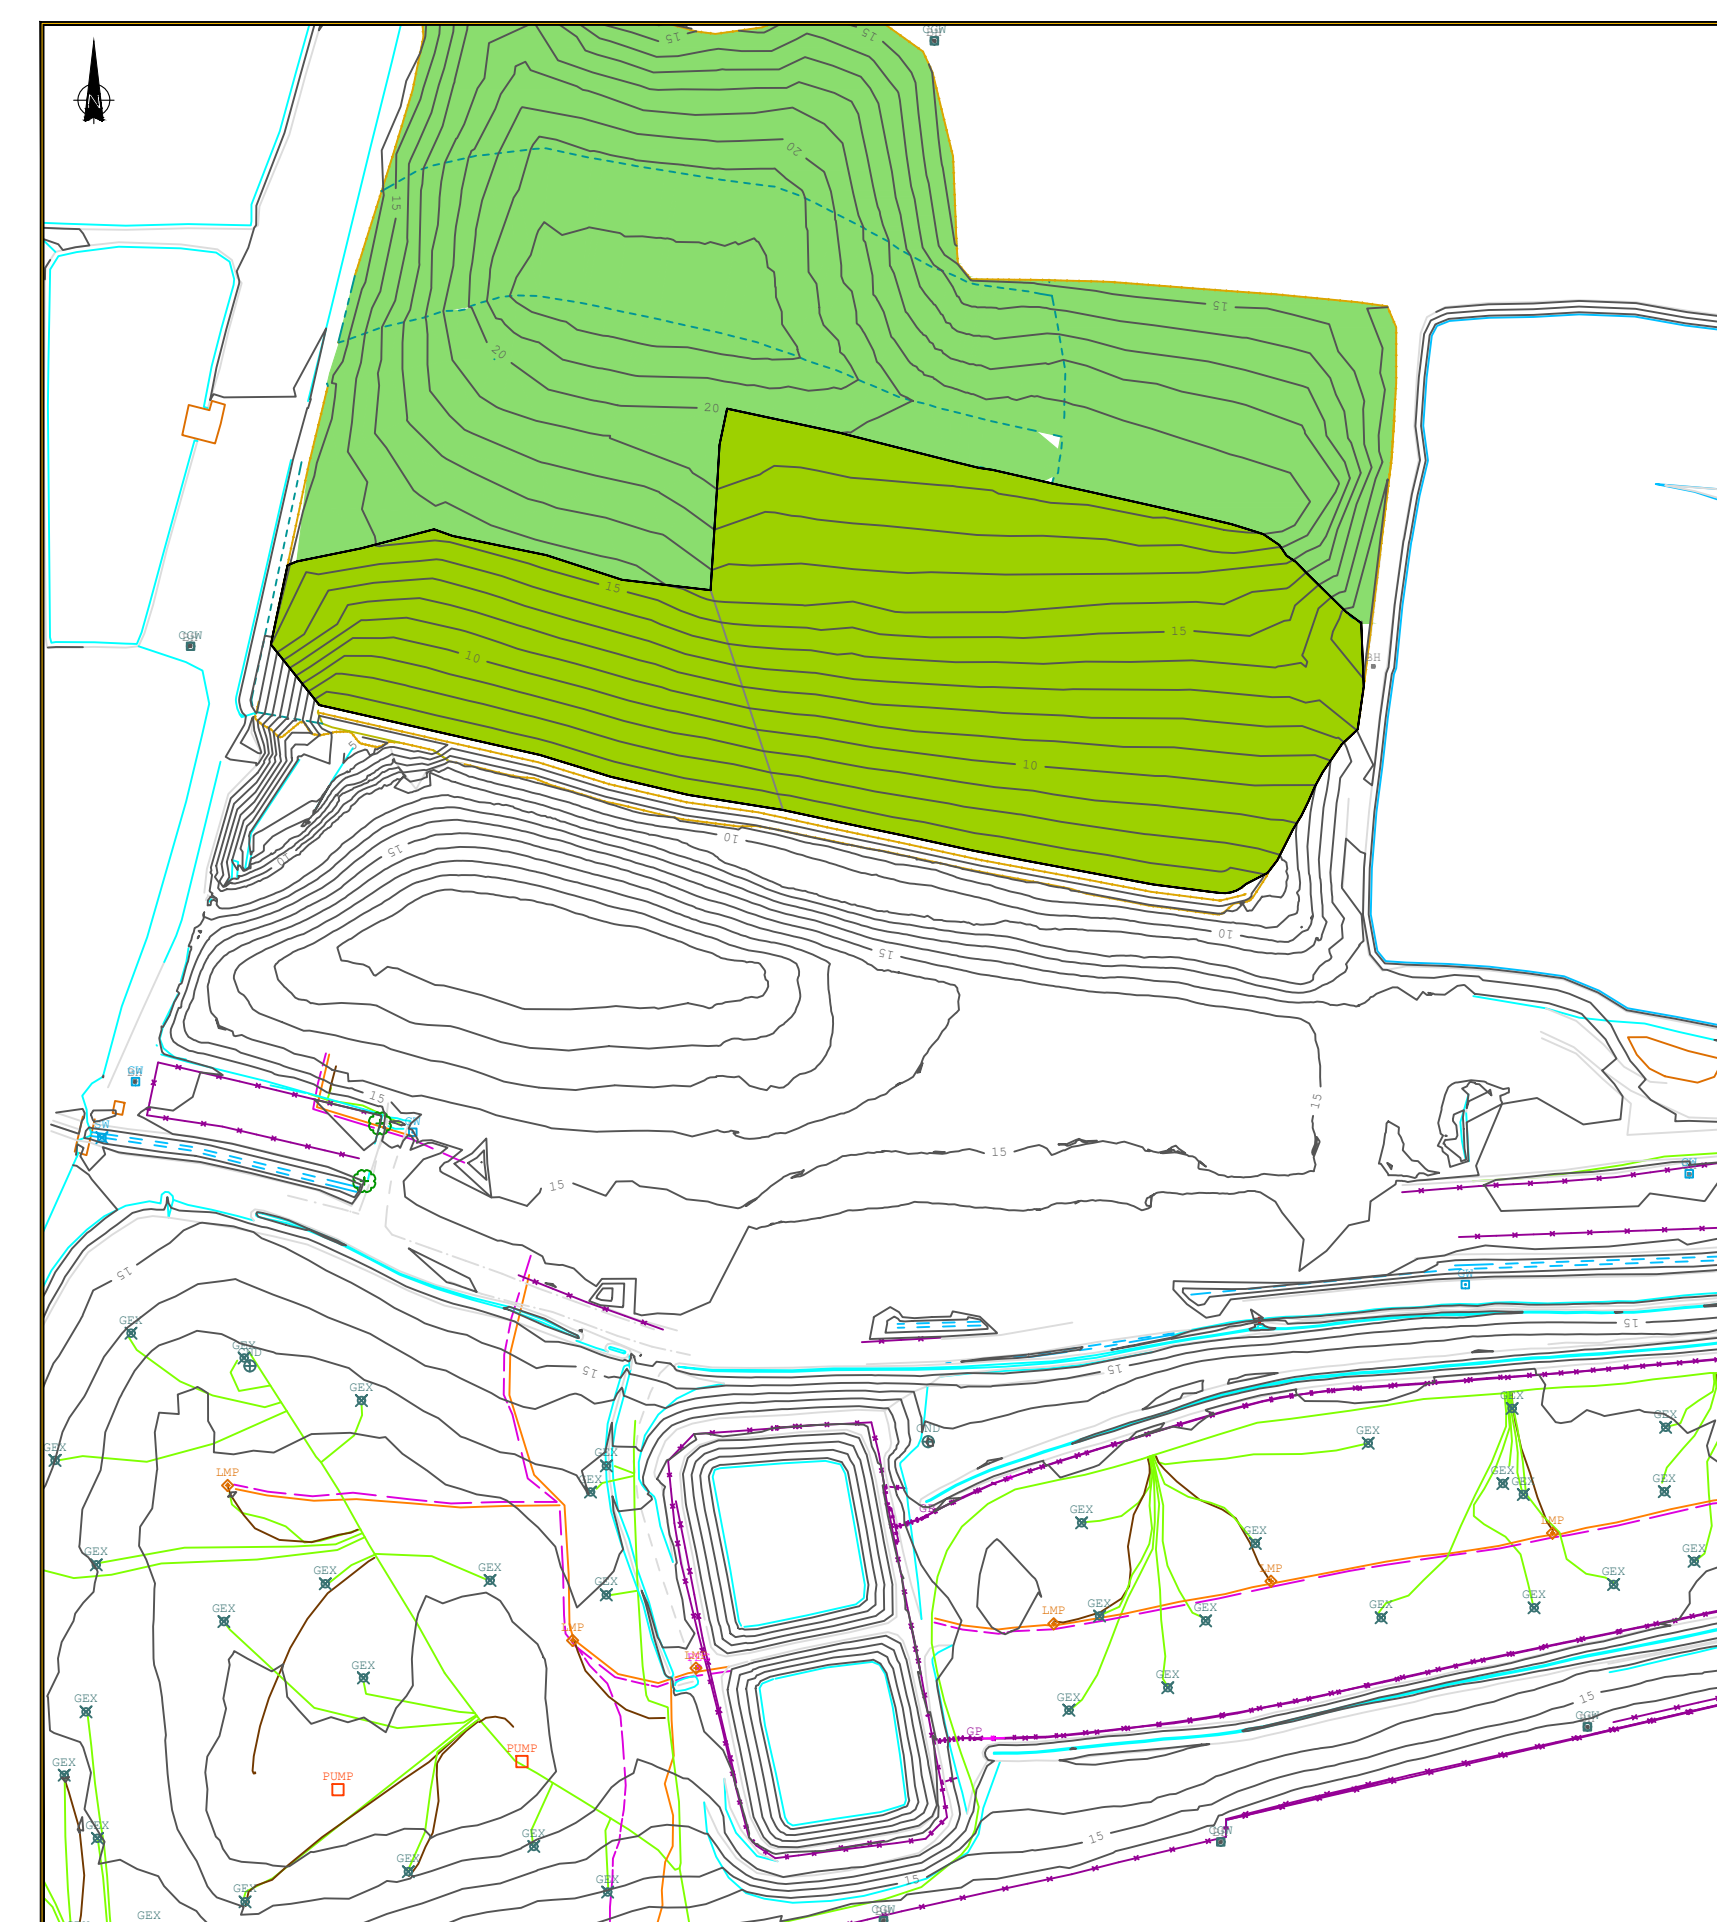
PROPOSED CELL 1, 2, 3 & 4 RESTORED - IBA PAD FILLED
SCALE 1:1250
