# DESK BASED GROUND GAS RISK ASSESSMENT

Newthorpe Quarry North Yorkshire LS25 6JW

Report Ref: 16-691-R1-1 Date Issued: March 2023

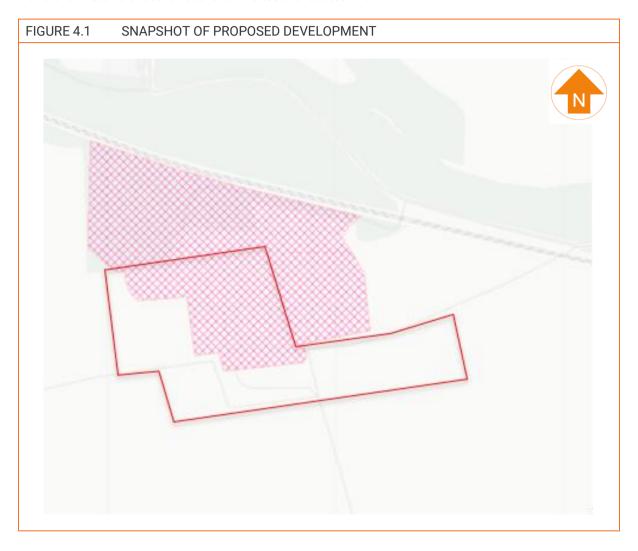
The subject site is a historic landfill site operated by Selby Rural District Council. Waste was input between 1973 and 1984, however no further information is available. The location of the landfill is shown in Figure 4.1.

The subject site is a historic landfill site operated by Selby Rural District Council. Waste was input between 1973 and 1984, however no further information is available.
