**PHASE I GEO-ENVIRONMENTAL SITE ASSESSMENT**  
**KINGSPAN**  
**SHERBURN IN ELMET**  
**LS25 6NA**  
**REC REFERENCE: 101374P1R0**

**REPORT PREPARED FOR: FISHER GERMAN**

**JUNE 2016**

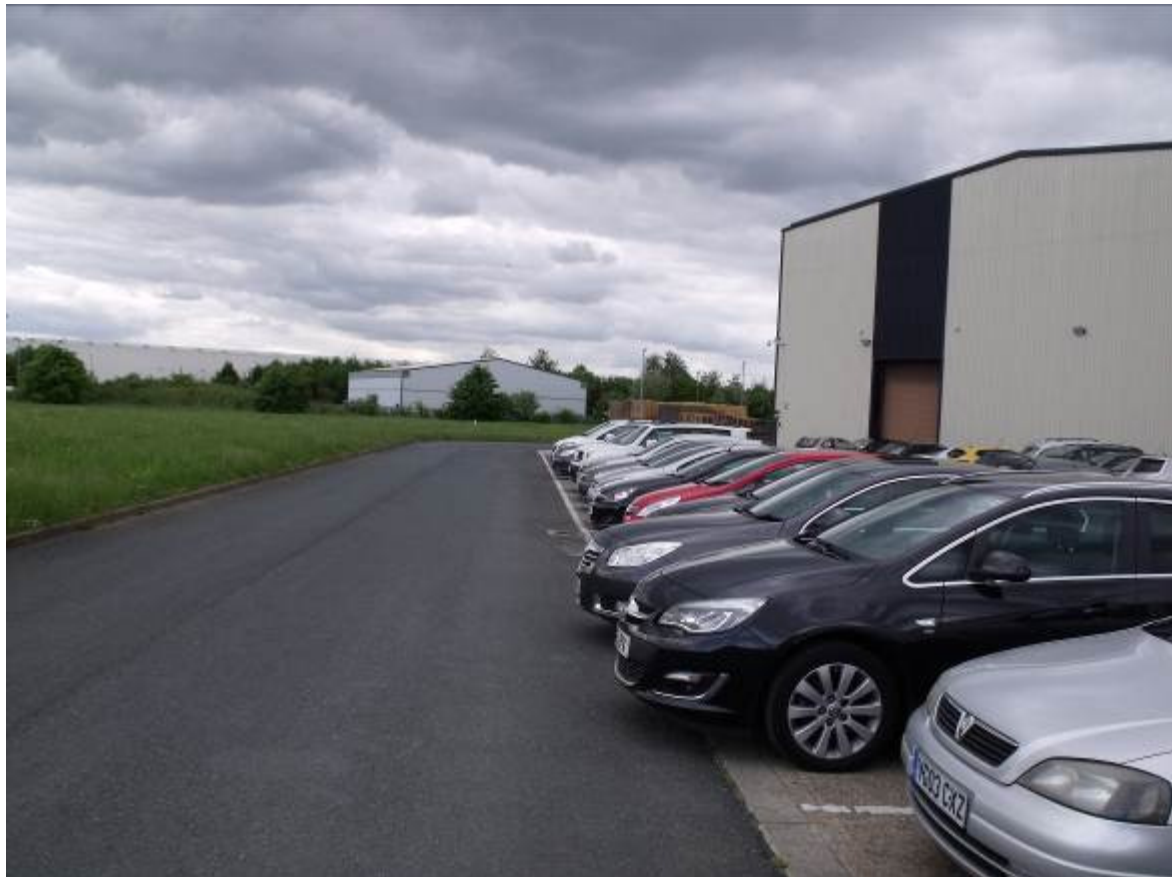
**PLATE 1: CAR PARK HARDSTANDING ON WEST OF SITE FACING SOUTH**

The majority of the site is mostly surfaced in grass with a level topography with limited areas of hard landscaping on the west of site including a tarmac road and car park hardstanding.

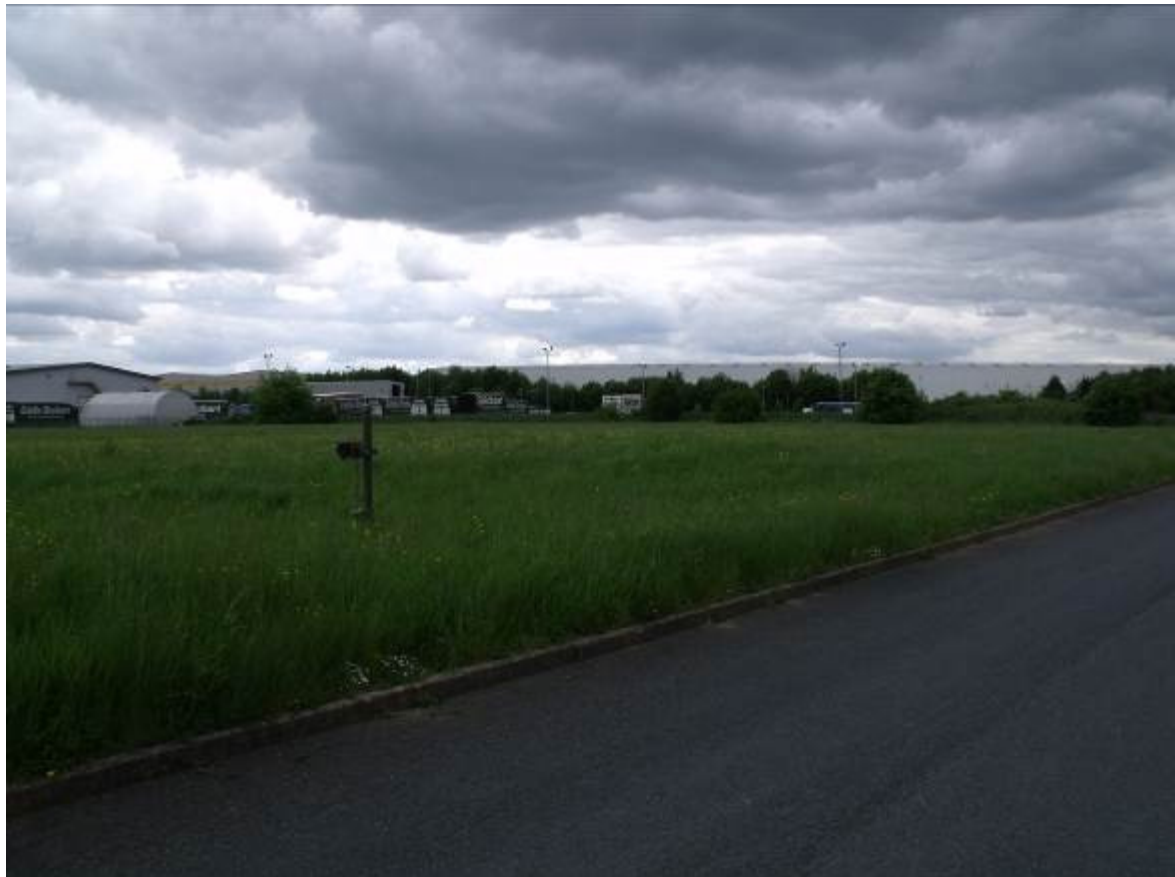
**PLATE 3: GENERAL VIEW OF SITE FACING SOUTH**

The site comprises a level grass field adjacent to the Kingspan factory to the north and west with a level grass field to the south. An aluminium clad portal frame structure is situated near the northern boundary of the site and houses a general waste skip. Another skip for scrap metal is located to the east of the portal frame structure.

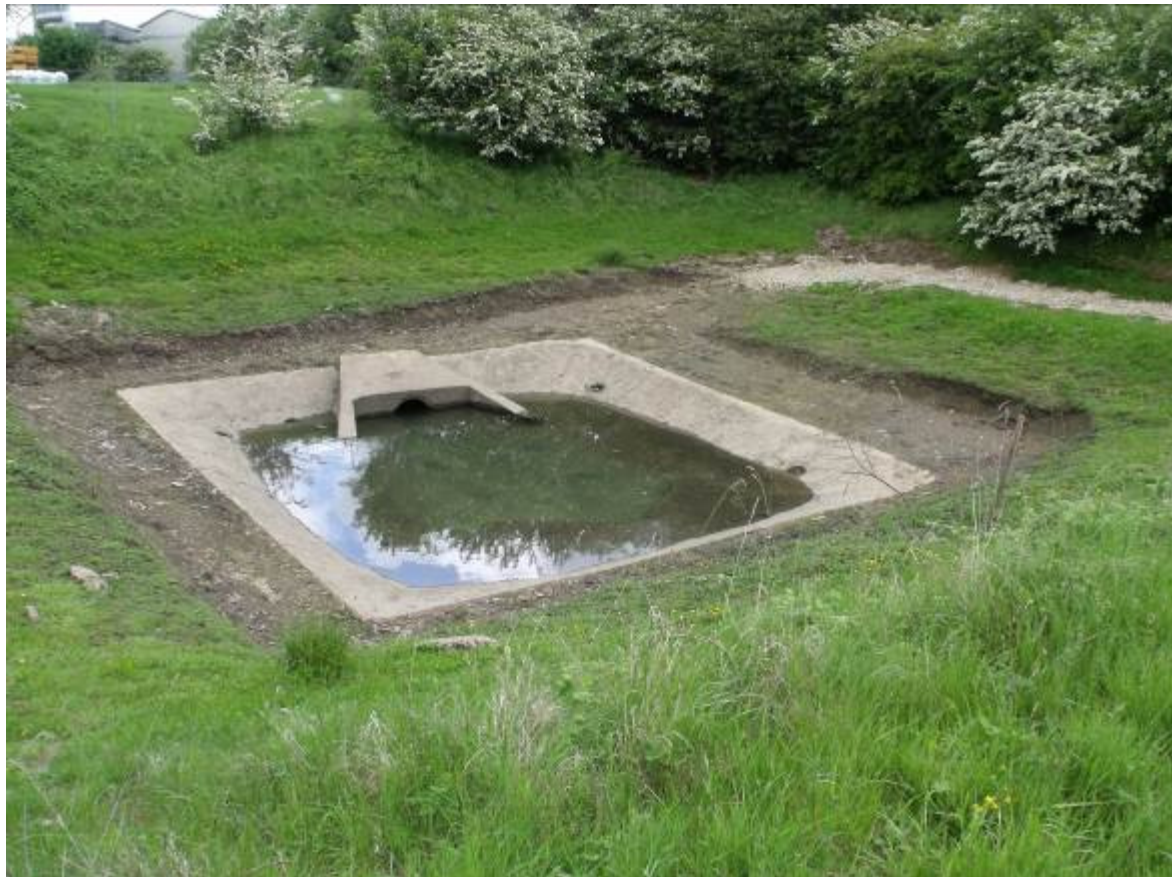
**PLATE 5: DELUGE POND TO EAST OF SITE**

The site has a man-made pond (approximately 20m x 20m) situated at 10m to the east which serves the role of a deluge pond for any spillages from the site. The Green Dyke is a submerged culvert flowing east-west across the southern section of the site at a depth of approximately 5.0m bgl (from site observations of the open channel section adjacent to the site). A small pump/electricity substation is associated with, and located adjacent to, the balancing pond and located on concrete hardstanding. A 'step' in the land is evident running east-west across the northern section of the site, where the culvert is located.

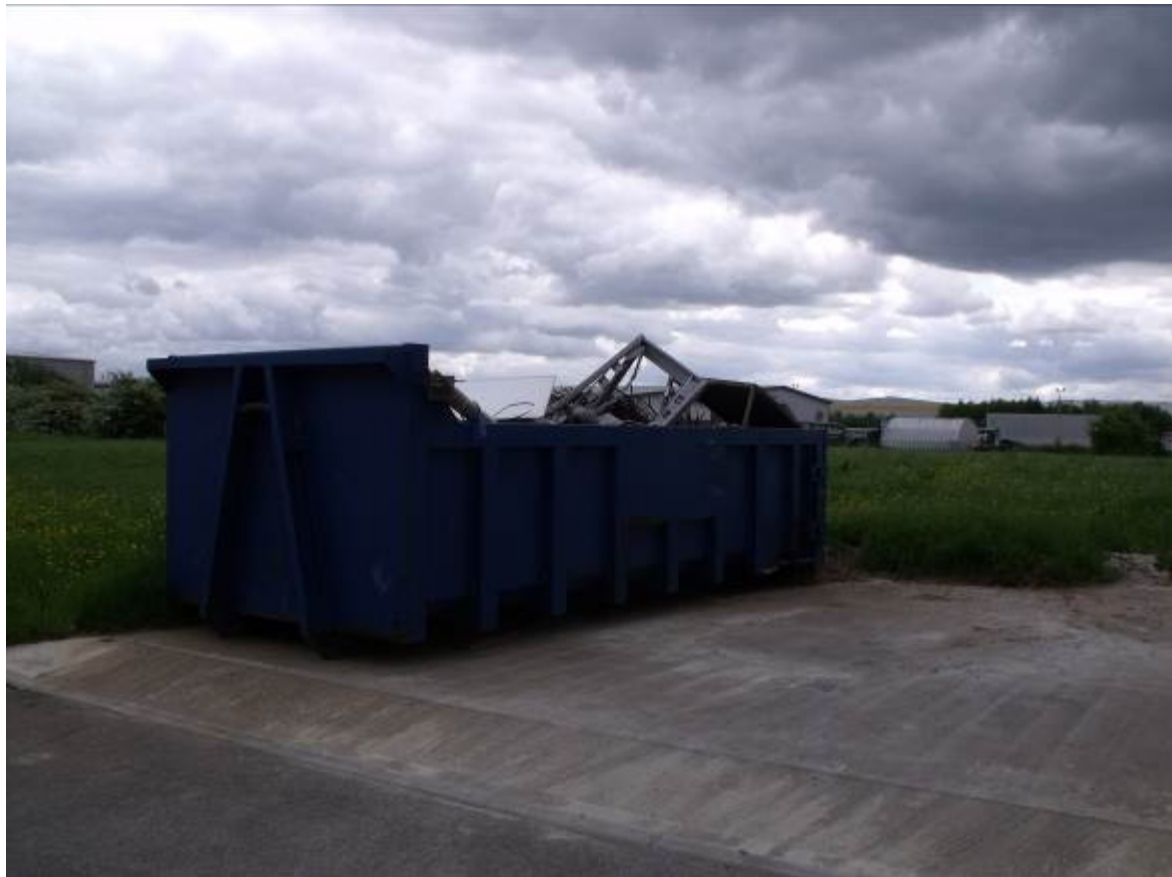
**PLATE 7: SKIP CONTAINING SCRAP METAL**

On site, there were two skips one holding scrap metal and another general waste. Further waste storage areas were demarcated around the factory unit, with caged areas for Calor gas cylinders (separate compartments for empty and full cylinders), as well as skips for designated waste types. No hazardous materials storage was noted on the site.

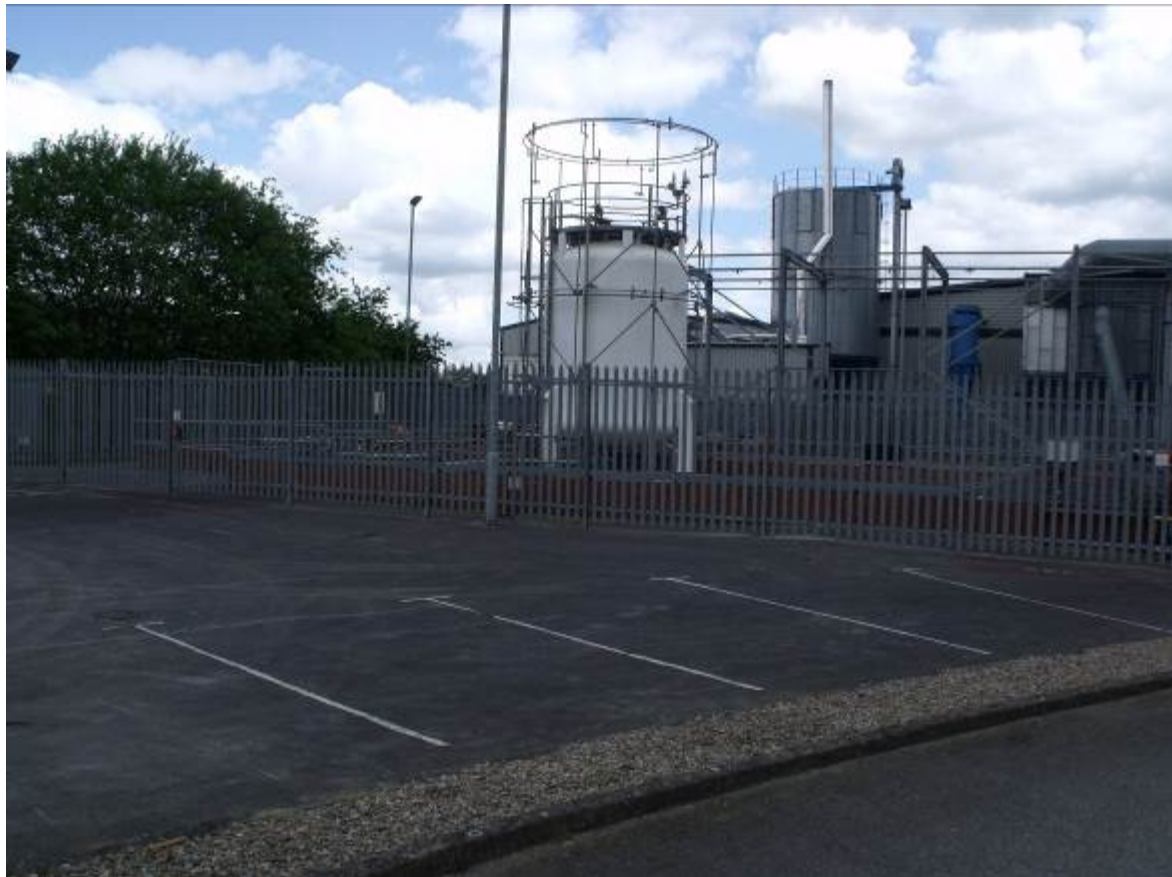
**PLATE 9: EXTERNAL AST HOLDING POLYOL**

No ASTs are located on site. There was one AST situated to the north east of site. This comprised of a 50,000kg resin AST holding MDI Polyols. The AST is bunded externally with the condition of the concrete hardstanding and brickwork bund appearing in good condition. Further ASTs of similar size and construction were located within the factory unit, the site representative did not provide any further information about the contents of these ASTs however, the ASTs are externally bunded and appear to be in good condition. If contamination from this source was to occur, the site is down gradient of these tanks and could be influenced by their contents.

A 50,000kg AST holding MDI Polyols is situated up gradient to the north of the site (potentially containing isocyanates and thiocyanate);
-

An above ground storage tank for MDI Polyols north and up gradient of the site is considered to have the potential to migrate significant amounts of hazardous material onto site.

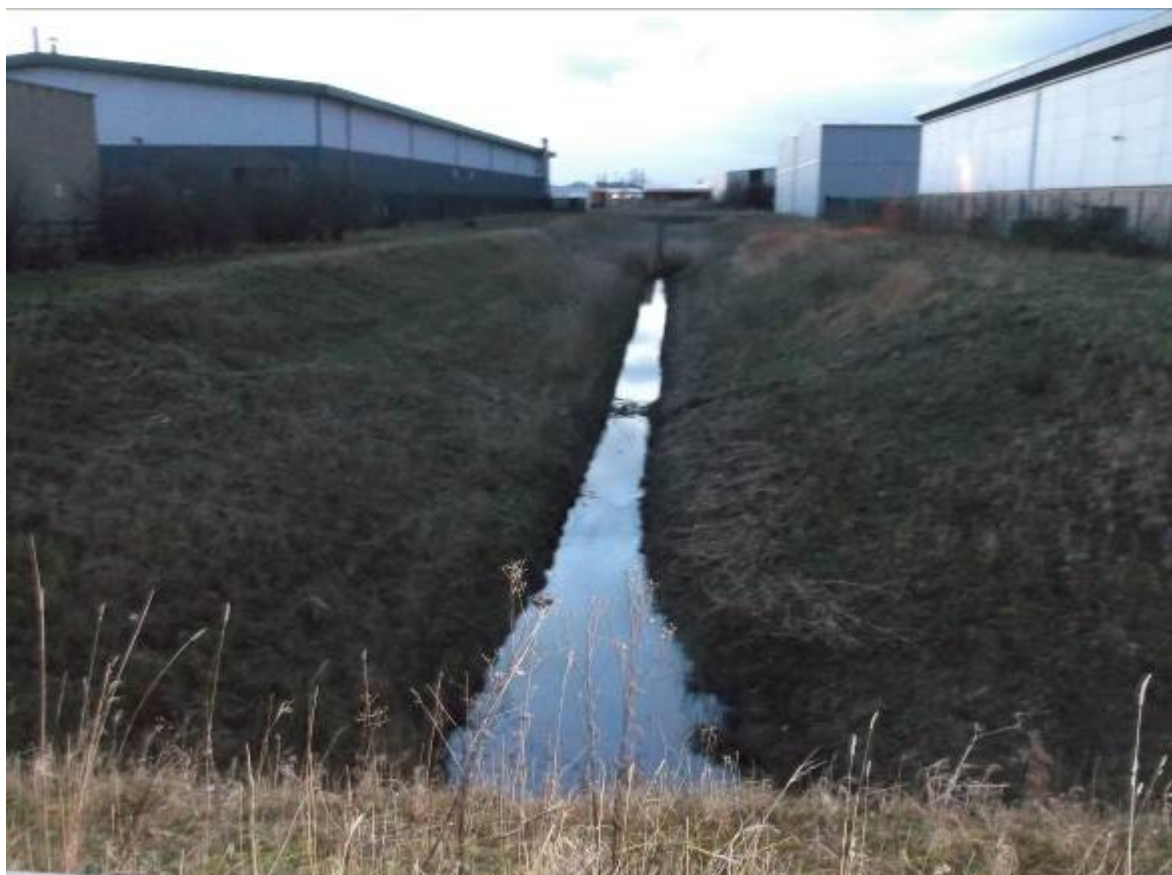
**PLATE 10: GREEN DYKE BEFORE ENTERING CULVERT TO SOUTH OF SITE**

Green Dyke is culverted flowing east-west across the southern section of the site and emerges into an open channel approximately 20m to the east;
-

A formal drainage survey has not been commissioned, however Green Dyke is known to culvert across the southern area of the site. It is recommended a drainage survey is conducted in order to determine the location, composition and condition of the culvert.
