EXPLORATORY HOLE LOCATION PLAN

Ground Investigation Report

February 2001
Issue: 1
Reference: 00/1494

**McGUINNESS & CO RELOCATION
ARDWICK, MANCHESTER
SITE INVESTIGATION**

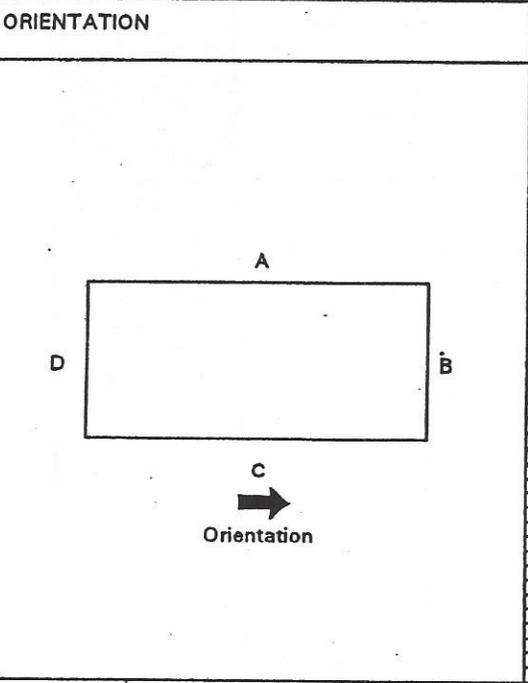
SAMPLE AND TEST RECORD			DEPTH	DESCRIPTION OF STRATUM (thickness)	STRATUM NO.	WATER DEPTH
DEPTH	TYPE	RESULT				
0.40	JAR		0.50	MADE GROUND comprising of very dense well graded broken brick and concrete hardcore (0.50)		
				Hard brickbat CONCRETE slab (0.70)		
1.50	JAR		1.20	Dense yellow/brown fine very silty SAND with some organic matter		
			2.60

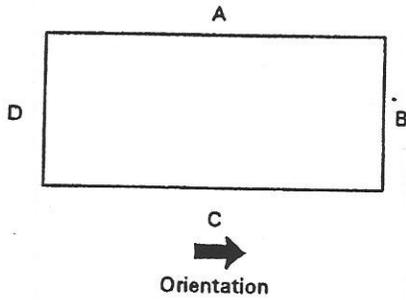
SAMPLE AND TEST RECORD			DEPTH	DESCRIPTION OF STRATUM (thickness)	STRATUM NO.	WATER DEPTH
DEPTH	TYPE	RESULT				
0.50	JAR		0.20	Grassed topsoil (0.20)		
			1.00	Loose MADE GROUND comprising soft clay with black ash, wood, brick etc (0.80)		
			2.20	Soft brown/black very silty CLAY varying to very clayey SILT (1.20)		
			2.60	Very stiff brown silty CLAY with frequent grey silt partings

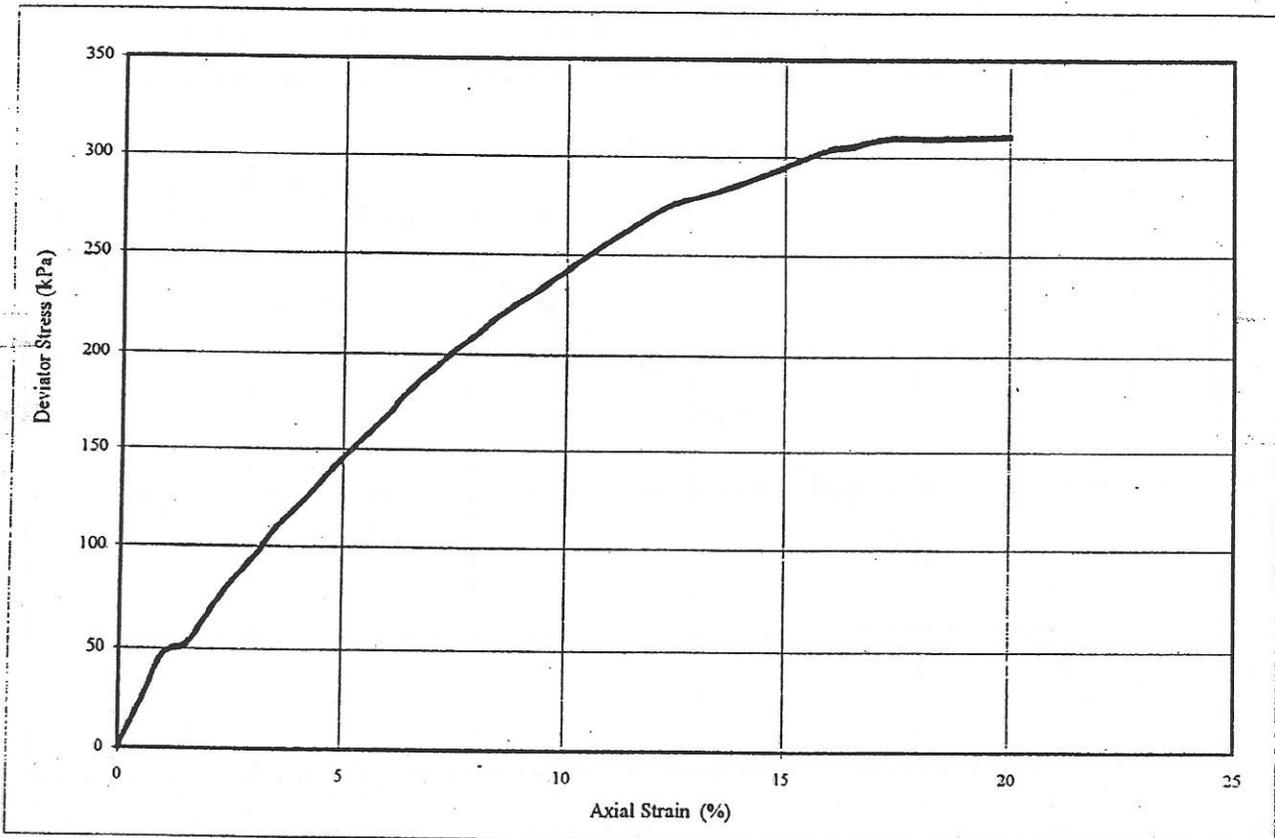
Diameter:	102 mm	X-Sectional Area:	8171 mm ²
Height:	204 mm	Bulk Density:	2.14 Mg/m ³
Mass:	3575.5 g	Dry Density:	1.79 Mg/m ³
Moisture Content:	20 %	Membrane Thickness:	0.5 mm

Stage	Cell Pressure (kN/m ²)	($\sigma_1 - \sigma_3$) _{max} (kN/m ²)	($\sigma_1 - \sigma_3$) _r (kN/m ²)	Cohesion (kN/m ²)	Failure Strain (%)	Mode of Failure
1	60	310	309	155	20.0	0
2	0	0	-1	0	0.0	0
3	0	0	-1	0	0.0	0

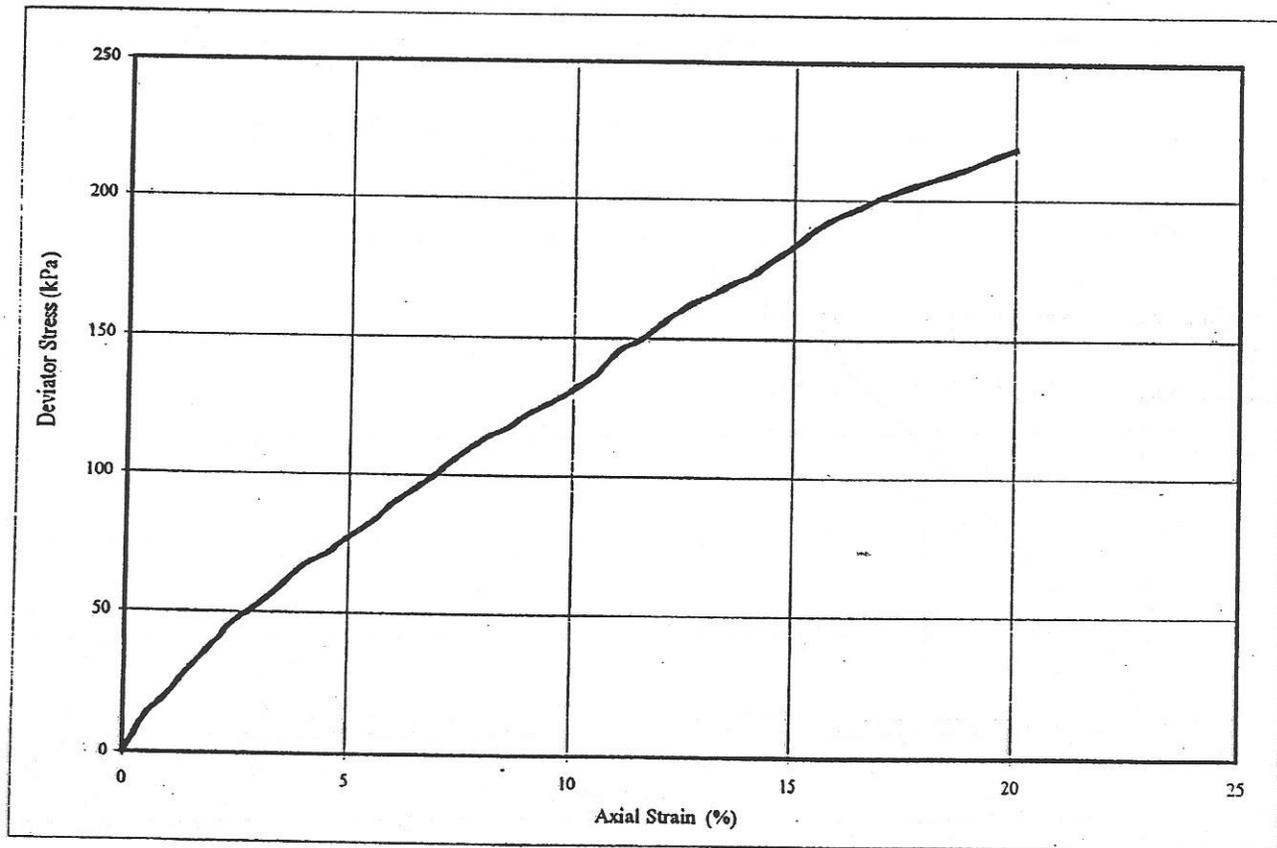
Diameter:	102 mm	X-Sectional Area:	8171 mm ²
Height:	204 mm	Bulk Density:	2.14 Mg/m ³
Mass:	3569.7 g	Dry Density:	1.82 Mg/m ³
Moisture Content:	18 %	Membrane Thickness:	0.5 mm

Stage	Cell Pressure (kN/m ²)	($\sigma_1 - \sigma_3$) _{max} (kN/m ²)	($\sigma_1 - \sigma_3$) _r (kN/m ²)	Cohesion (kN/m ²)	Failure Strain (%)	Mode of Failure
1	80	218	217	109	20.0	0
2	0	0	-1	0	0.0	0
3	0	0	-1	0	0.0	0

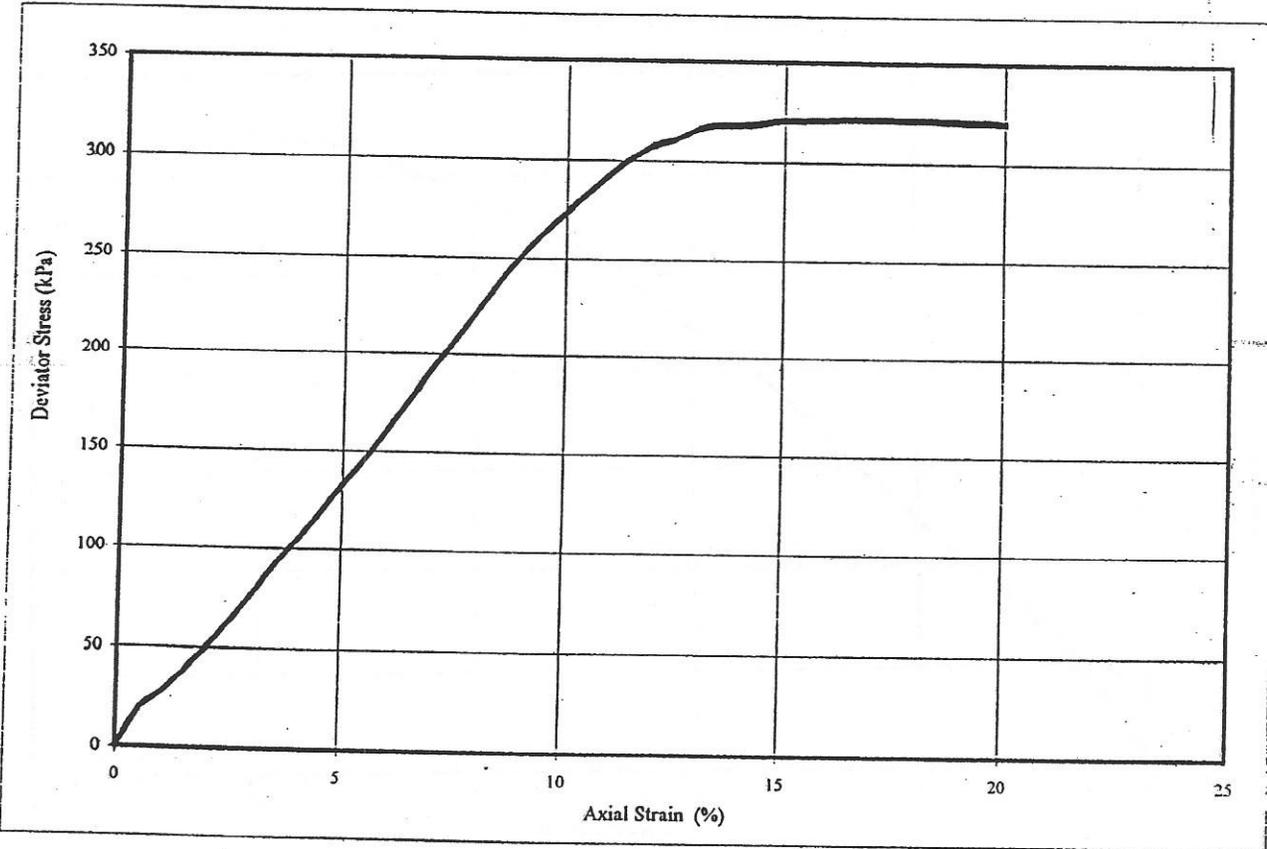
Diameter:	102 mm	X-Sectional Area:	8171 mm ²
Height:	204 mm	Bulk Density:	2.21 Mg/m ³
Mass:	3677.8 g	Dry Density:	1.91 Mg/m ³
Moisture Content:	16 %	Membrane Thickness:	0.5 mm

Stage	Cell Pressure (kN/m ²)	($\sigma_1 - \sigma_3$) _{max} (kN/m ²)	($\sigma_1 - \sigma_3$) _r (kN/m ²)	Cohesion (kN/m ²)	Failure Strain (%)	Mode of Failure
1	100	321	320	160	20.0	0
2	0	0	-1	0	0.0	0
3	0	0	-1	0	0.0	0

Sample Description	
Very stiff brown slightly clayey SILT

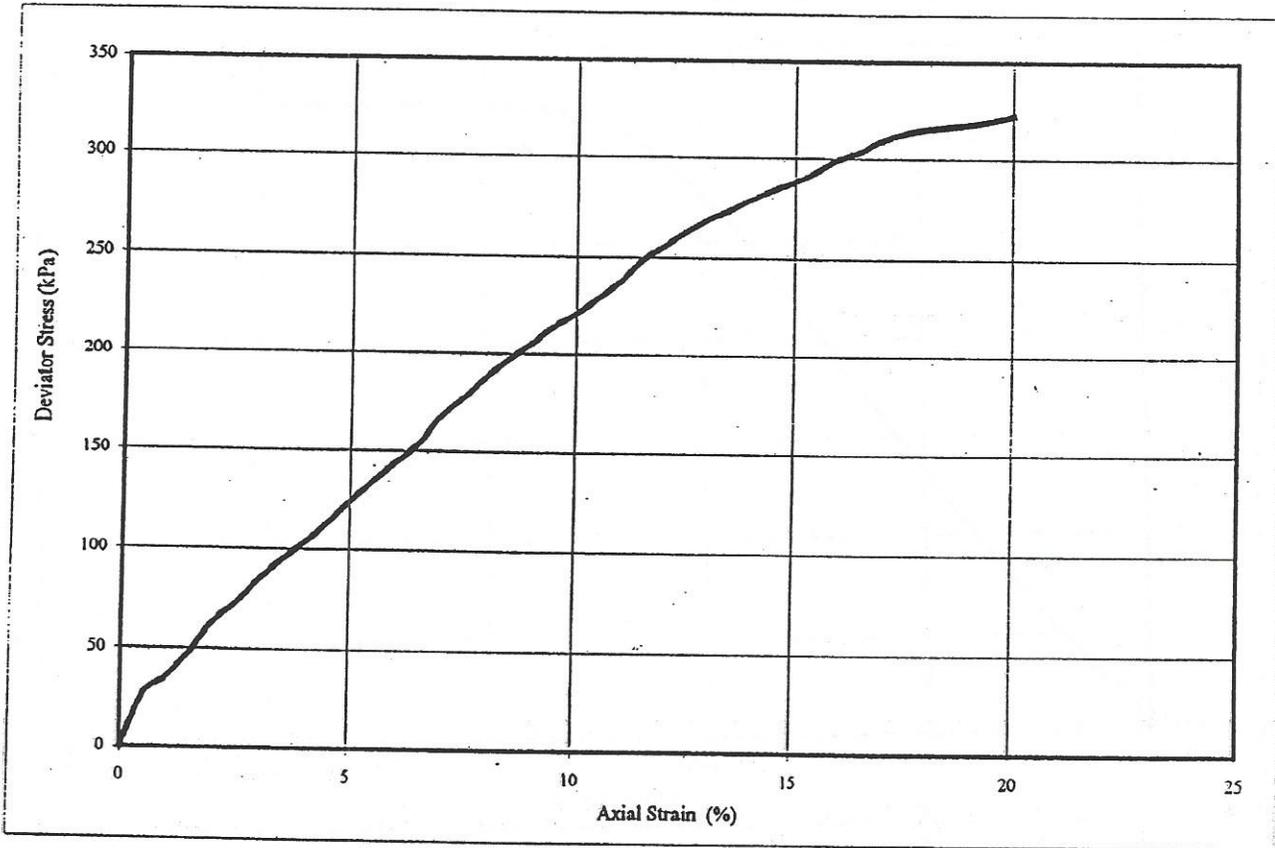
Diameter:	102 mm	X-Sectional Area:	8171 mm ²
Height:	204 mm	Bulk Density:	2.13 Mg/m ³
Mass:	3558.9 g	Dry Density:	1.77 Mg/m ³
Moisture Content:	21 %	Membrane Thickness:	0.5 mm

Stage	Cell Pressure (kN/m ²)	($\sigma_1 - \sigma_3$) _{max} (kN/m ²)	($\sigma_1 - \sigma_3$) _r (kN/m ²)	Cohesion (kN/m ²)	Failure Strain (%)	Mode of Failure
1	60	322	321	161	20.0	0
2	0	0	-1	0	0.0	0
3	0	0	-1	0	0.0	0

Sample Description
Very stiff brown silty CLAY with occasional fine gravel

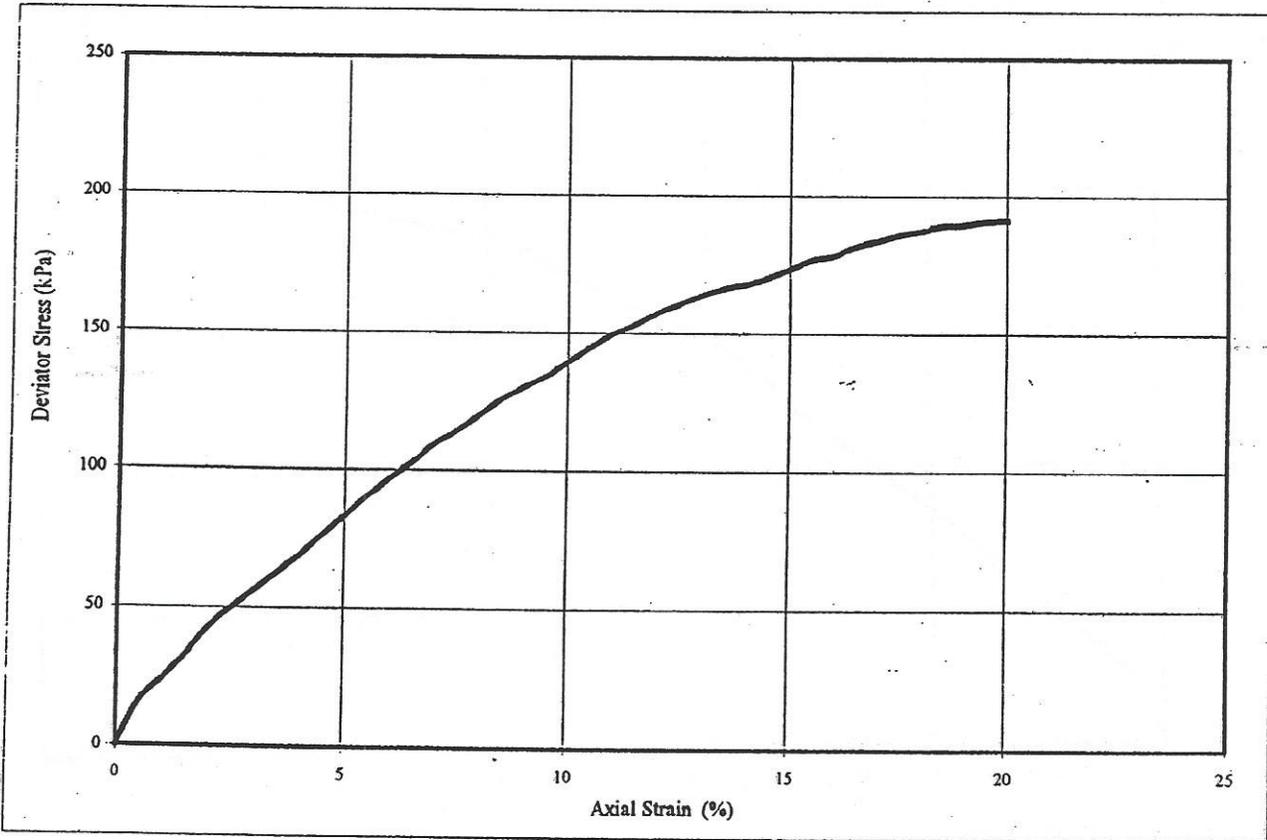
Diameter:	102 mm	X-Sectional Area:	8171 mm ²
Height:	204 mm	Bulk Density:	2.14 Mg/m ³
Mass:	3573.4 g	Dry Density:	1.81 Mg/m ³
Moisture Content:	18 %	Membrane Thickness:	0.5 mm

Stage	Cell Pressure (kN/m ²)	($\sigma_1 - \sigma_3$) _{max} (kN/m ²)	($\sigma_1 - \sigma_3$) _f (kN/m ²)	Cohesion (kN/m ²)	Failure Strain (%)	Mode of Failure
1	80	191	190	95	20.0	0
2	0	0	-1	0	0.0	0
3	0	0	-1	0	0.0	0

Sample Description
Stiff brown silty slightly gravelly CLAY with rare coal fragments

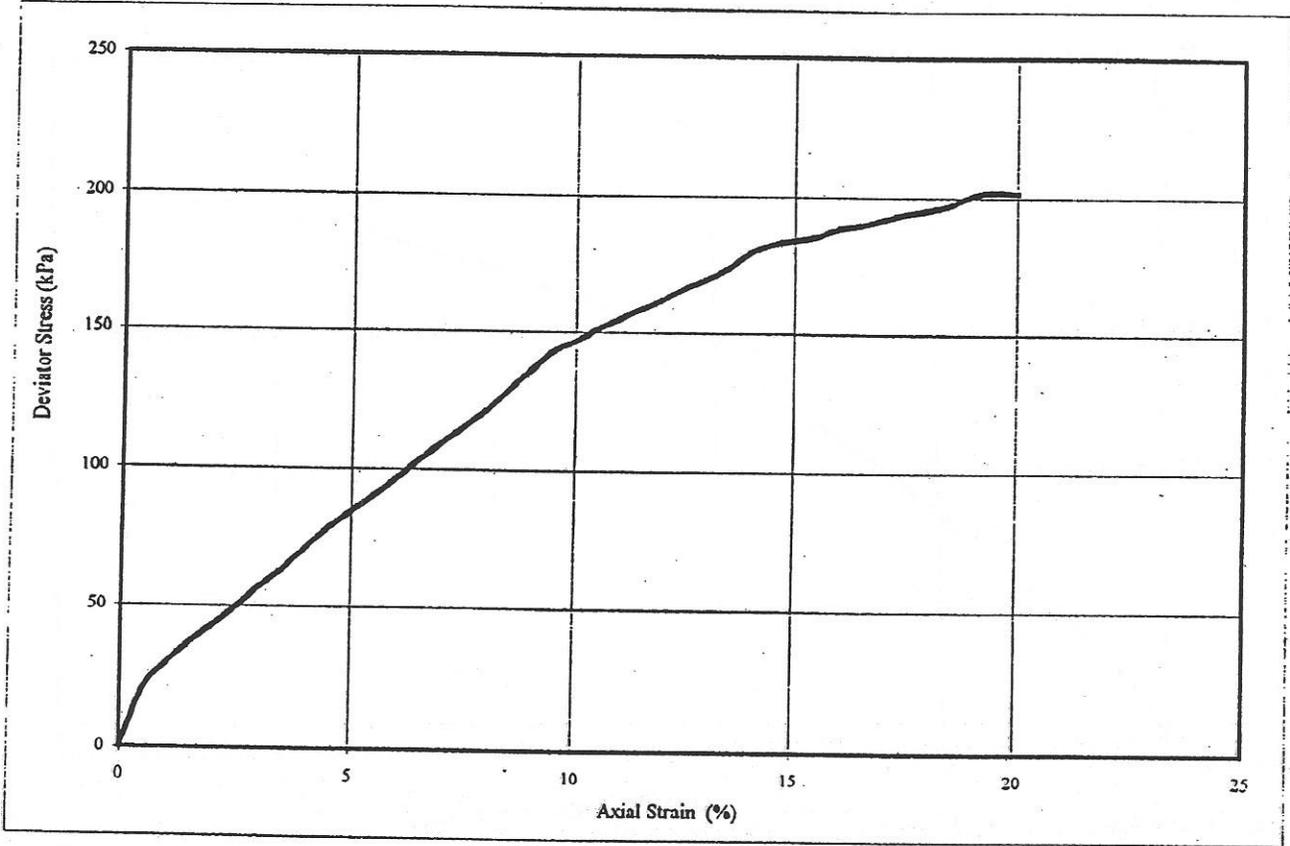
Diameter:	102 mm	X-Sectional Area:	8171 mm ²
Height:	204 mm	Bulk Density:	2.21 Mg/m ³
Mass:	3685.6 g	Dry Density:	1.86 Mg/m ³
Moisture Content:	19 %	Membrane Thickness:	0.5 mm

Stage	Cell Pressure (kN/m ²)	($\sigma_1 - \sigma_3$) _{max} (kN/m ²)	($\sigma_1 - \sigma_3$) _r (kN/m ²)	Cohesion (kN/m ²)	Failure Strain (%)	Mode of Failure
1	160	201	200	100	20.0	0
2	0	0	-1	0	0.0	0
3	0	0	-1	0	0.0	0

Sample Description
Stiff brown silty slightly gravelly CLAY

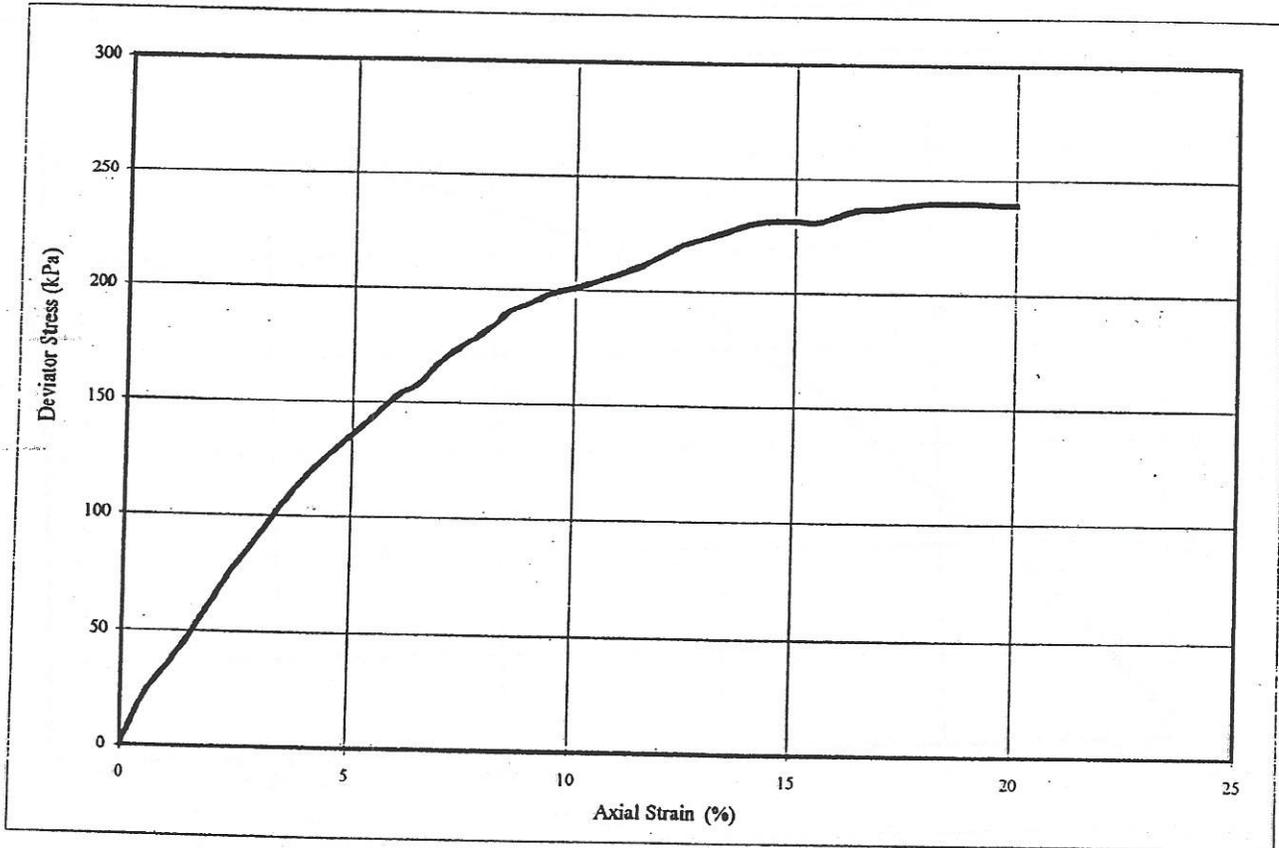
Diameter:	102 mm	X-Sectional Area:	8171 mm ²
Height:	204 mm	Bulk Density:	2.15 Mg/m ³
Mass:	3590.6 g	Dry Density:	1.80 Mg/m ³
Moisture Content:	20 %	Membrane Thickness:	0.5 mm

Stage	Cell Pressure (kN/m ²)	($\sigma_1 - \sigma_3$) _{max} (kN/m ²)	($\sigma_1 - \sigma_3$) _f (kN/m ²)	Cohesion (kN/m ²)	Failure Strain (%)	Mode of Failure
1	60	239	238	119	20.0	0
2	0	0	-1	0	0.0	0
3	0	0	-1	0	0.0	0

Sample Description
Stiff brown silty slightly gravelly CLAY with rare coal fragments

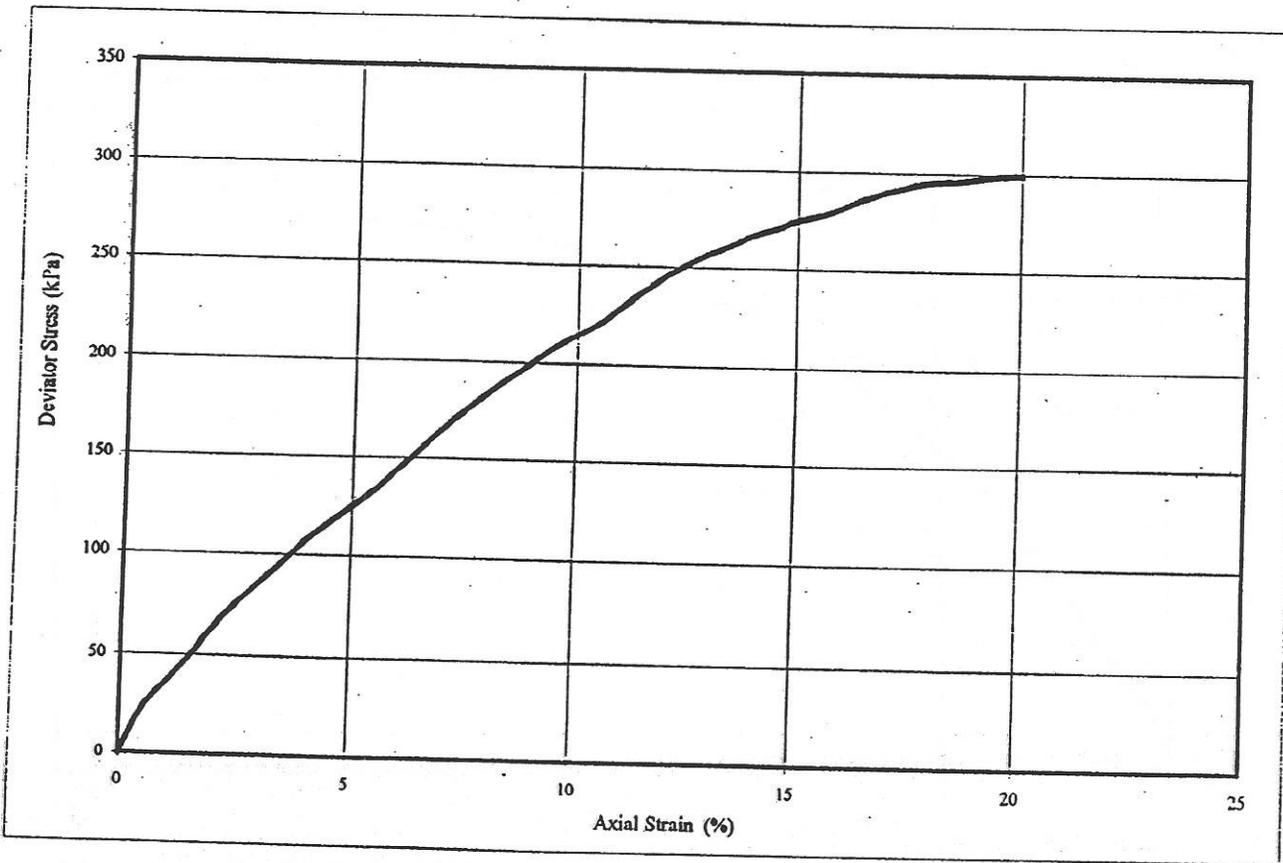
Diameter:	102 mm	X-Sectional Area:	8171 mm ²
Height:	204 mm	Bulk Density:	2.12 Mg/m ³
Mass:	3529.6 g	Dry Density:	1.77 Mg/m ³
Moisture Content:	19 %	Membrane Thickness:	0.5 mm

Stage	Cell Pressure (kN/m ²)	($\sigma_1 - \sigma_3$) _{max} (kN/m ²)	($\sigma_1 - \sigma_3$) _f (kN/m ²)	Cohesion (kN/m ²)	Failure Strain (%)	Mode of Failure
1	80	299	298	149	20.0	0
2	0	0	-1	0	0.0	0
3	0	0	-1	0	0.0	0

Sample Description
Stiff brown silty slightly gravelly CLAY with rare coal fragments

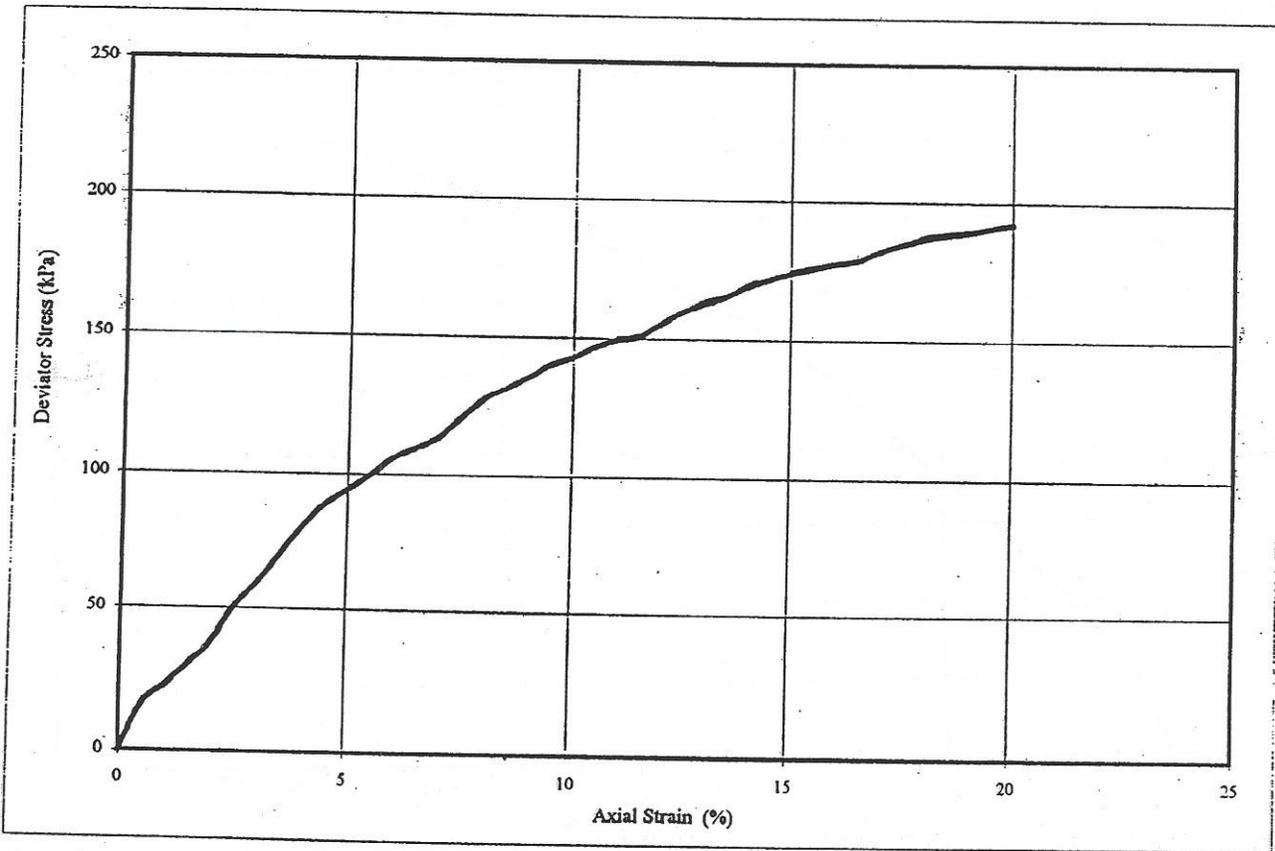
Diameter:	102 mm	X-Sectional Area:	8171 mm ²
Height:	204 mm	Bulk Density:	2.15 Mg/m ³
Mass:	3584.7 g	Dry Density:	1.81 Mg/m ³
Moisture Content:	19 %	Membrane Thickness:	0.5 mm

Stage	Cell Pressure (kN/m ²)	($\sigma_1 - \sigma_3$) _{max} (kN/m ²)	($\sigma_1 - \sigma_3$) _r (kN/m ²)	Cohesion (kN/m ²)	Failure Strain (%)	Mode of Failure
1	100	191	190	95	20.0	0
2	0	0	-1	0	0.0	0
3	0	0	-1	0	0.0	0

Sample Description
Stiff brown silty CLAY with some fine/medium gravel and occ coal fragments

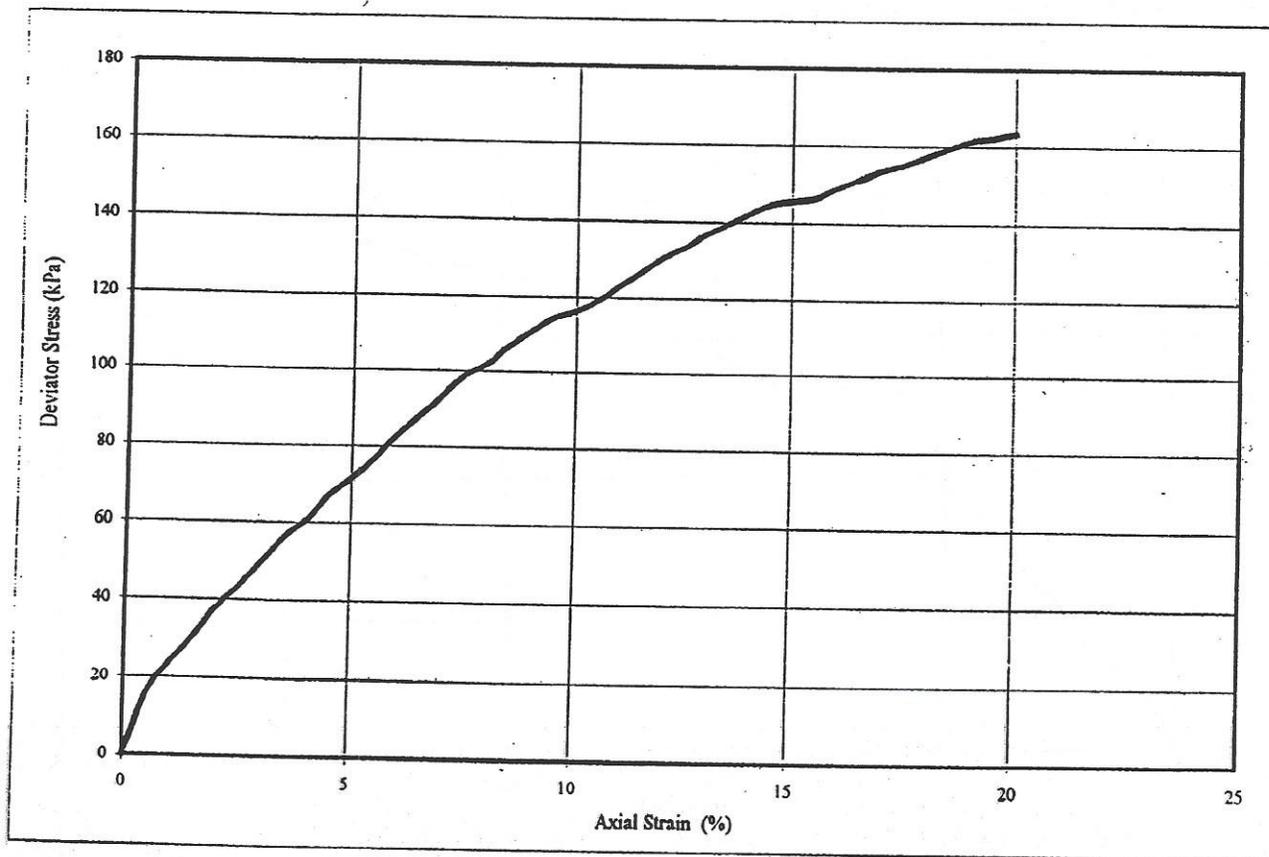
Diameter:	102 mm	X-Sectional Area:	8171 mm ²
Height:	204 mm	Bulk Density:	2.07 Mg/m ³
Mass:	3445 g	Dry Density:	1.73 Mg/m ³
Moisture Content:	20 %	Membrane Thickness:	0.5 mm

Stage	Cell Pressure (kN/m ²)	($\sigma_1 - \sigma_3$) _{max} (kN/m ²)	($\sigma_1 - \sigma_3$) _f (kN/m ²)	Cohesion (kN/m ²)	Failure Strain (%)	Mode of Failure
1	130	163	162	81	20.0	0
2	0	0	-1	0	0.0	0
3	0	0	-1	0	0.0	0

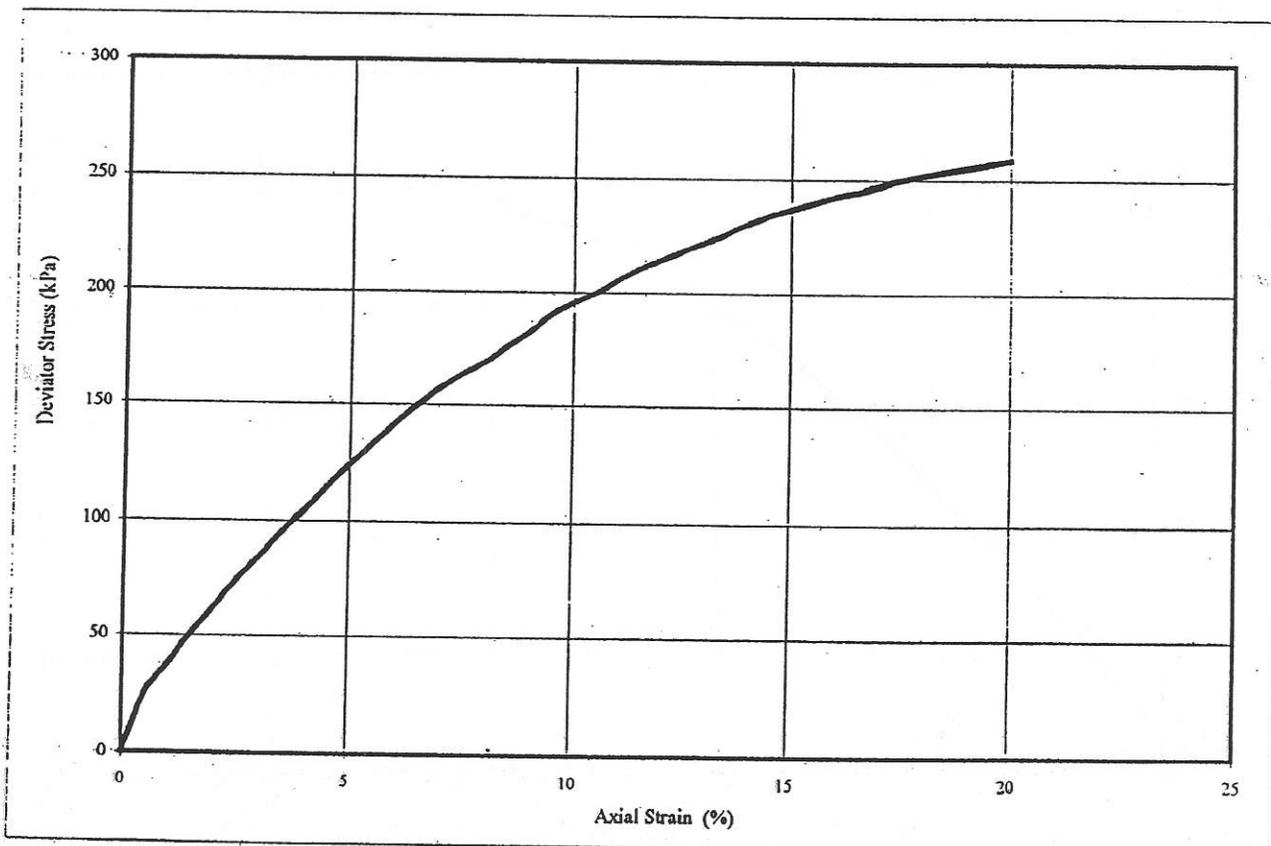
Diameter:	102 mm	X-Sectional Area:	8171 mm ²
Height:	204 mm	Bulk Density:	2.17 Mg/m ³
Mass:	3623.2 g	Dry Density:	1.87 Mg/m ³
Moisture Content:	16 %	Membrane Thickness:	0.5 mm

Stage	Cell Pressure (kN/m ²)	($\sigma_1 - \sigma_3$) _{max} (kN/m ²)	($\sigma_1 - \sigma_3$) _r (kN/m ²)	Cohesion (kN/m ²)	Failure Strain (%)	Mode of Failure
1	160	258	257	129	20.0	0
2	0	0	-1	0	0.0	0
3	0	0	-1	0	0.0	0

Sample Description	
Stiff brown silty slightly gravelly CLAY

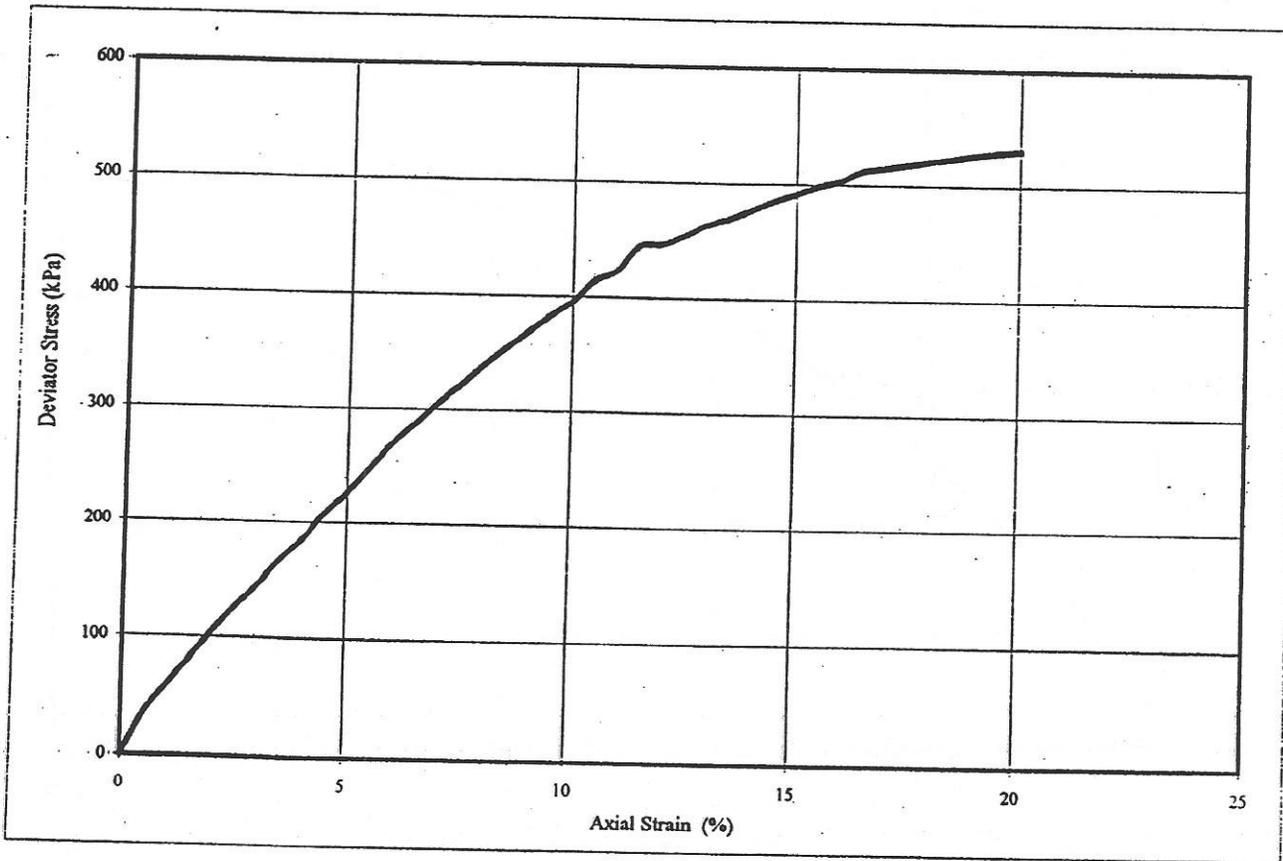
Diameter:	102 mm	X-Sectional Area:	8171 mm ²
Height:	204 mm	Bulk Density:	2.23 Mg/m ³
Mass:	3717.6 g	Dry Density:	1.91 Mg/m ³
Moisture Content:	17 %	Membrane Thickness:	0.5 mm

Stage	Cell Pressure (kN/m ²)	($\sigma_1 - \sigma_3$) _{max} (kN/m ²)	($\sigma_1 - \sigma_3$) _f (kN/m ²)	Cohesion (kN/m ²)	Failure Strain (%)	Mode of Failure
1	40	529	528	264	20.0	0
2	0	0	-1	0	0.0	0
3	0	0	-1	0	0.0	0

Sample Description
Very stiff brown silty CLAY with occasional fine to medium gravel

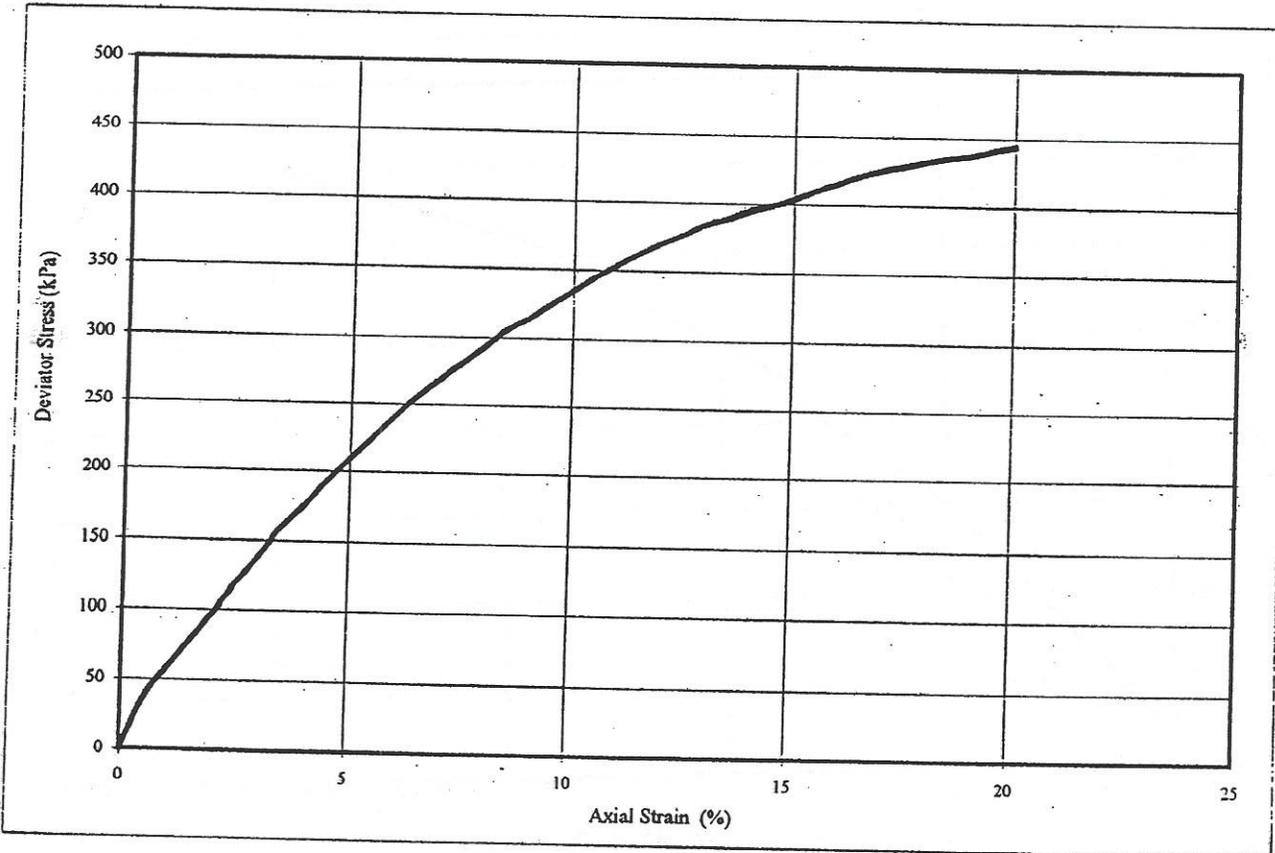
Diameter:	102 mm	X-Sectional Area:	8171 mm ²
Height:	204 mm	Bulk Density:	2.26 Mg/m ³
Mass:	3773.8 g	Dry Density:	2.01 Mg/m ³
Moisture Content:	13 %	Membrane Thickness:	0.5 mm

Stage	Cell Pressure (kN/m ²)	($\sigma_1 - \sigma_3$) _{max} (kN/m ²)	($\sigma_1 - \sigma_3$) _r (kN/m ²)	Cohesion (kN/m ²)	Failure Strain (%)	Mode of Failure
1	60	443	442	221	20.0	0
2	0	0	-1	0	0.0	0
3	0	0	-1	0	0.0	0

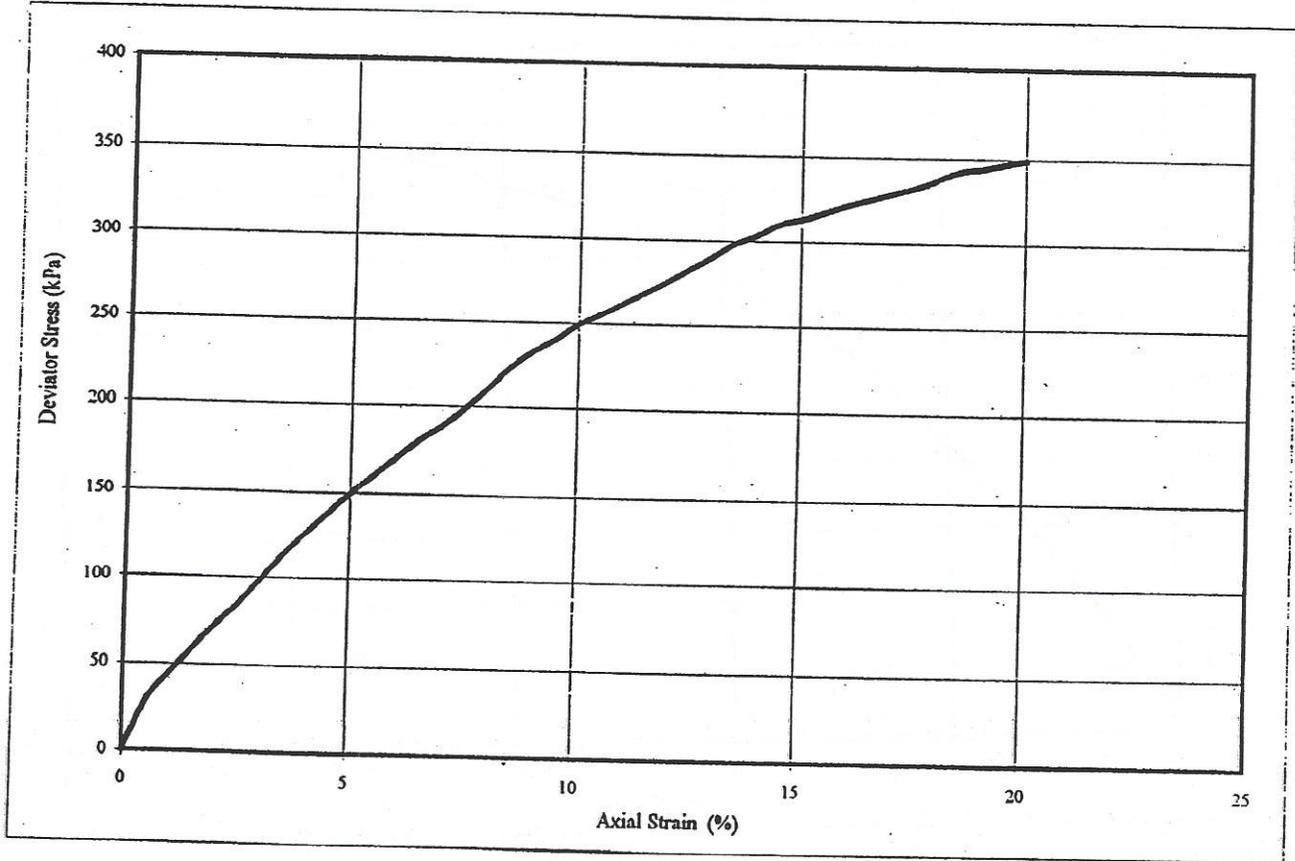
Diameter:	102 mm	X-Sectional Area:	8171 mm ²
Height:	204 mm	Bulk Density:	2.30 Mg/m ³
Mass:	3836.7 g	Dry Density:	2.05 Mg/m ³
Moisture Content:	12 %	Membrane Thickness:	0.5 mm

Stage	Cell Pressure (kN/m ²)	($\sigma_1 - \sigma_3$) _{max} (kN/m ²)	($\sigma_1 - \sigma_3$) _r (kN/m ²)	Cohesion (kN/m ²)	Failure Strain (%)	Mode of Failure
1	80	348	347	174	20.0	0
2	0	0	-1	0	0.0	0
3	0	0	-1	0	0.0	0

Sample Description
Very stiff brown silty gravelly CLAY with occasional brown sand pockets
