# Geo-Environmental Investigation & Assessment

Process Facility, Axion Trafford

Axion Polymers Ltd

Report No. 10785G-WML-XX-ZZ RP-G-0001

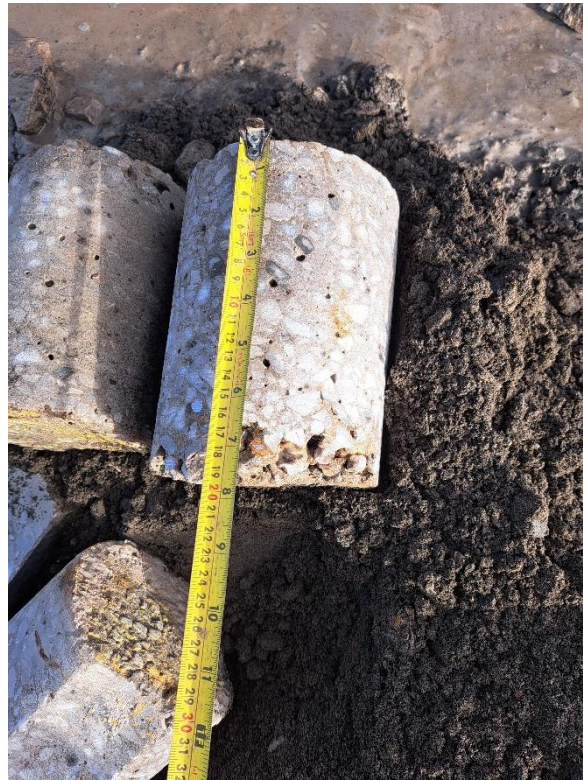
**Photograph 1**  
**BH02 inspection pit arisings and concrete core detail.**

- 5.4 However, within BH01 this comprised granular demolition material of limestone, brick and concrete, overlying a loose black ash and brick fill. Within BH02 the made ground comprised limestone gravel to a depth of 0.30 mbgl.

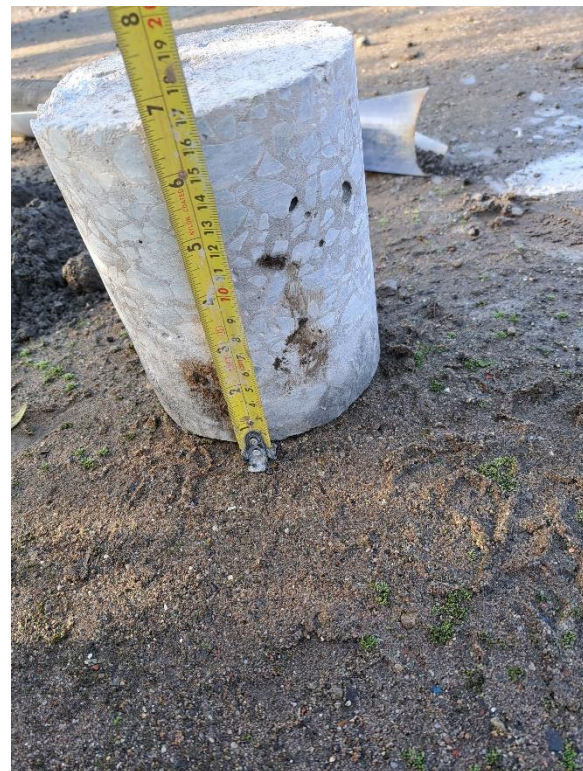
**Photograph 2**  
**WS01 detail of concrete core.**

- 5.2 Concrete hardstanding was encountered from the surface in exploratory holes WS01, WS02, WS03 and BH02. This was noted to extend to depths of between 0.16 and 0.20 mbgl.
