# **Reliance Street MTR, TLS and HWRC Site Condition Report**

**August 2025**

Site Reliance Street - MTR, TLS & HWRC

Title Site Location and Layout Plan

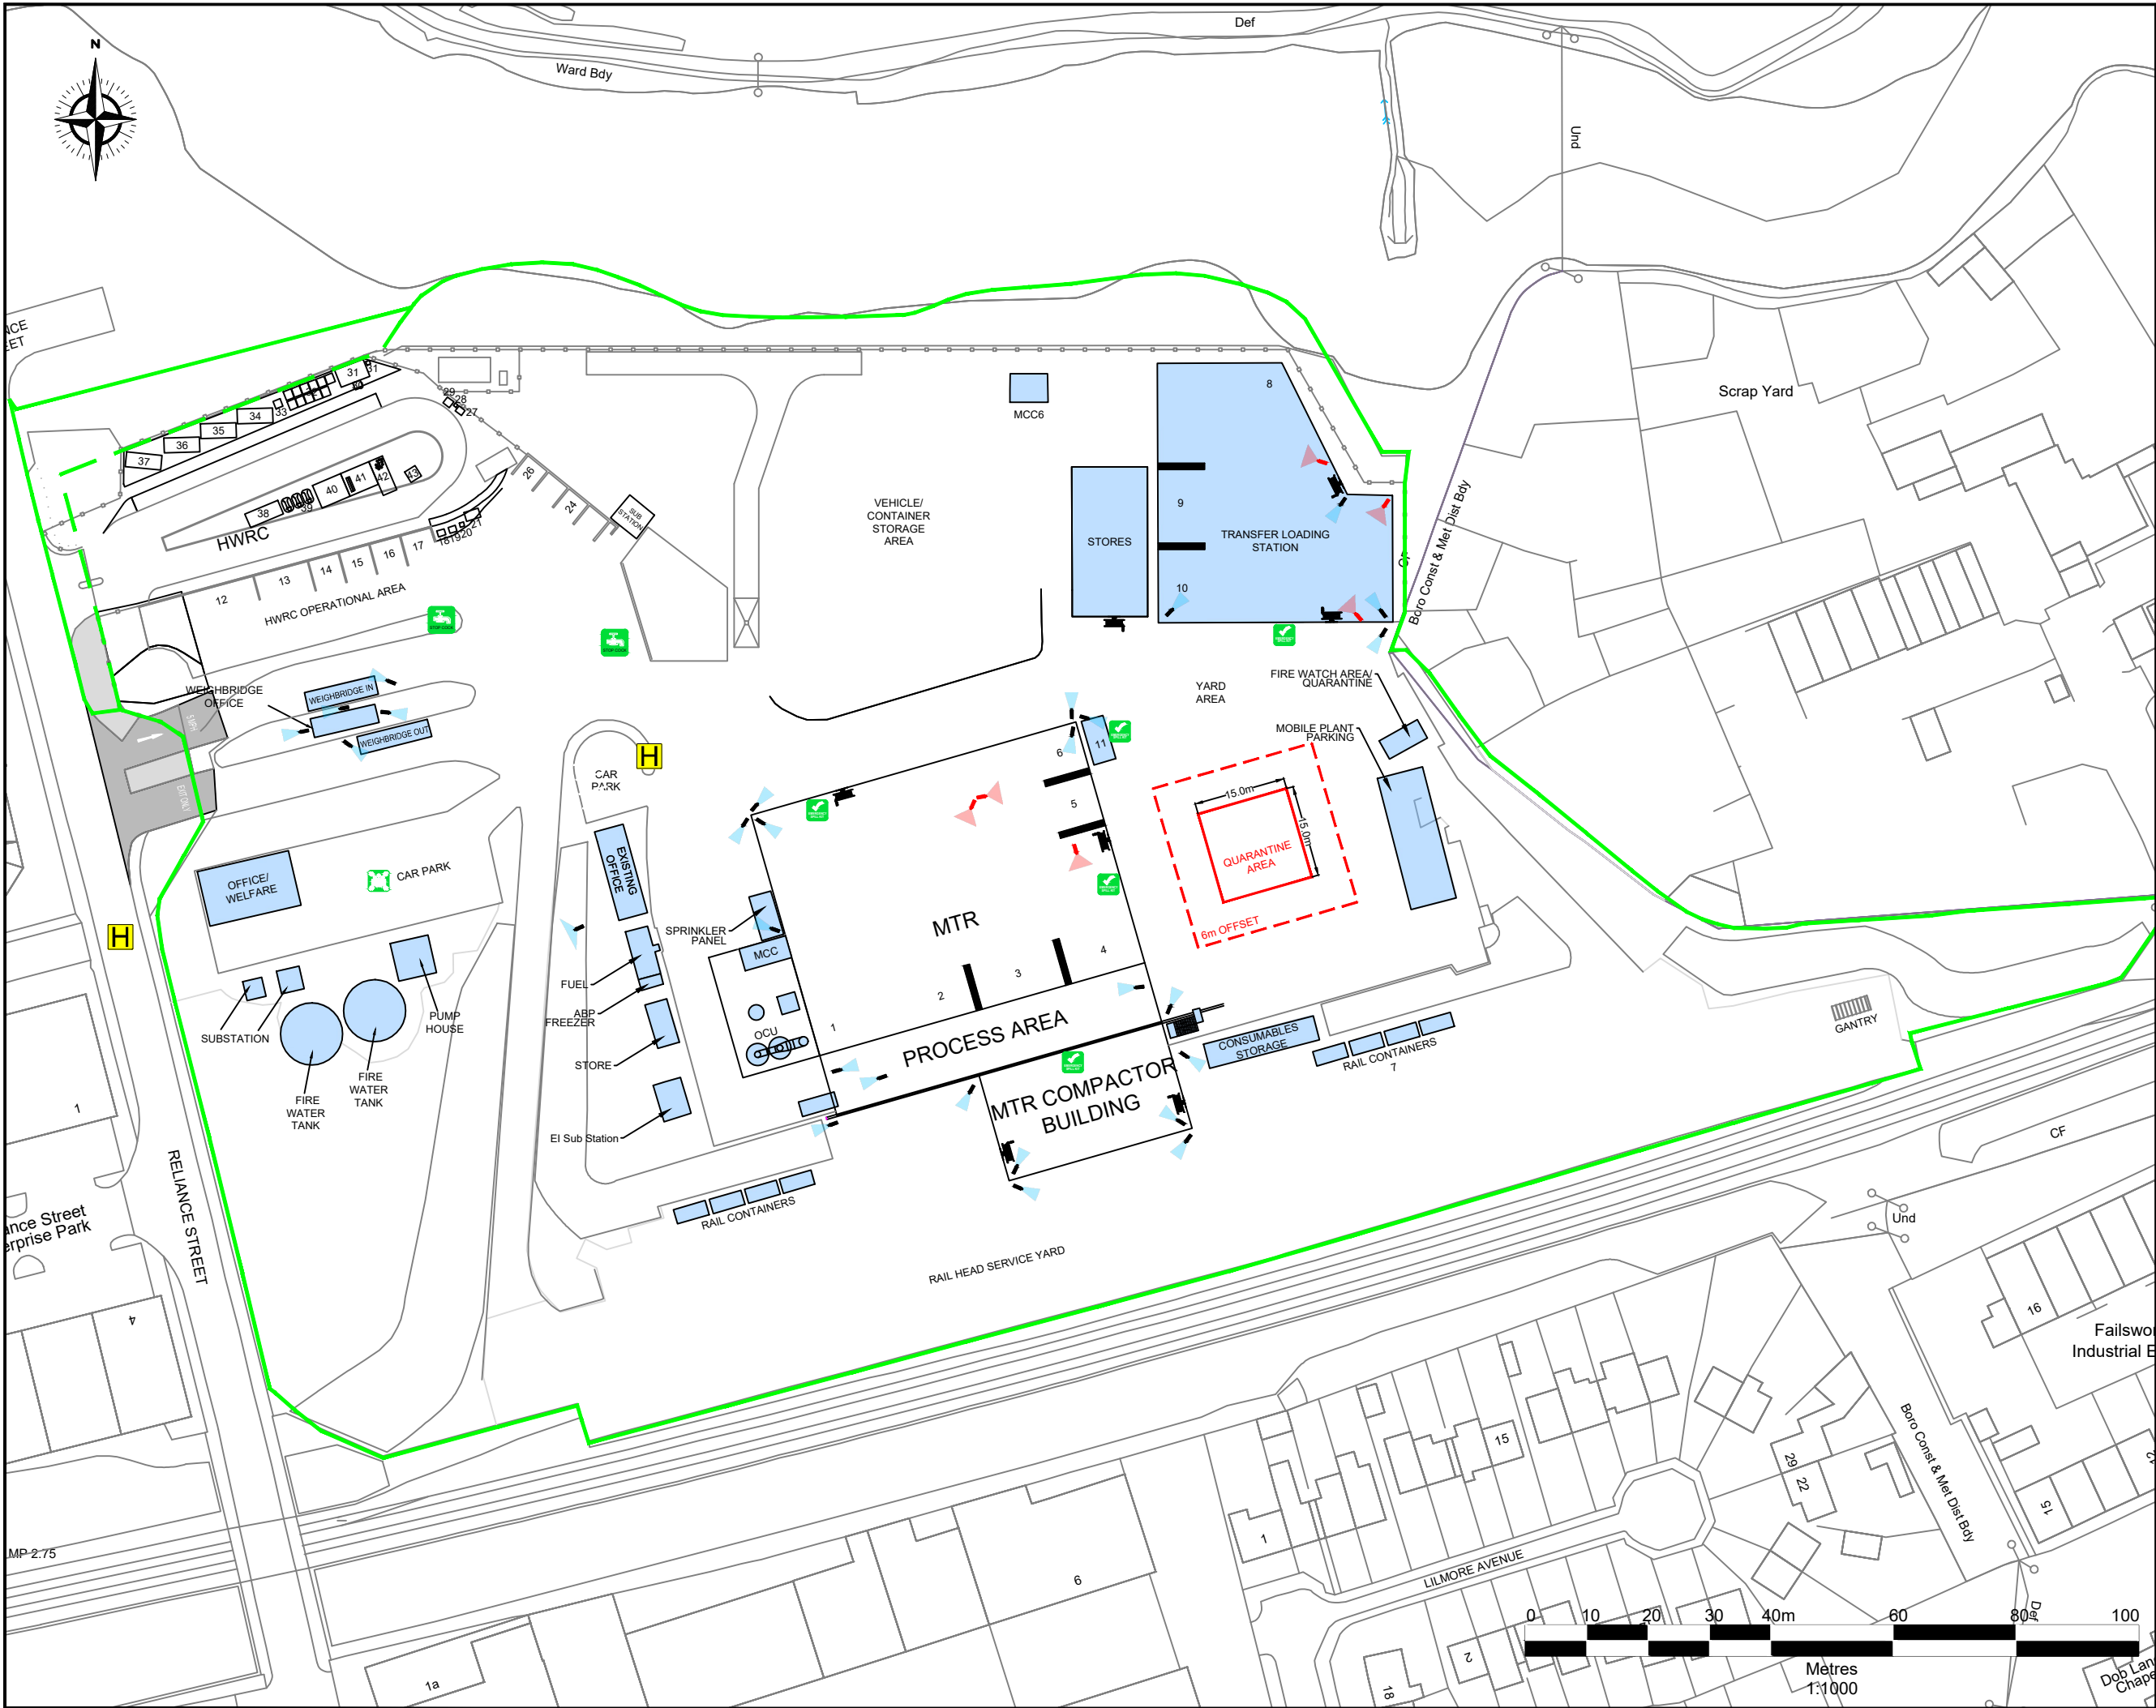
*Figure 1. Site Permit Boundary*

The current and proposed permit boundaries are shown on Figure 1. The dashed green line shows the extent of the current HWRC permit boundary and the extension area is identified by the solid green.

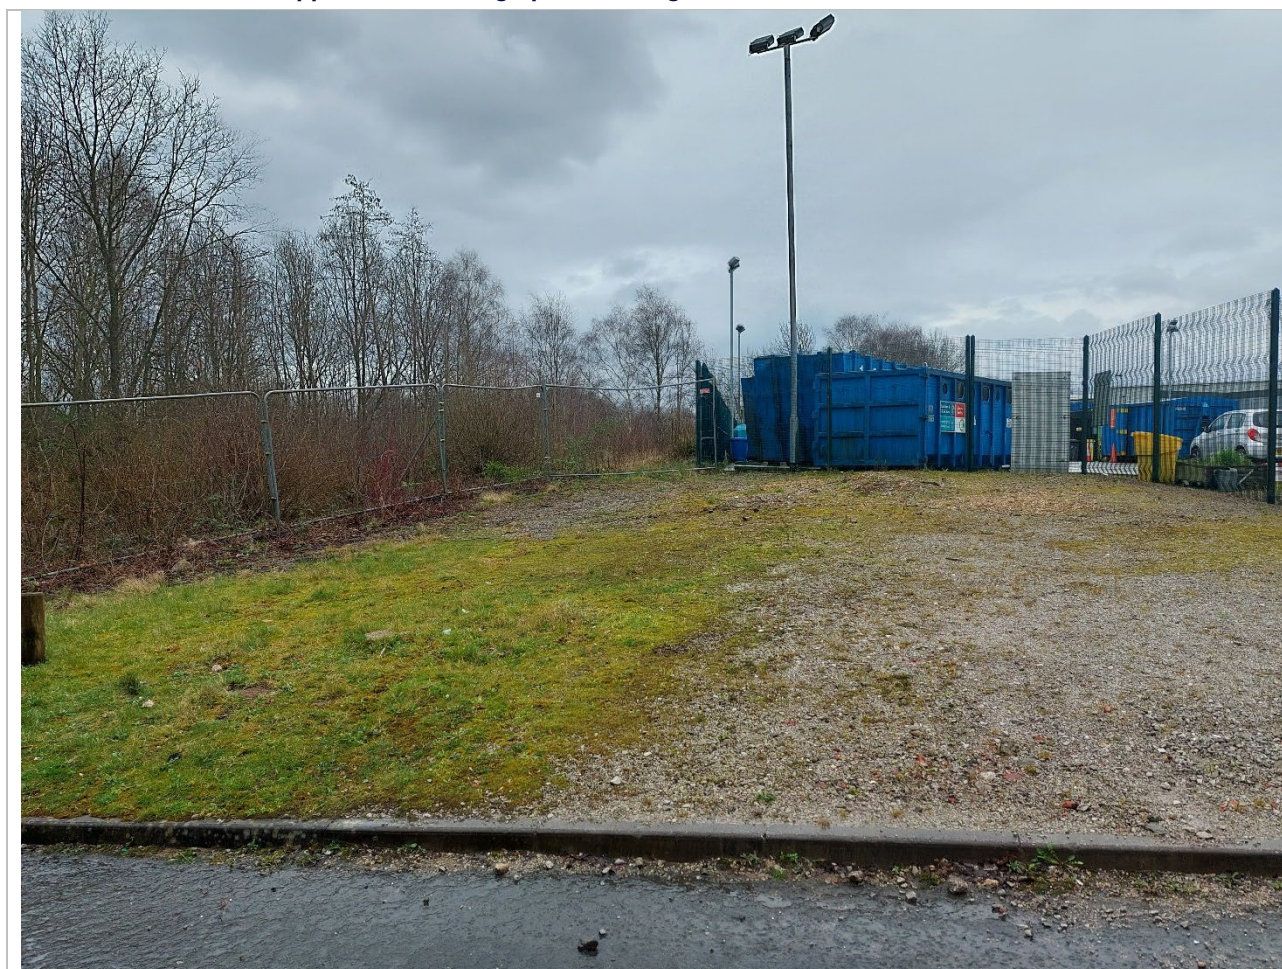
Photograph showing the proposed extension to the northern and western HWRC boundary. The current green fence on the right is the permit boundary and the temporary fencing indicates the approximate increase in the permit boundary.

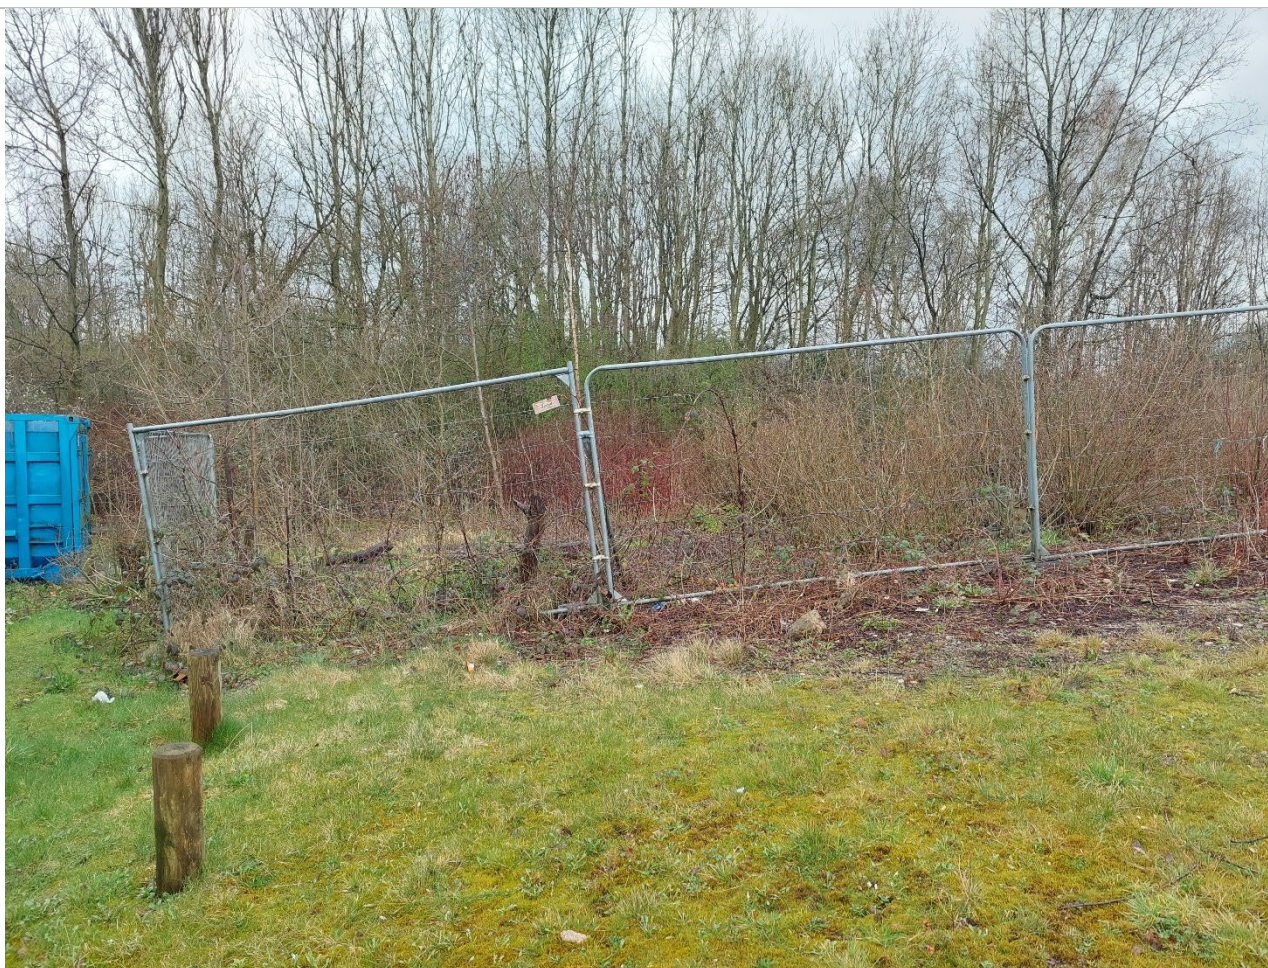
Photograph showing the view north of the proposed permit extension area for the redeveloped HWRC entrance.

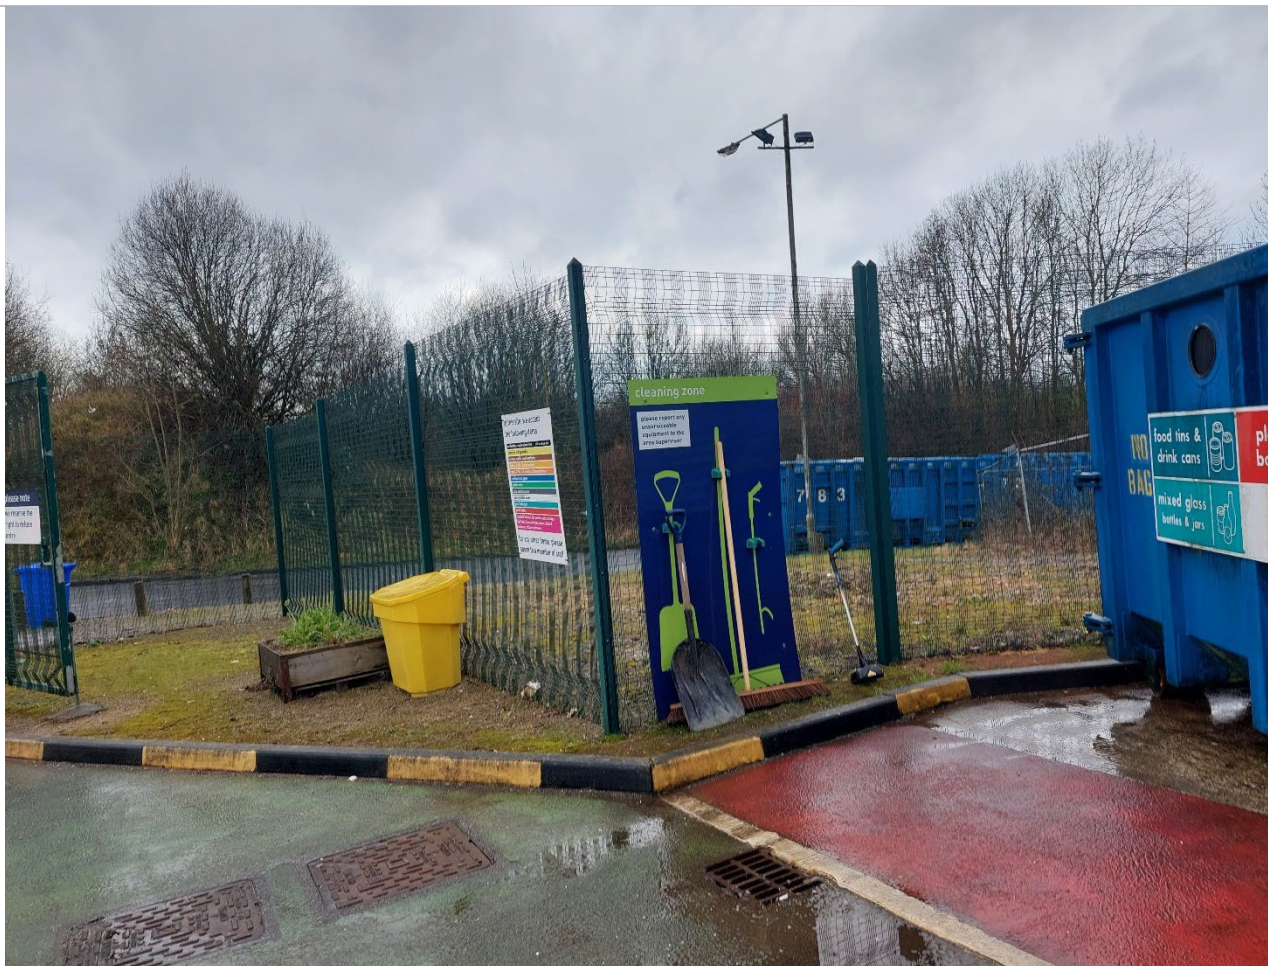
Photograph showing the view north towards the proposed HWRC extension area from the current HWRC entrance.

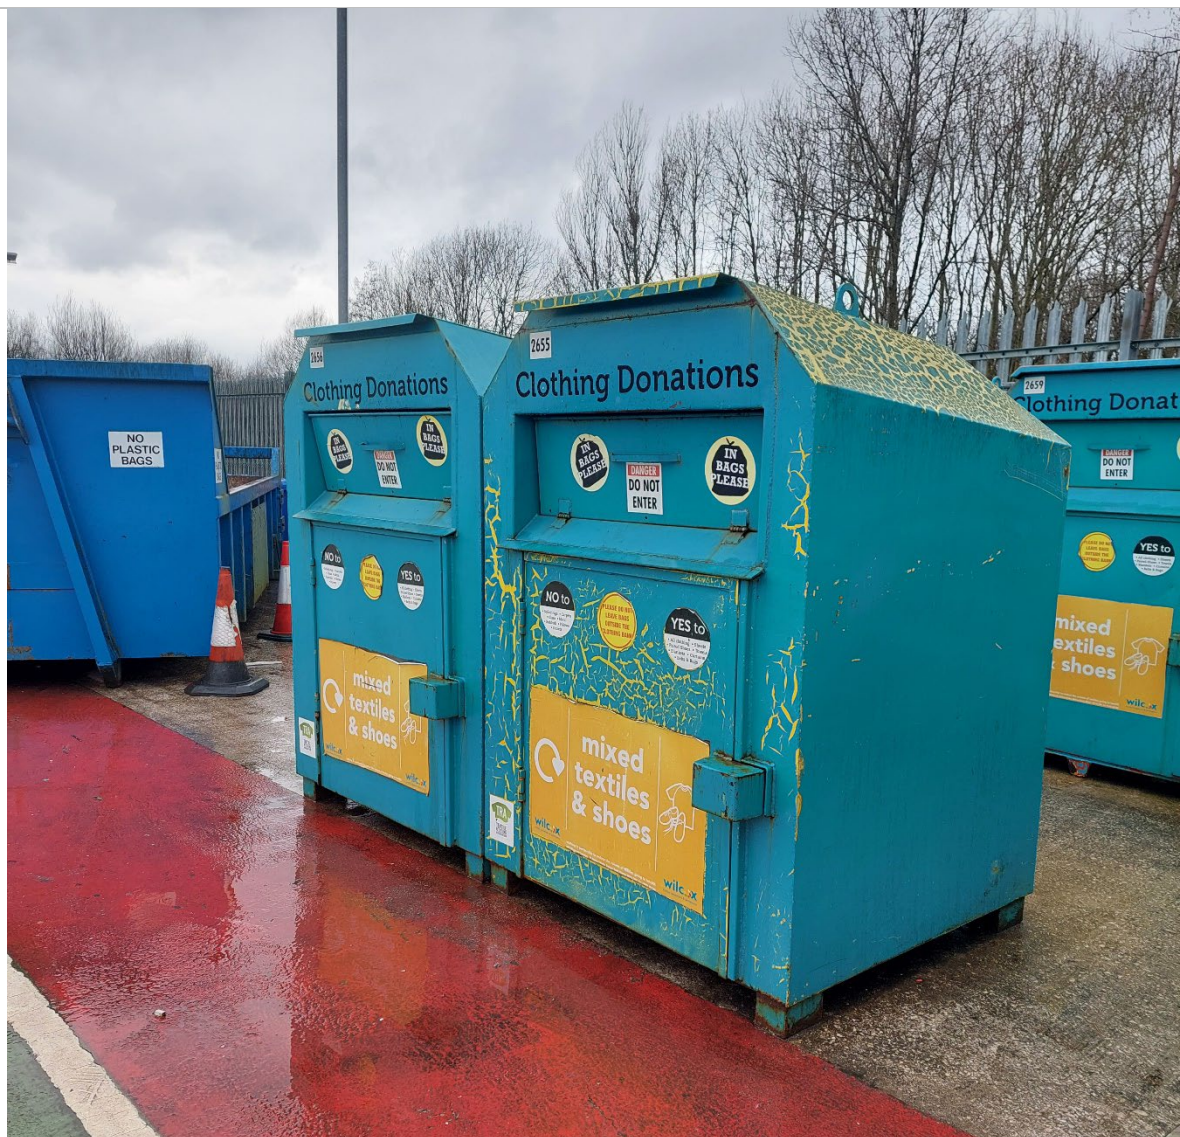
Photograph showing the clothing banks along the site permit boundary northern edge (this section of boundary is unchanged in the proposed permit variation).

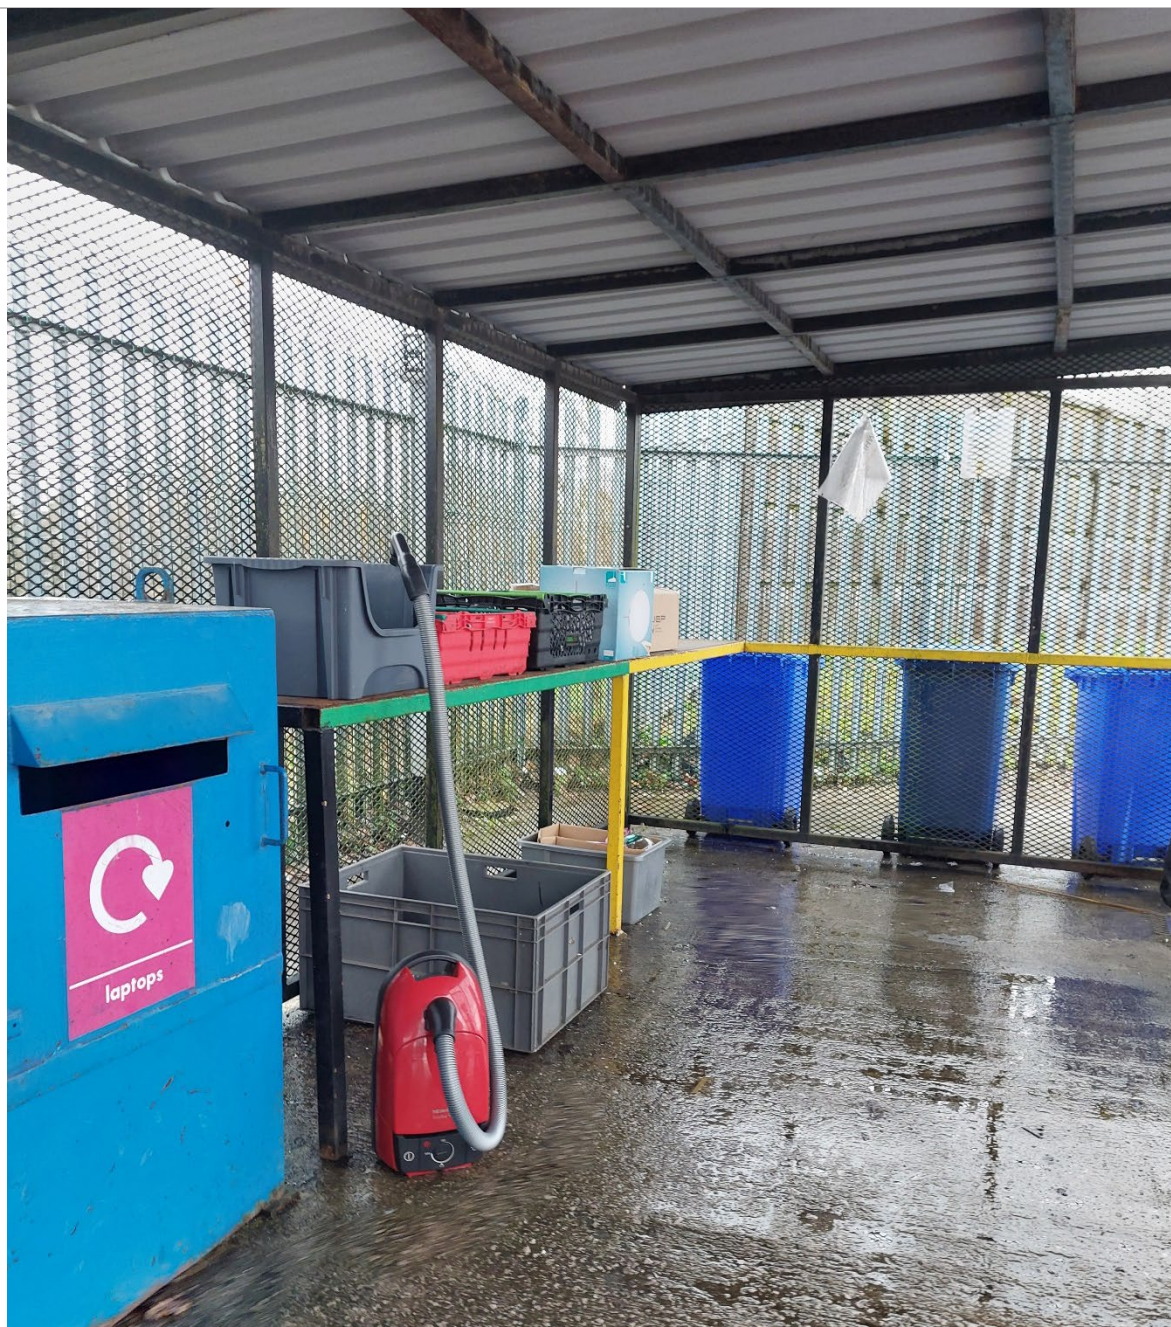
Photograph showing the electricals (WEEE) cage along the site permit boundary northern edge (this section of boundary is unchanged in the proposed permit variation).

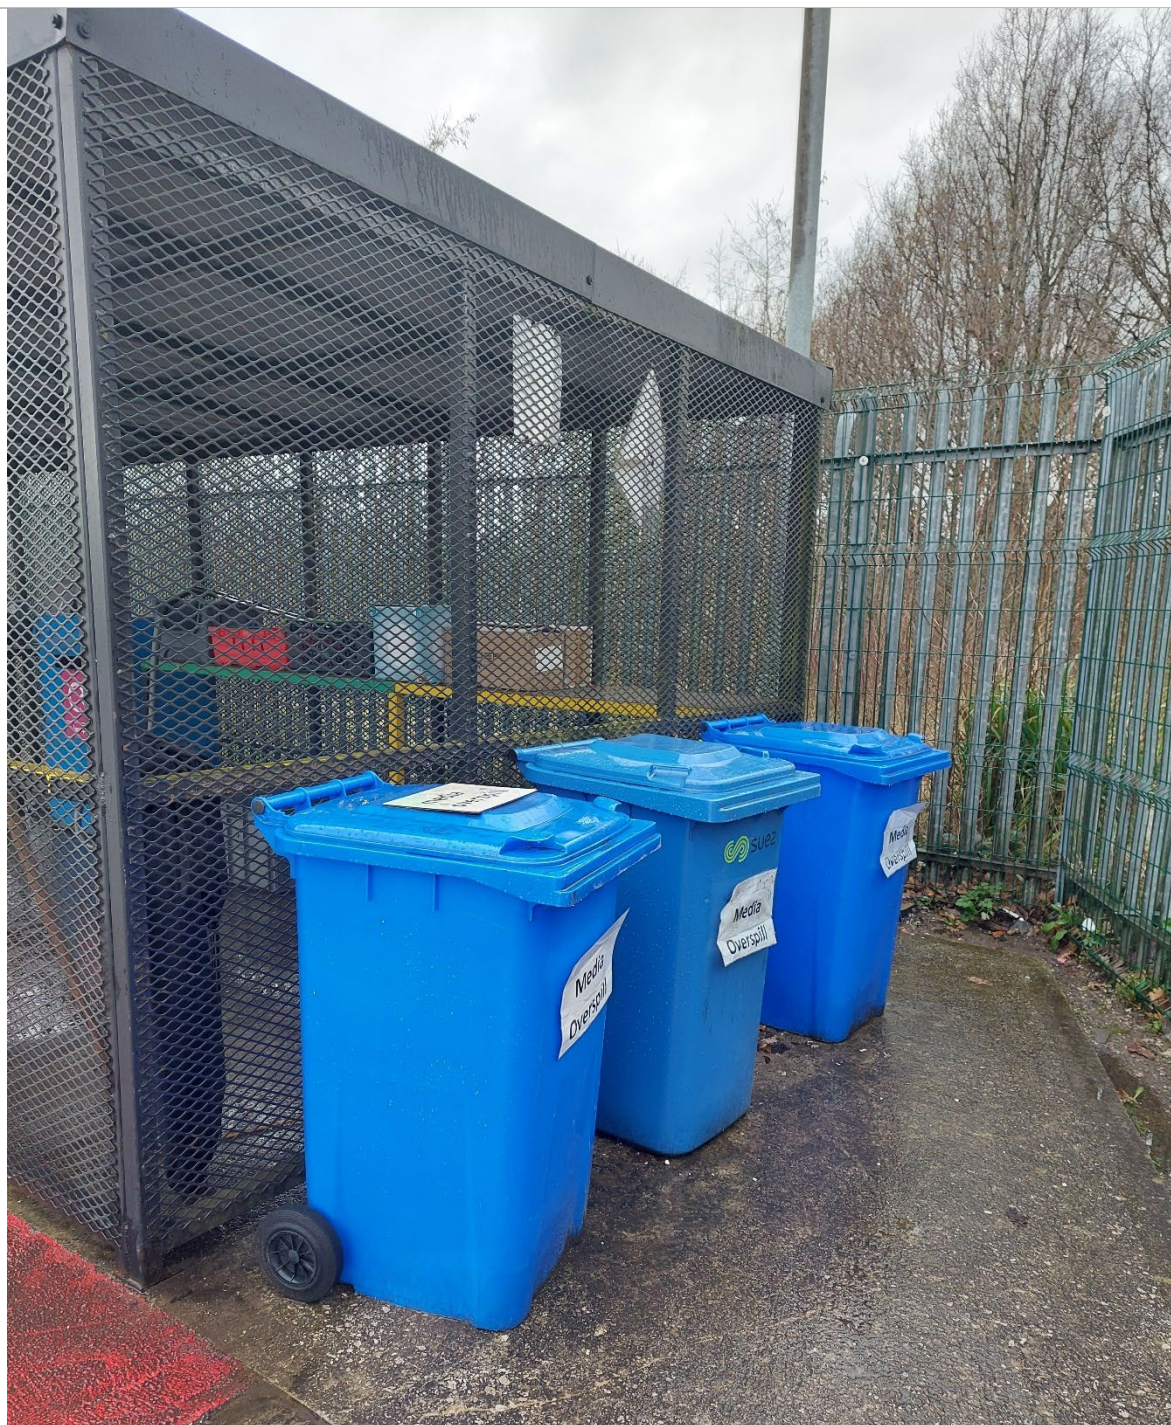
Photograph showing the electricals (WEEE) cage along northern permit boundary edge (this section boundary is unchanged in the proposed permit variation).

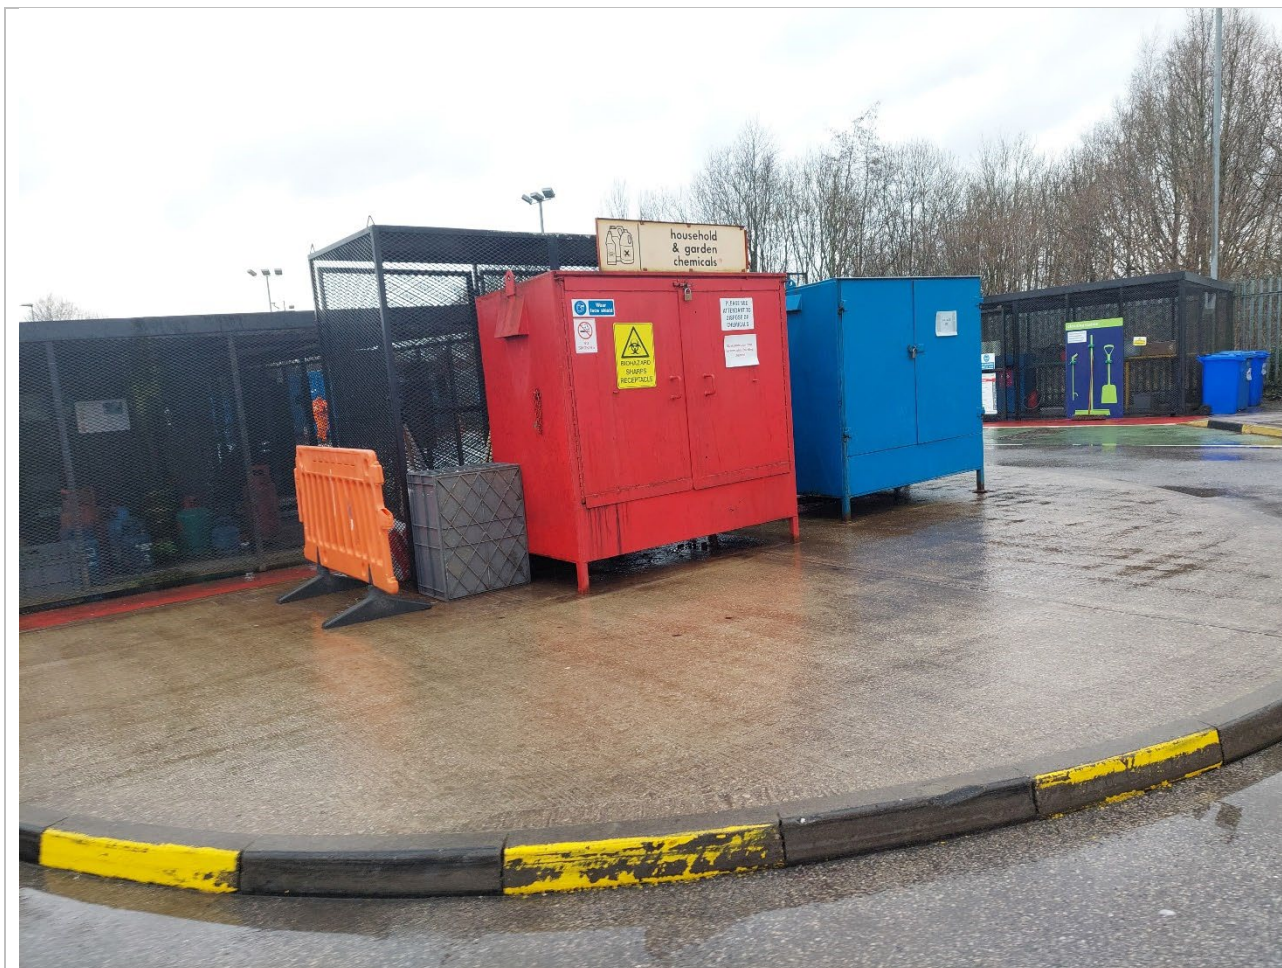
Photograph showing the chemical storage containers looking towards the electricals (WEEE) cage (this section of boundary is unchanged in the proposed permit variation).

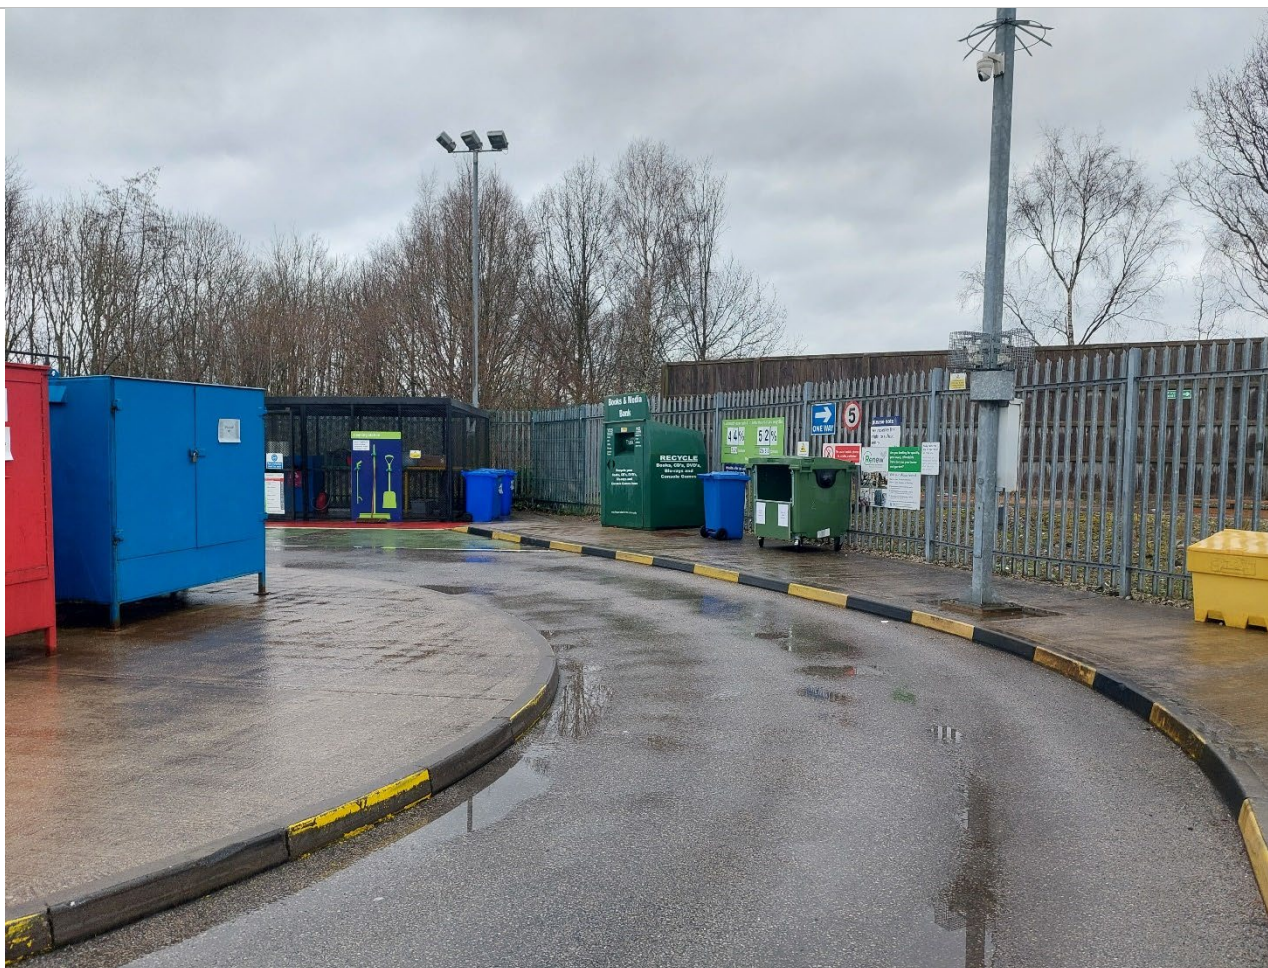
Photograph showing the eastern permit boundary and the northern permit boundary and the WEEE cage in the distance (this section is of boundary unchanged in the proposed permit variation).

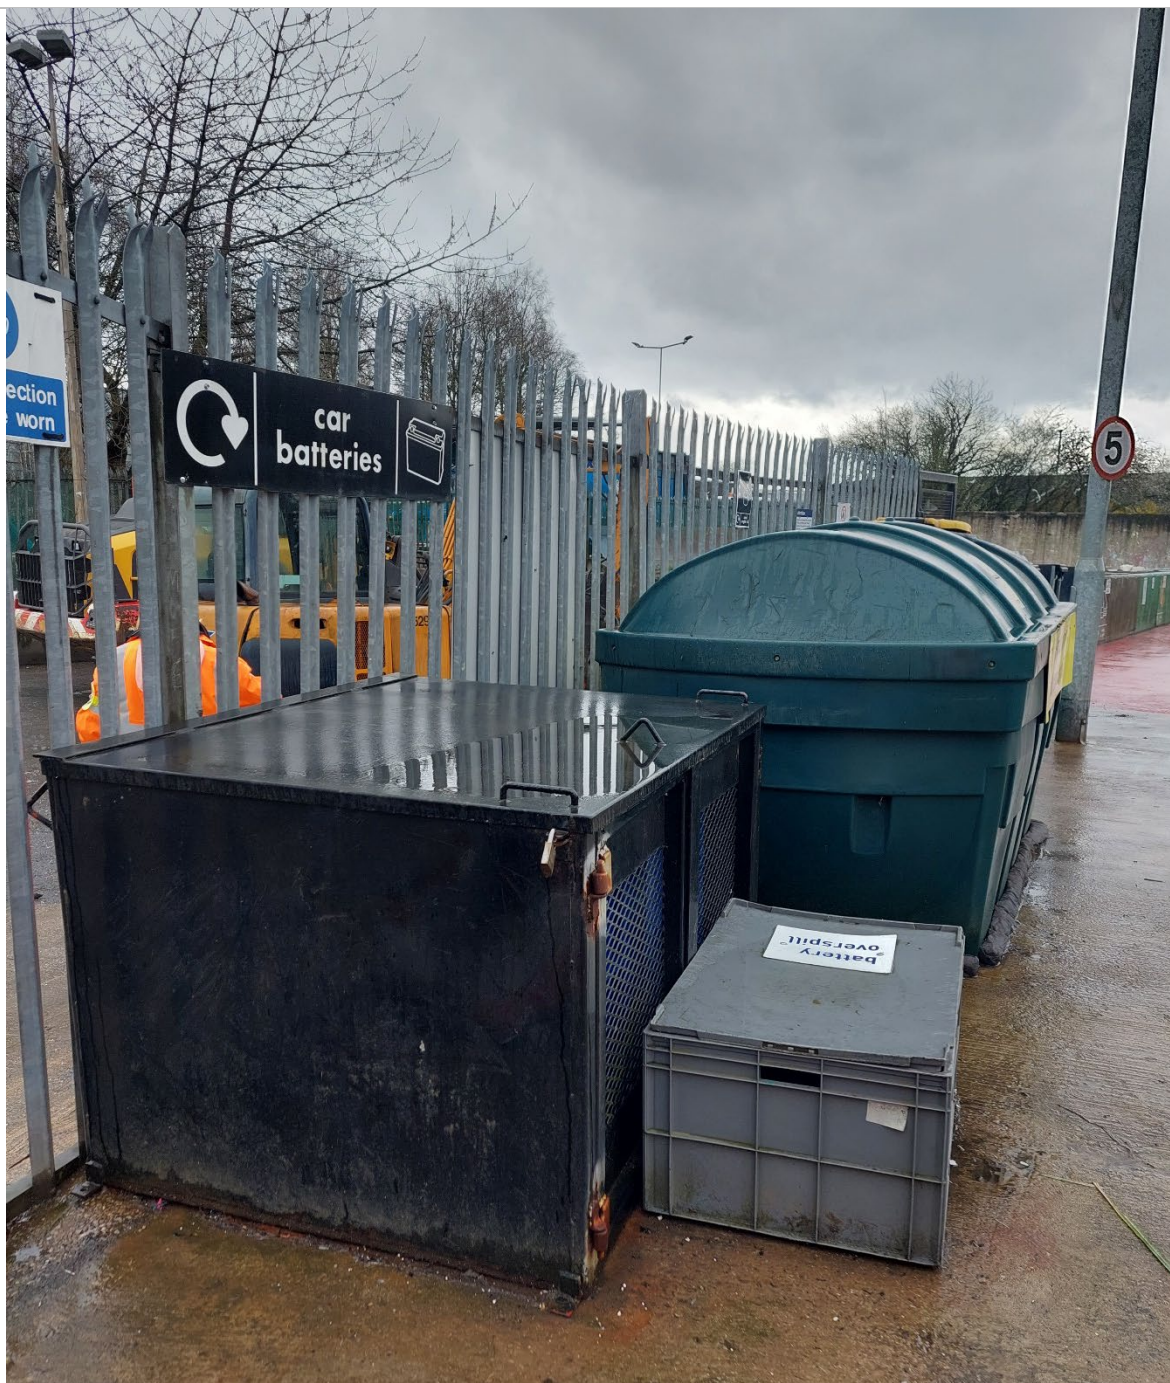
Photograph showing the oil and battery storage with the HWRC bays in the distance along the southern boundary of the site (this section of boundary is unchanged in the proposed permit variation).
