Intended for
RGE Recycling Ltd
Date
October 2025
Project Number
(RGE-2025/001)

Site Condition Report

Project No. RGE-2025/001
Issue No. 1
Date October 2025
Author Kieran Ball
Checked Stephen Griffiths

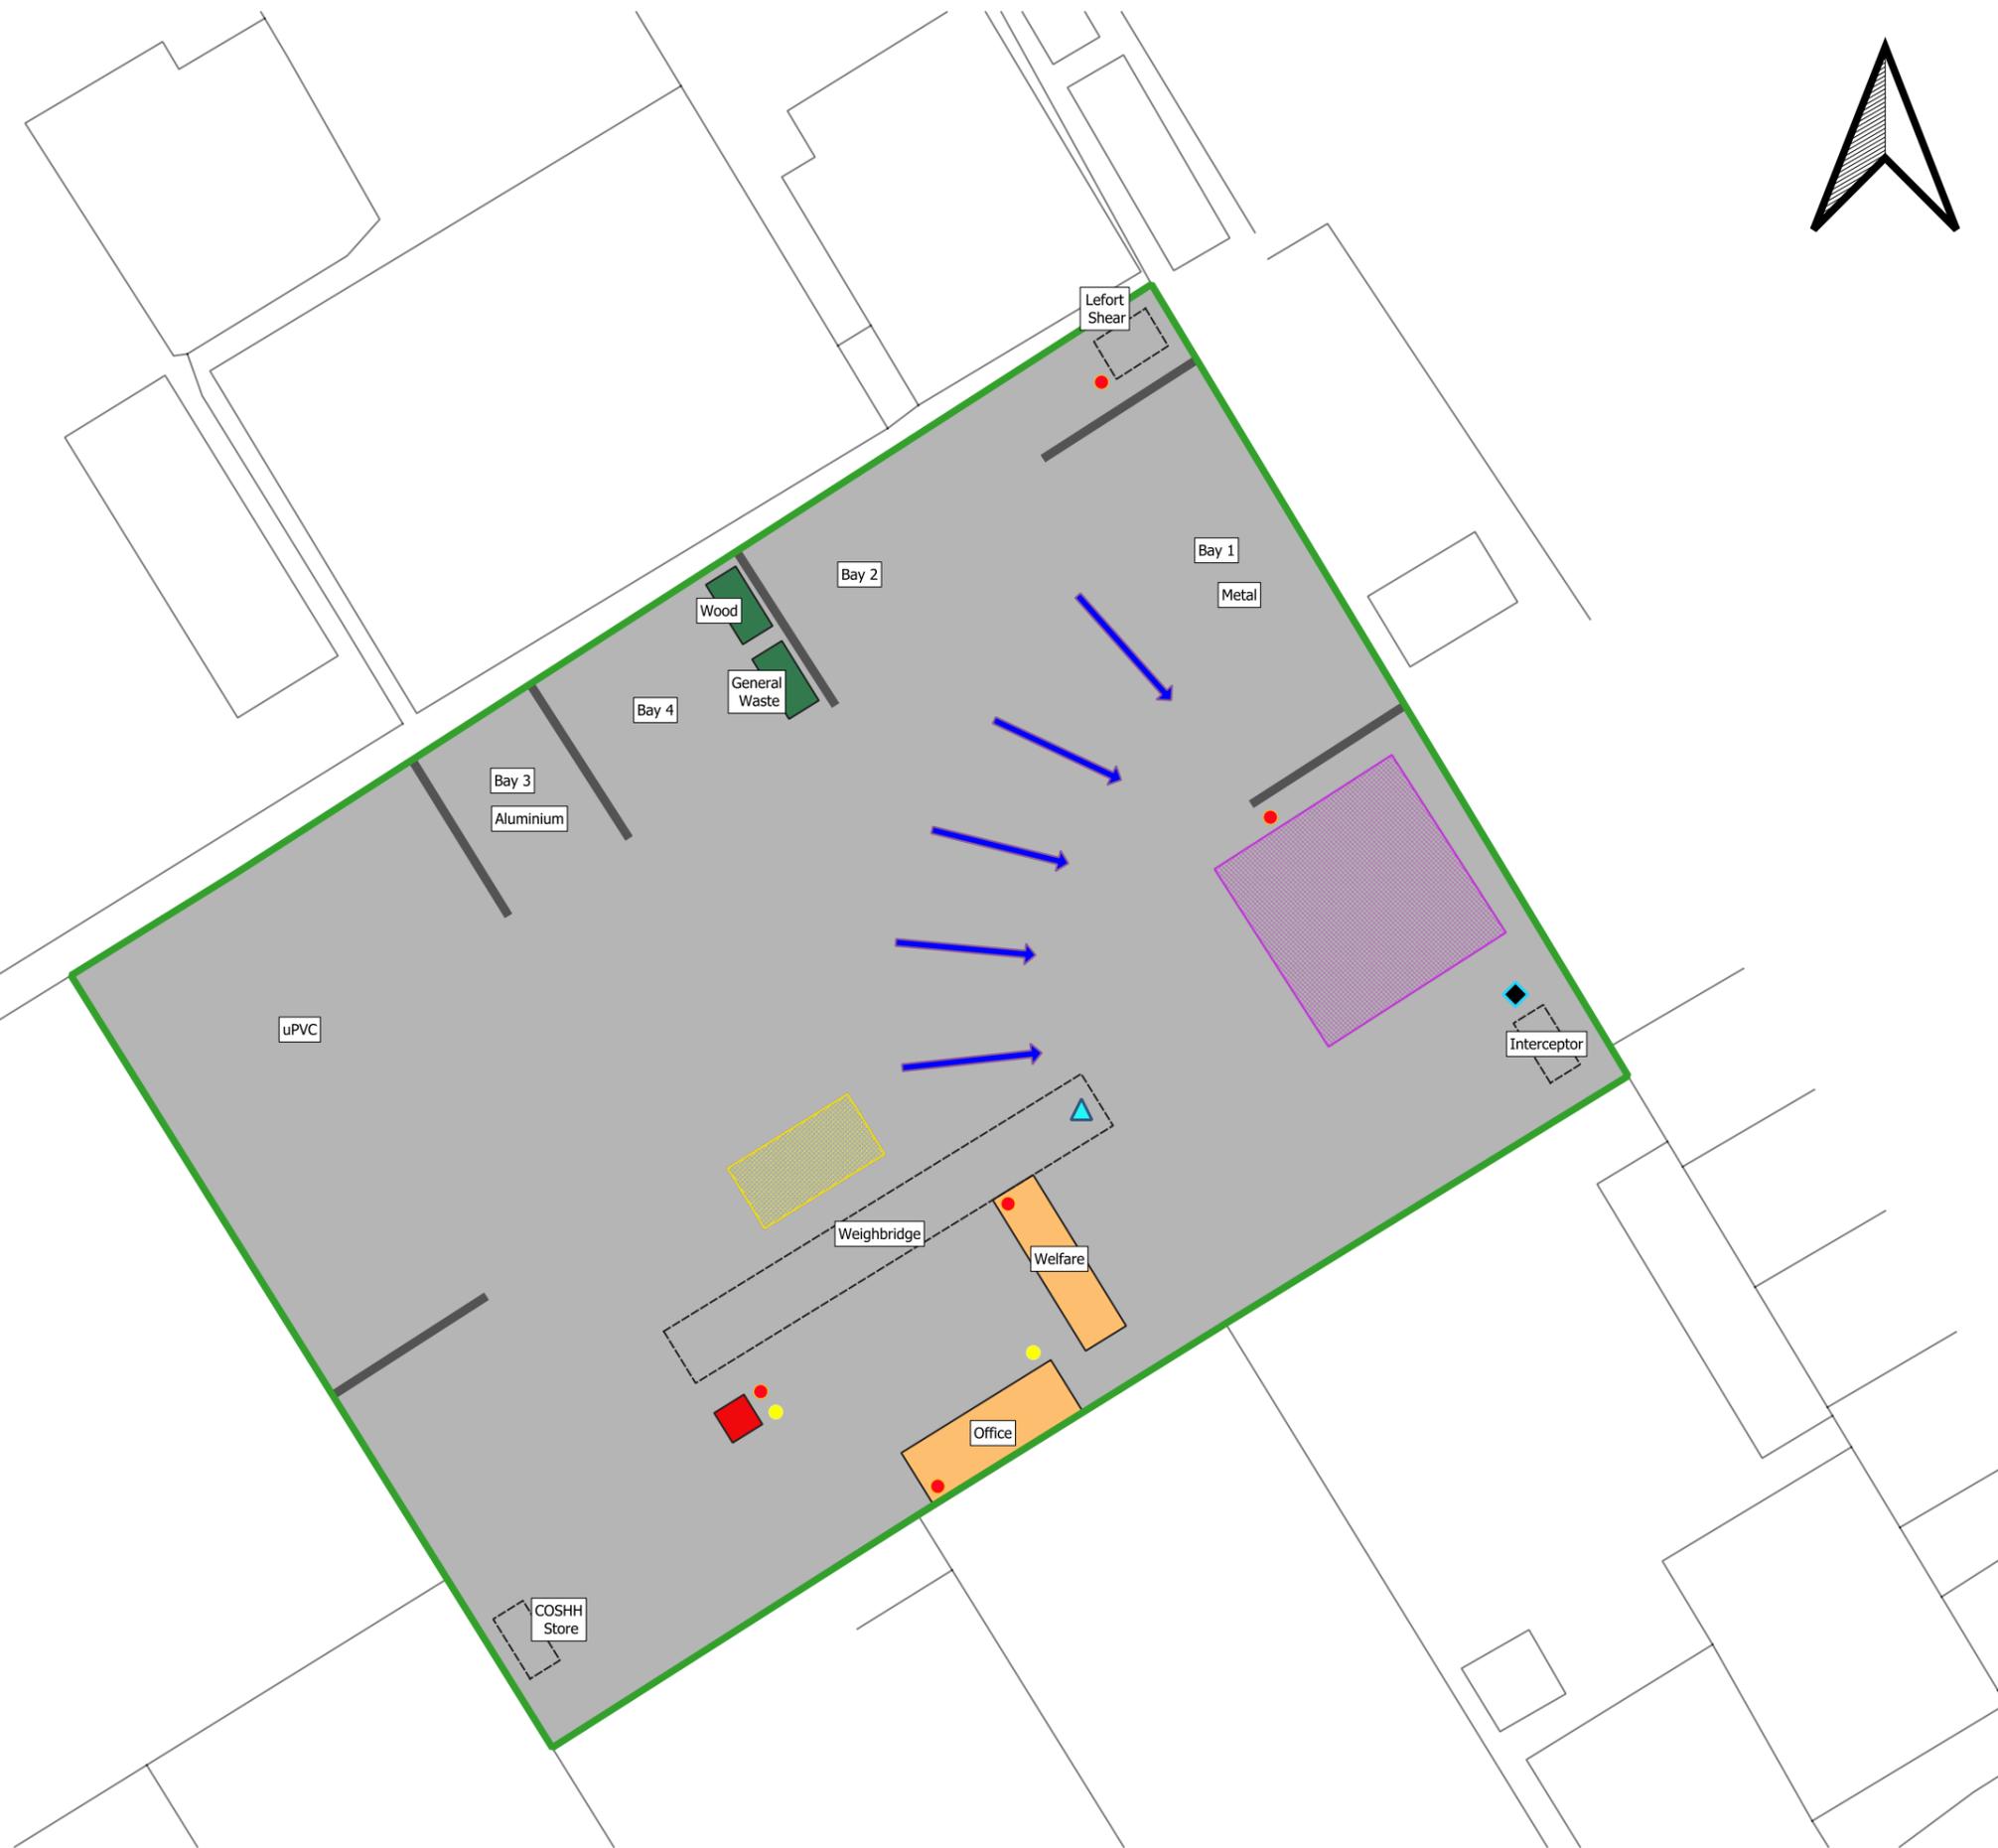
Appendix 2: Permit Boundary

Drawing Title: Site Layout Plan
 Ref:
 Scale: 1:400 (A3)
 Date: 2025-07-30
 Revison:
 Drawn By: TW
 Address: RGE Recycling, Royal Eagle Close, Rochester, Kent, ME2 4NF
 Changelog:
 - N/A
