# Stewartby Waste Transfer Station

## Site Condition Report

FCC Waste Services (UK) Ltd

**Report No. 14-K0157-ENV-R-00002**

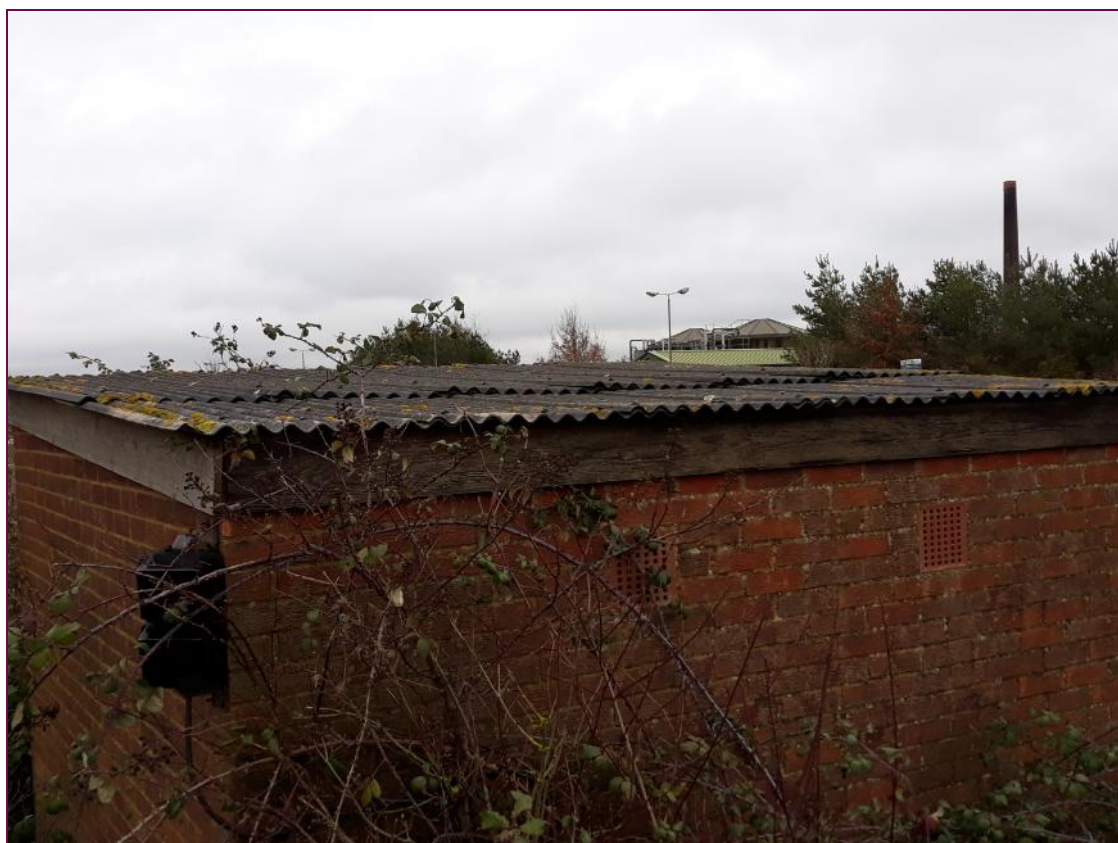
**Photograph 8: Possible asbestos cement sheeting roof located within the western site area.**

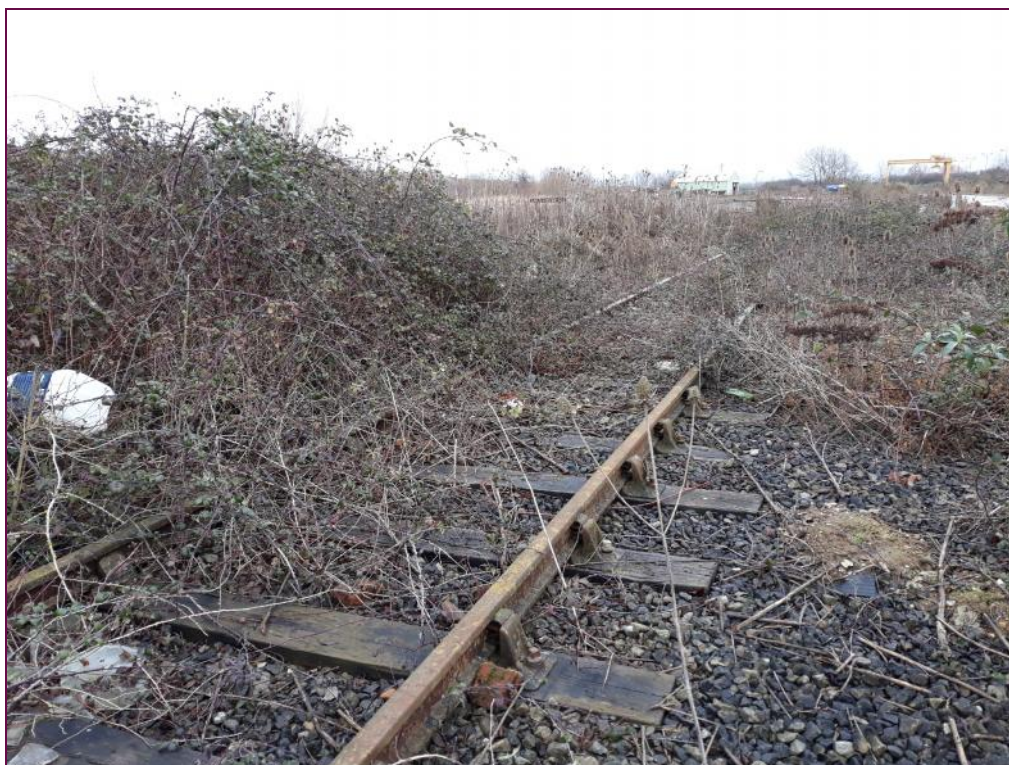
**Photograph 9: Example of overgrown railway sidings, looking east**

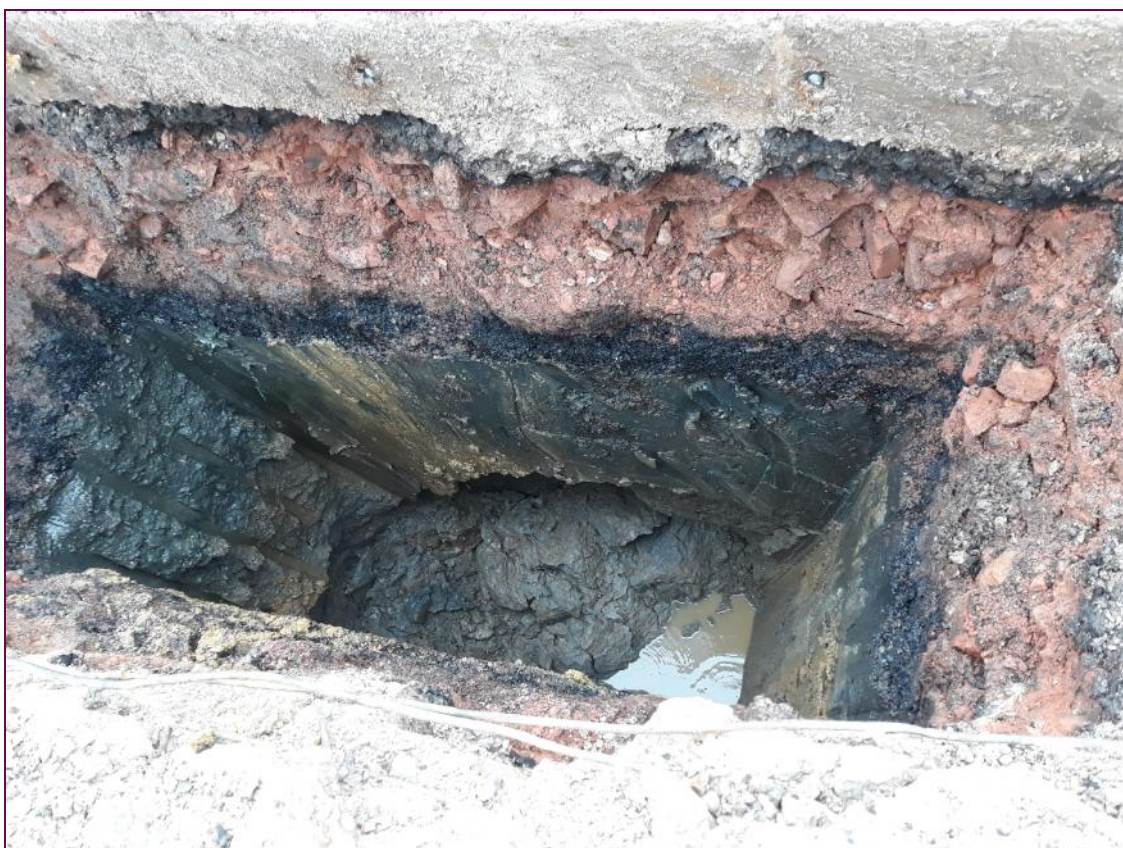
**Photograph 13: Excavated TP05.**

It should be noted that TP05 was terminated due to the presence of a leachate pipeline, and consequently two additional trial pits scheduled to target the former water courses were not completed.

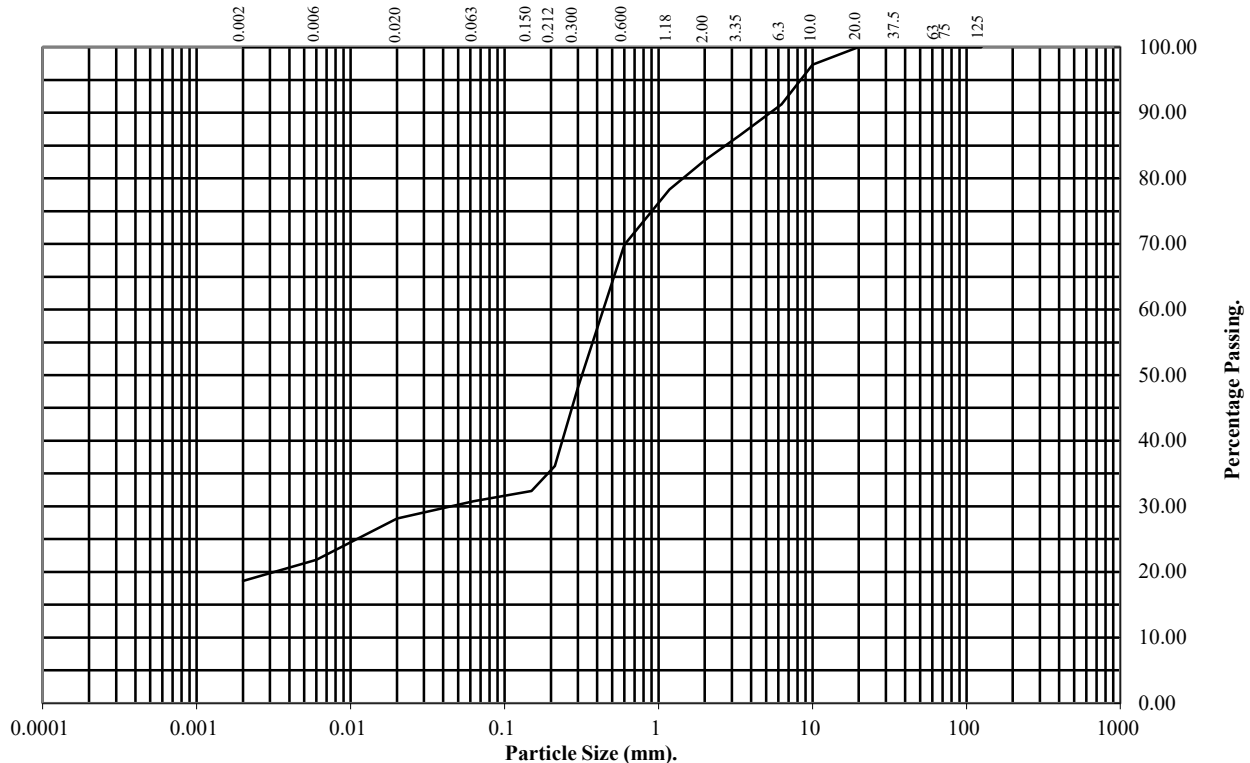
BS Test Sieve (mm)	Percentage Passing
125	100
75	100
63	100
37.5	100
20	100
10	97
6.3	91
3.35	87
2	83
1.18	78
0.6	70
0.3	48
0.212	36
0.15	32
0.063	31

Particle Diameter	Percentage Passing
0.02	28
0.006	22
0.002	19

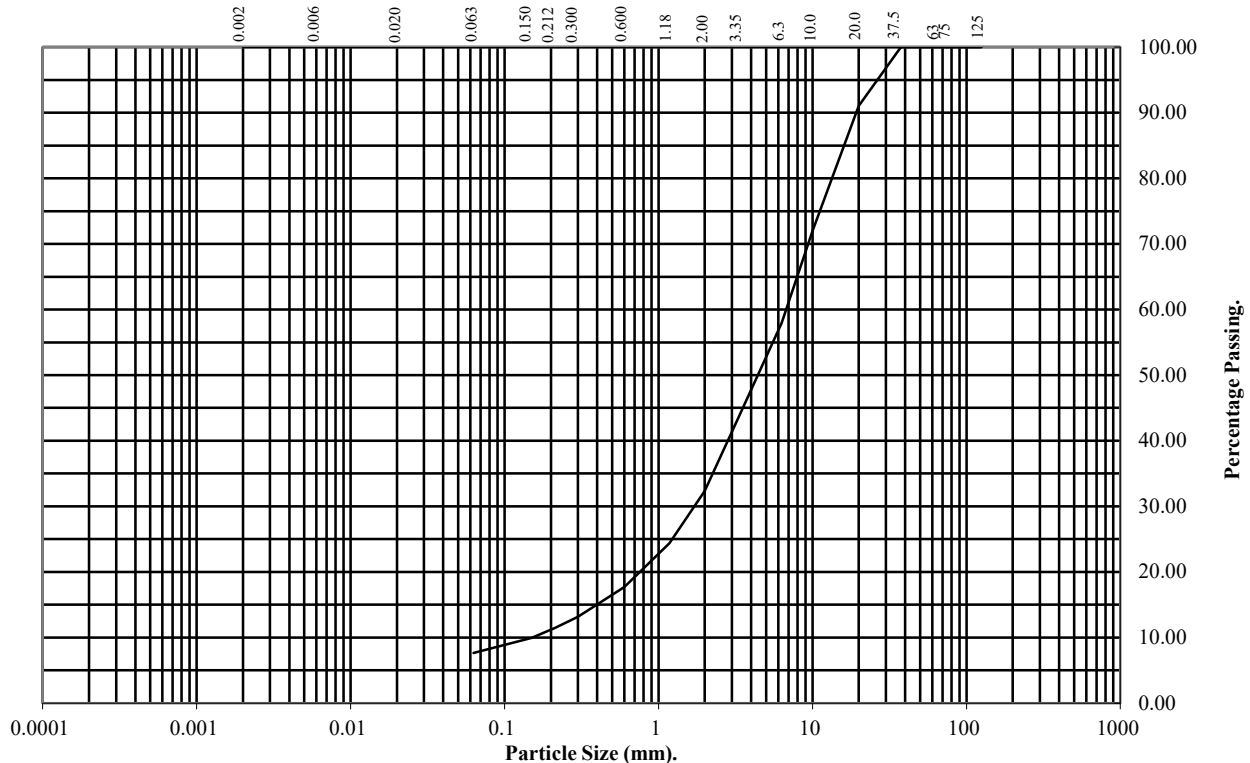
BS Test Sieve (mm)	Percentage Passing
125	100
75	100
63	100
37.5	100
20	91
10	72
6.3	58
3.35	44
2	32
1.18	24
0.6	18
0.3	13
0.212	11
0.15	10
0.063	8

Soil Fraction	Total Percentage
Cobbles	0
Gravel	68
Sand	24
Silt/Clay	8

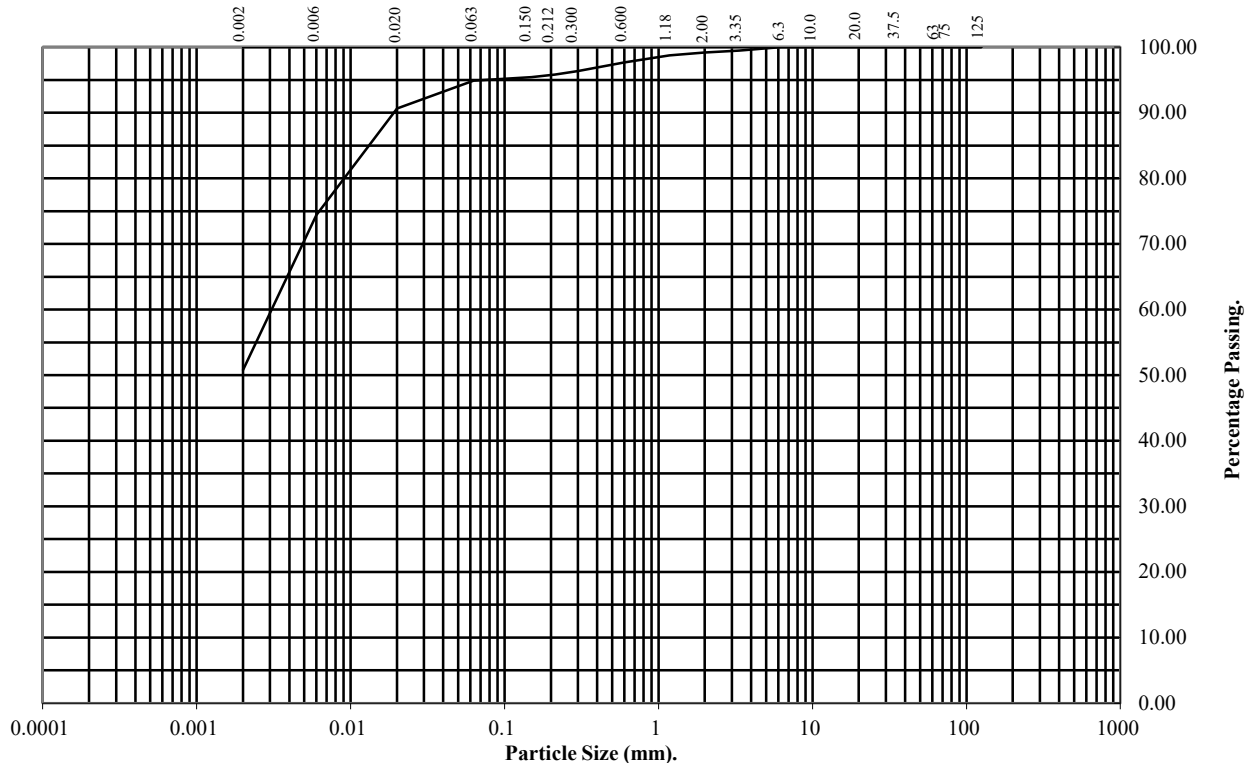
BS Test Sieve (mm)	Percentage Passing
125	100
75	100
63	100
37.5	100
20	100
10	100
6.3	100
3.35	99
2	99
1.18	99
0.6	98
0.3	96
0.212	96
0.15	95
0.063	95

Particle Diameter	Percentage Passing
0.02	91
0.006	74
0.002	51

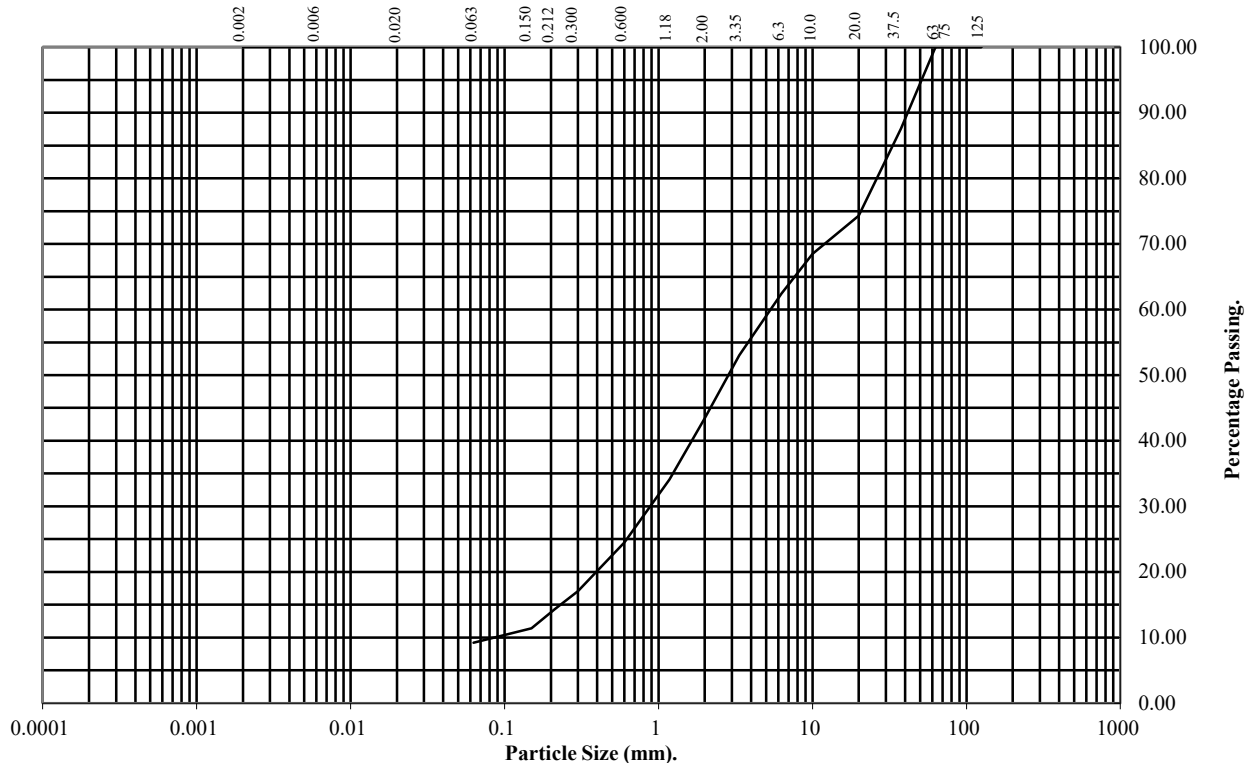
BS Test Sieve (mm)	Percentage Passing
125	100
75	100
63	100
37.5	88
20	74
10	68
6.3	62
3.35	53
2	43
1.18	34
0.6	24
0.3	17
0.212	14
0.15	11
0.063	9

Soil Fraction	Total Percentage
Cobbles	0
Gravel	57
Sand	34
Silt/Clay	9

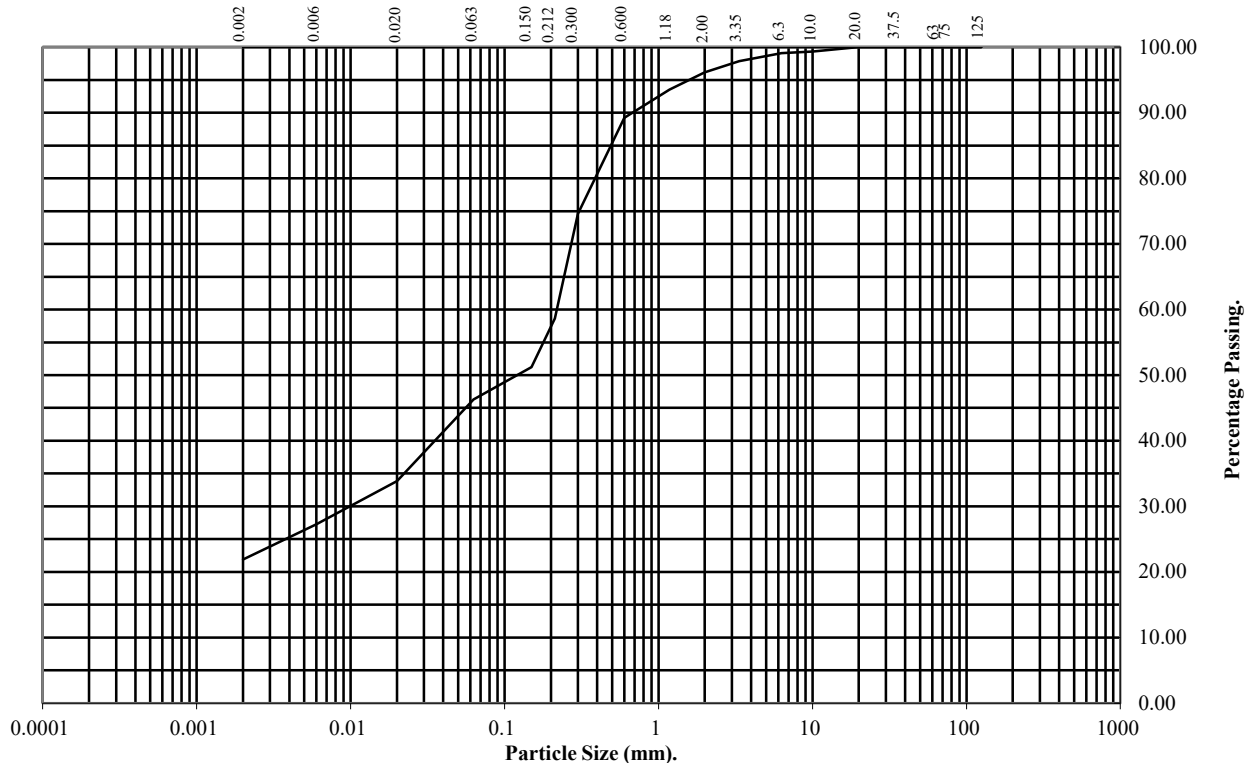
BS Test Sieve (mm)	Percentage Passing
125	100
75	100
63	100
37.5	100
20	100
10	99
6.3	99
3.35	98
2	96
1.18	94
0.6	89
0.3	75
0.212	59
0.15	51
0.063	46

Particle Diameter	Percentage Passing
0.02	34
0.006	27
0.002	22

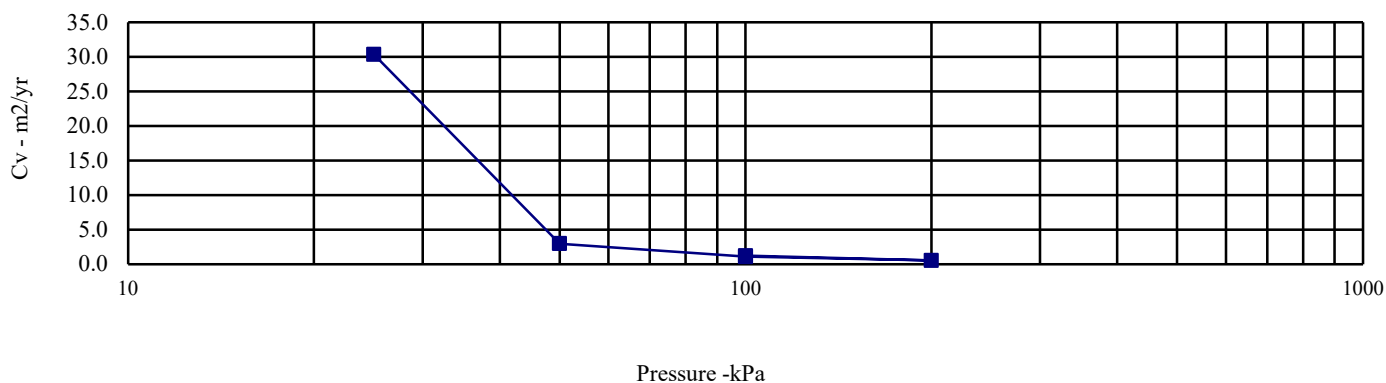
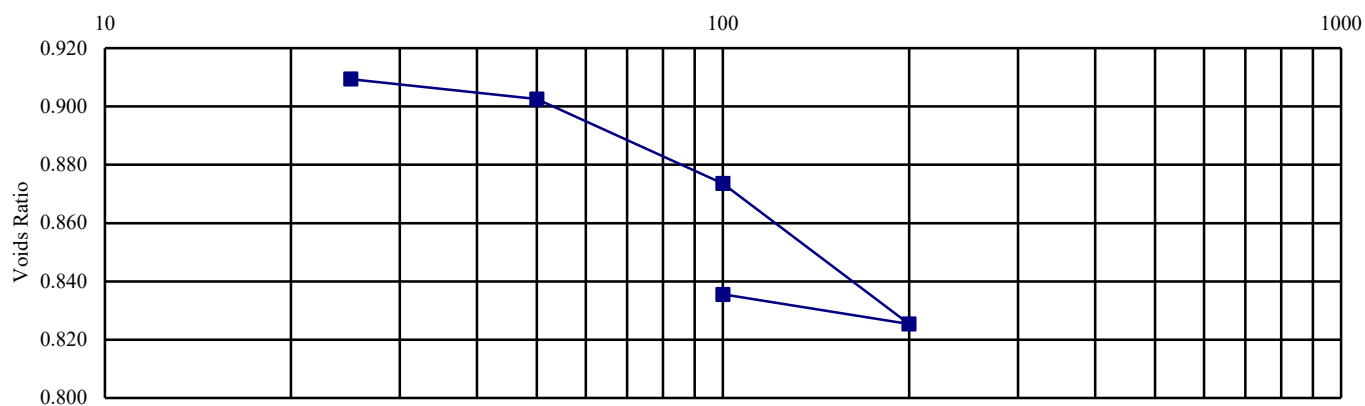
Initial Conditions		Pressure Range		Mv	Cv	Specimen location	
Moisture Content (%):	32	kPa		m2/MN	m2/yr	within tube:	Top
Bulk Density (Mg/m3):	1.82	0	25	0.309	30.350	Method used to	
Dry Density (Mg/m3):	1.38	25	50	0.143	2.956	determine CV:	T90
Voids Ratio:	0.924	50	100	0.304	1.085	Nominal temperature	
Degree of saturation:	91.6	100	200	0.257	0.544	during test ' C:	20
Height (mm):	19.954	200	100	0.055	1.220	Remarks:	See summary of soil descriptions
Diameter (mm)	75.03						
Particle Density (Mg/m3):	2.65						
Assumed

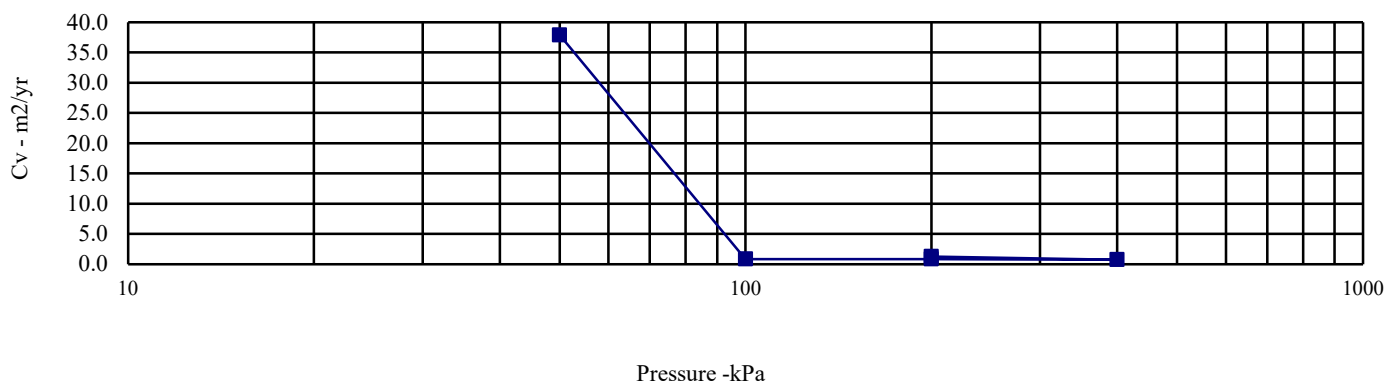
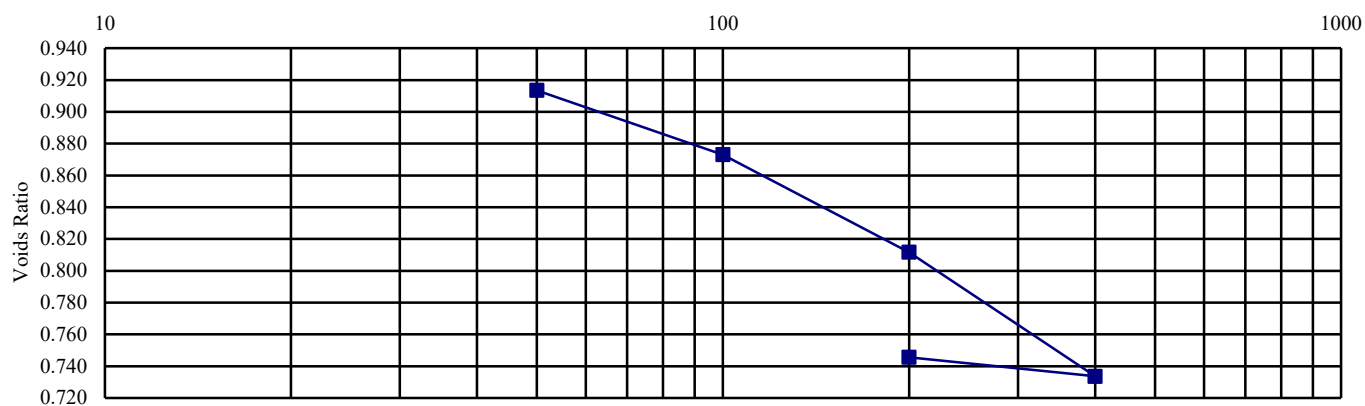
Initial Conditions		Pressure Range		Mv	Cv	Specimen location	
Moisture Content (%):	35	kPa		m2/MN	m2/yr	within tube:	Top
Bulk Density (Mg/m3):	1.82	0	50	0.542	37.875	Method used to	
Dry Density (Mg/m3):	1.35	50	100	0.423	0.855	determine CV:	T90
Voids Ratio:	0.967	100	200	0.328	0.839	Nominal temperature	
Degree of saturation:	96.6	200	400	0.215	0.747	during test ' C:	20
Height (mm):	19.8	400	200	0.035	1.276	Remarks:	
Diameter (mm)	75.045					See summary of soil descriptions	
Particle Density (Mg/m3):	2.65						
Assumed

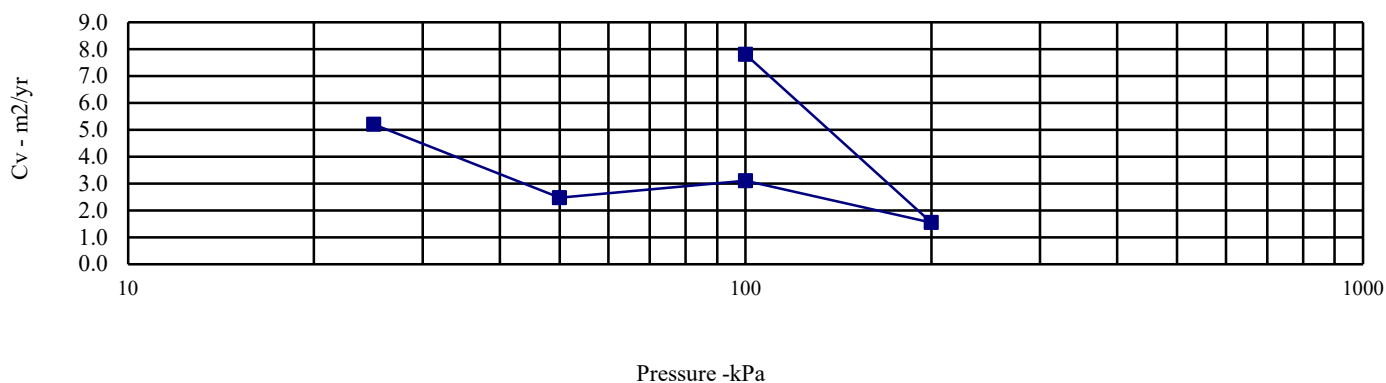
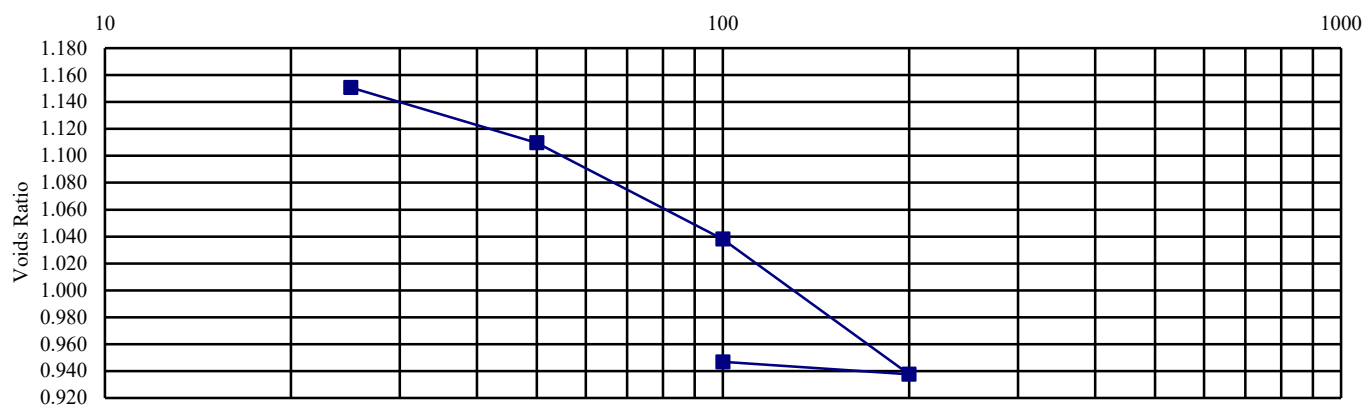
Initial Conditions		Pressure Range		Mv	Cv	Specimen location	
Moisture Content (%):	41	kPa		m2/MN	m2/yr	within tube:	Top
Bulk Density (Mg/m3):	1.70	0	25	0.905	5.203	Method used to	
Dry Density (Mg/m3):	1.20	25	50	0.762	2.470	determine CV:	T90
Voids Ratio:	1.201	50	100	0.679	3.102	Nominal temperature	
Degree of saturation:	90.4	100	200	0.493	1.550	during test ' C:	20
Height (mm):	19.174	200	100	0.047	7.805	Remarks: See summary of soil descriptions	
Diameter (mm)	75.033						
Particle Density (Mg/m3): Assumed	2.65

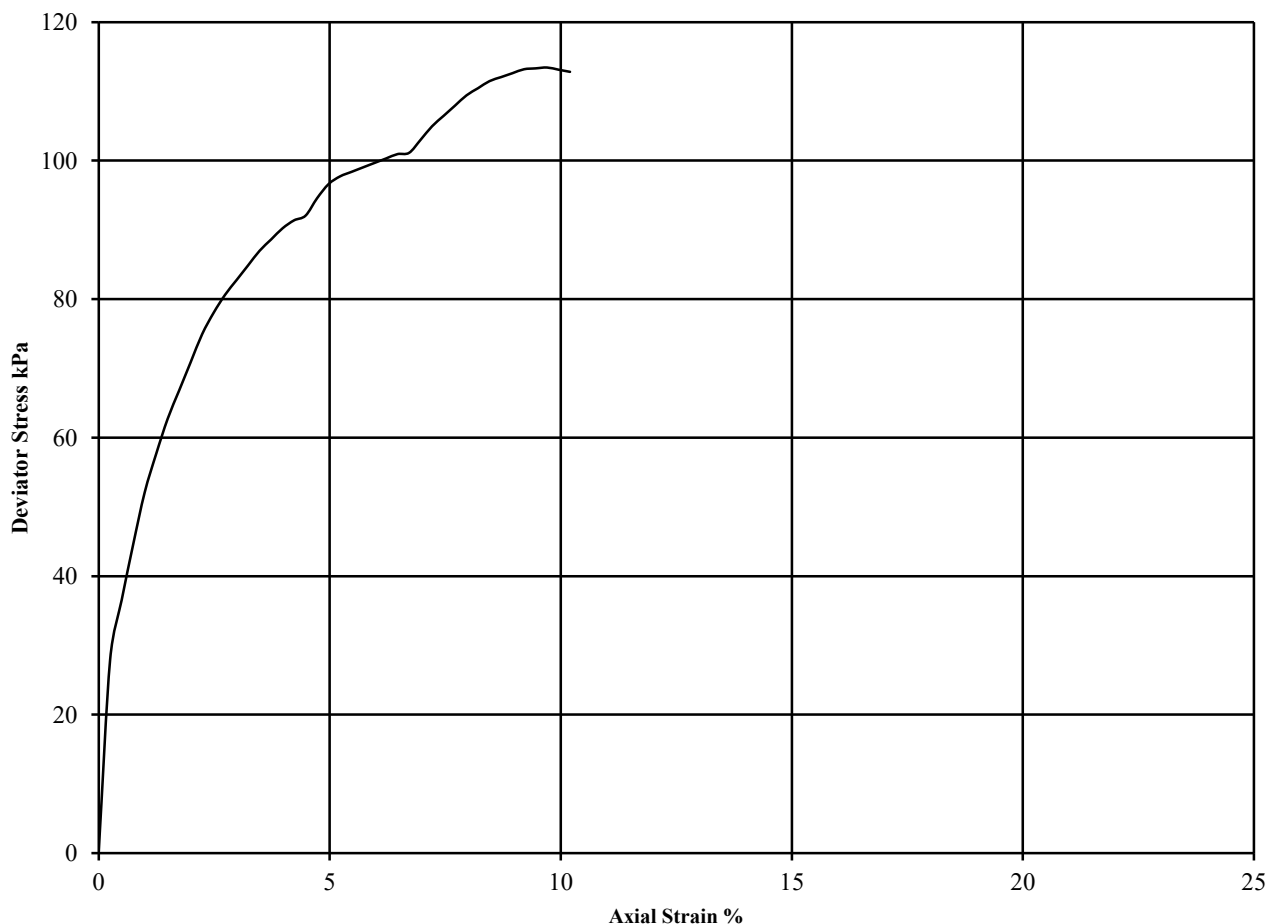
Diameter (mm):		103		Height (mm):		207	Test:	UU Multistage		Remarks
Specimen	Moisture Content (%)	Bulk Density (Mg/m <sup>3</sup> )	Dry Density (Mg/m <sup>3</sup> )	Cell Pressure (kPa)	Corr. Max. Deviator Stress (kPa)	Shear Strength Cu (kPa)	Failure Strain (%)	Mode of Failure	Undisturbed Sample Sample taken from top of tube Rate of strain = 2 %/min Latex Membrane used 0.2 mm thick Membrane Correction applied (kPa) 0.36      0.36      0.35 See summary of soil descriptions	
	1	33	1.86	1.40	25	92	46	4.5		
				50	101	51	6.7			
				100	113	57	9.7	Plastic

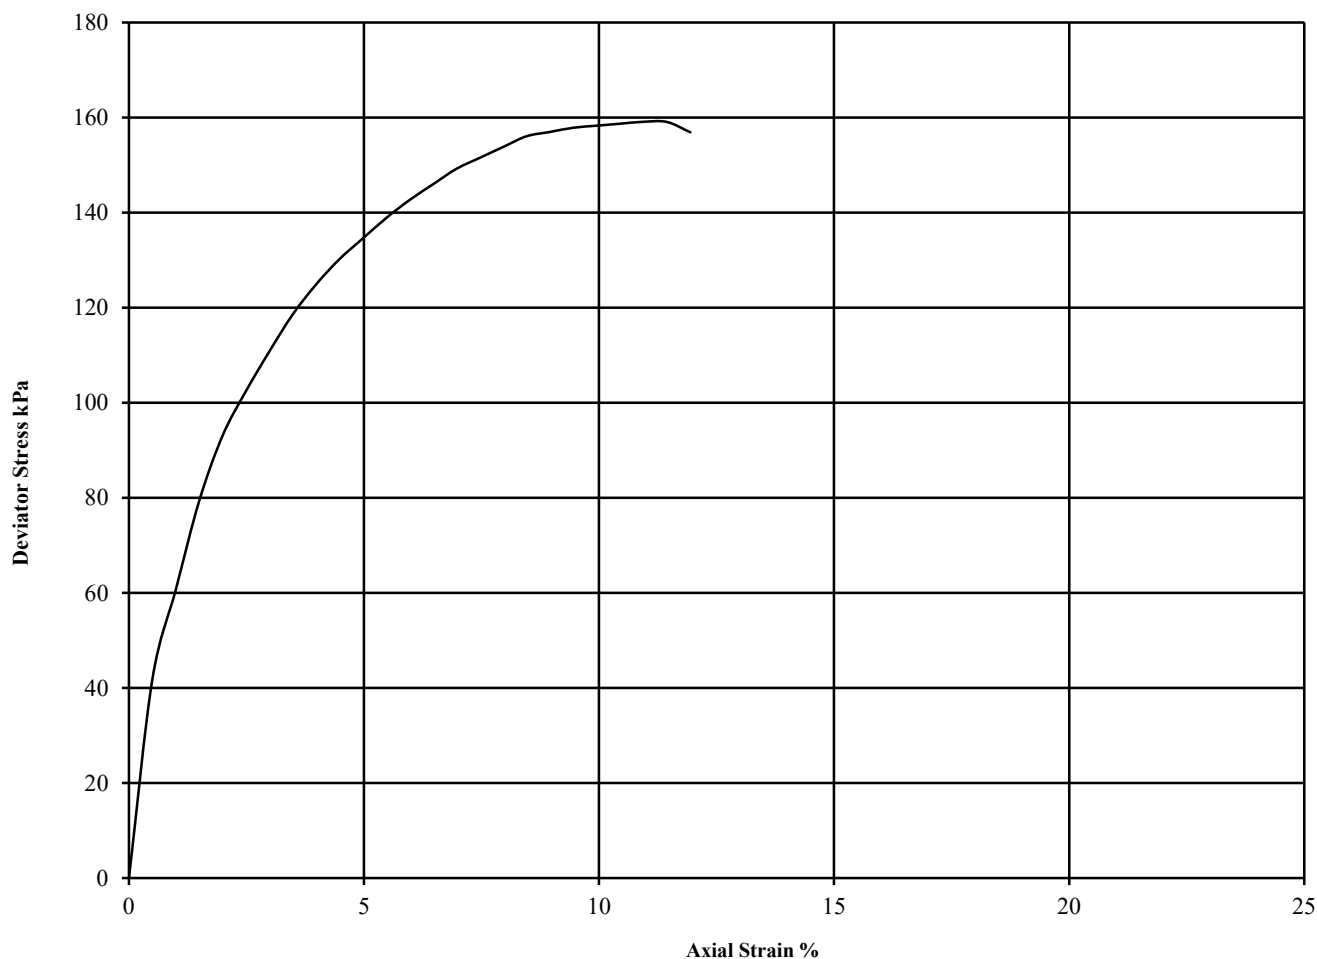
Diameter (mm):		103		Height (mm):		207		Test:	UU Single Stage		Remarks:
Specimen	Moisture Content (%)	Bulk Density (Mg/m <sup>3</sup> )	Dry Density (Mg/m <sup>3</sup> )	Cell Pressure (kPa)	Corr. Max. Deviator Stress (kPa)	Shear Strength Cu (kPa)	Failure Strain (%)	Mode of Failure	Undisturbed Sample Sample taken from top of tube Rate of strain = 2 %/min Latex Membrane used 0.2 mm thick, Correction applied 0.35 See summary of soil descriptions		
				$\theta_3$	$(\theta_1 - \theta_3)_f$	$1/2(\theta_1 - \theta_3)_f$					
1	31	1.91	1.46	50	159	80	10.9	Brittle

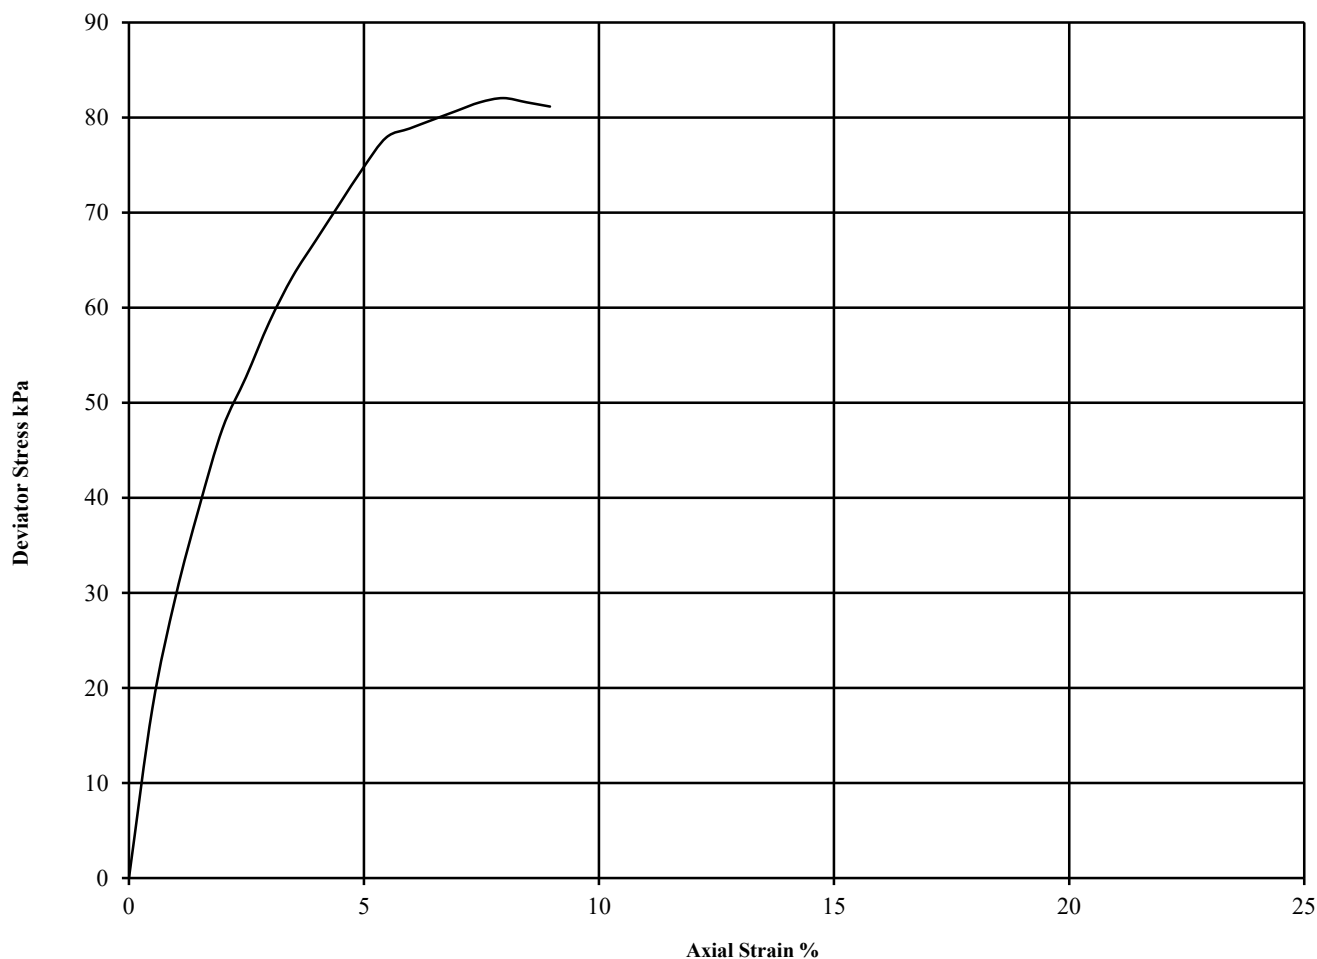
Diameter (mm):		103		Height (mm):		207		Test:	UU Single Stage		Remarks:
Specimen	Moisture Content (%)	Bulk Density (Mg/m <sup>3</sup> )	Dry Density (Mg/m <sup>3</sup> )	Cell Pressure (kPa)	Corr. Max. Deviator Stress (kPa)	Shear Strength Cu (kPa)	Failure Strain (%)	Mode of Failure	Undisturbed Sample Sample taken from top of tube Rate of strain = 2 %/min Latex Membrane used 0.2 mm thick, Correction applied 0.35 See summary of soil descriptions		
				$\theta_3$	$(\theta_1 - \theta_3)_f$	$\frac{1}{2}(\theta_1 - \theta_3)_f$					
1	35	1.81	1.34	100	82	41	8.0	Brittle

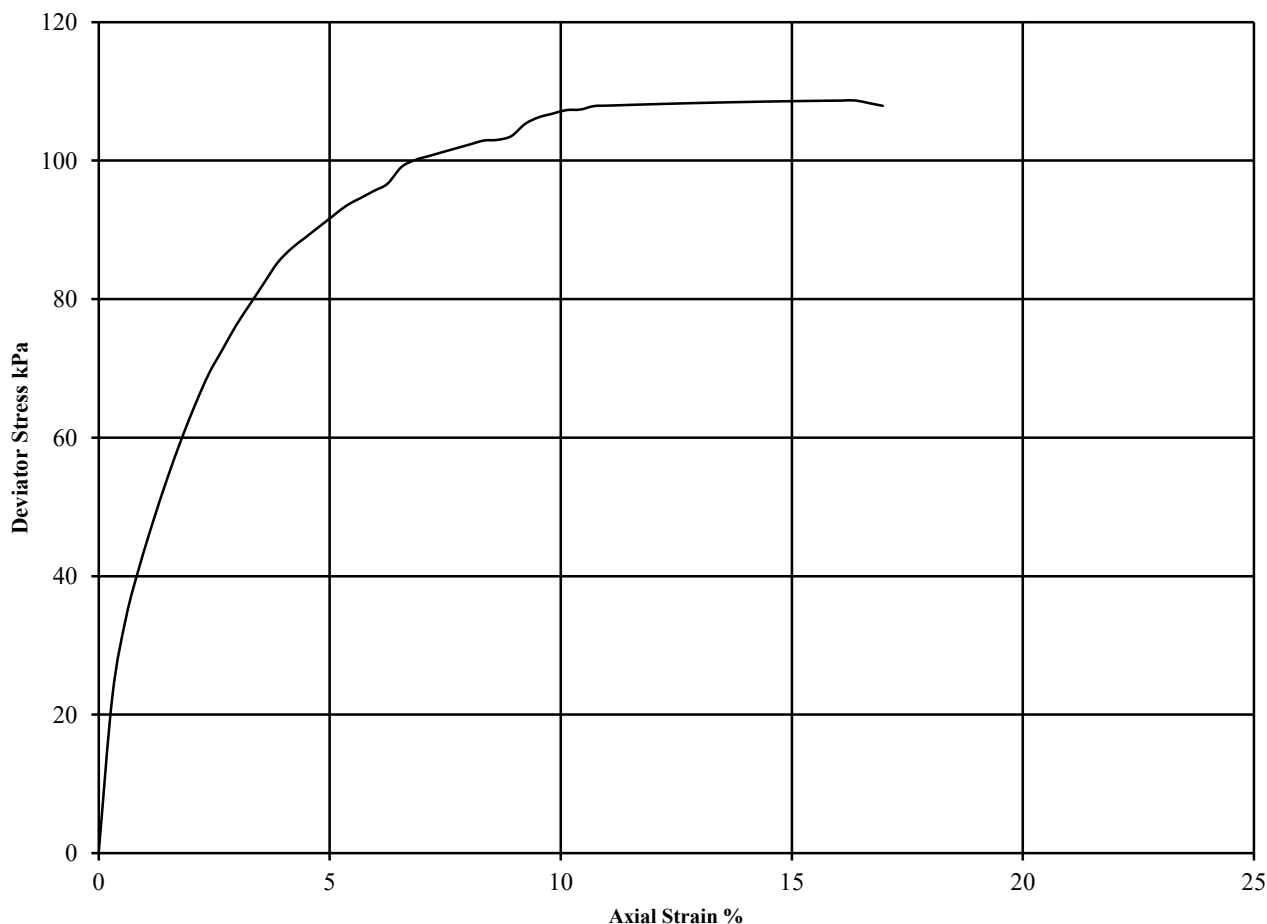
Diameter (mm):		103	Height (mm):		173	Test:	UU Multistage		Remarks
Specimen	Moisture Content (%)	Bulk Density (Mg/m3)	Dry Density (Mg/m3)	Cell Pressure (kPa)	Corr. Max. Deviator Stress (kPa)	Shear Strength Cu (kPa)	Failure Strain (%)	Mode of Failure	Undisturbed Sample Sample taken from top of tube Rate of strain = 2 %/min Latex Membrane used 0.2 mm thick Membrane Correction applied (kPa) 0.36      0.35      0.34 See summary of soil descriptions
	41	1.75	1.24	25	97	48	6.3		
				50	104	52	8.9		
				100	109	54	16.4	Plastic

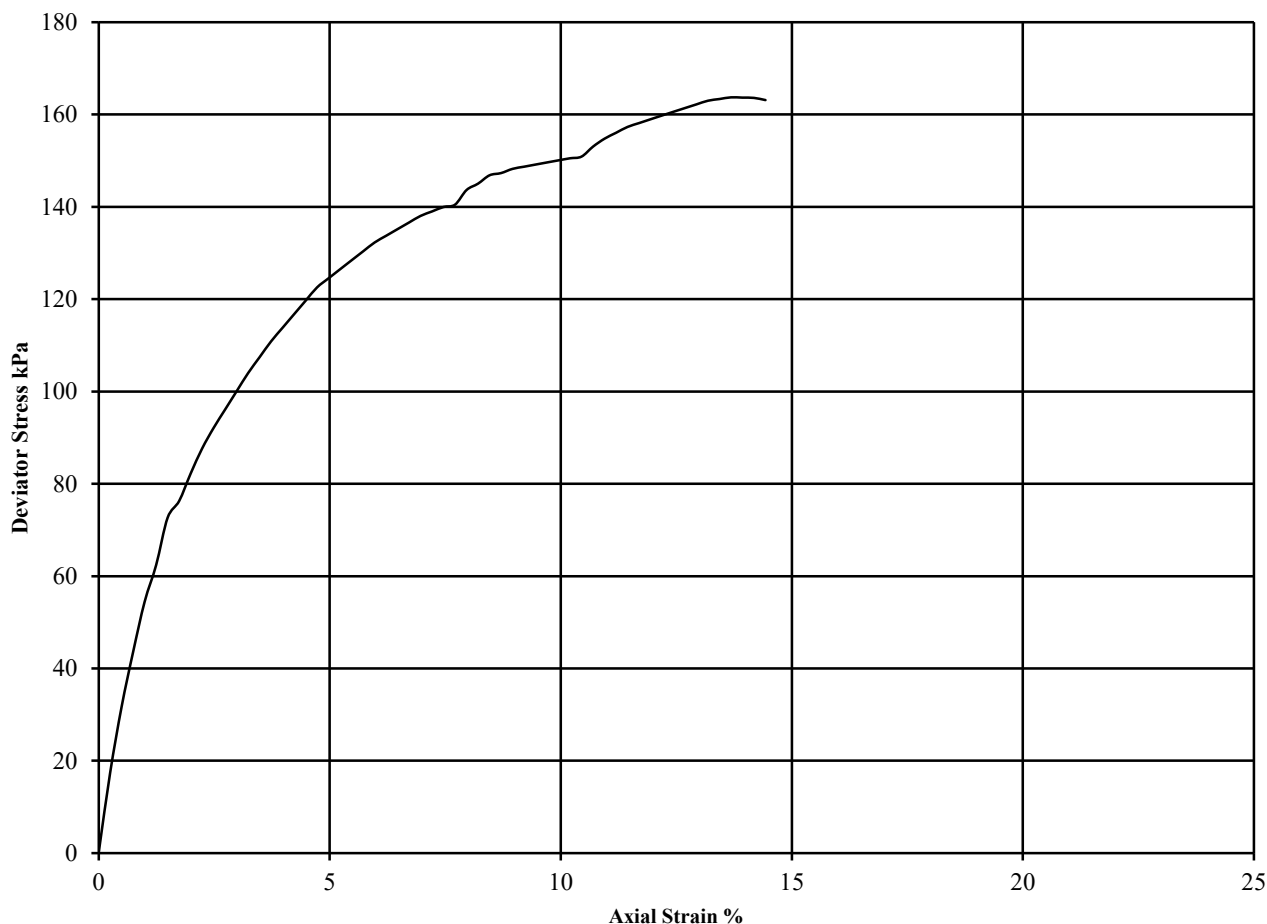
Diameter (mm):		103		Height (mm):		207	Test:	UU Multistage		Remarks
Specimen	Moisture Content (%)	Bulk Density (Mg/m3)	Dry Density (Mg/m3)	Cell Pressure (kPa)	Corr. Max. Deviator Stress (kPa)	Shear Strength Cu (kPa)	Failure Strain (%)	Mode of Failure	Undisturbed Sample Sample taken from top of tube Rate of strain = 2 %/min Latex Membrane used 0.2 mm thick Membrane Correction applied (kPa) 0.35      0.35      0.34 See summary of soil descriptions	
	31	1.88	1.43	50	140	70	7.7			
				100	151	75	10.2			
				200	164	82	13.7	Brittle
