Growing Beds Recycling Services Limited

Site Condition Report

Date: July 2022

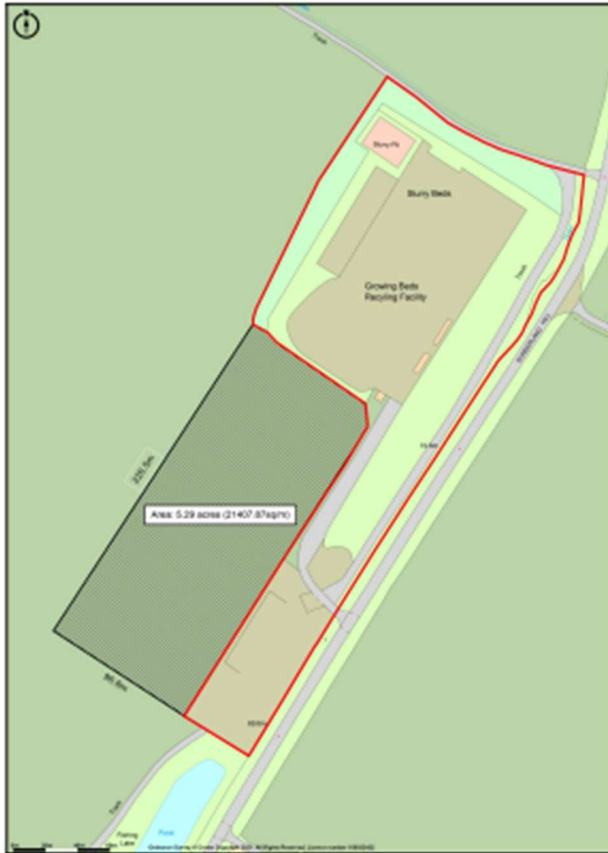
Figure 2.1 Site Layout Plan

An installation layout drawing is shown below in Figure 2.1.

The 49,000 tonnes per annum throughput will be split across the composting and wood shredding activity. There is no proposed maximum on each process other than the total throughput of the site to allow for operational flexibility and seasonality of each activity. The currently permitted area is shown in Figure 2.1 below.

4.0 Changes to the activity	
Have there been any changes to the activity boundary?	Yes- increase to boundary see Figure 2.1. This will allow the addition of 2 additional shredded wood bays and bays for the storage of top soil, sand and stones, mixing bay and PAS100 compost.
Have there been any changes to the permitted activities?	<p>Yes- The site has operated a wood shredding activity since 2005 to provide shredded wood to a local waste wood biomass incineration plant. The EA in their pre-application advice state:</p> <p>“the operator has been undertaking a shredding activity for several years and the permit has not been subject to any variation applications to incorporate this into the permit. Therefore, the waste wood shredding operation has not been subject to formal assessments of its operating techniques, risk assessments and required management plans. However, I acknowledge that there has been discussions with the local regulatory officers regarding the fire prevention plan”.</p> <p>This has been known and allowed at local site level pending a permit application to include the waste shredding activity within the permit.</p> <p>This application and SCR is to include the addition of the non-hazardous wood shredding activity.</p>
