The fire resistance performance of a specimen of a non-loadbearing, wall assembly tested in accordance with BS 476: Part 22: 1987, Clause 5

397322

Poundfield Products Limited

23rd August 2018

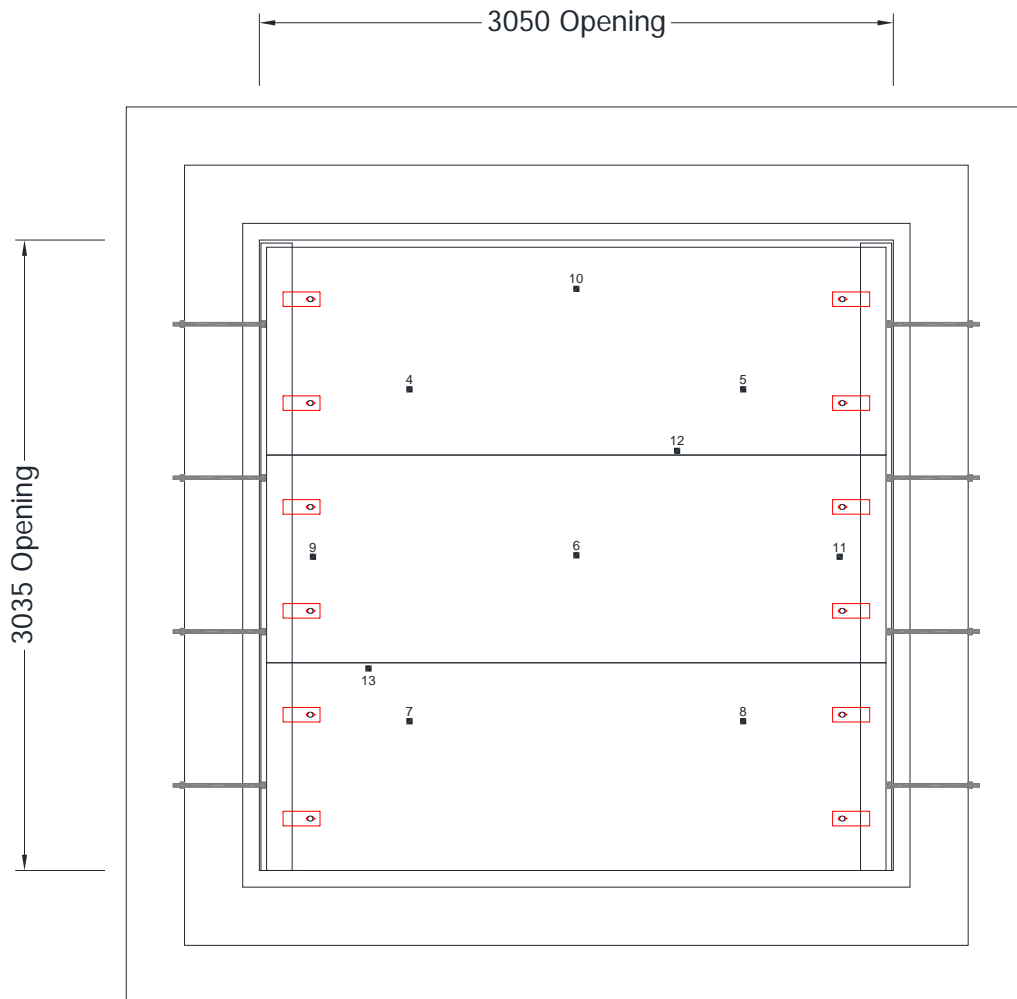
Figure 1- General Elevation of the Unexposed Face of the Test Construction

GENERAL ELEVATION SHOWING
THERMOCOUPLE LOCATIONS
AT UNEXPOSED FACE

General	The instrumentation was provided in accordance with the requirements of the Standard.
Furnace	The furnace was controlled so that its mean temperature complied with the requirements of BS 476: Part 20: 1987, Clause 3.1. Using nine mineral insulated thermocouples distributed over a plane 100 mm from the surface of the test construction.
Thermocouple Allocation	Thermocouples were provided to monitor the unexposed surface of the specimen and the output of all instrumentation was recorded at no less than one minute intervals as follows:
Thermocouples 4 to 8	At five positions, one approximately at the centre and one at approximately the centre of each quarter section of the assembly.
Thermocouple 9	At one position at approximately mid-width, near to the head of the assembly.
Thermocouples 10 and 11	At two positions adjacent to the horizontal joints, at approximately three-quarters the height of the specimen. The locations and reference numbers of the various unexposed surface thermocouples are shown in Figure 1.

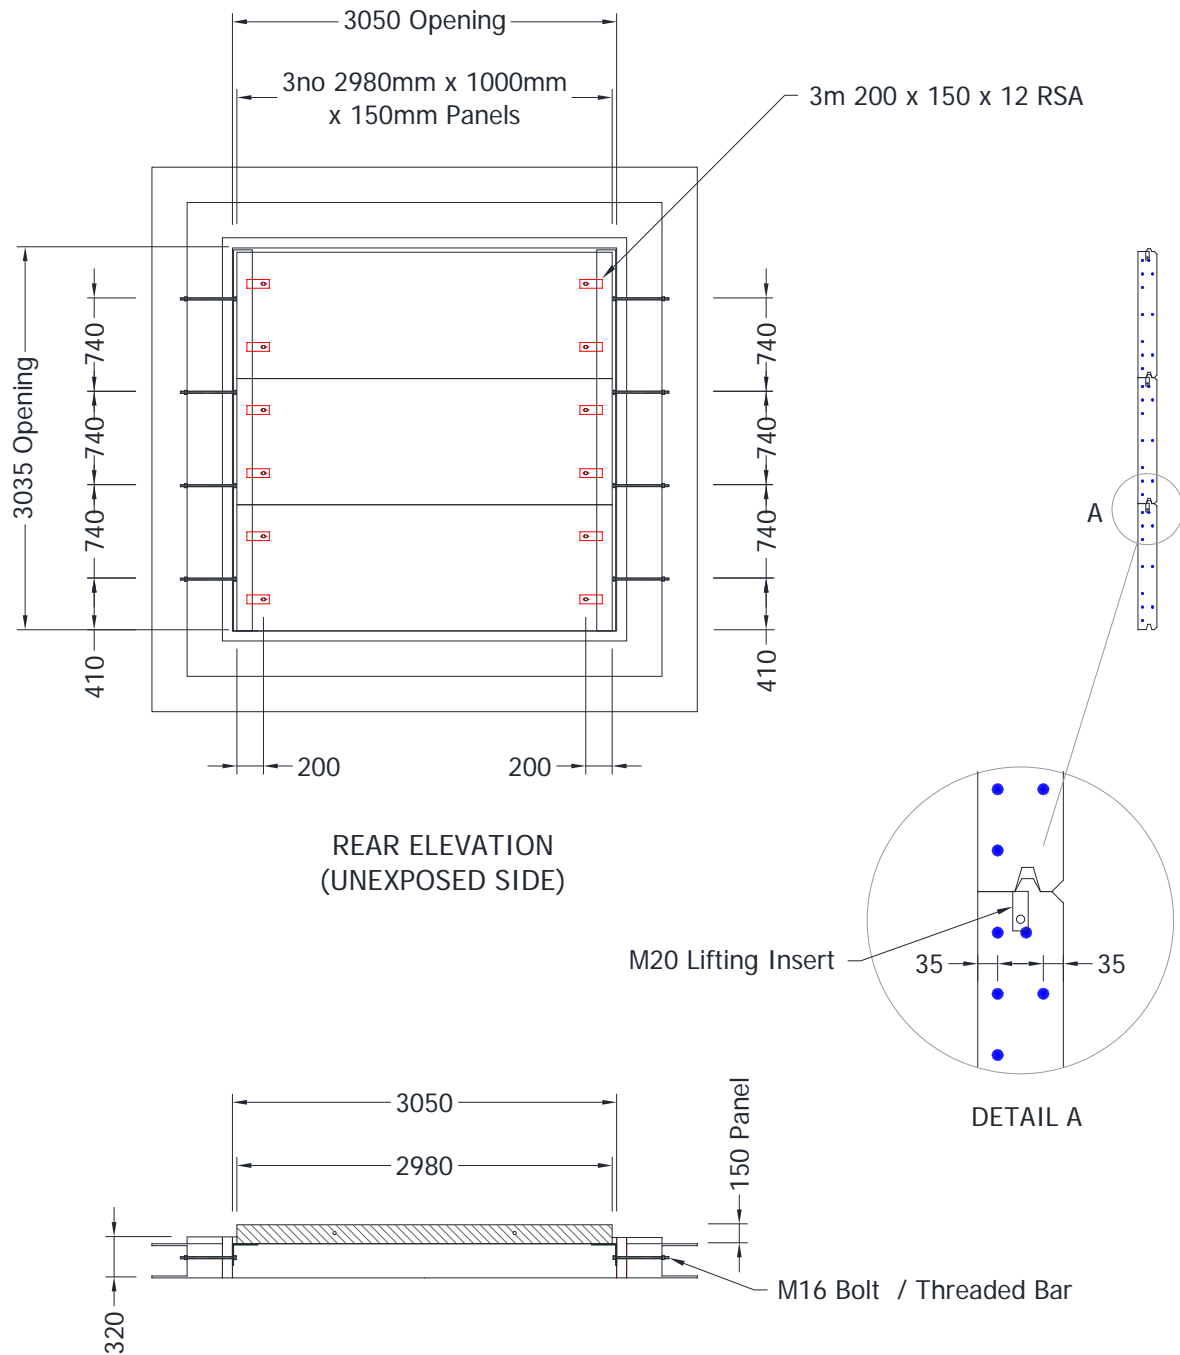
Figure 2 – General Elevation and Sections Showing Specimen Detail

Summary of Tested Specimen The test assembly had overall nominal dimensions of 3035 mm high by 3000 mm wide by 100 mm thickness and comprised three horizontally joined concrete panels. The edges of the panels were profiled such that they interlocked.

The specimen was fixed to the furnace restraint frame along the top and bottom and one vertical edge.

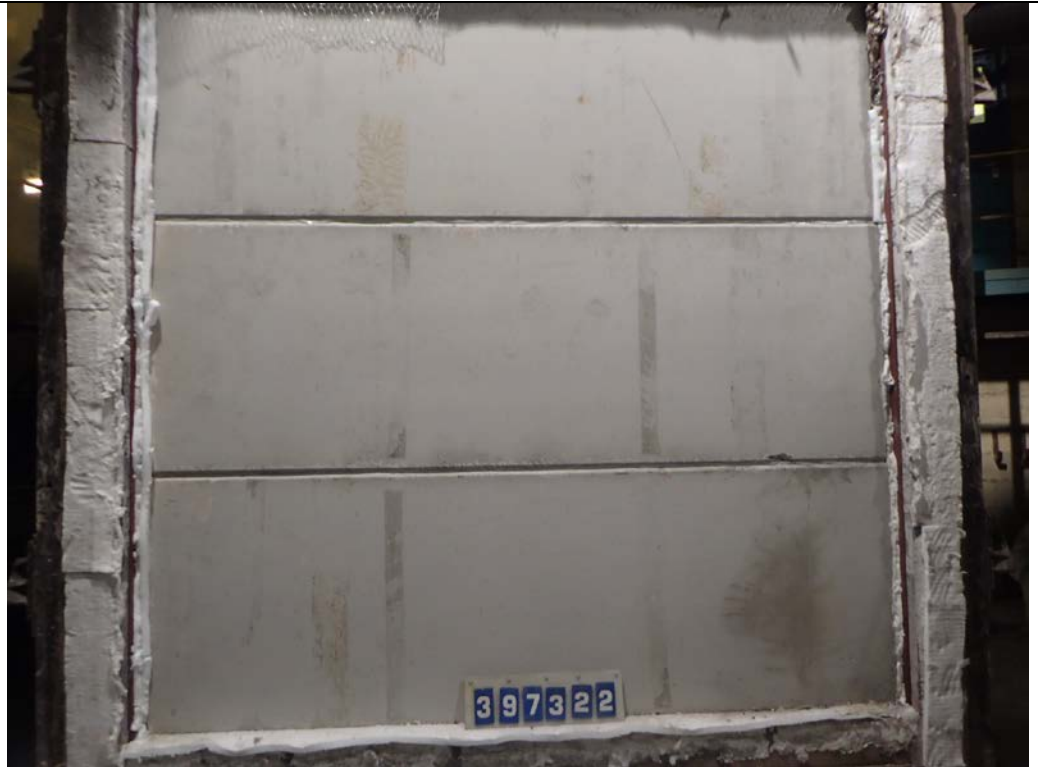
The exposed face of the test specimen prior to testing

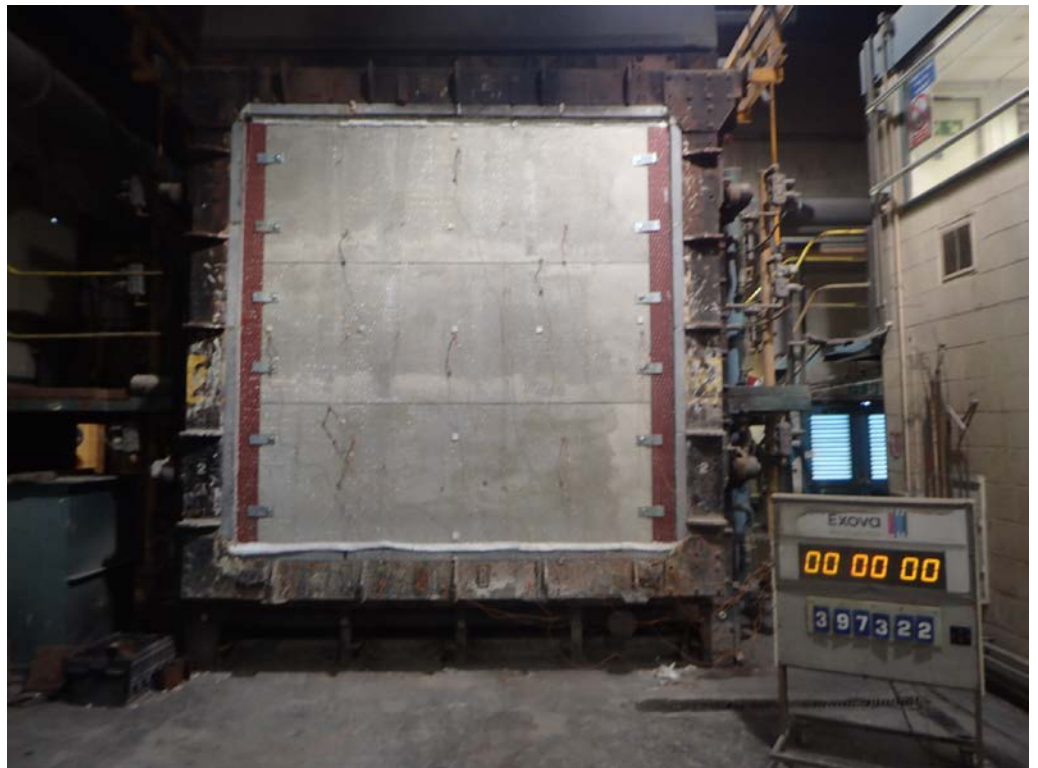
The unexposed face of the test specimen prior to testing

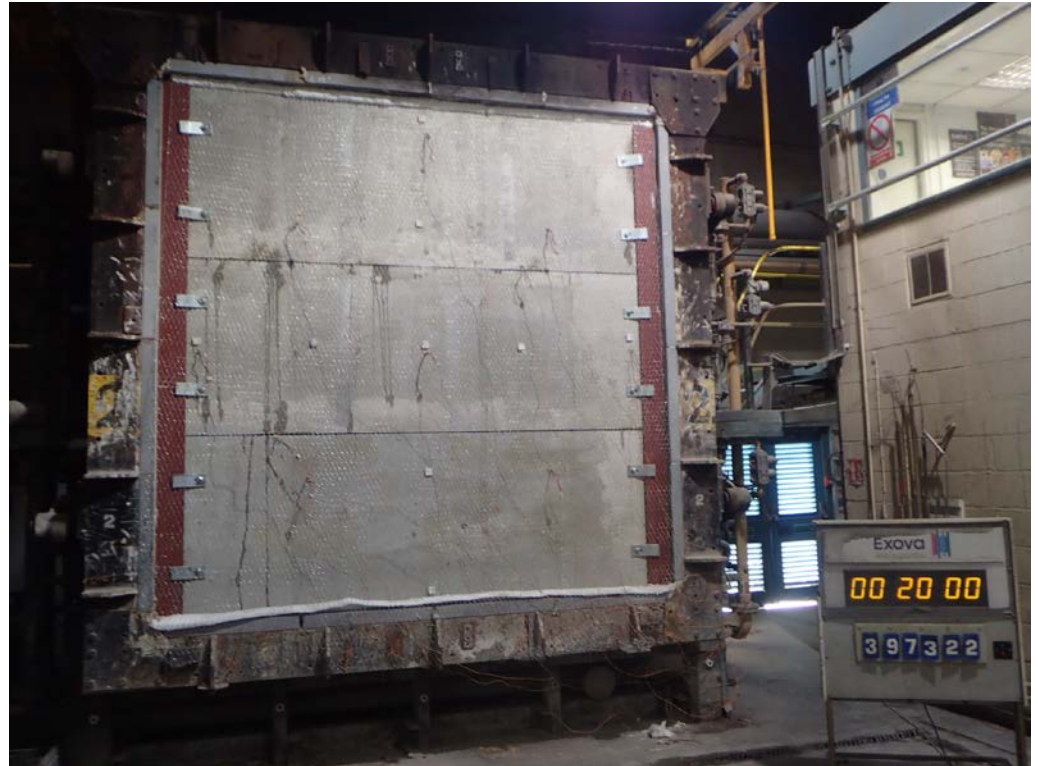
The unexposed face of the test specimen after 20 minutes of testing

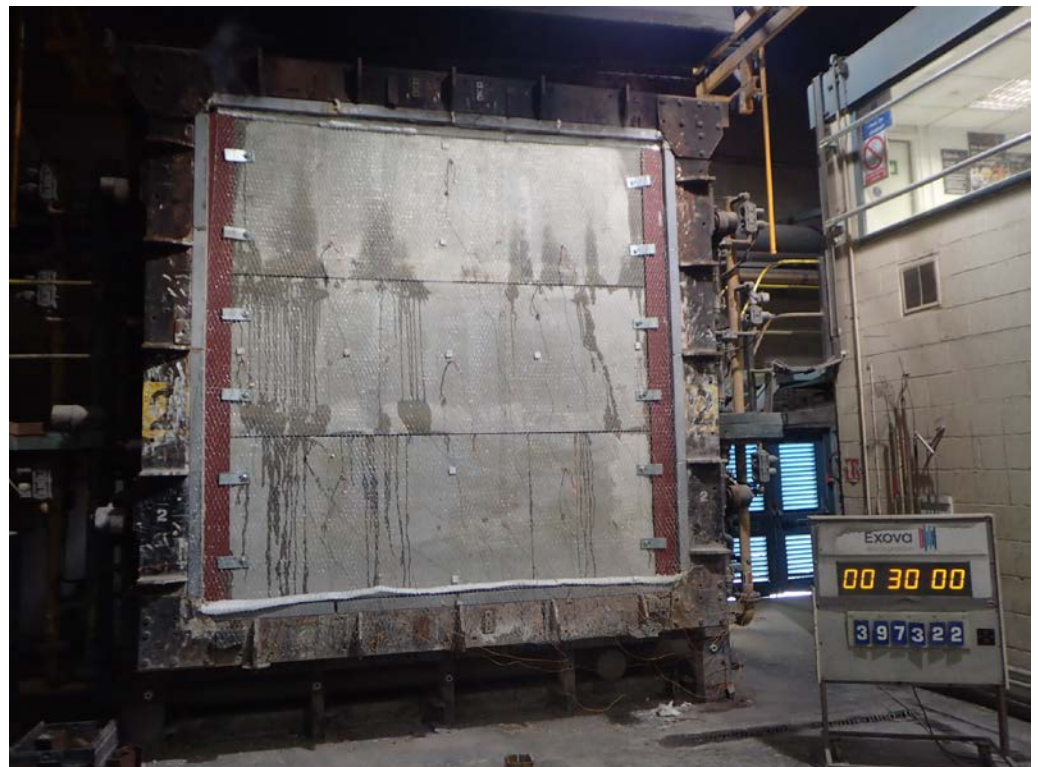
The unexposed face of the test specimen after 30 minutes of testing

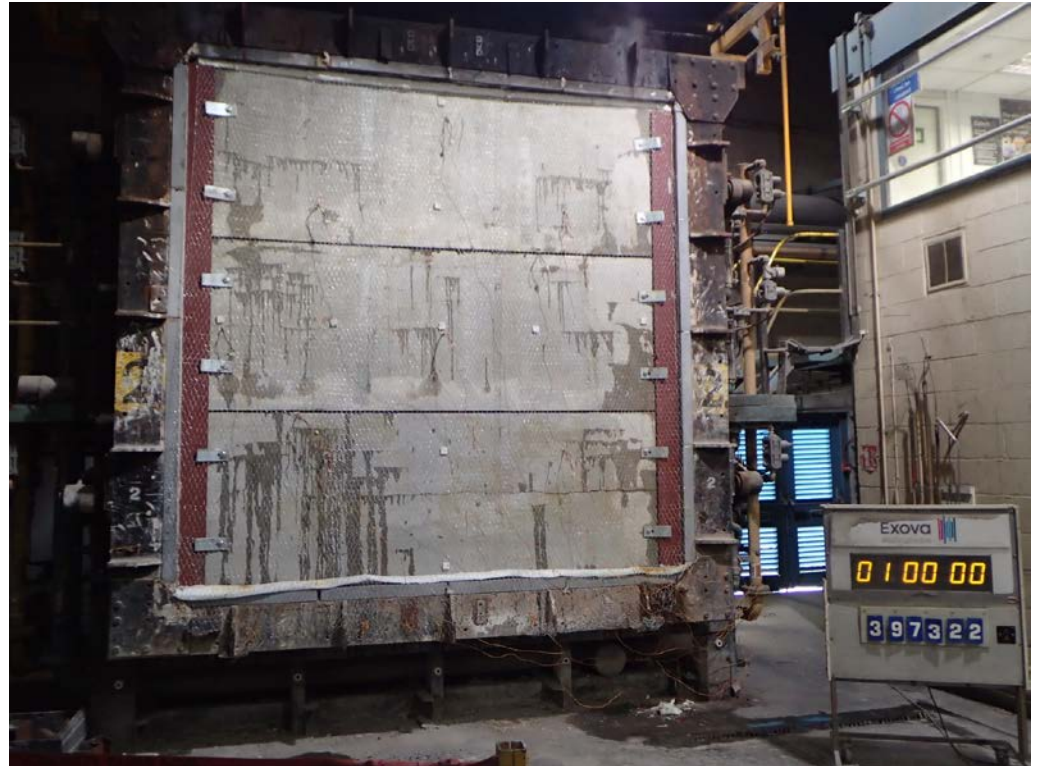
The unexposed face of the test specimen after 60 minutes of testing

60	00	The specimen continues to satisfy the integrity and insulation criteria.
90	00	The specimen continues to satisfy the integrity and insulation criteria.
92	00	A large horizontal fissure is evident at the right side of the lower panel. A smaller crack appears at each side of each panel.
120	00	The specimen continues to satisfy the integrity and insulation criteria.
132	00	Test discontinued.

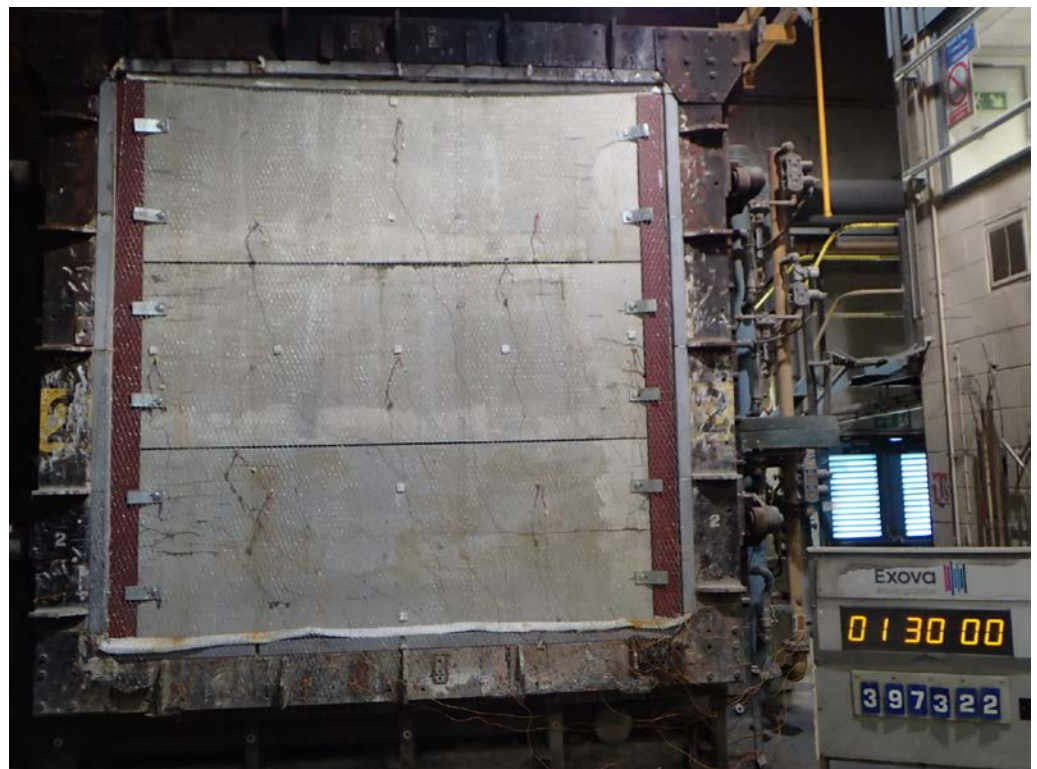
The unexposed face of the test specimen after 90 minutes of testing

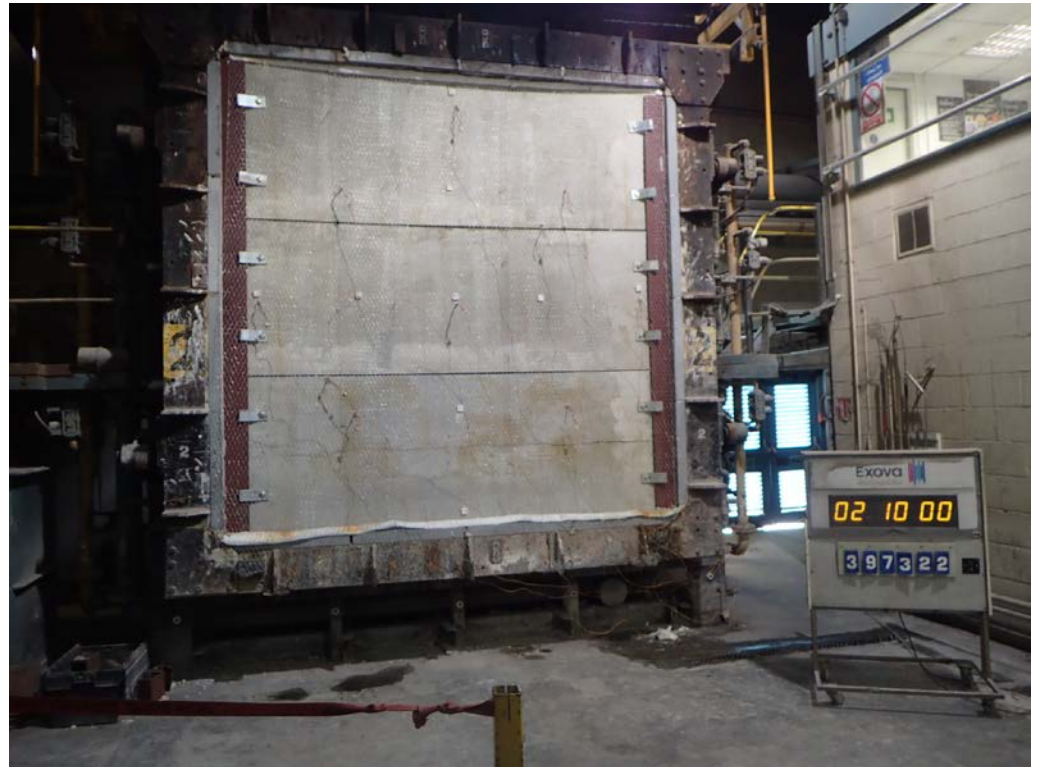
The unexposed face of the test specimen after 130 minutes of testing

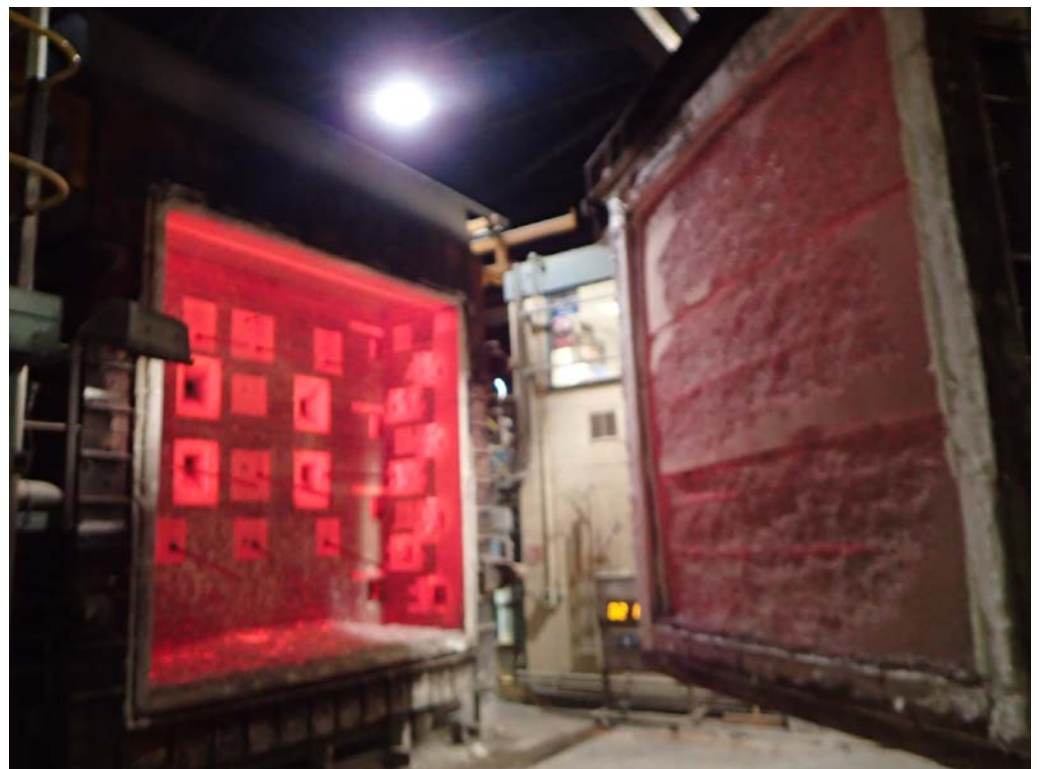
The exposed face of the test specimen immediately after the test

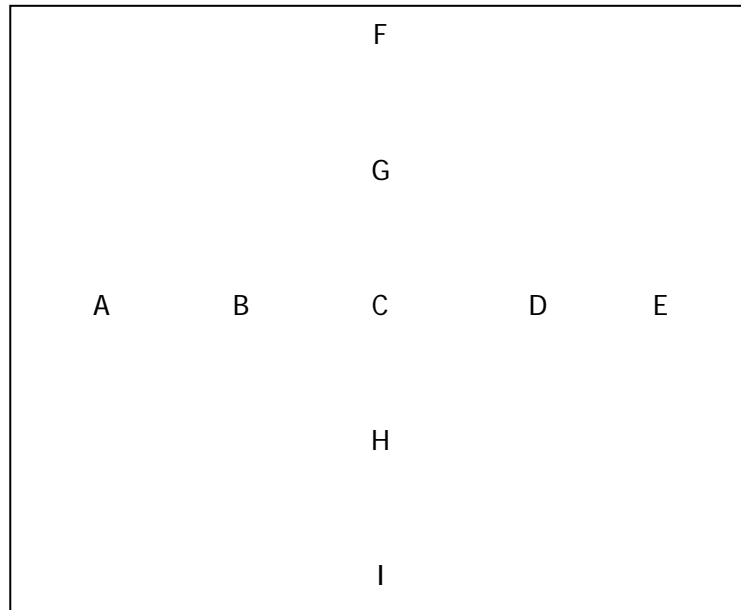
Deflection Of The Specimen During The Test

Deflections - mm									
TIME mins	A	B	C	D	E	F	G	H	I
0	0	0	0	0	0	0	0	0	0
10	7	16	17	16	5	16	17	11	9
20	11	24	26	25	8	26	29	24	15
30	21	40	44	41	20	35	39	31	20
40	28	50	57	53	24	38	48	37	25
50	34	59	67	59	29	41	57	49	31
60	34	65	69	62	34	42	63	53	31
70	90	72	82	71	35	50	70	56	34
80	42	75	85	74	39	53	75	*	35
90	43	75	87	78	39	53	80		38
100	41	80	91	82	42	53	88		39
110	39	79	114	82	40	58	88		36
120	48	89	113	89	42	56	89		37
130	62	90	105	92	43	60	94		40

All deflections are in mm
 Positive readings indicate movement towards the furnace
 *Reading malfunction

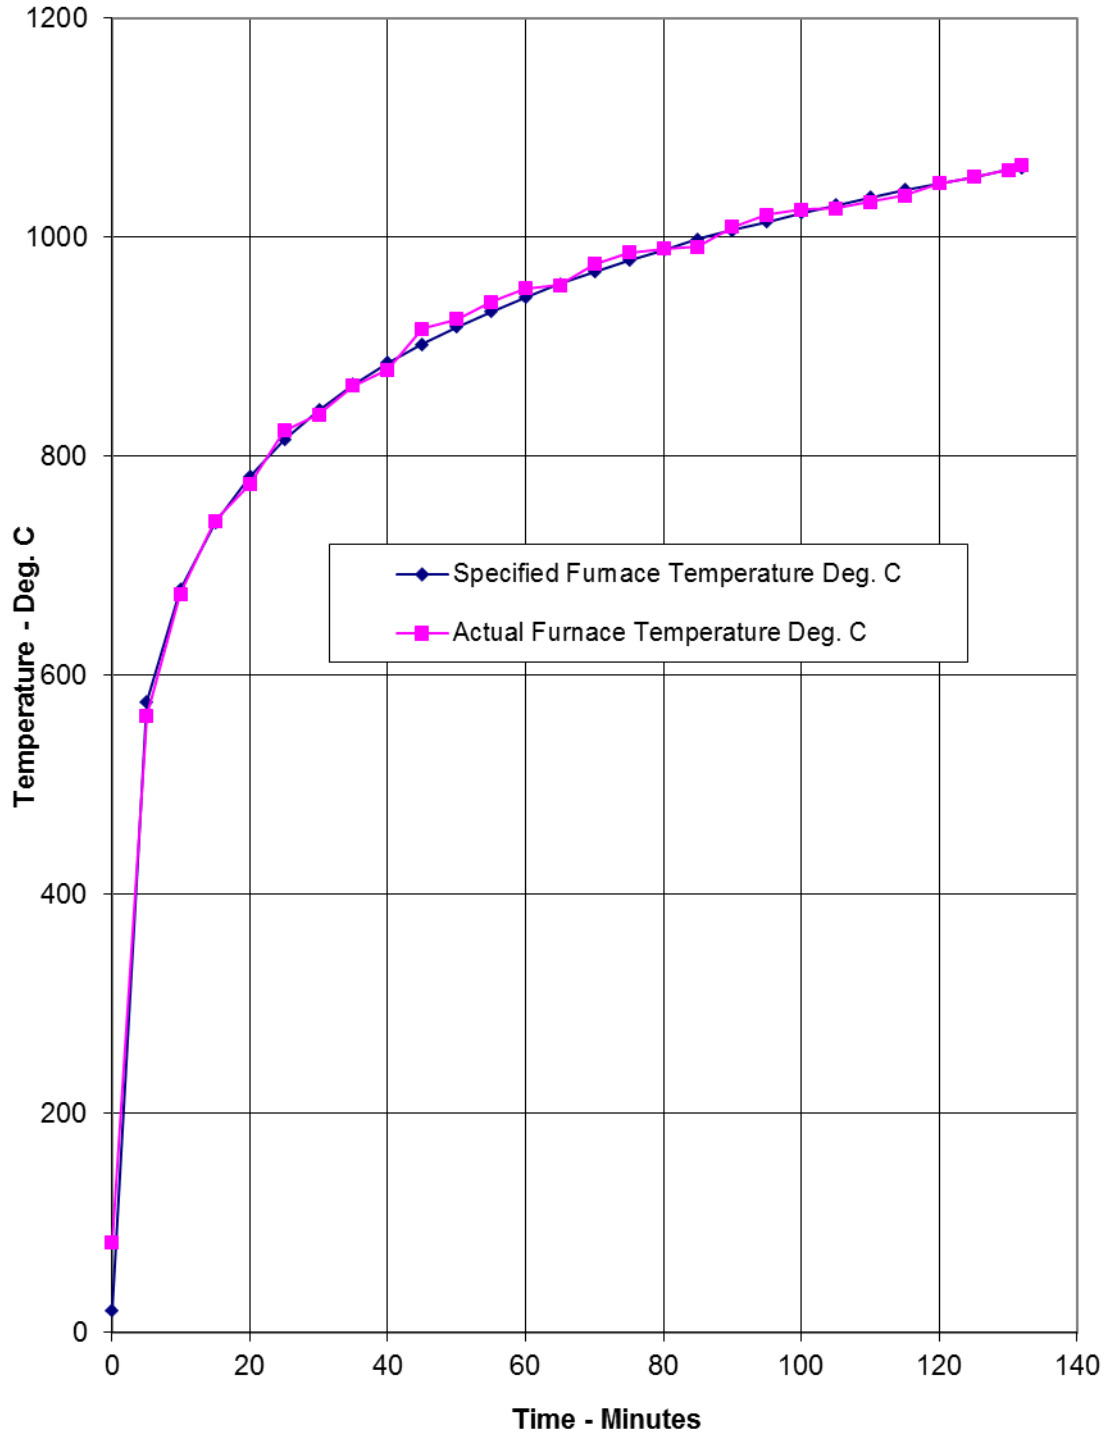
Graph showing mean furnace temperature, together with the temperature/time relationship specified in the Standard

Time Mins	Specified Furnace Temperature Deg. C	Actual Furnace Temperature Deg. C
0	20	82
5	576	563
10	678	674
15	739	741
20	781	774
25	815	823
30	842	838
35	865	864
40	885	879
45	902	916
50	918	925
55	932	941
60	945	953
65	957	956
70	968	975
75	979	986
80	988	989
85	998	991
90	1006	1009
95	1014	1020
100	1022	1025
105	1029	1026
110	1036	1032
115	1043	1038
120	1049	1049
125	1055	1055
130	1061	1061
132	1063	1066

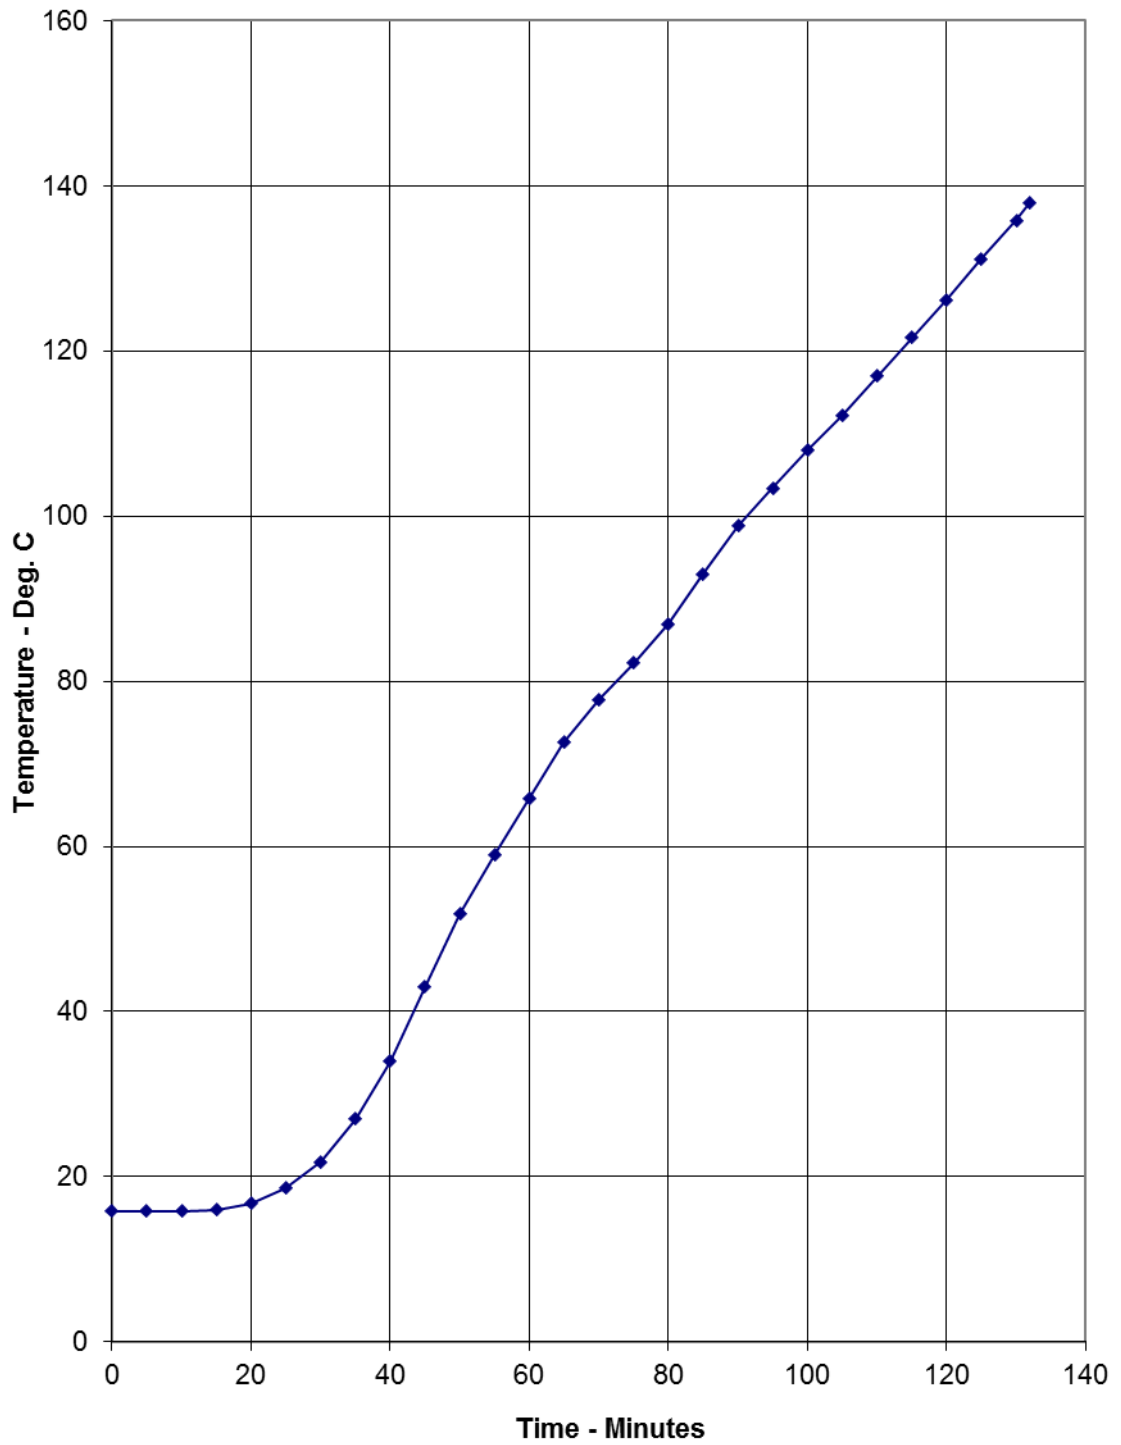
Graph showing mean temperatures recorded on the unexposed surface

Time Mins	T/C Number 4 Deg. C	T/C Number 5 Deg. C	T/C Number 6 Deg. C	T/C Number 7 Deg. C	T/C Number 8 Deg. C	Mean Temp Deg. C
0	16	16	16	16	15	16
5	16	16	16	16	15	16
10	16	16	16	16	15	16
15	16	16	16	16	16	16
20	17	17	17	17	16	17
25	19	20	18	18	18	19
30	23	24	21	20	21	22
35	30	29	26	24	26	27
40	38	35	33	29	35	34
45	46	42	42	36	49	43
50	54	49	51	44	61	52
55	61	53	58	52	71	59
60	68	56	65	61	79	66
65	74	59	73	71	86	73
70	80	61	79	77	92	78
75	85	64	85	80	97	82
80	89	71	90	87	98	87
85	93	80	95	95	102	93
90	96	88	99	100	111	99
95	98	93	102	104	120	103
100	100	97	106	109	128	108
105	103	100	110	114	134	112
110	107	104	114	119	141	117
115	111	107	119	124	147	122
120	114	111	123	129	154	126
125	118	115	128	134	161	131
130	122	119	132	138	168	136
132	123	121	134	140	172	138

Insulation It is required that the mean temperature rise of the unexposed surface shall not be greater than 140°C and that the maximum temperature rise shall not be greater than 180°C. Insulation failure also occurs simultaneously with integrity failure. These requirements were satisfied for a period of 132 minutes.
