# Westwood Bund Ground Investigation

## Ground Investigation Report

### Biogen UK Ltd

SLR Project No.: 403.065590.00001

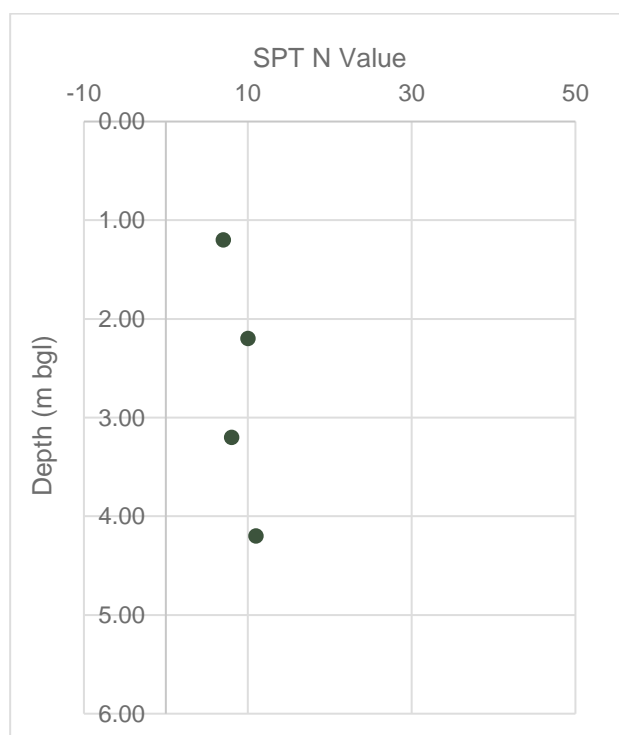
**Figure 3-1 SPT N-Value with Depth.**

A total of 4No. in situ SPT's were undertaken in BH01 at 1.0m centres to a maximum depth of 4.20m bgl to obtain information on the relative density of strata encountered. Results are included on the borehole logs in Appendix B, summarised in Table 3-3 and presented graphically in Figure 3-1.

All 4No. SPT tests were conducted within the Oadby Member which were consistent with depth. A correlation between undrained strength in clay and SPT N-value is proposed by Stroud<sup>6</sup> (1989) which indicates the glacial till, as a low to medium strength material with undrained shear strengths of between 35kPa and 55kPa. However, the relationship is not considered to be as reliable as laboratory testing and alternative in-situ test methods.

Strata	N Value (Min)	N Value (Max)	N Value (Average)	Tests
Oadby Member	7	11	9	4

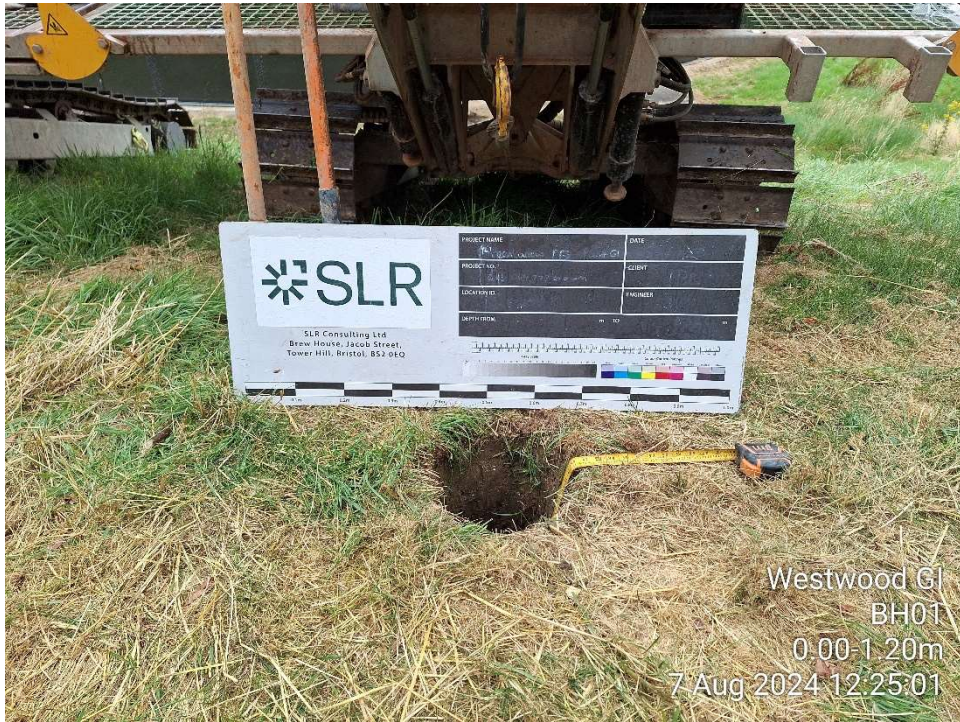
**Photo 1: BH01 0.00-1.20m**

Topsoil was identified in both exploratory locations, recorded to a maximum depth of 0.15m bgl (at both BH01 and BH02). Topsoil was consistent across the Site comprising dark brown silty slightly sandy clay with frequent rootlets and occasional fine to medium rounded gravel.

Reworked clay was identified in BH01 from 0.15- 1.20m. Reworked clay was recorded to comprise firm light brown locally grey mottled slightly gravelly clay. Gravel was subangular to rounded fine to medium of quartz and chalk with rare brick fragments. This was differentiated from the Oadby Member by the identification of the rare brick fragments.

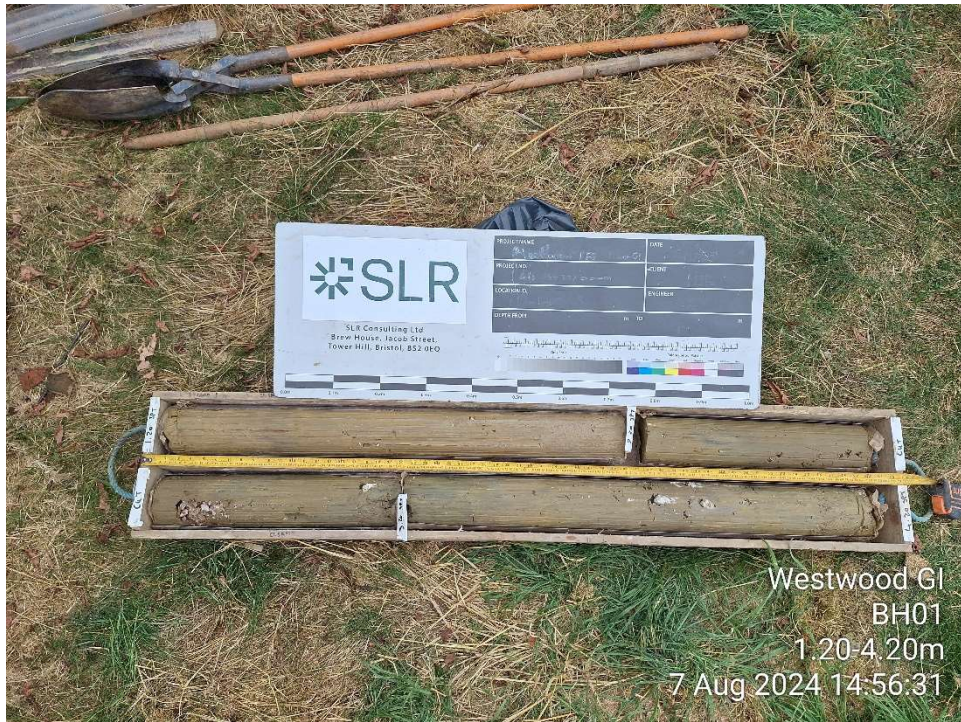
**Photo 3: BH01 1.20-4.20m**

The Oadby Member was identified from 1.10m to 1.20m in BH02 and BH01 respectively. The Oadby Member was consistent across the Site comprising soft to firm yellowish brown locally mottled grey slightly gravelly clay. Gravel was subangular to angular fine to medium of quartz and chalk. Stiffness was observed to generally increase with depth becoming stiff in BH02 from 4.90m bgl.

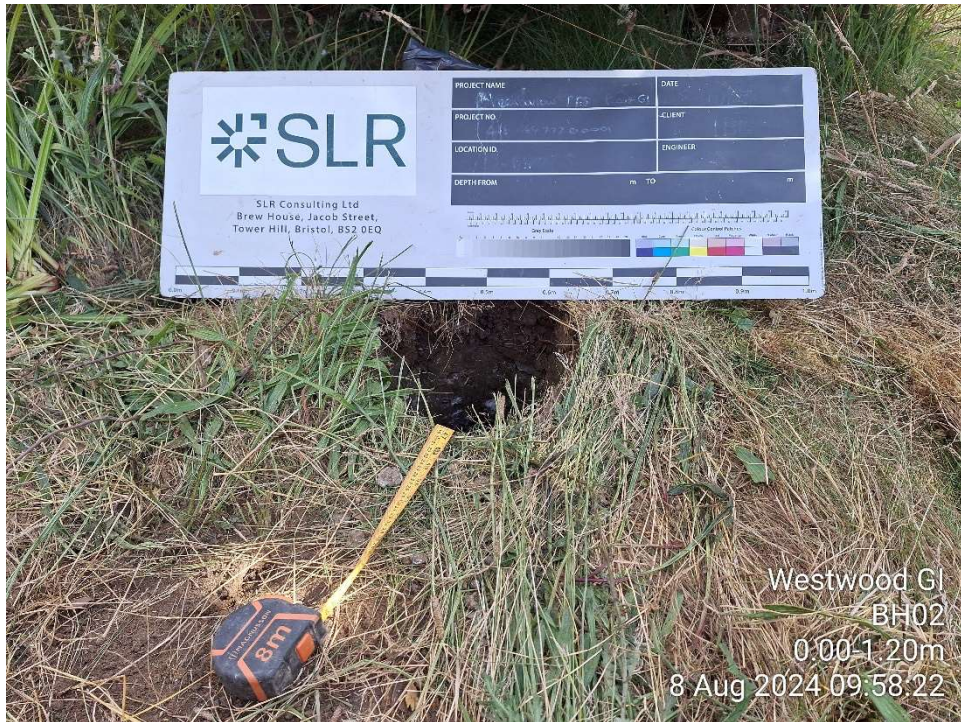
**Photo 5: BH02 0.00-1.20m**

Made Ground was identified in BH02, recorded to a depth of 1.10m bgl comprising brownish grey clayey silty fine to medium gravel of subangular to rounded quartz and chalk.

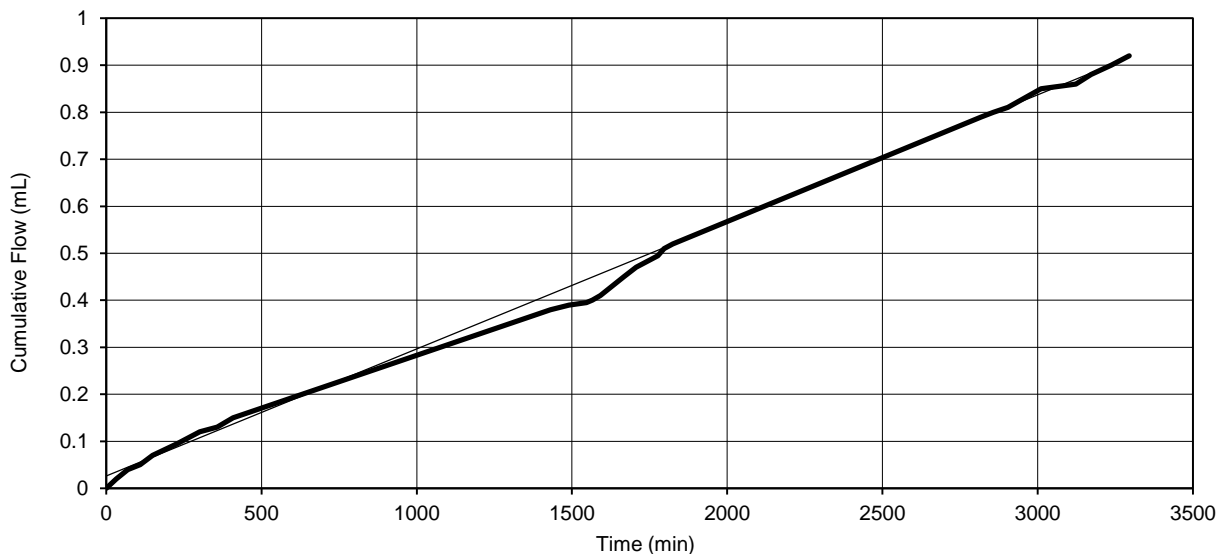
Location BH01  
 Sample Depth 5.20-5.65 m  
 Sample Type U

Stiff brown and yellowish brown mottled light grey gravelly CLAY. Gravel is fine to medium.

INITIAL	FINAL
Diameter	mm	103.40	102.93
Height	mm	99.57	99.12
Water Content	%	17.4	18.0
Bulk Density	Mg/m <sup>3</sup>	2.14	2.18
Dry Density	Mg/m <sup>3</sup>	1.82	1.84
Average Laboratory Temperature	°C	20	
Source of Permeant Water		De-aired tap water

Pressure difference across specimen kPa 10  
 Hydraulic gradient 10.3  
 Mean effective stress kPa 104  
 Correction for head loss kPa 0

$$k_v \text{ at } 20 \text{ }^\circ\text{C} = 5.3 \times 10^{-11} \text{ m/s}$$

Upon receipt of the laboratory certificates, it was confirmed that the two UT100 samples recovered from the secondary containment bund at BH01 and BH02 exhibited Coefficients of Permeability values of  $5.3 \times 10^{-11}$  m/s and  $1.2 \times 10^{-10}$  m/s, respectively.

These Coefficient of Permeability values are significantly lower than the required threshold of  $1 \times 10^{-9}$  m/s, demonstrating that the material complies with the permeability requirements outlined in C736<sup>1</sup>.

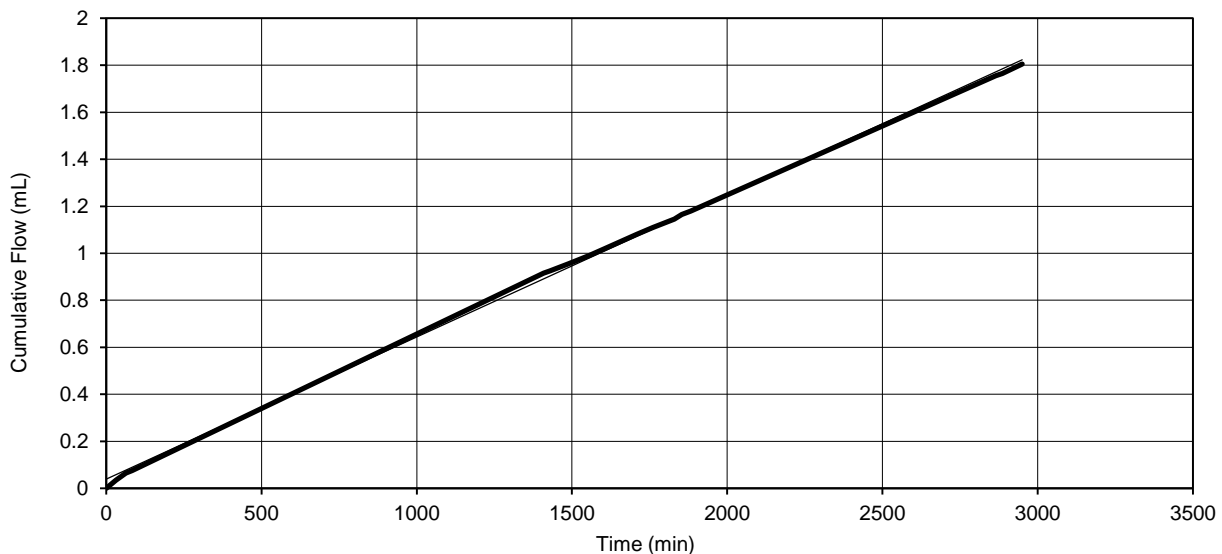
Location BH02  
 Sample Depth 2.20-2.65 m  
 Sample Type U

Stiff yellowish brown mottled light grey slightly gravelly CLAY. Gravel is fine.

INITIAL	FINAL
Diameter	mm	103.35	103.22
Height	mm	99.76	99.63
Water Content	%	19.3	20.1
Bulk Density	Mg/m <sup>3</sup>	2.13	2.15
Dry Density	Mg/m <sup>3</sup>	1.78	1.79
Average Laboratory Temperature	°C	20	
Source of Permeant Water		De-aired tap water

Pressure difference across specimen kPa 10  
 Hydraulic gradient 10.2  
 Mean effective stress kPa 44  
 Correction for head loss kPa 0

$$k_v \text{ at } 20^\circ\text{C} = 1.2 \times 10^{-10} \text{ m/s}$$
