Westwood AD

CIRIA C736 Containment assessment

Biogen

25 September 2024

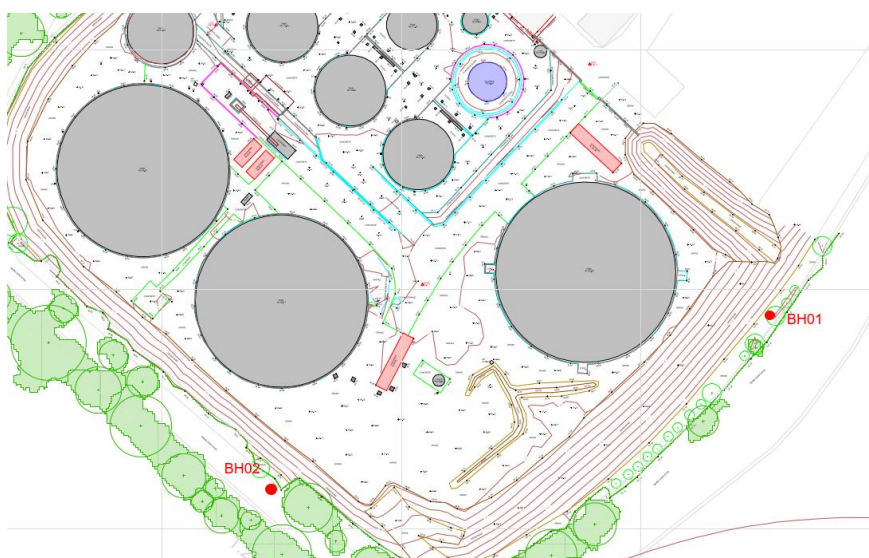
Figure 3 Borehole locations

SLR completed an intrusive site investigation on the 7th and 8th August 2024. This comprised advancing 2Nr boreholes through the existing earth bund and into underlying subsoils and recovering samples for laboratory testing. Borehole locations are shown in Figure 3 below;

The boreholes identified that the containment bunds are formed from Clay identified predominantly as the Oadby member – Diamicton. Samples were extracted from this material for laboratory permeability testing, which gave results for Coefficients of Permeability of 5.3×10^{-11} m/s and 1.2×10^{-10} m/s. These Permeability values are

significantly lower than the required threshold of 1×10^{-9} m/s contained within C736 and other similar guidance.

Unlined earth bunds are an allowable design for class 1 sites, with C736 specifying a minimum thickness of 1m of Clay with an impermeability lower than 1×10^{-9} m/s. The bund at Westwood exceeds these minimum criteria, with a greater thickness of material with significantly lower permeability.
