# Rectory Farm Landfill (EPR/BT98791Y)

## Surrender Report

*For Mick George Ltd*

Doc ref    23880-HYD-XX-XX-RP-GE-0011

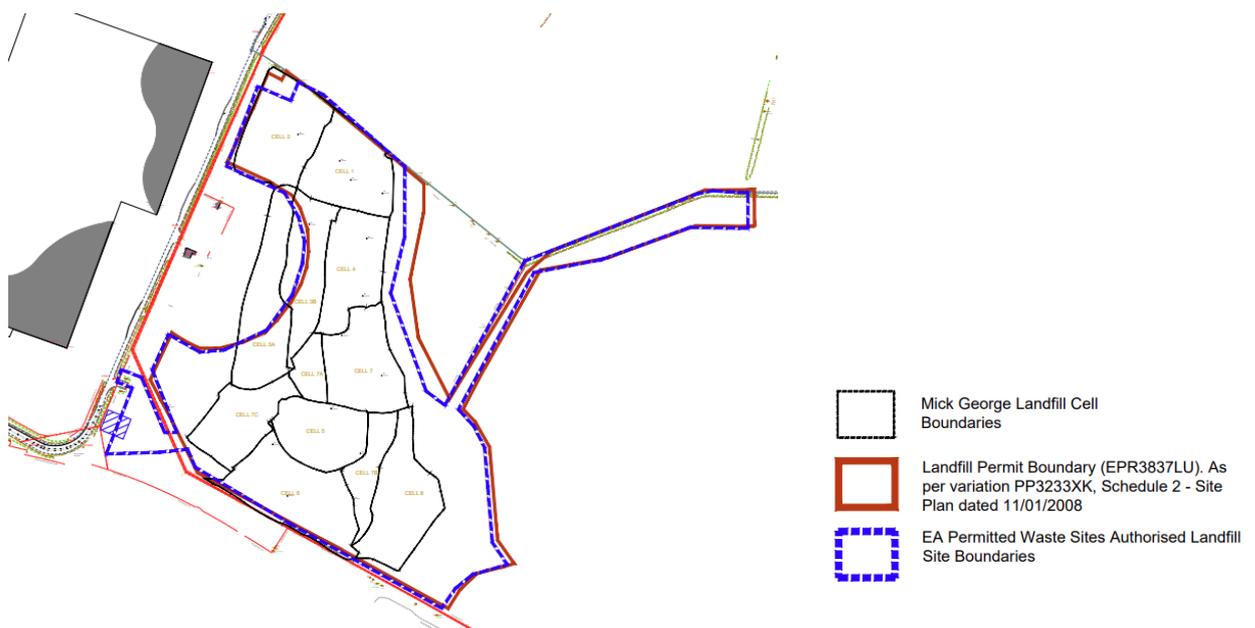
Figure 2.1: Permit boundary plans

The blue boundary shown on Drawing Reference 23880-HYD-XX-XX-DR-GE-1021 at Appendix E and copied in Figure 2.1 below is based on the EA's on-line interactive map data (Authorised Landfills). It is noted to differ slightly from that shown in the permit., in that it includes an area of land in the southwest and a small strip in the northeast that is not coincident with the Schedule 2 Site Plan.

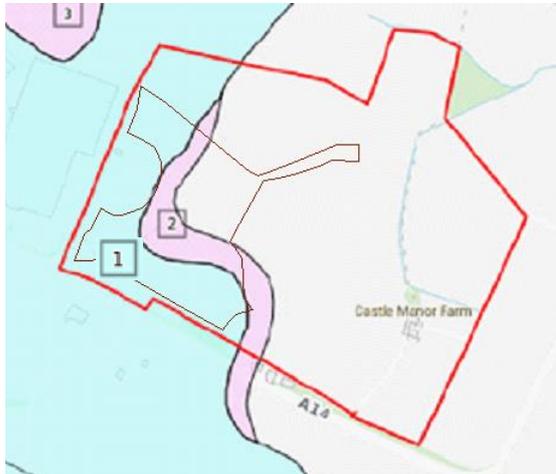
Figure 3.1: Superficial deposits

Landfill waste is present over majority of the permitted site, with other (non-waste) Made Ground on the periphery, especially in the eastern overhang, associated with the backfill of the settlement ponds and in the west, placed to create areas of hardstanding.

Extracts from the map of the wider development site are shown in Figures 3.1 and 3.2. The information is summarised in Table 3.2.

Ref. for Figures 3.1 and 3.2	Location	Stratigraphic Name	Regional Description
<b>Superficial Deposits</b>			
1	On site	Glacial Till - Oadby Member	Grey weathering brown clay with subordinate lenses of sand and gravel with chalk and flint fragments.
2		Glaciofluvial Deposits	Sand and gravels: mostly removed by quarrying and backfilled with waste
<b>Solid Geology</b>			
5	On site	Oxford Clay Formation	Silicate mudstone, grey with sporadic beds of limestone.
4		Kellaways Sand Member	Silicate sandstone and siltstone, pale grey with interbeds of sandy and silty mudstone (typically 3 to 5m within the East Midlands).
9		Kellaways Clay Member	Grey mudstone (typically 2 to 3m within the East Midlands).
8		Cornbrash Formation	Medium to fine grained, blueish grey, weathering olive or yellowish-brown, limestone (up to 10.50m thick but generally 2-4m).
6		Blisworth Clay Formation	Silicate mudstone, grey with frequent fossils, rootlets and ironstone nodules (typically 2-4m thick).

Mapping indicates that Oxford Clay Formation is locally overlain by the superficial deposits. The 2021 Hydrock investigation found the Glacial Till overlying the Glaciofluvial Deposits, with majority of the latter having mostly been removed during historic sand and gravel extraction activities.

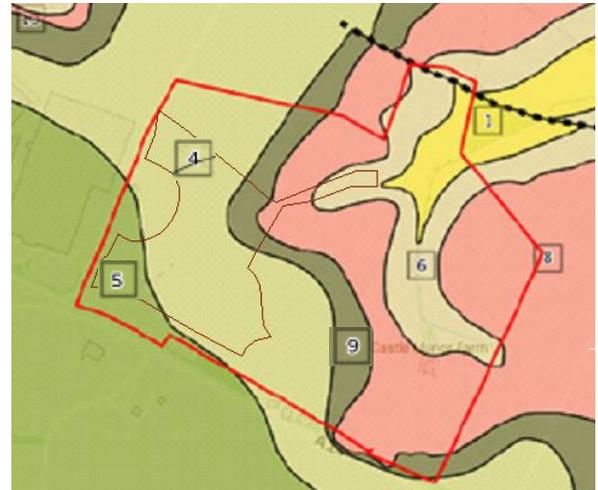
Figure 3.2: Bedrock geology

(red line boundary is the future development site boundary) (Reproduced with permission from Groundsure)

A minor fault line is shown to the north of the site, trending east to west with downthrow to the north (Figure 3.2 above).

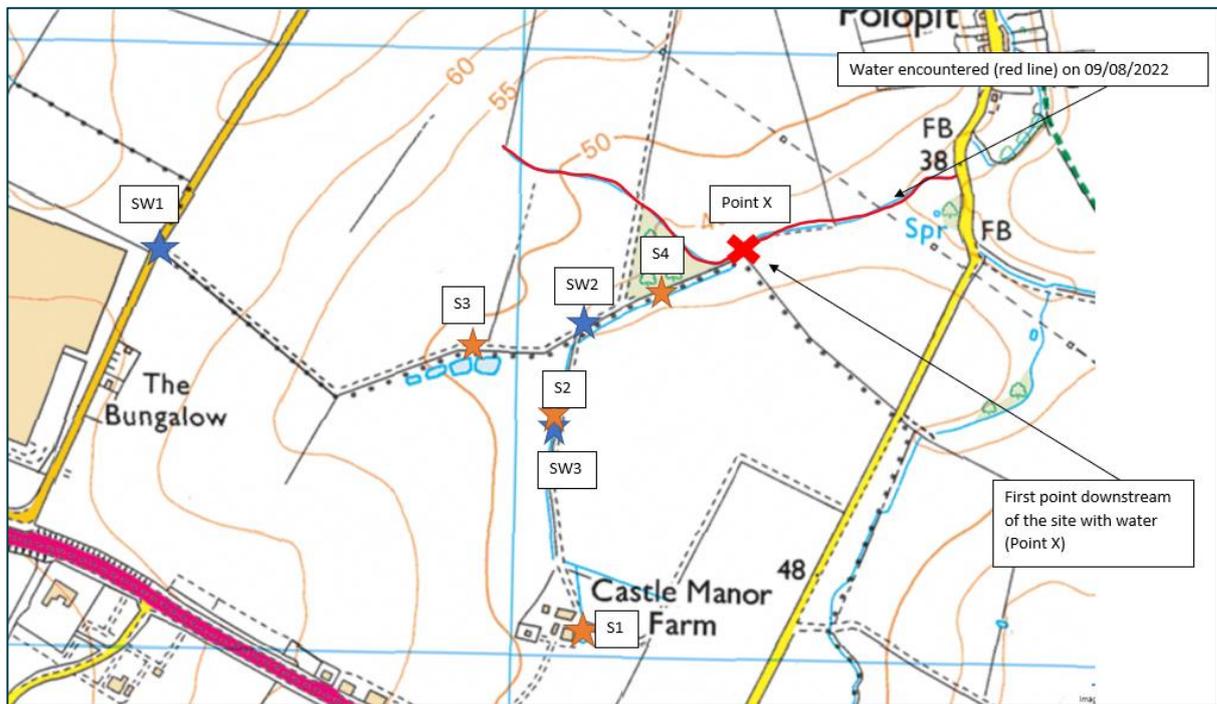
Figure 3.3: Surface water occurrence and monitoring locations

As per Figure 3.3 below, the first permanent water 'downstream' of the landfill site is subject to other water quality influences (such as agricultural activity). Whilst this potential extraneous effect compromises the effectiveness of any long-term monitoring, for precautionary reasons, it is proposed to include this location in the post closure monitoring regime.

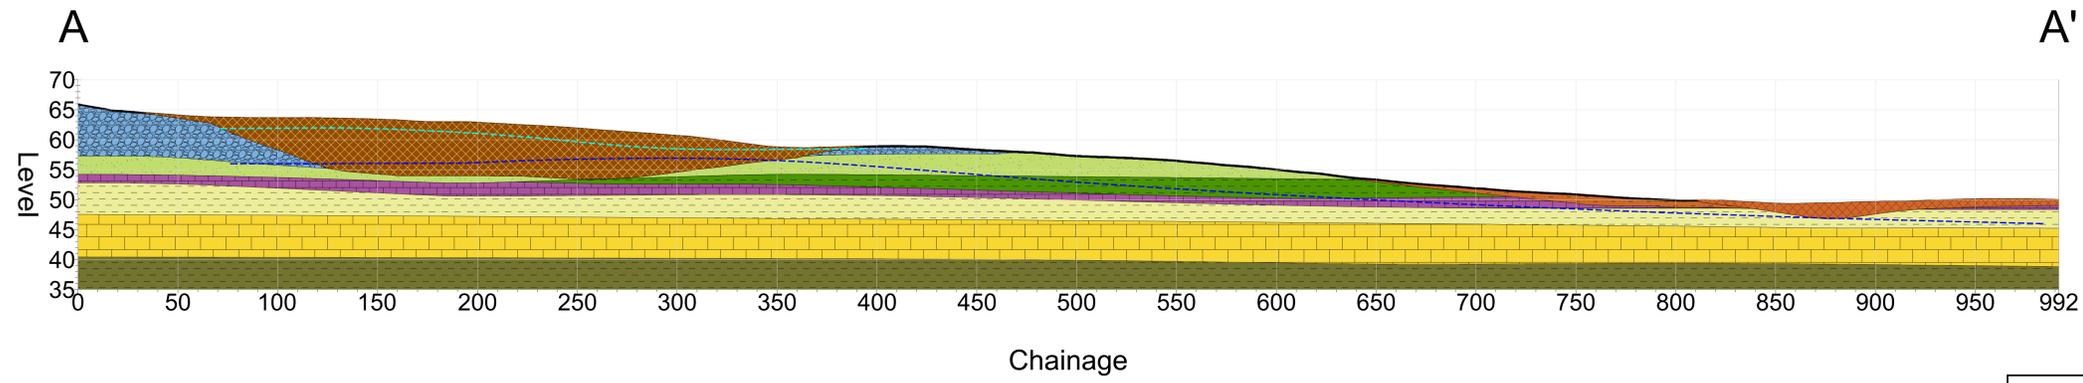
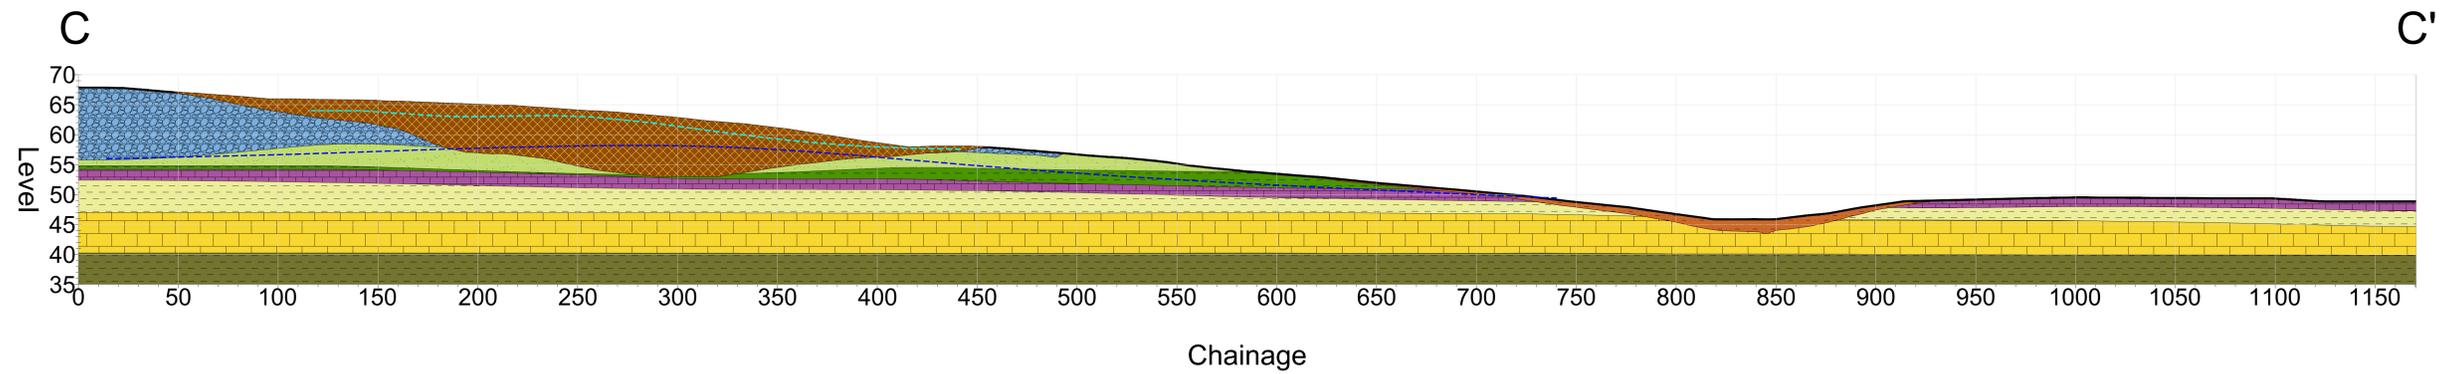
KEY	
	Top Soil + Agriculturally Top Soil
	Glacial Till + Glaciofluvial Deposits
	Blisworth Clay Formation
	Landfill Made Ground
	Kellaways Sand Member
	Blisworth Limestone Formation
	Made Ground
	Kellaways Clay Member
	Rutland Formation
	Head
	Combrash Formation
	Site Boundary (approximate)
	Trial Pit
	Cable Percussion Borehole
	Rotary Percussion / Core Borehole
	Hand Dug Excavation Pit
	Ground water level from BH with the screened zone within the Landfill made ground
	Ground water level from BH with the screened zone within the Combrash formation

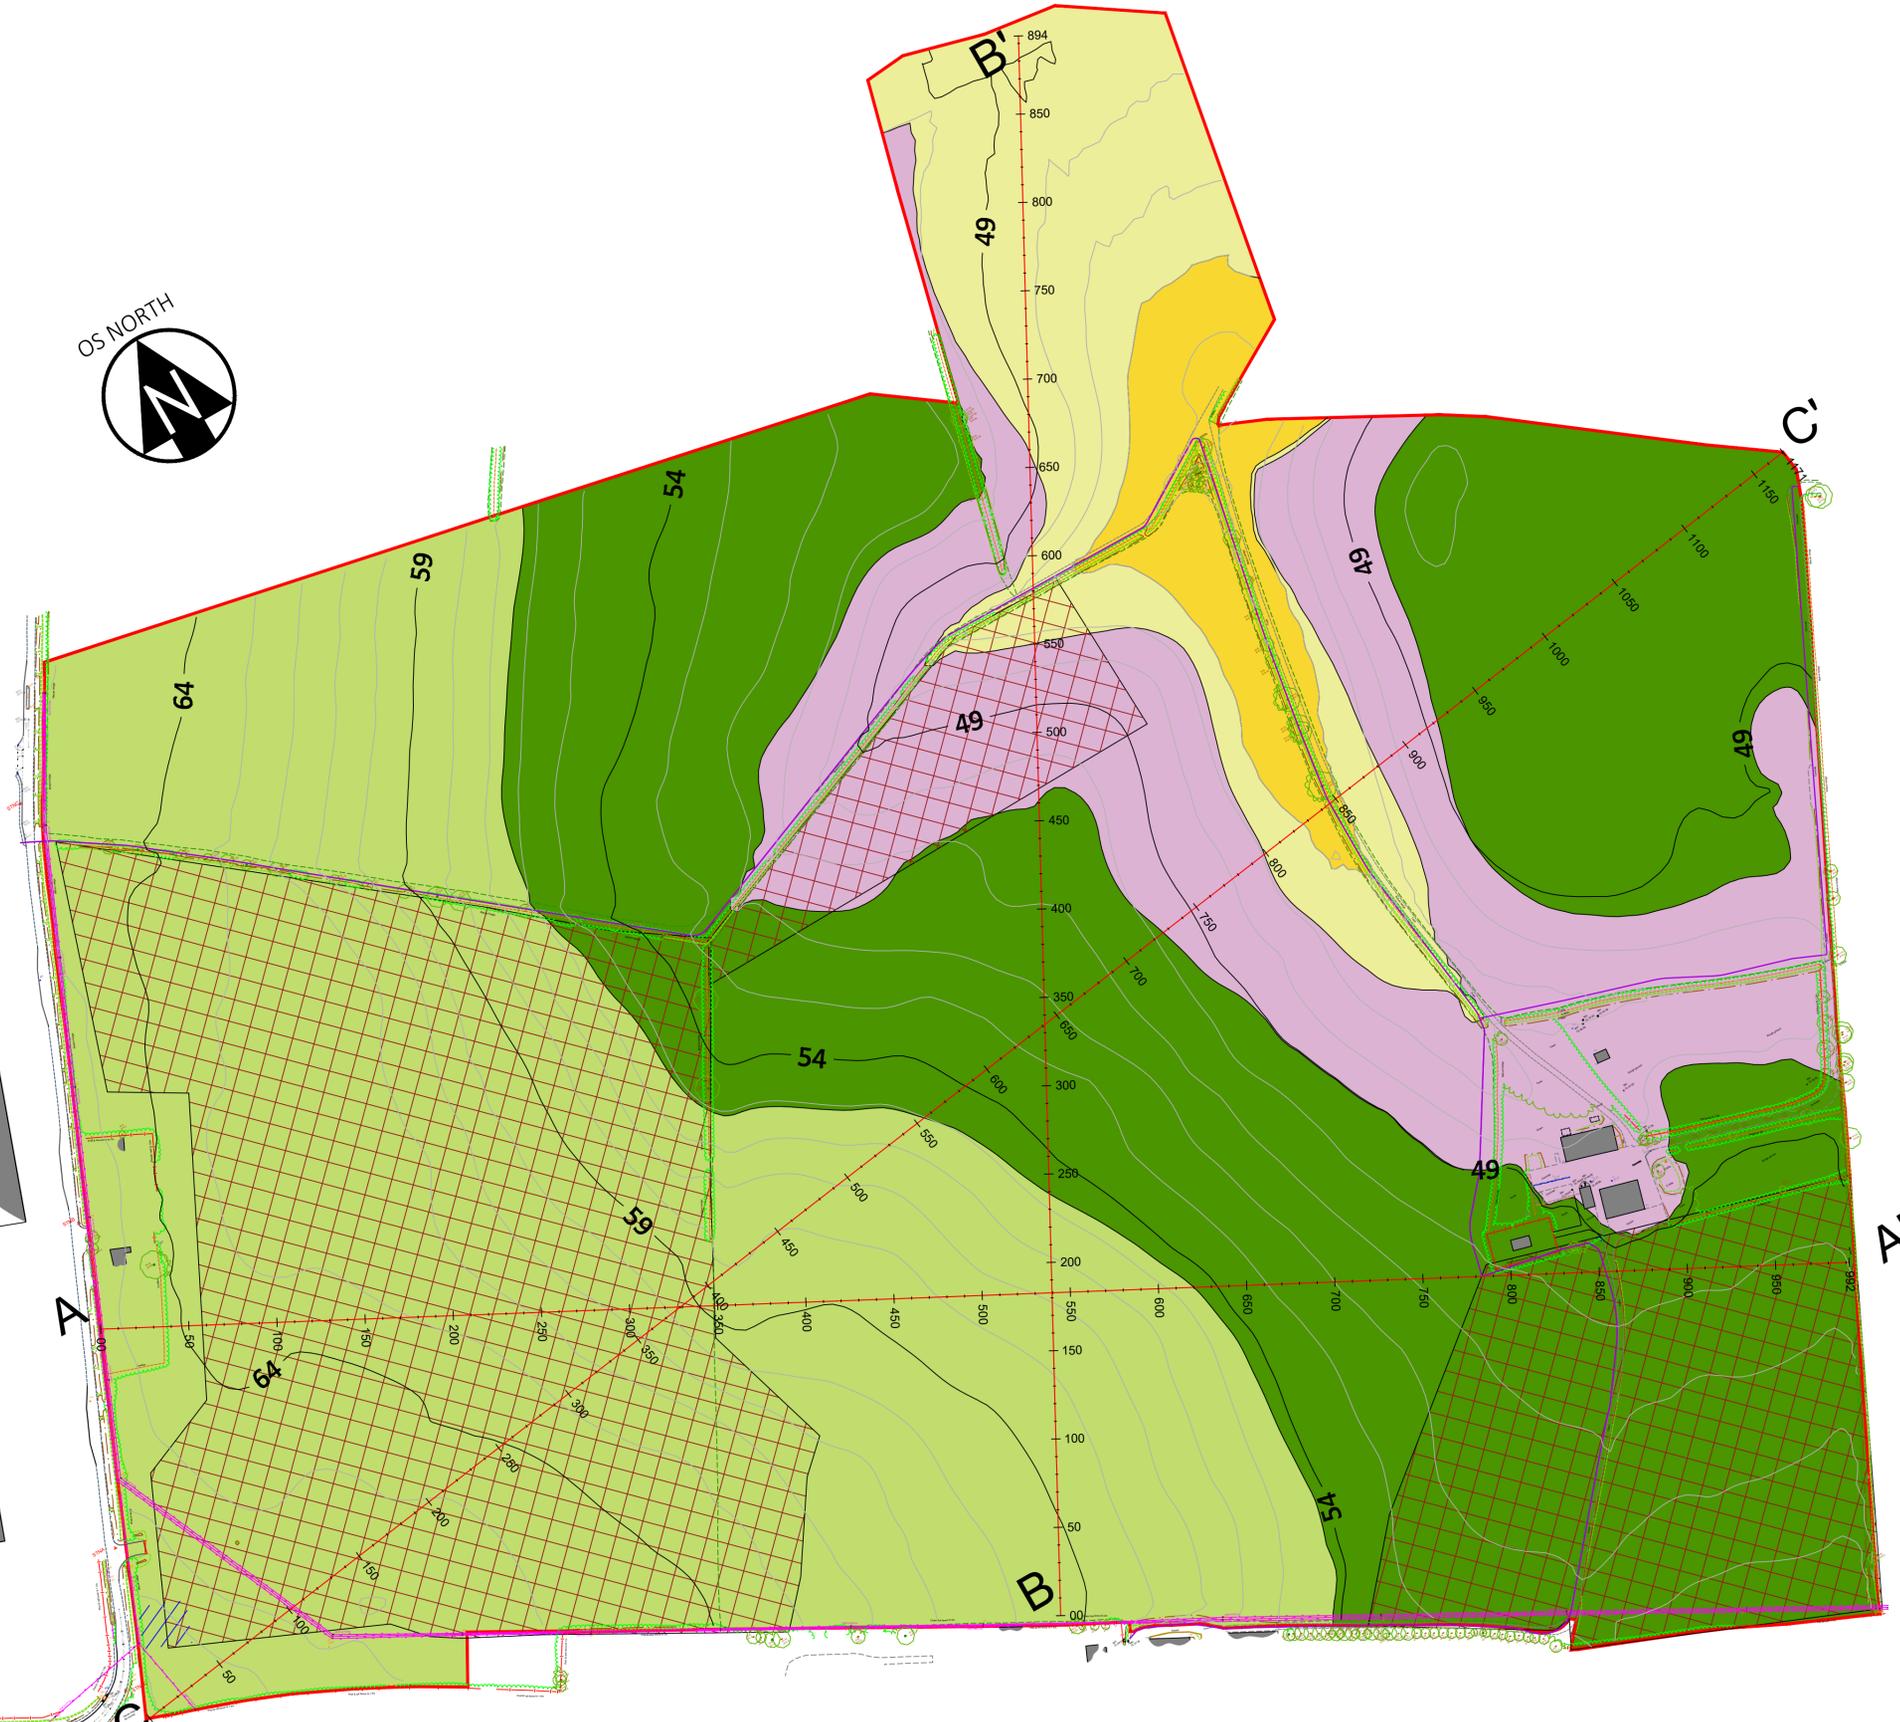
TITLE	SOLID GEOLOGY - OUTCROP LEVEL	
HYDROCK PROJECT NO.	C-18443	SCALE @ A1 1:2000
PURPOSE OF ISSUE	SUITABLE FOR INFORMATION	STATUS S2
DRAWING NO. (PROJECT CODE-ORIGINATOR-ZONE-LEVEL-TYPE-ROLE-NUMBER)	18443-HYD-XX-ZZ-DR-GE-1015	REVISION P2

- Kellaways Sand Member
- Kellaways Clay Member
- Cornbrash Formation
- Blisworth Clay Formation
- Blisworth Limestone Formation
- Made Ground

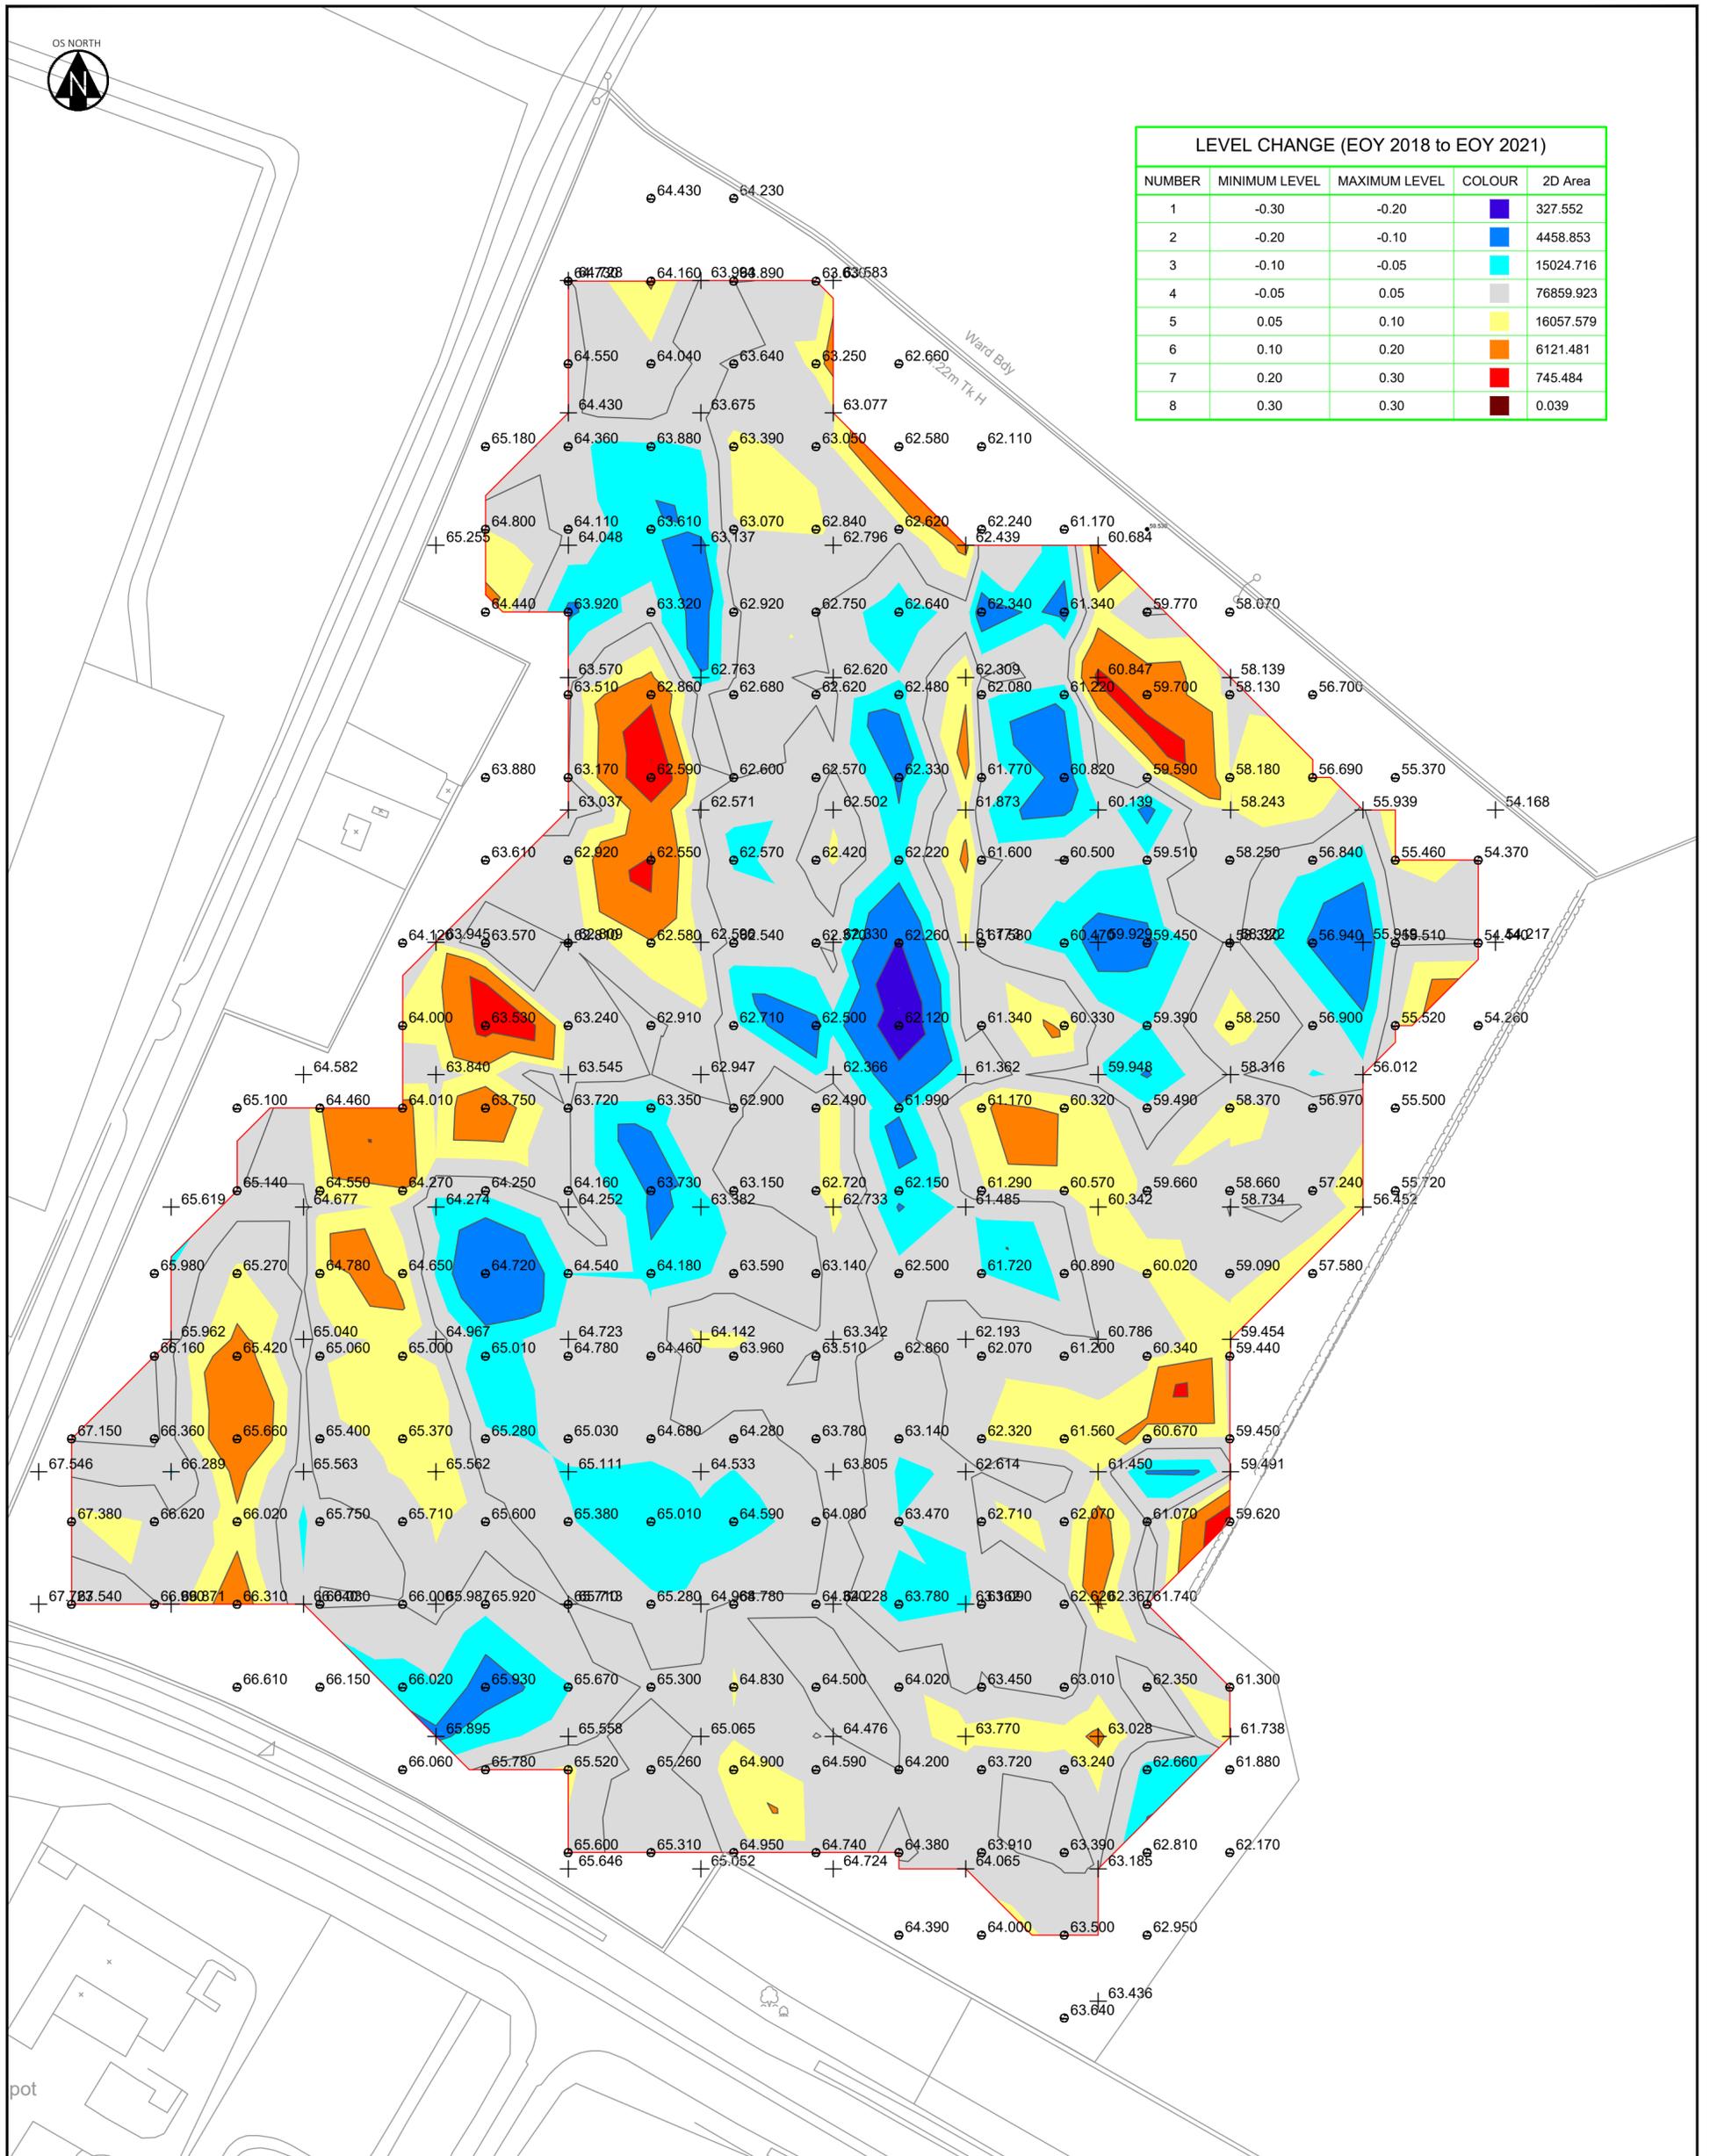
LEVEL CHANGE (EOY 2018 to EOY 2021)				
NUMBER	MINIMUM LEVEL	MAXIMUM LEVEL	COLOUR	2D Area
1	-0.30	-0.20	Dark Blue	327.552
2	-0.20	-0.10	Blue	4458.853
3	-0.10	-0.05	Cyan	15024.716
4	-0.05	0.05	Light Blue	76859.923
5	0.05	0.10	Yellow	16057.579
6	0.10	0.20	Orange	6121.481
7	0.20	0.30	Red	745.484
8	0.30	0.30	Dark Red	0.039

KEY	
2018 EOY SPOTHEIGHTS	⊙ 59.530
2021 EOY SPOTHEIGHTS	+ 56.452

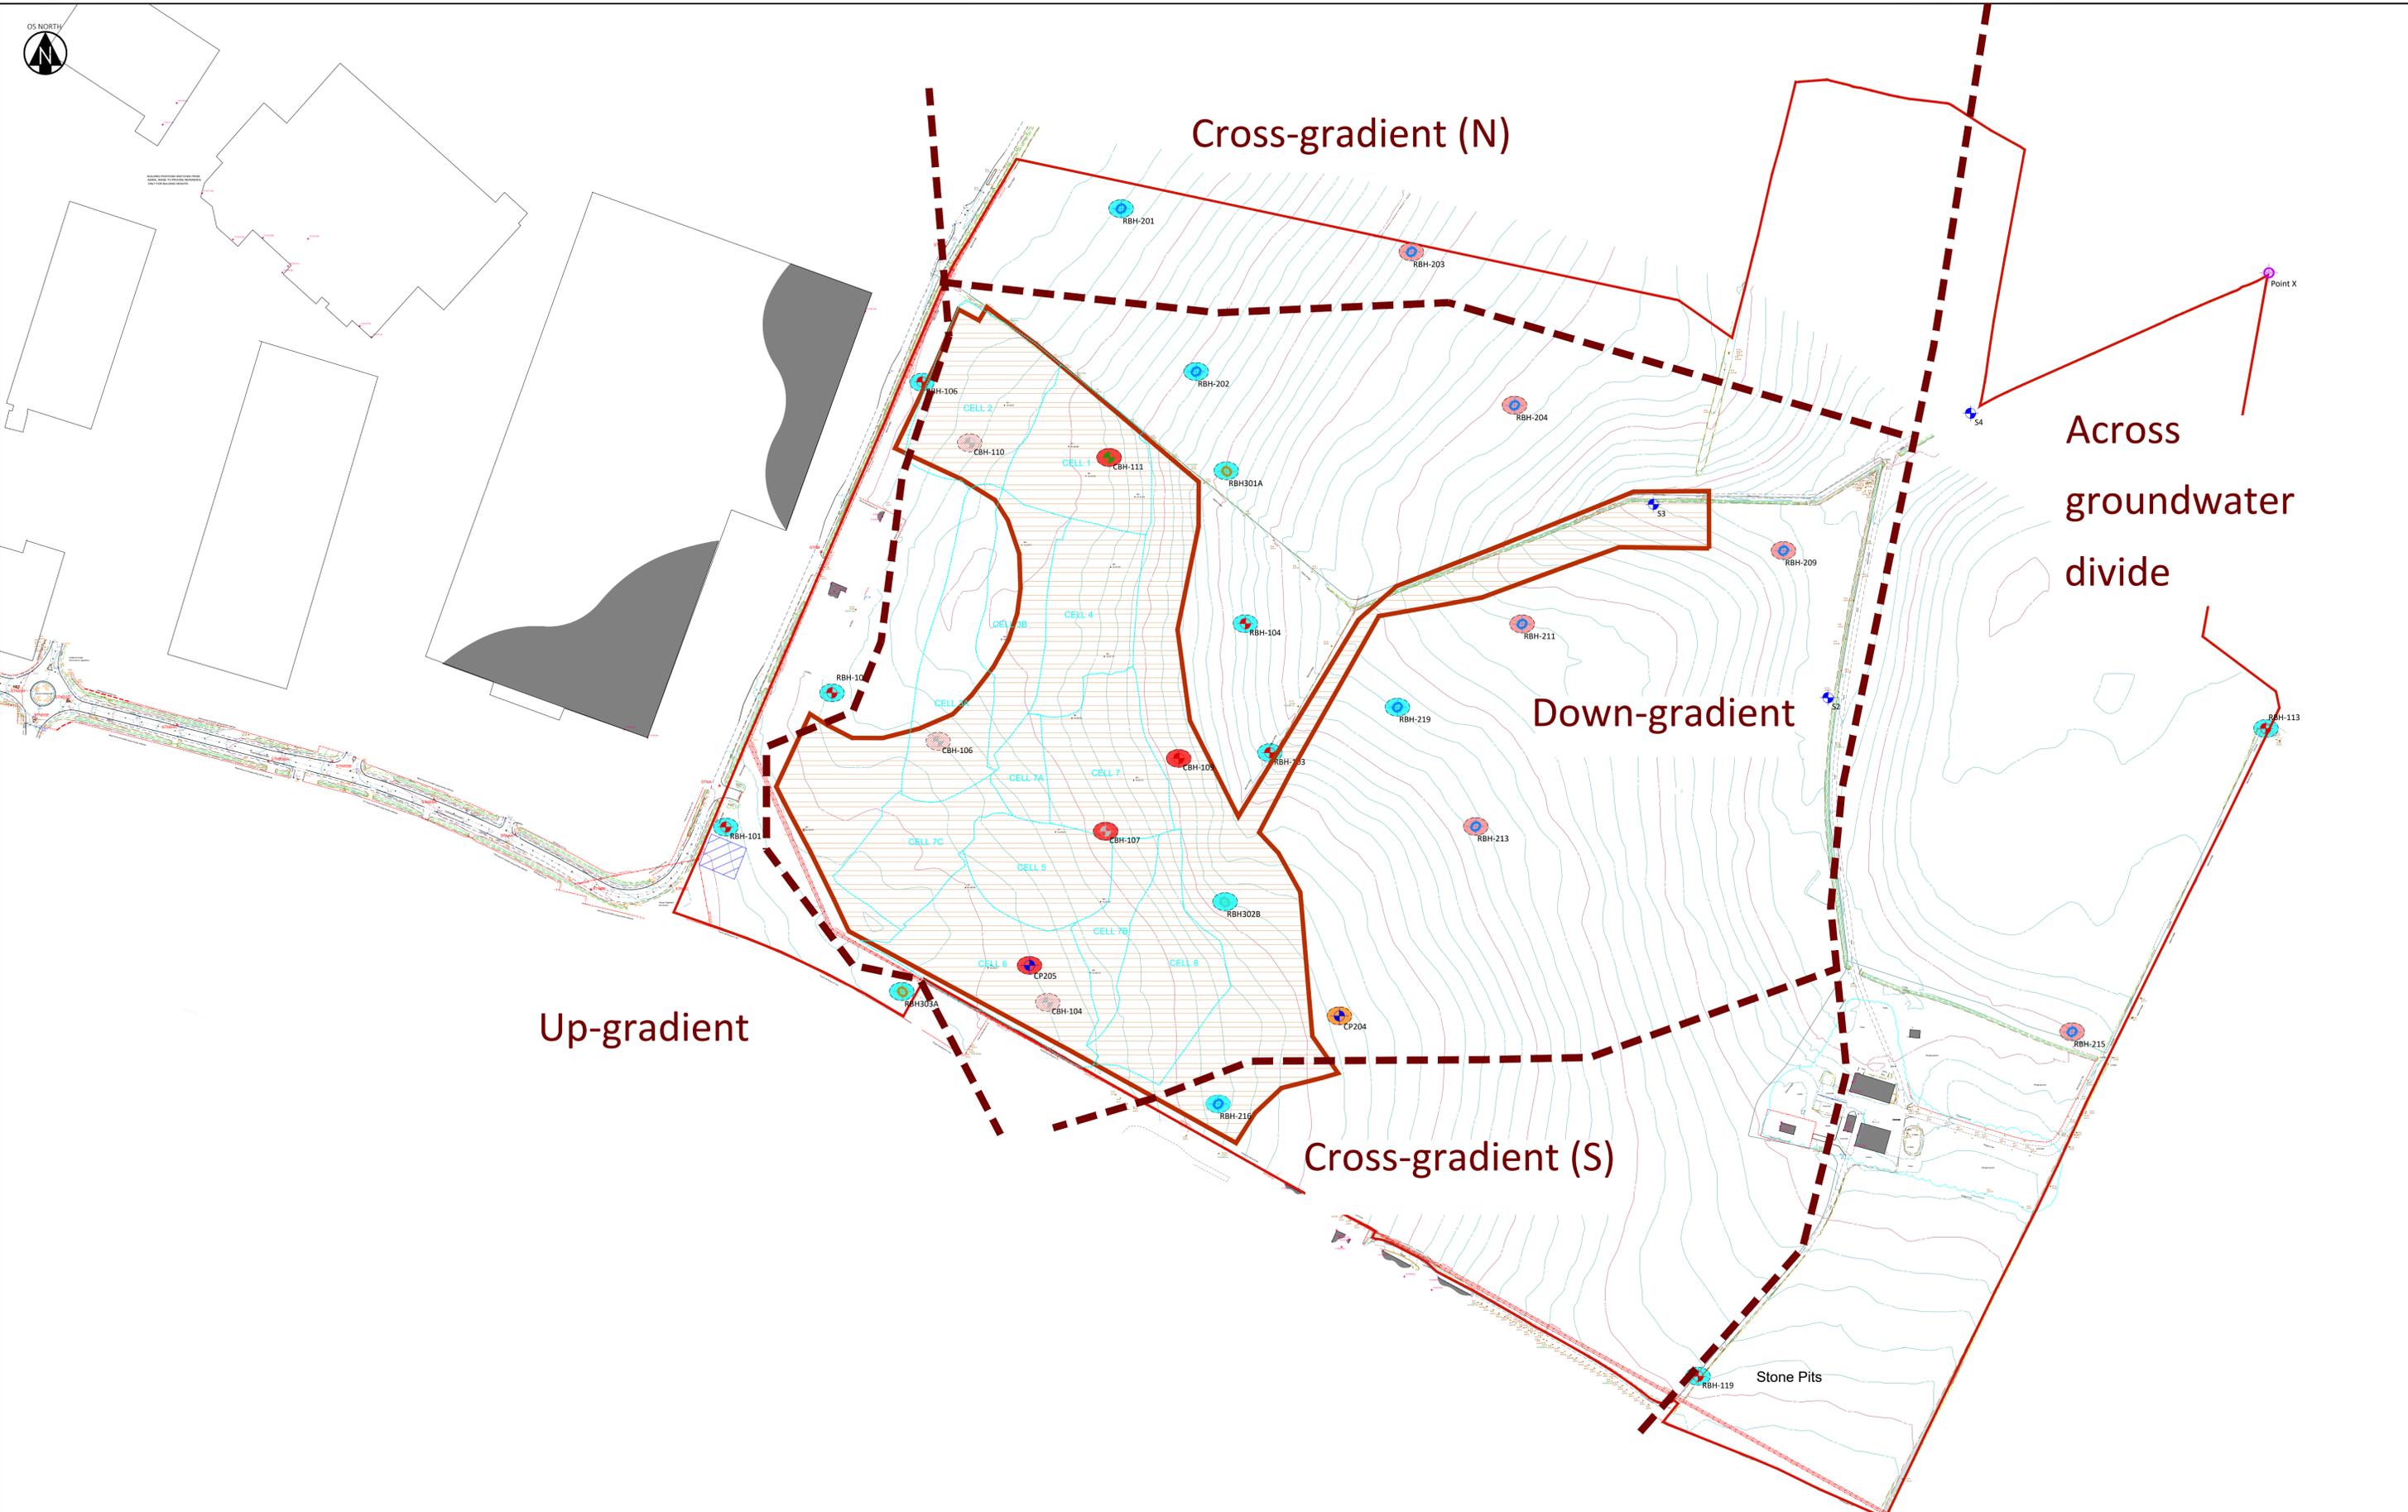
TITLE <b>INSTALLED MONITORING POINTS</b>	
HYDROCK PROJECT NO. <b>23880</b>	SCALE @ A0 <b>1:1500</b>
PURPOSE OF ISSUE <b>SUITABLE FOR INFORMATION</b>	STATUS <b>S2</b>
DRAWING NO. (PROJECT CODE, ORIGINATOR, ZONE LEVEL, TYPE, ROLE NUMBER) <b>23880-HYD-XX-ZZ-DR-GE-1012</b>	REVISION <b>P02</b>

Site Investigation Boreholes (June/July 2021)

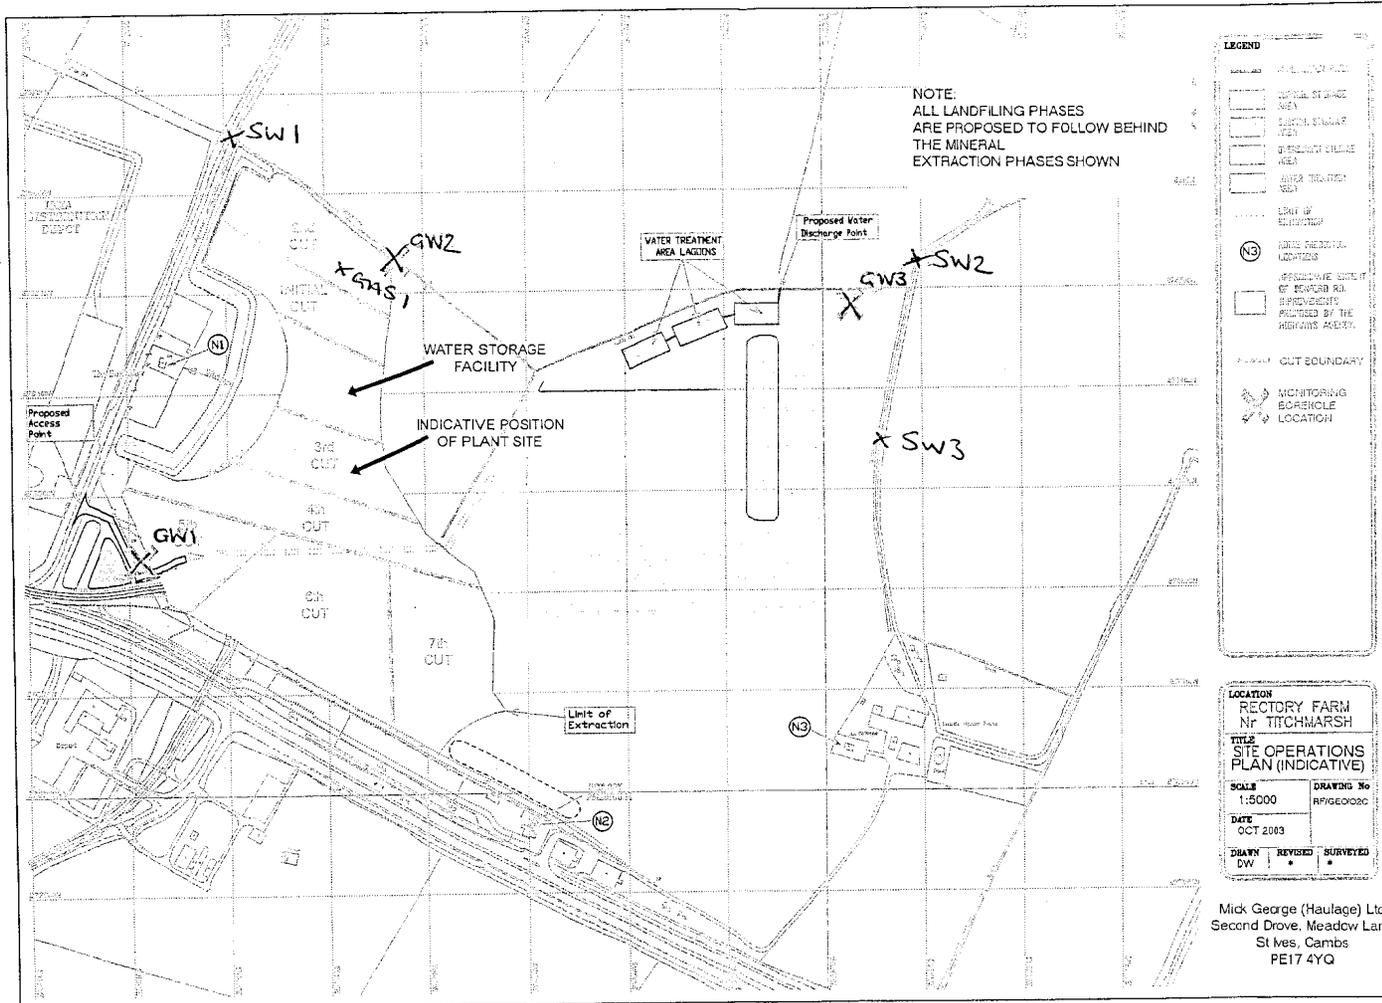
LOCATION			Thrapston	SITE REF		T2/4
METHOD			Borehole using Rotary Flush Rig	NUMBER		GW1
DATE			21st August 2003	SHEET		1/1
CASING	LEGEND	LITHOLOGY	DEPTH	THICKNESS	SAMPLE	
Casing		Dry Brown Topsoil/ Clayey SubSOIL	0.6m	0.6m		
		Firm to stiff Brown Slightly Grey CHALK, and flinty stoney clay, becoming stiffer and darker in colour from 3m down <b>(TILL (OADBY MEMBER))</b>	3.6m	3.0m		
		Hardstone/ ROCK Layer <b>(TILL (OADBY MEMBER))</b>	3.9m	0.3m		
		Firm to stiff Brown Slightly Grey CHALK, and flinty stoney clay, becoming stiffer and darker in colour from 3m down <b>(TILL (OADBY MEMBER))</b>	6.0m	2.1m		
		Stiff Brown CLAY <b>(TILL (LOWER TILL))</b>	6.2m	0.2m		
		Broken sand and Gritty GRAVEL <b>(GLACIOFLUVIAL SAND AND GRAVEL)</b>	10.1m	3.9m	Groundwater Struck @ 9.5m	
	Grey ROCK <b>(OXFORD CLAY)</b>	10.5m	10.4m 0.4m	End of Casing End of Hole

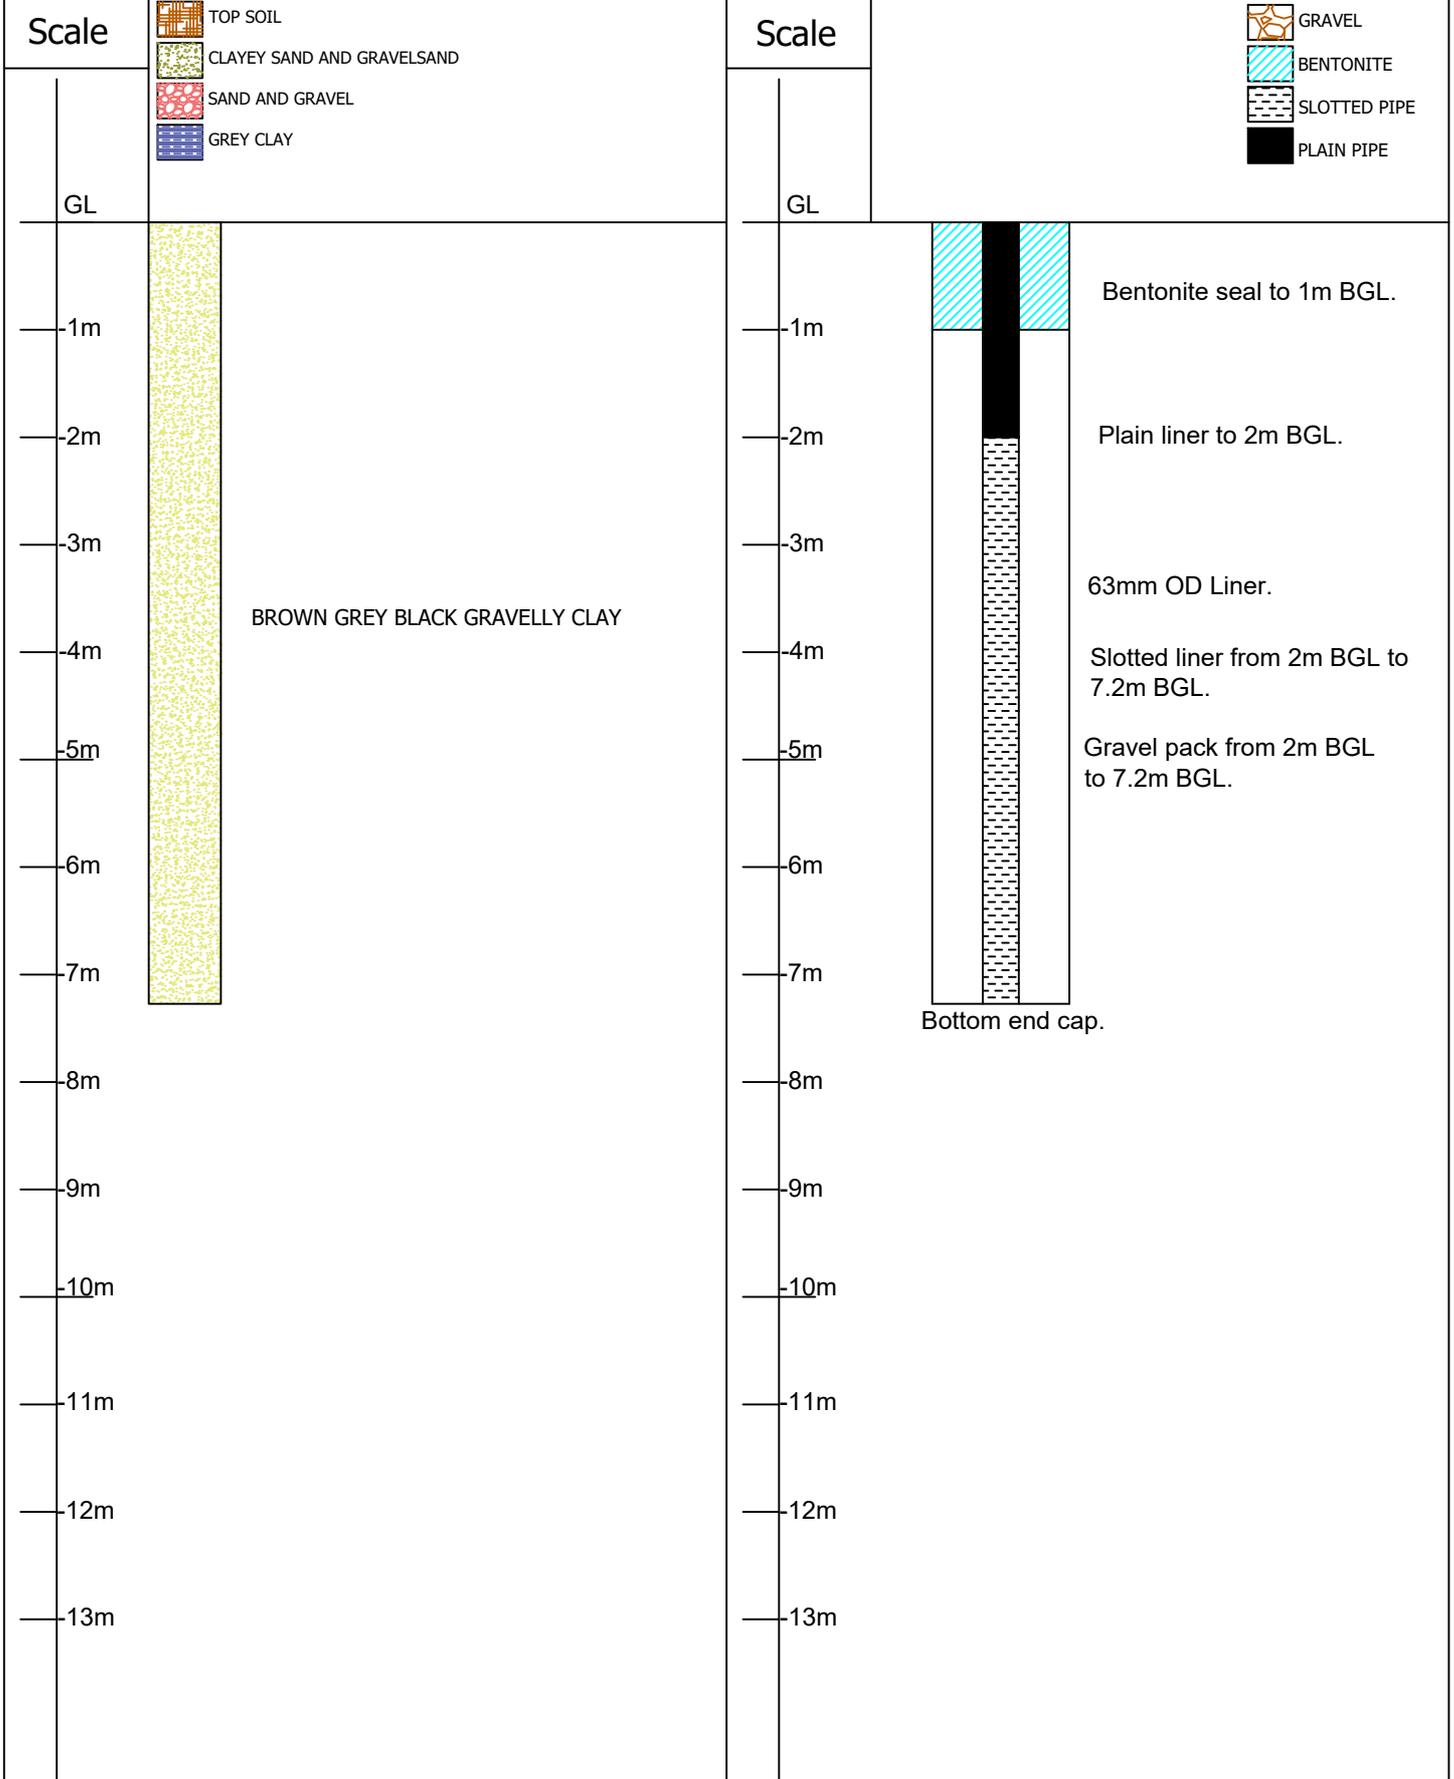
Start Date: 28.8.19		Site/BH ID: Borehole 2	
Finish Date: 28.8.19		Contractor: T Bedford	Driller: K Davey
Bore Diameter: 150mm		Client: Mick George Limited	RIG: Cable Percussion
Northings: 501498	Eastings: 278537	Ground Level (mAOD): 62.50

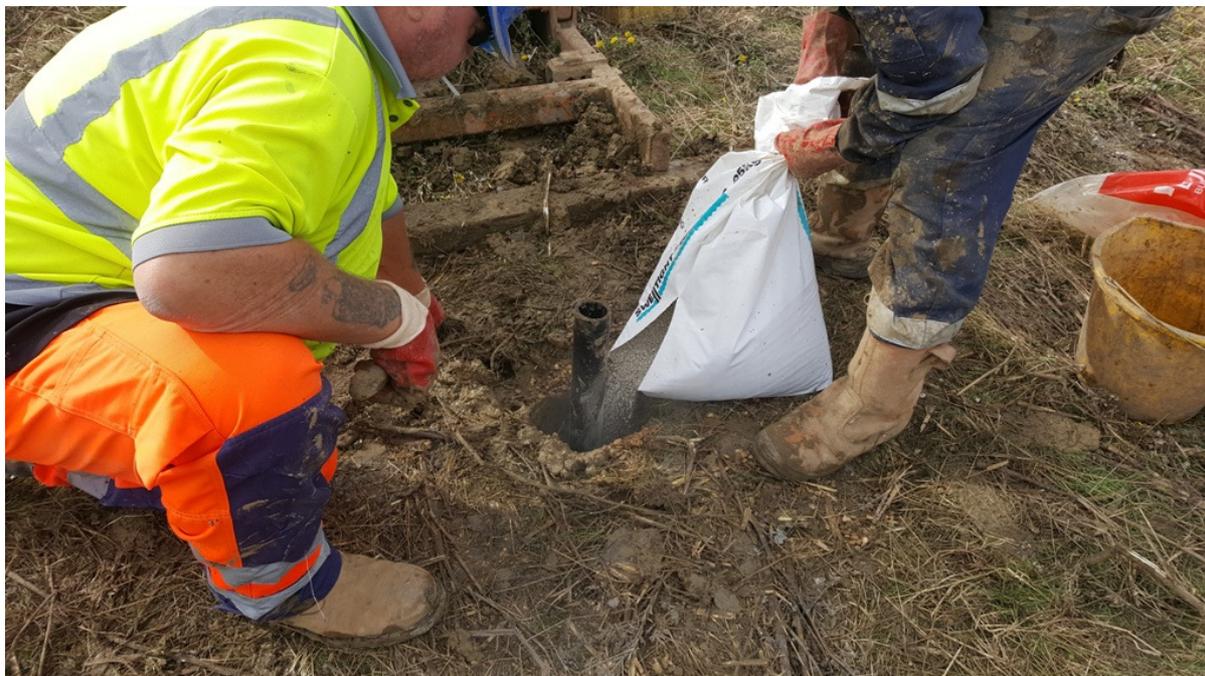
**Plate 4 – Metal protective casing secured in place by concrete around top of standpipe**

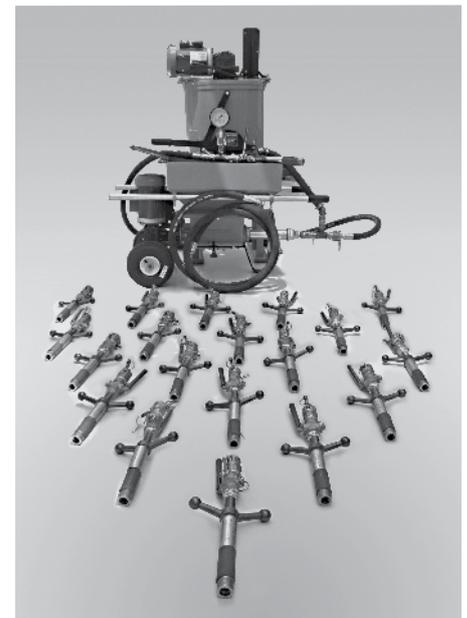
CETCO BENTOGROUT Pump, Mixer and Accessories

**Equipment:** CETCO recommends the use of the CETCO BENTOGROUT Pump and Mixer as the equipment is designed specifically for BENTOGROUT. Use mixing equipment capable of producing continuous shear and agitation movement. CETCO BENTOGROUT Equipment is comprised of progressive cavity pumps with vertical paddle and horizontal ribbon blender type mixers. It is not recommended to use a piston style pump due to the high spikes in back-pressure generated.

The CETCO BEN TOGROUT Pump and Mixer are separate wheel mounted units that weigh 77 kg and 95 kg respectively; each are ran by 1 HP electric motors (Figure 2). The CETCO BEN TOGROUT Pump consists of a rotor-stator ribbon pump that is capable of pumping a consistent 11 litres per minute and has a 68 litres hopper. The CETCO BEN TOGROUT Mixer is able to mix a 25 kg bag of BEN TOGROUT in approx. 8 minutes with its three mixing paddles and has a mixing capacity of 83 litres. Both units are completely electric and only require a 120 V, 15 AMP current (standard GFI outlet). For information or to purchase the CETCO BEN TOGROUT Pump, Mixer and accessories, contact your local CETCO sales representative.

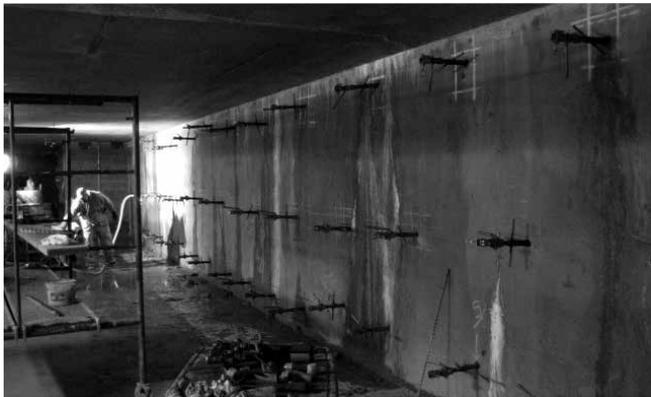
INTERIOR SURFACE GROUT INJECTION: BEN TOGROUT is applied to the inside of the building without excavating the site

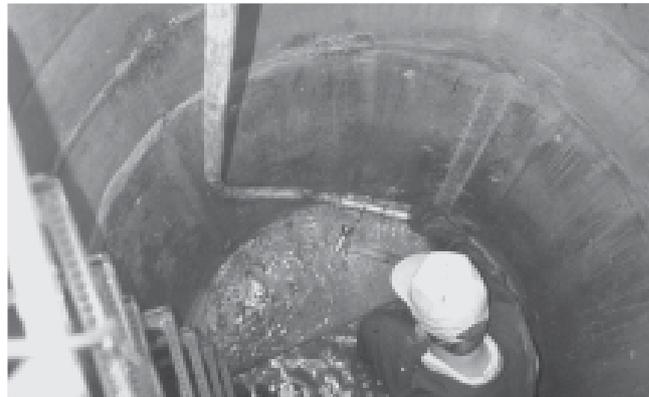
INTERIOR THROUGH WALL APPLICATION: BEN TOGROUT injected to the exterior of a manhole through pre-drilled holes using a short injection wand

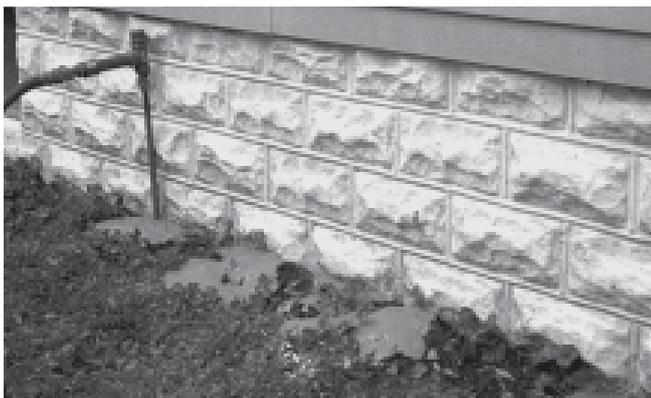
EXTERIOR MASONRY WALL APPLICATION: Inject BEN TOGROUT along the exterior of a foundation wall at 600 mm on centre intervals

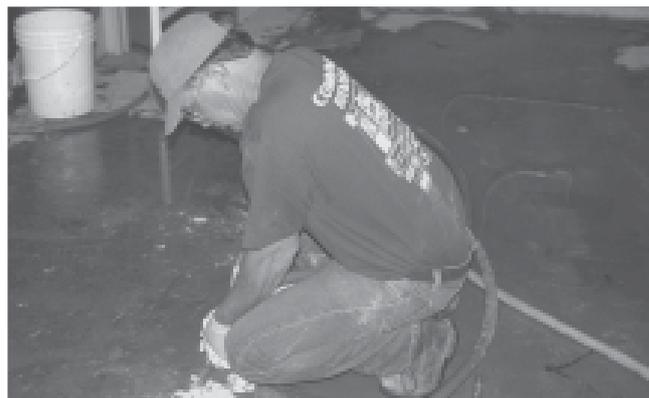
STRUCTURAL SLAB APPLICATION: Inject BEN TOGROUT under an existing slab to provide waterproofing and fill void areas
