# Rectory Farm Landfill (EPR/BT98791Y)

## Surrender Report

*For Mick George Ltd*

Doc ref    23880-HYD-XX-XX-RP-GE-0011

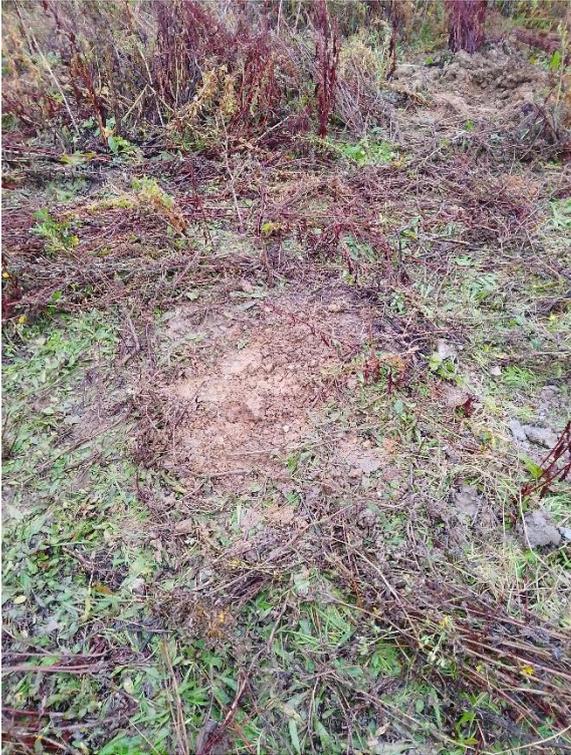
<p><b>Site Investigation Photograph 1</b></p>

<p><b>Date:</b> 20/10/22</p>	
<p><b>Direction Photograph Taken:</b> n/a.</p>	
<p><b>Description:</b> RBH-108 backfilled and reinstated with surrounding topsoil.</p>

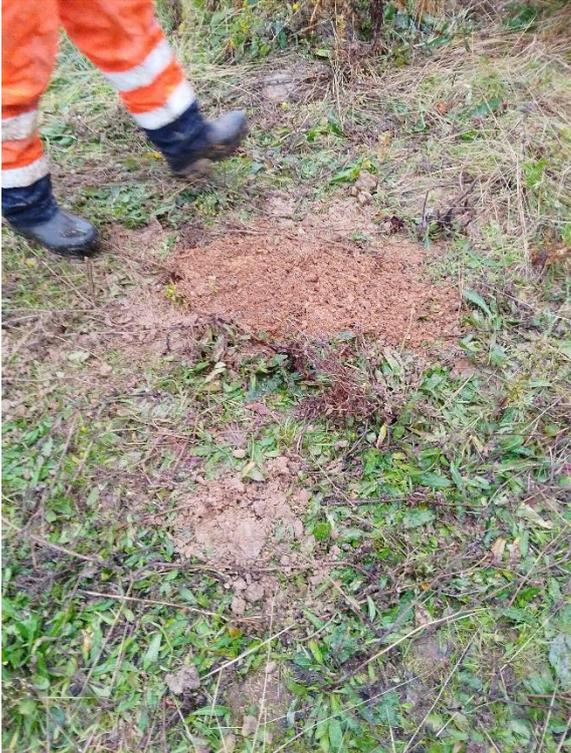
<p><b>Site Investigation Photograph 2</b></p>

<p><b>Date:</b> 20/10/22</p>	
<p><b>Direction Photograph Taken:</b> n/a.</p>	
<p><b>Description:</b> CBH-110 backfilled and reinstated with surrounding topsoil.</p>

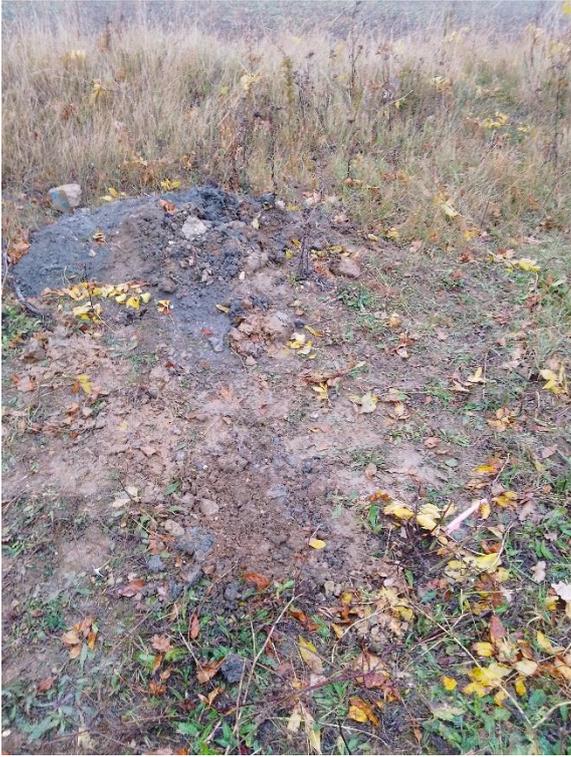
<p><b>Site Investigation Photograph 3</b></p>

<p><b>Date:</b> 20/10/22</p>	
<p><b>Direction Photograph Taken:</b> n/a.</p>	
<p><b>Description:</b> CBH-101 backfilled and reinstated with surrounding topsoil.</p>

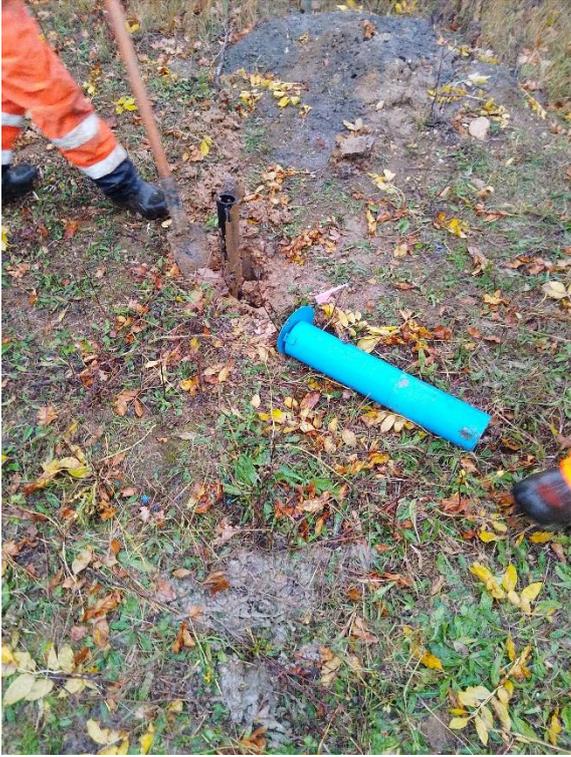
<p><b>Site Investigation Photograph 4</b></p>

<p><b>Date:</b> 20/10/22</p>	
<p><b>Direction Photograph Taken:</b> n/a.</p>	
<p><b>Description:</b> CP206 digging out top 1m of pipe after grouting.</p>

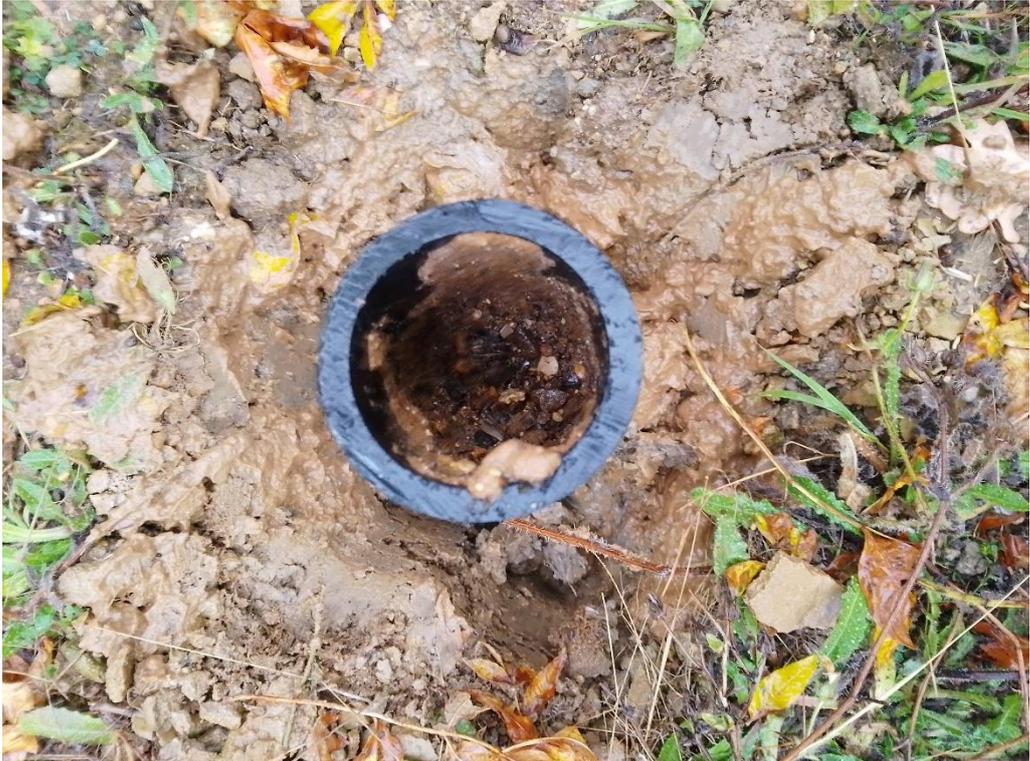
<p><b>Date:</b> 20/10/22</p>	
<p><b>Direction Photograph Taken:</b> n/a.</p>	
<p><b>Description:</b> Down pipe showing grout backfilled in the hole.</p>

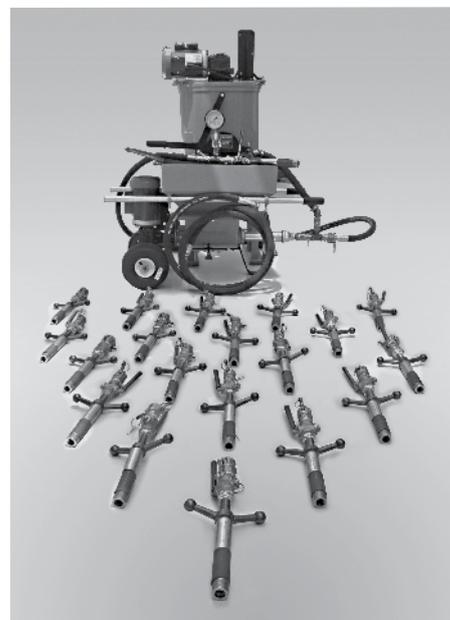
CETCO BENTOGROUT Pump, Mixer and Accessories

**Equipment:** CETCO recommends the use of the CETCO BENTOGROUT Pump and Mixer as the equipment is designed specifically for BENTOGROUT. Use mixing equipment capable of producing continuous shear and agitation movement. CETCO BENTOGROUT Equipment is comprised of progressive cavity pumps with vertical paddle and horizontal ribbon blender type mixers. It is not recommended to use a piston style pump due to the high spikes in back-pressure generated.

The CETCO BEN TOGROUT Pump and Mixer are separate wheel mounted units that weigh 77 kg and 95 kg respectively; each are ran by 1 HP electric motors (Figure 2). The CETCO BEN TOGROUT Pump consists of a rotor-stator ribbon pump that is capable of pumping a consistent 11 litres per minute and has a 68 litres hopper. The CETCO BEN TOGROUT Mixer is able to mix a 25 kg bag of BEN TOGROUT in approx. 8 minutes with its three mixing paddles and has a mixing capacity of 83 litres. Both units are completely electric and only require a 120 V, 15 AMP current (standard GFI outlet). For information or to purchase the CETCO BEN TOGROUT Pump, Mixer and accessories, contact your local CETCO sales representative.

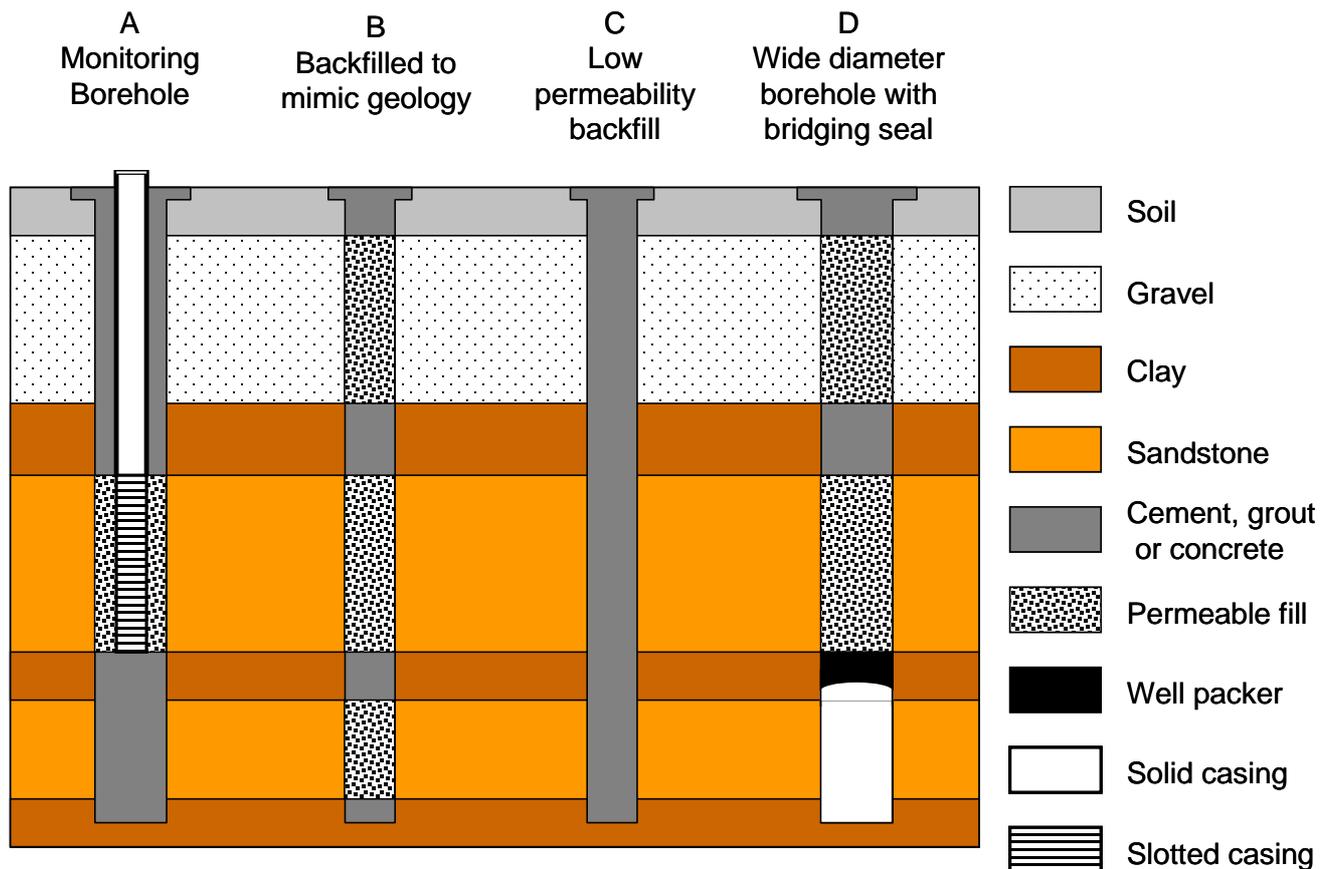
**Figure 1: Schematic options (B–D) for decommissioning wells and boreholes**
