Rectory Farm (Thrapston)  
Landfill (EPR/BT9879IY)

Hydrogeological Risk  
Assessment Review

*For Mick George (Haulage) Limited*

Doc ref: 23880-HYD-XX-XX-RP-GE-0003

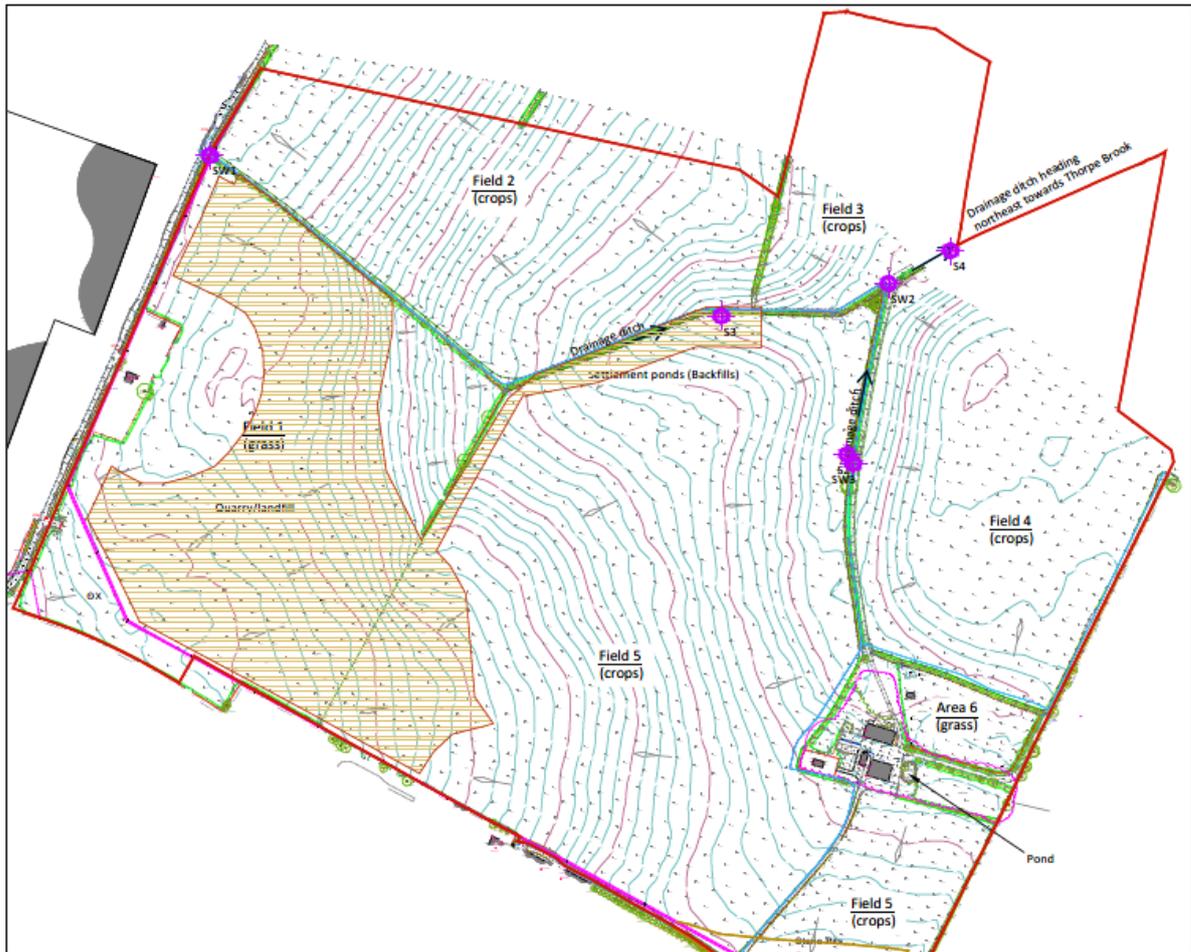
Figure 5.1: Hydrology and drainage features including surface water monitoring points (purple) (red line boundary is the future development site boundary).

Both drainage ditches intersect 130m east of the site and drain north-east towards Thorpe Brook, which ultimately joins the River Nene 3km to the north at an elevation approximately 20m lower than the lowest point on site. Hydrology and drainage features are shown in Figure 5.1. Figure 5.9 below shows the furthest point upstream in the drainage system where water was observed during dry weather on 08 August 2022.

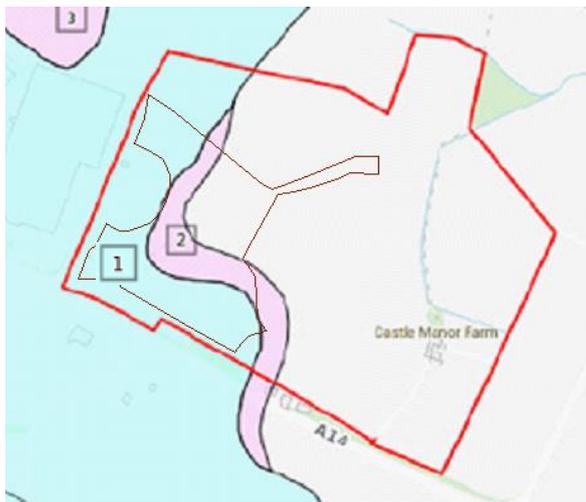
Figure 5.2: Superficial deposits  
(red line boundary is the future development site boundary)  
(Reproduced with permission from Groundsure)

The general geology of the site area is shown on the British Geological Survey (BGS) 1:50,000 geological map of Kettering (Sheet 171) and a 1:10,000 BGS map extract, reproduced as part of a Groundsure report for a wider site (reference GS-7926027) is included at Appendix E. The information is summarised in Table 5.1. Extracts from the map of the wider site are shown in Figure 5.2 and Figure 5.3.

Ref. for Figures 5.2 and 5.3	Location	Stratigraphic Name	Description
<b>Superficial Deposits (Figure 5.2)</b>			
1	On site	Glacial Till - Oadby Member	Grey weathering brown clay with subordinate lenses of sand and gravel with chalk and flint fragments.
2		Glaciofluvial Deposits	Sand and gravels.
<b>Solid Geology (Figure 5.3)</b>

The mapping indicates that Oxford Clay Formation is locally overlain by the superficial deposits (see also 5.5.3.6 below). The 2021 Hydrock investigation found the Glacial Till overlying the Glaciofluvial Deposits, with majority of the latter having mostly been removed during historical sand and gravel extraction work.

Glaciofluvial Deposits were encountered at the landfill area of the site, typically underlying the Glacial Till. Glaciofluvial Deposits have mostly been removed as part of gravel extraction works, to be replaced by landfill.

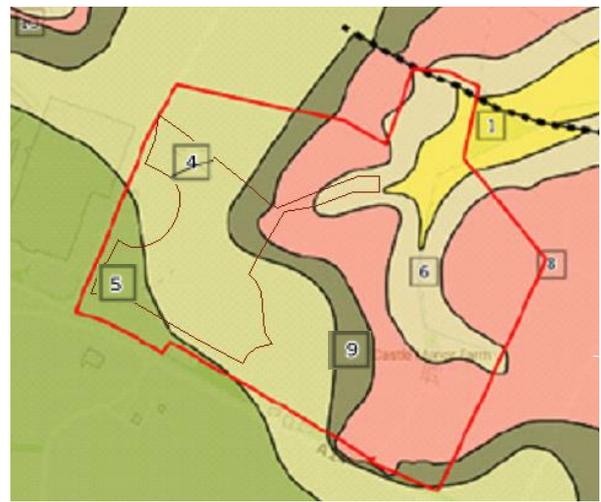
Figure 5.3: Solid geology  
(red line boundary is the future development site boundary)  
(Reproduced with permission from Groundsure)

Ref. for Figures 5.2 and 5.3	Location	Stratigraphic Name	Description
5	On site	Oxford Clay Formation	Silicate mudstone, grey with sporadic beds of limestone.
4		Kellaways Sand Member	Silicate sandstone and siltstone, pale grey with interbeds of sandy and silty mudstone (typically 3 to 5m within the East Midlands).
9		Kellaways Clay Member	Grey mudstone (typically 2 to 3m within the East Midlands).
8		Cornbrash Formation	Medium to fine grained, blueish grey, weathering olive or yellowish-brown limestone (up to 10.50m thick but generally 2-4m).
6		Blisworth Clay Formation	Silicate mudstone, grey with frequent fossils, rootlets and ironstone nodules (typically 2-4m thick).
1		Blisworth Limestone Formation	Pale grey or off-white yellowish limestone (typically 2-4m thick).

A minor fault line is shown to the north of the site, trending east to west with downthrow to the north (see Figure 5.3).

As noted previously, a fault line is shown to the north of the site, trending east to west with downthrow to the north (see Figure 5.3).

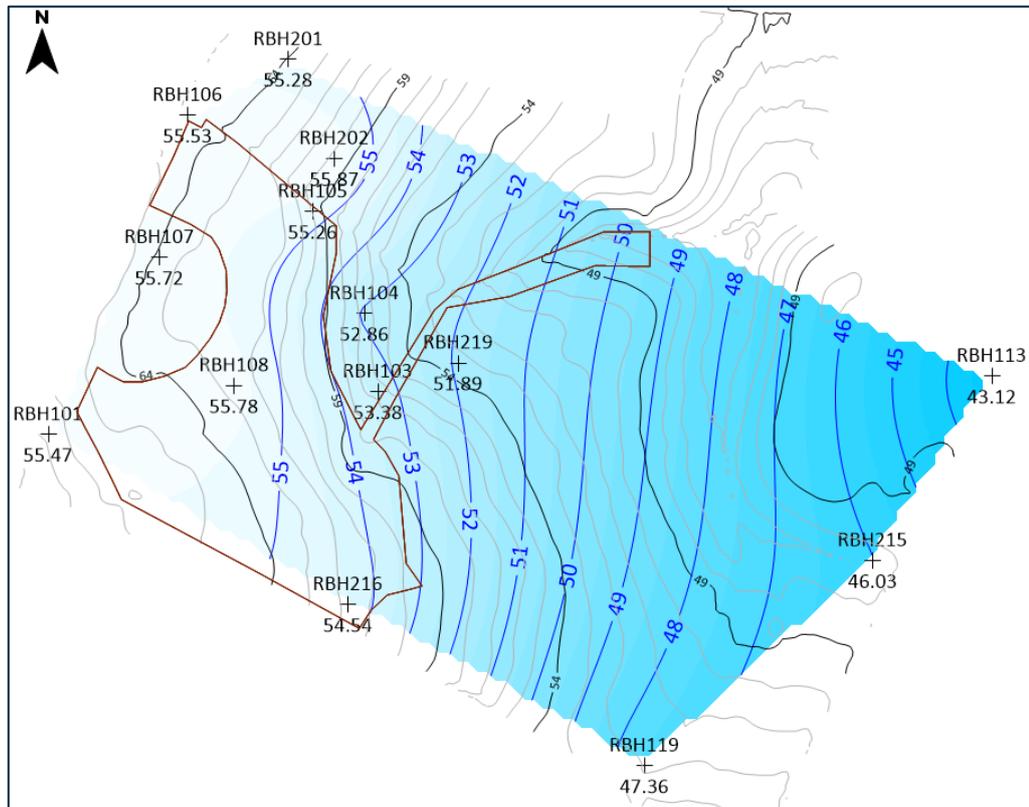
Contours for groundwater levels in the Cornbrash Limestone Formation (July 2022) are shown in Figure 5.5. In general groundwater flow within the Cornbrash Limestone Formation is towards the east following topographic profile. Groundwater levels recorded at RBH-102 are anomalous and have been removed from the dataset.

Figure 5.5: Groundwater contour plot (blue) for Cornbrash Limestone Formation 04/07/2022

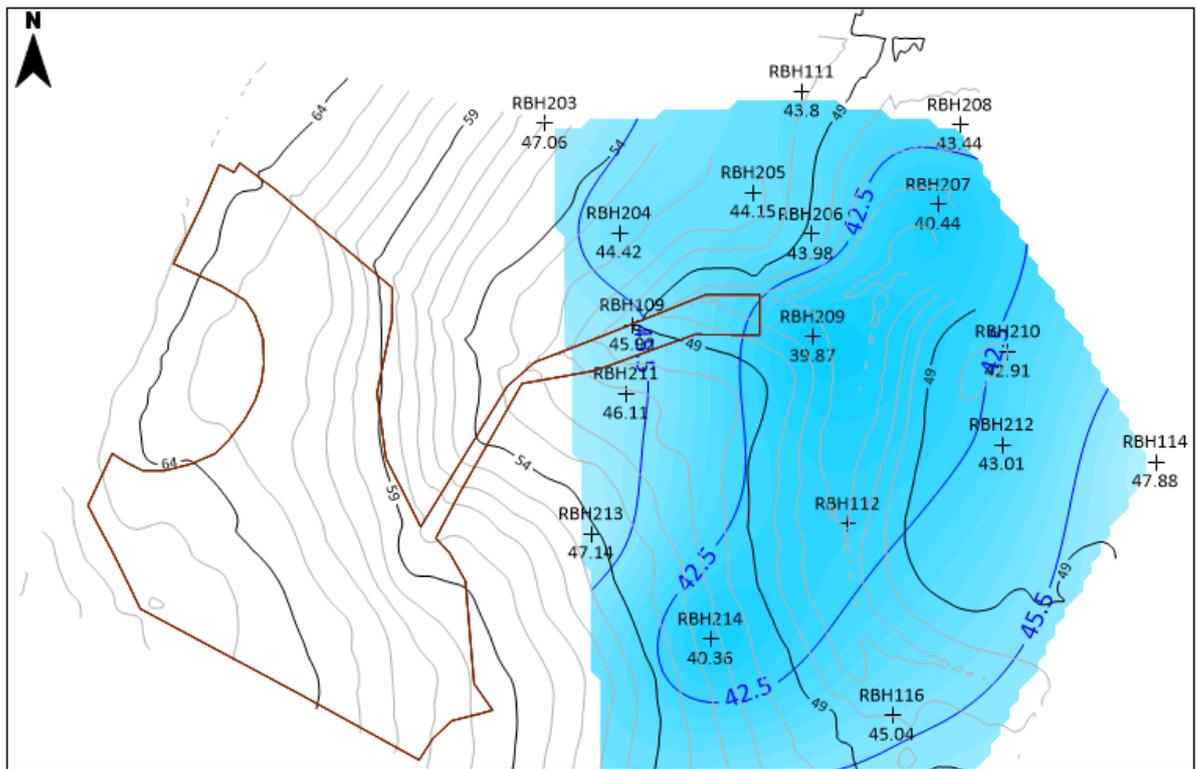
The Blisworth Limestone Formation is separated from the Cornbrash Limestone Formation by the Blisworth Clay Formation. Groundwater flow beneath the site within the Blisworth Formation is generally towards the north east following topographic profile as shown in Figure 5.6.

Figure 5.6: Groundwater contour plot for Blisworth Limestone Formation 04/07/2022

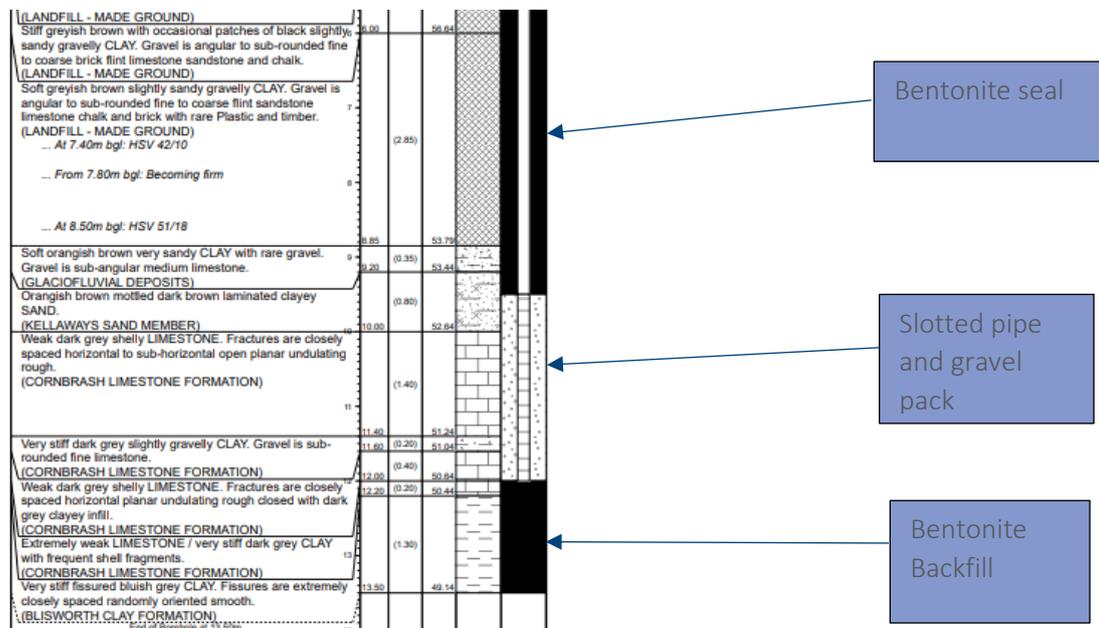
Logs of these boreholes are presented in Appendix C and an example completion configuration is shown in Figure 5.8 below (RBH 108). Such a completion arrangement would not be expected to cause a breach of the liner or any natural seal.

Figure 5.8: RBH-108 Completion Details

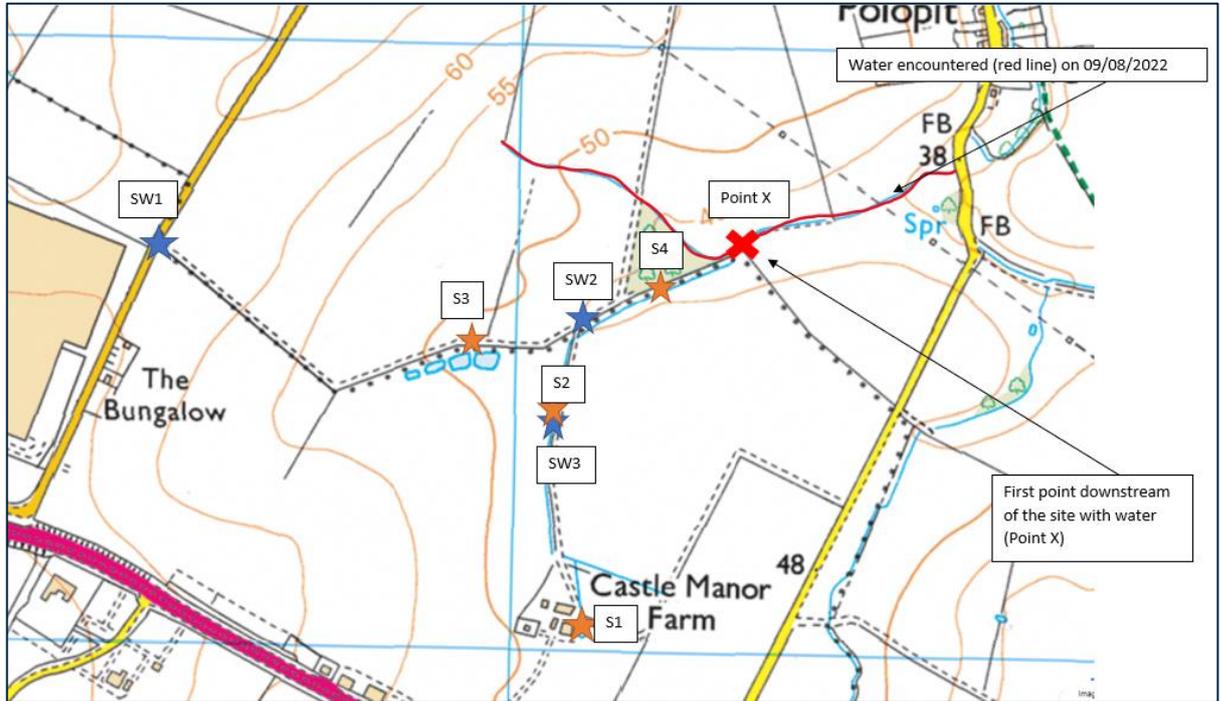
As per Figure 5.9 below, the first permanent water 'downstream' of the landfill site is subject to other water quality influences (such as agricultural activity). Whilst this potential extraneous effect compromises the effectiveness of any long-term monitoring, for precautionary reasons, it is proposed to include this location in the post closure monitoring regime.

Figure 5.9: Surface Water Monitoring Points

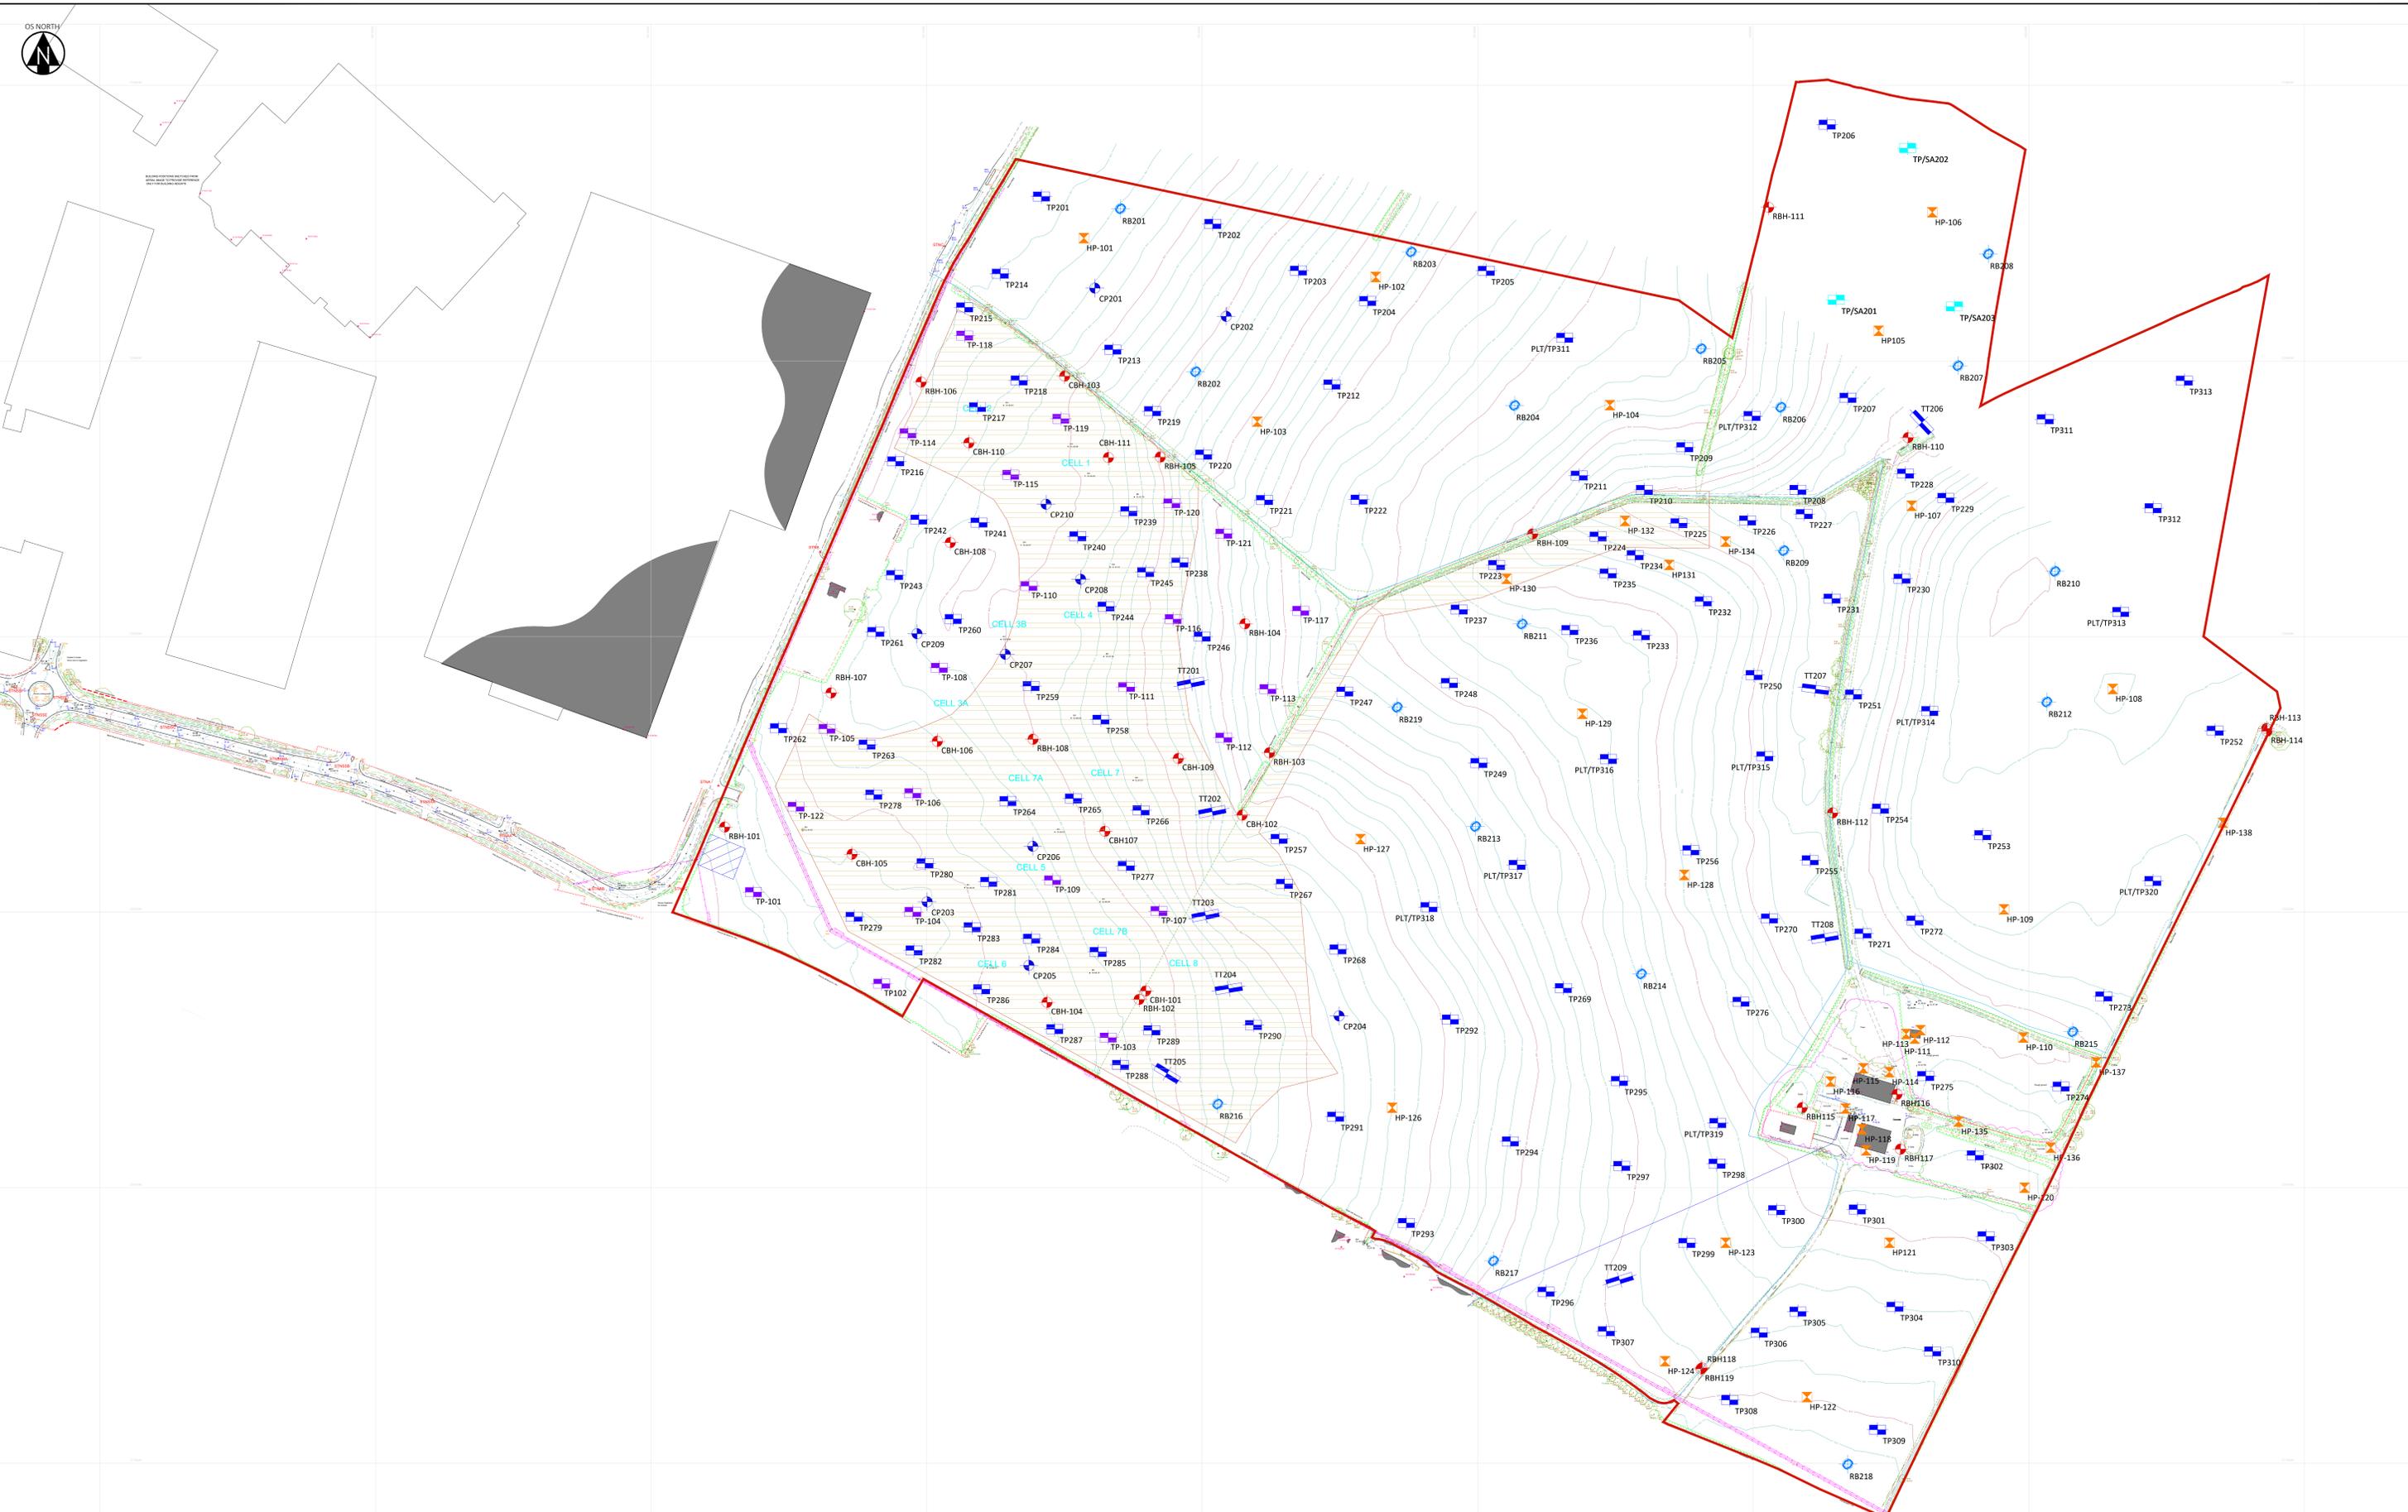
## *Hydrock Site Investigation Plan*

- Initial Site Investigation (June/July 2021)
- Trial Pit
  - Cable Percussion Borehole
  - Rotary Percussion / Core Borehole
  - Hand Dug Excavation Pit
  - Made Ground encountered

TITLE EXPLORATORY HOLE LOCATION PLAN	
HYDROCK PROJECT NO. C-18443	SCALE @ A0 1:1500
PURPOSE OF ISSUE SUITABLE FOR INFORMATION	STATUS S2
DRAWING NO. (PROJECT CODE, ORIGINATOR, ZONE LEVEL, TYPE, ROLE NUMBER) 18443-HYD-XX-ZZ-DR-GE-1004	REVISION P07

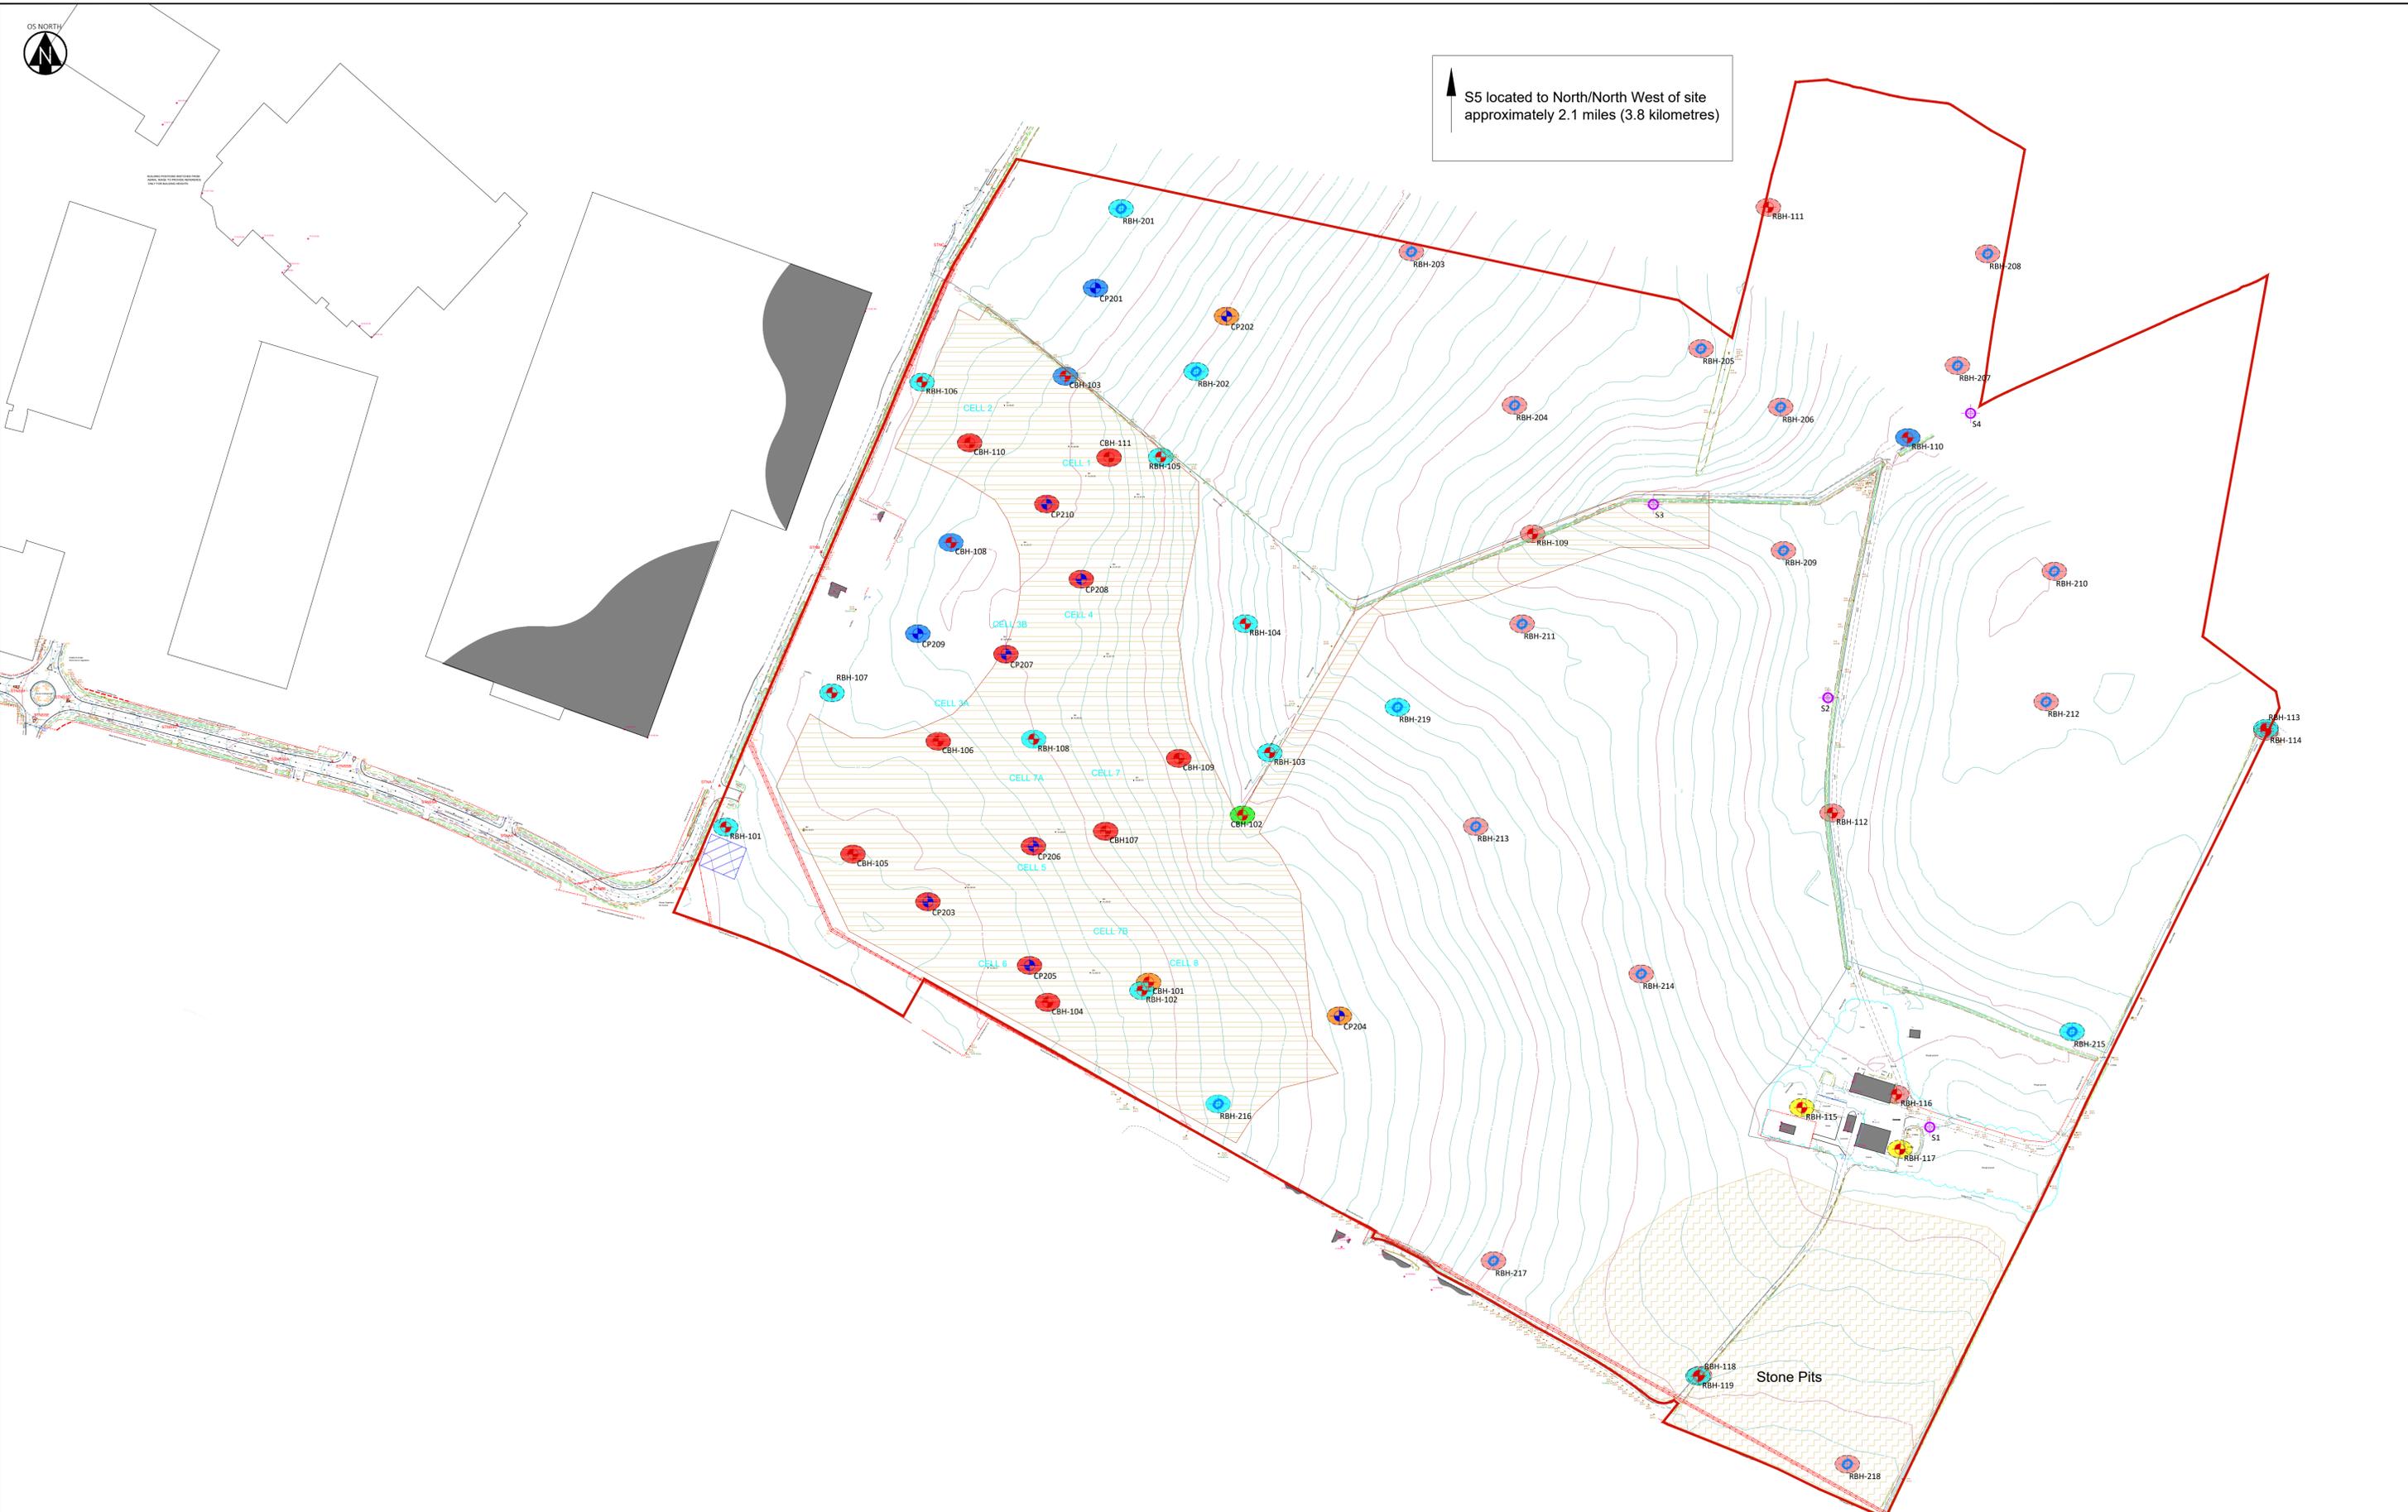
- Site Investigation Boreholes (June/July 2021)**
- RBHX Cable Percussion Borehole
  - RBHX Rotary Percussion / Core Borehole
- Detailed Site Investigation**
- CP# Cable Percussion Borehole
  - RB# Rotary Borehole
  - S# Water sample location

<b>TITLE</b> Borehole Installed and Groundwater Sample Plan	
<b>HYDROCK PROJECT NO.</b> C-18443	<b>SCALE @ A0</b> 1:1500
<b>PURPOSE OF ISSUE</b> SUITABLE FOR INFORMATION	<b>STATUS</b> S2
<b>DRAWING NO. (PROJECT CODE ORIGINATOR ZONE LEVEL/TITLE/ROLE/NUMBER)</b> 18443-HYD-XX-ZZ-DR-GE-1019	<b>REVISION</b> POS

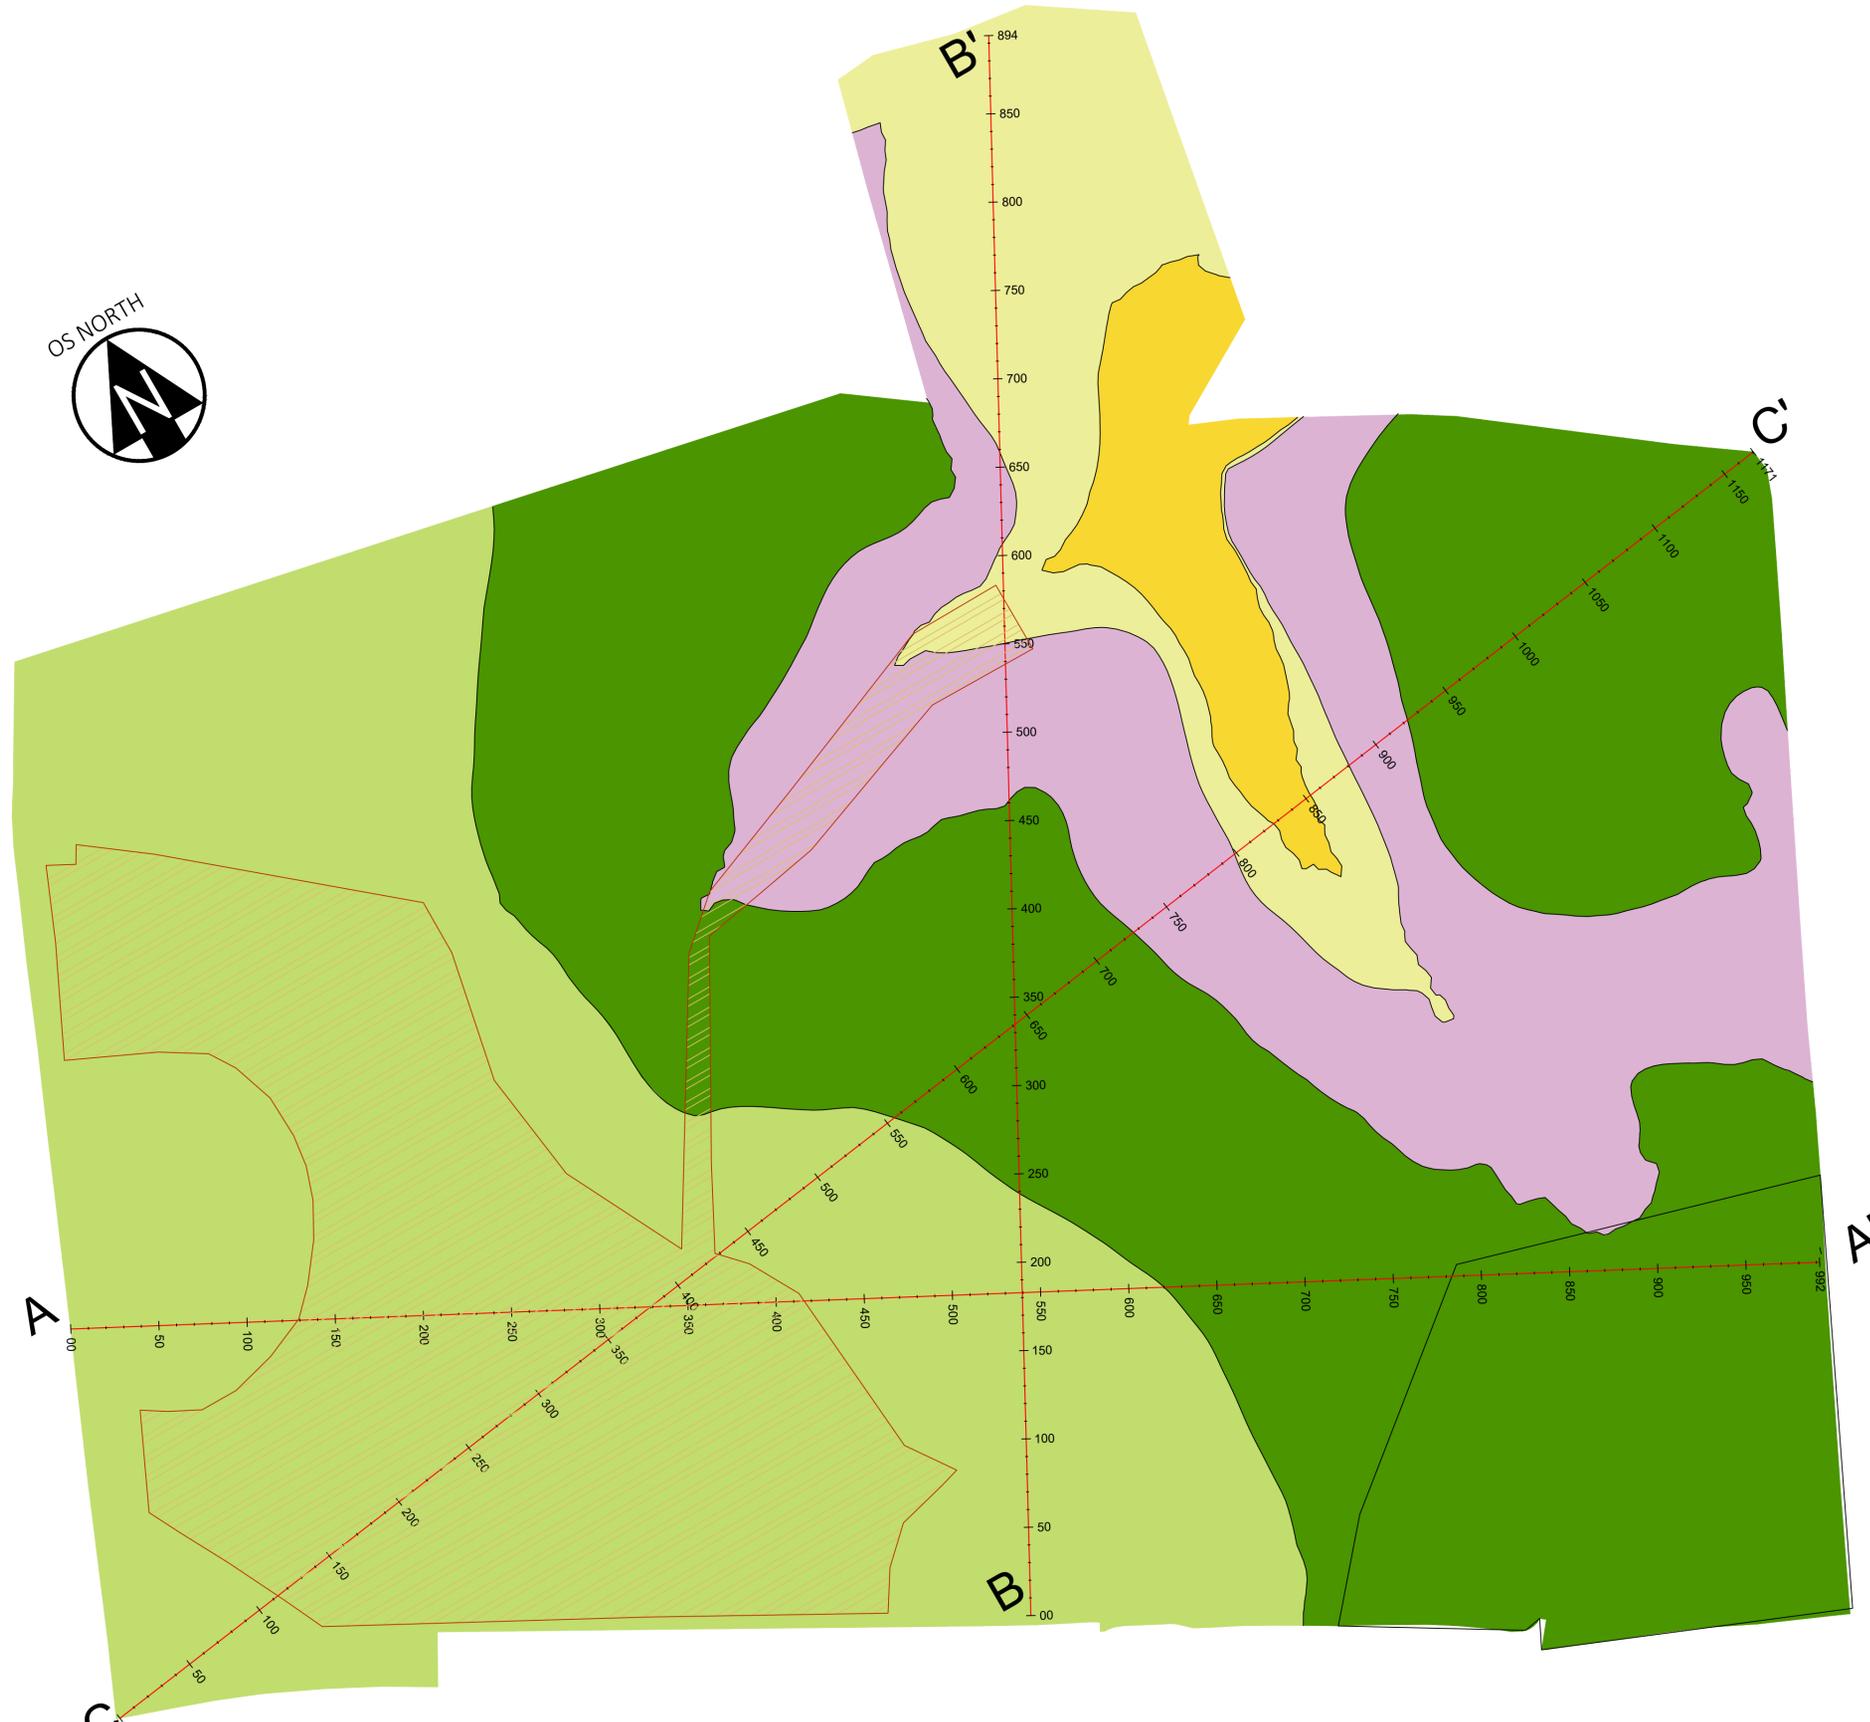
*Solid Geology Map*

- Kellaways Sand Member
- Kellaways Clay Member
- Cornbrash Formation
- Blisworth Clay Formation
- Blisworth Limestone Formation
- Made Ground

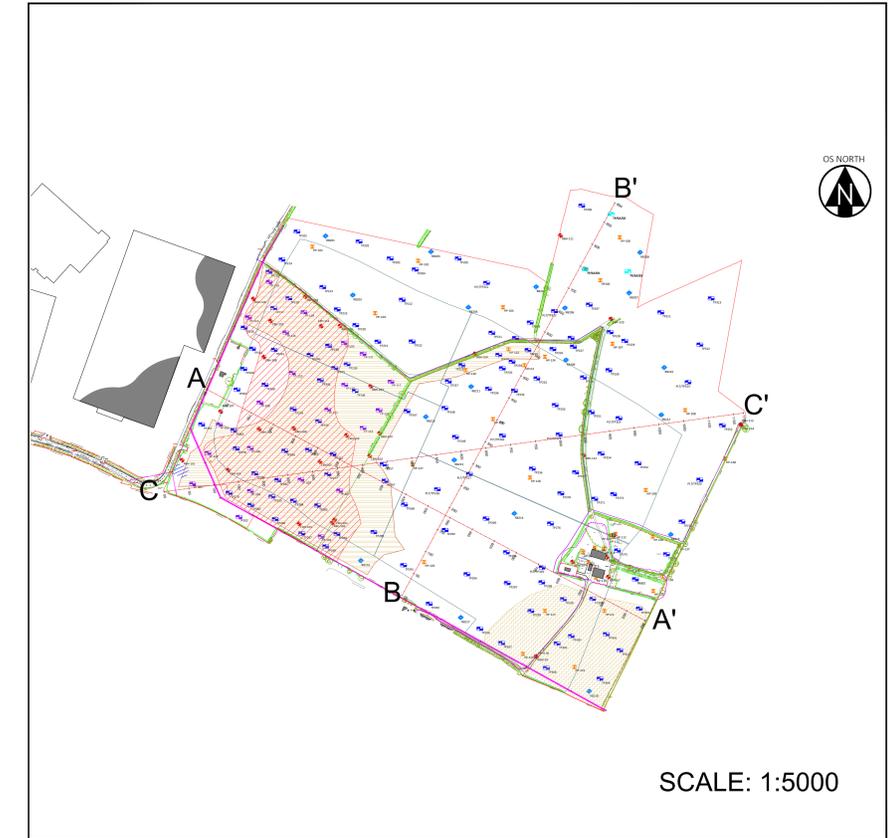
## *Cross Sections*

KEY	
	Top Soil + Agriculturally Top Soil
	Glacial Till + Glaciofluvial Deposits
	Blisworth Clay Formation
	Landfill Made Ground
	Kellaways Sand Member
	Blisworth Limestone Formation
	Made Ground
	Kellaways Clay Member
	Rutland Formation
	Combrash Formation
	Site Boundary (approximate)
	TPXX Trial Pit
	BHXX Cable Percussion Borehole
	RBHXX Rotary Percussion / Core Borehole
	HP## Hand Dug Excavation Pit
	Ground water level from BH with the screened zone within the Landfill made ground
	Ground water level from BH with the screened zone within the Combrash formation

The Cornbrash Limestone Formation was encountered underlying the Kellaways Clay Member across the majority of the landfill site except for the eastern half of the eastern overhang. As indicated on the geological sections A-A' and C-C' (Appendix F) there is an area beneath the centre of the landfill where both the Kellaways Sand and the Kellaways Clay are missing, such that the Cornbrash directly underlies the basal seal to deposited waste.
