## Groundwater Monitoring and Maintenance Plan

Proposed Redevelopment

Land Off Napier Road, Rockingham

Document no.: STP3966D-LQ-R02-Rev\_B

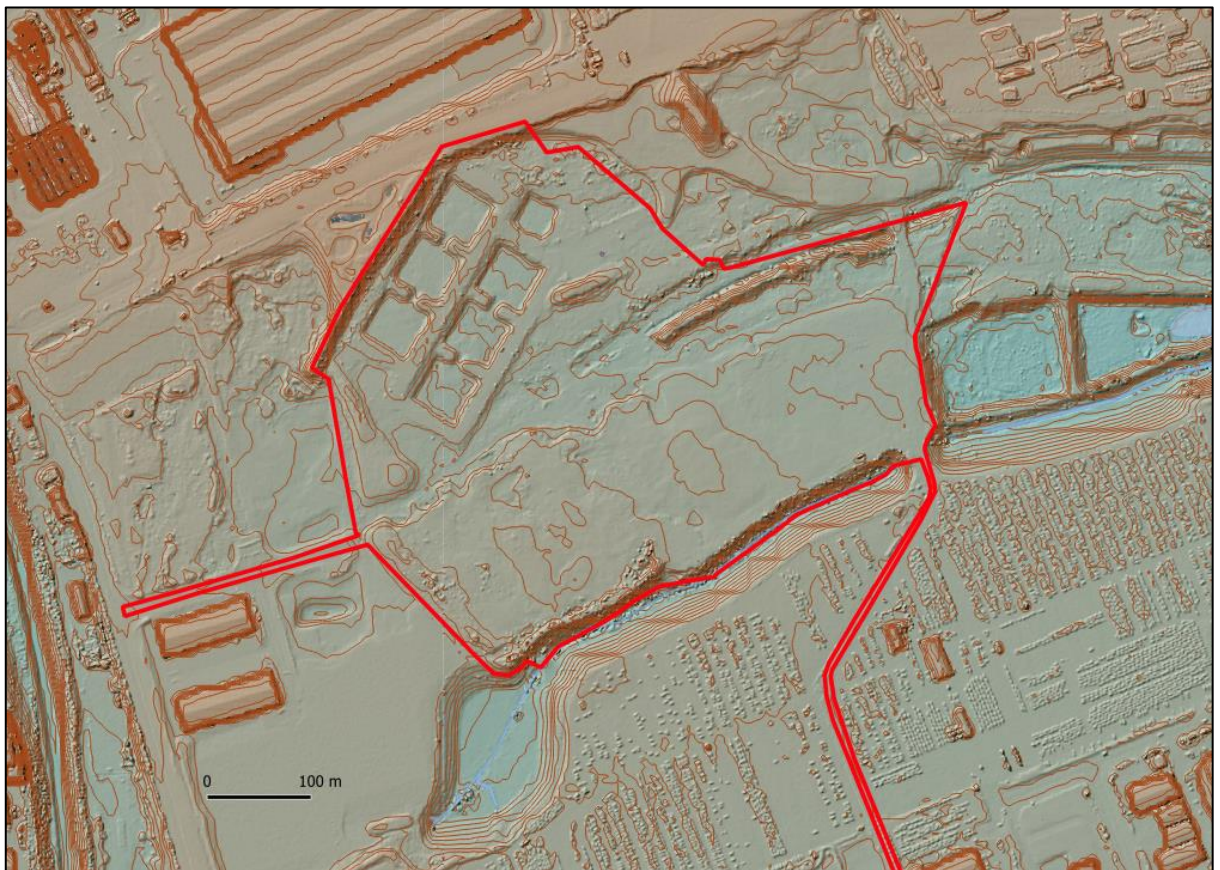
Figure 2-A: Site Topography

- 2.1.4 The natural, local topography of the site and surrounding area generally falls to the east culminating at the low point of Willow Brook which forms the sites southern Boundary, as shown in the figure below.

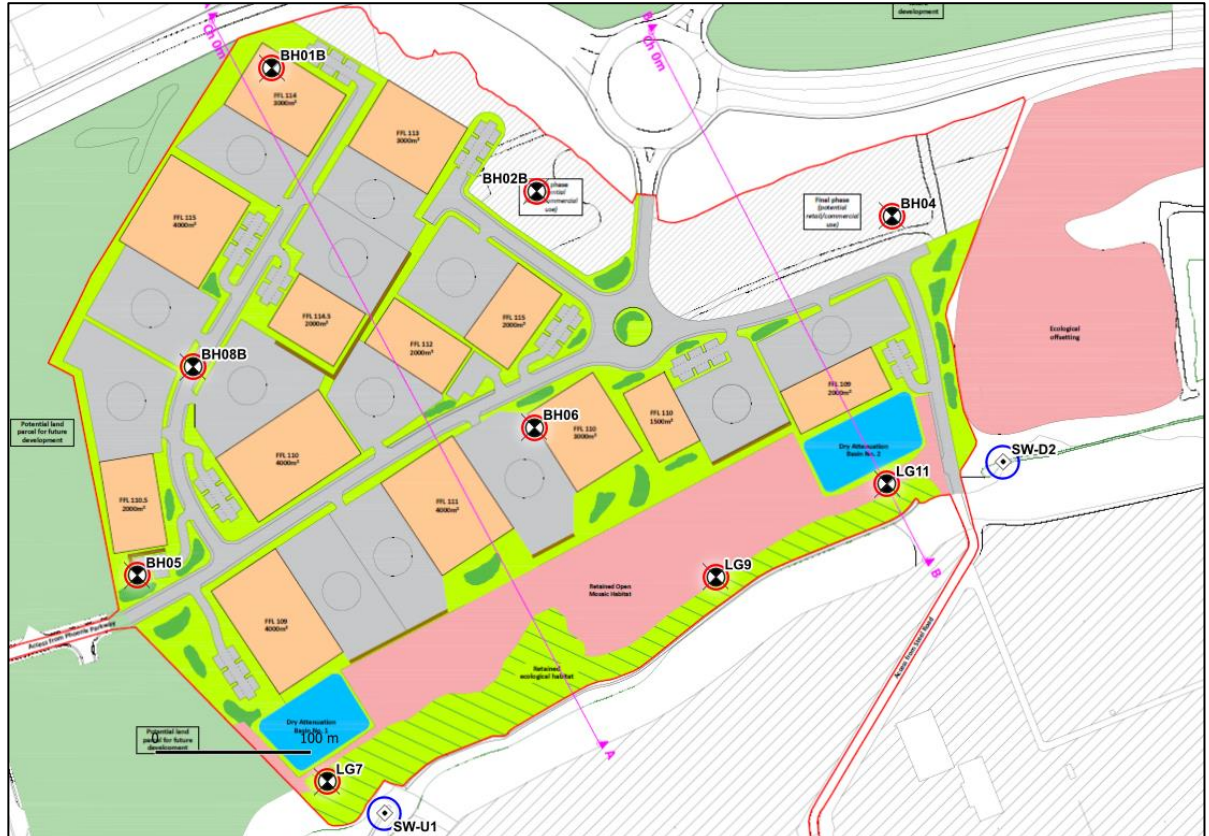
Figure 3-B: Proposed Monitoring Locations

3.5.2 A site plan is provided below for reference.

3.5.1 The following wells and surface water monitoring points are proposed to be established as the long term monitoring locations for the development. Preference has been given to existing boreholes which have previously utilised to obtain groundwater quality data, to enable comparison with the extensive baseline dataset.
