HARLESTONE INERT LANDFILL

ENVIRONMENTAL PERMIT APPLICATION

Stability Risk Assessment Report

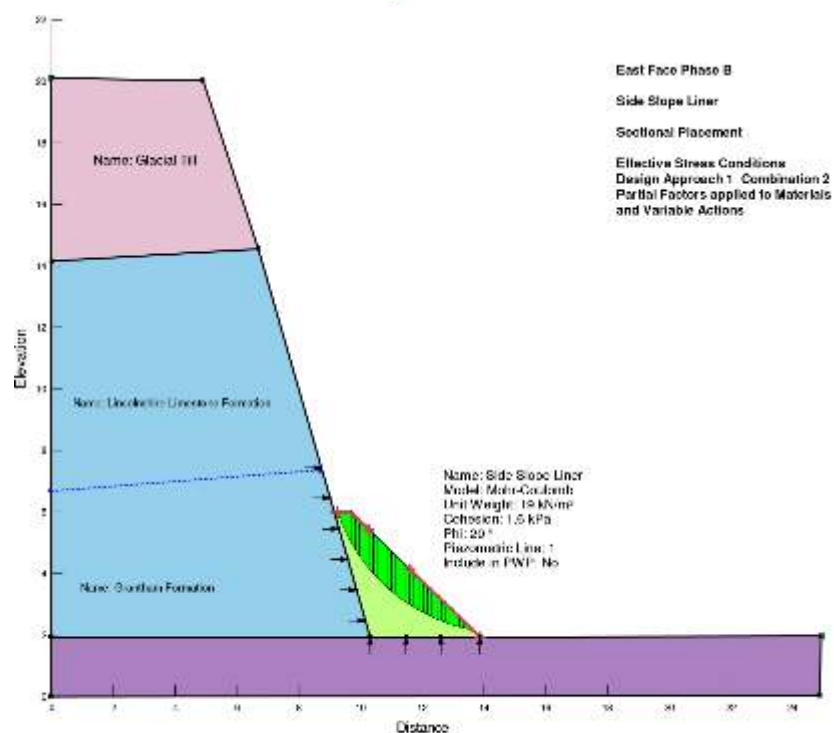
SlopeW Worksheets – Side Slope Liner

- 2.24 The results of the side slope liner stability analyses are shown in Table SRA5 and the SlopeW worksheets presented in Appendix 3.

Run	File Name	Shear Strength		Factor of Safety		Notes
		c	ϕ	C1	C2	
Side Slope Gradient up to 80 °						
01	SLINER1	50	0	6.04		Total Stress
02	SLINER2	36	0			
03	SLINER3	2	25	0.48		long term exposure – Full effective stress conditions
04	SLINER4	1.6	20			
05	SLINER5	1.6	20	1.16	1.07	Gradient slackened to 1(v) : 2 (h)

- 2.36 A 4m high lift of side slope liner has been analysed and is shown to be stable in the short term under total stress conditions with a minimum factor of safety of 5.94 being returned under Design Approach 1 Combination 2 factoring.

- 2.37 However, if left unsupported in the long-term such that fully drained effective stress conditions are achieved the liner becomes unstable. To achieve long term stability the side slope liner gradient needs to be slackened to 2(h) : 1(v) which then returns a factor of safety of 1.07 under the more onerous Combination 2 factoring.

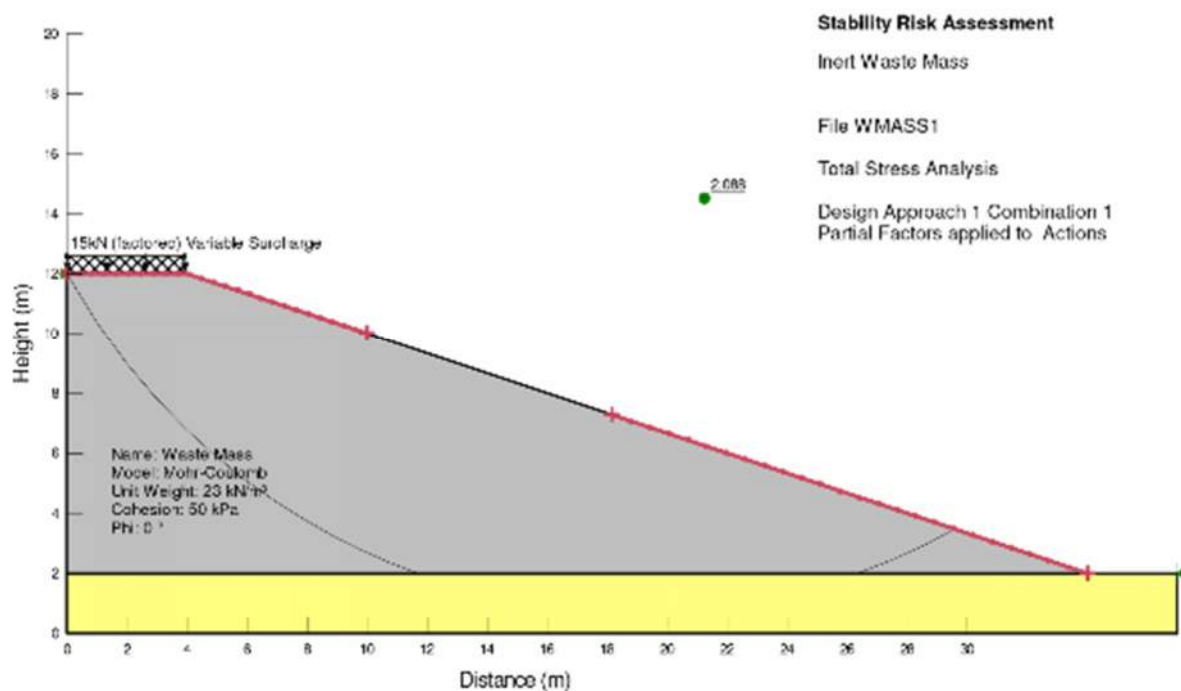
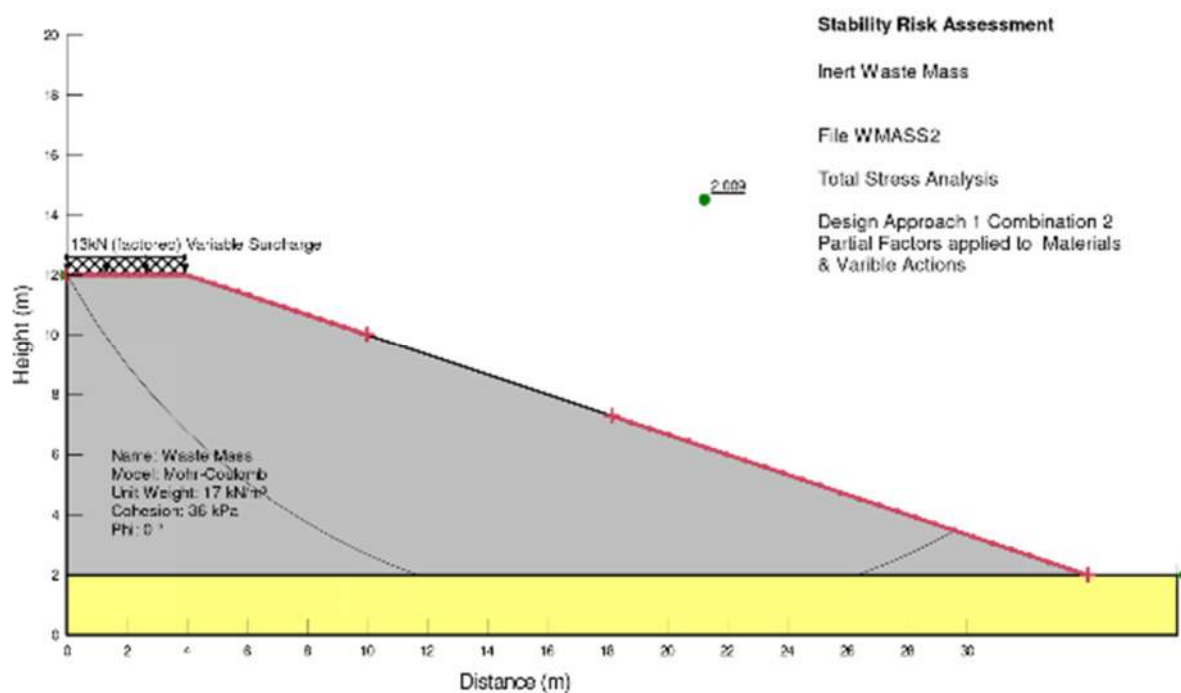
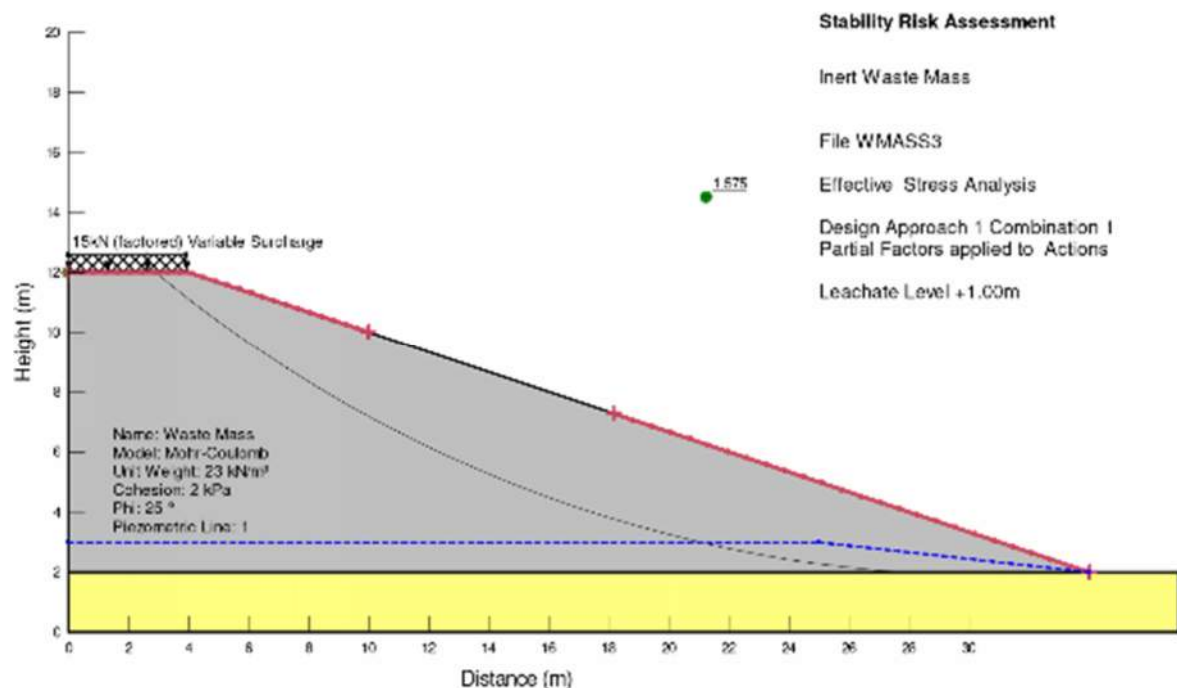
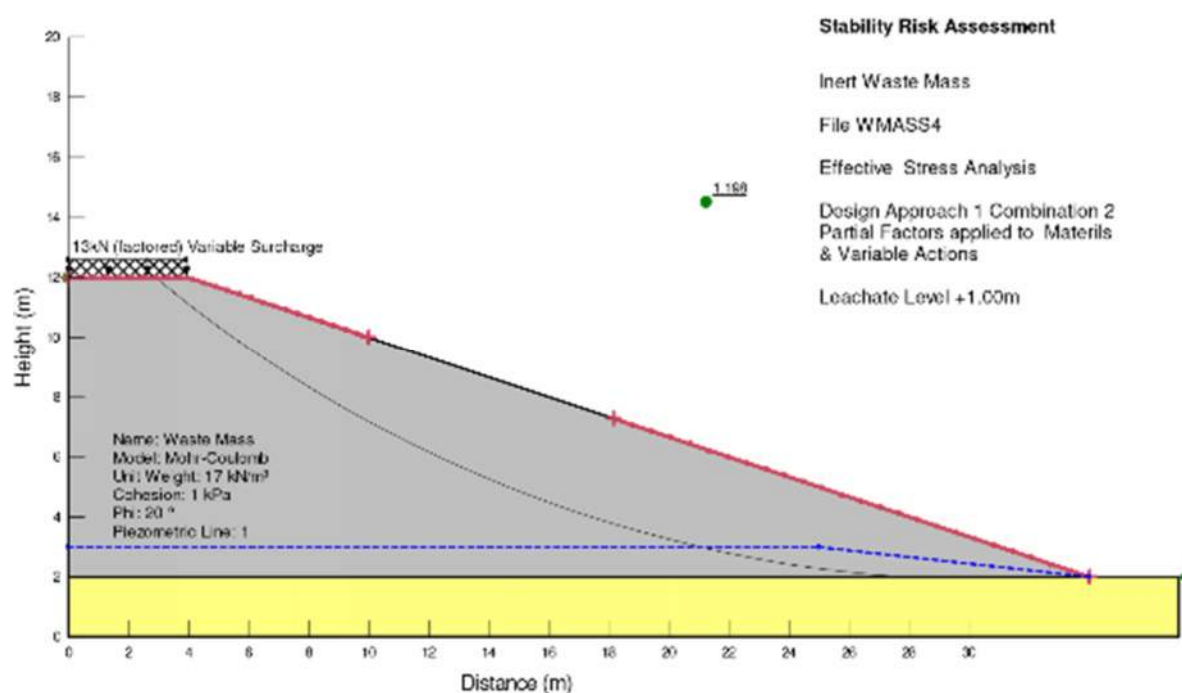
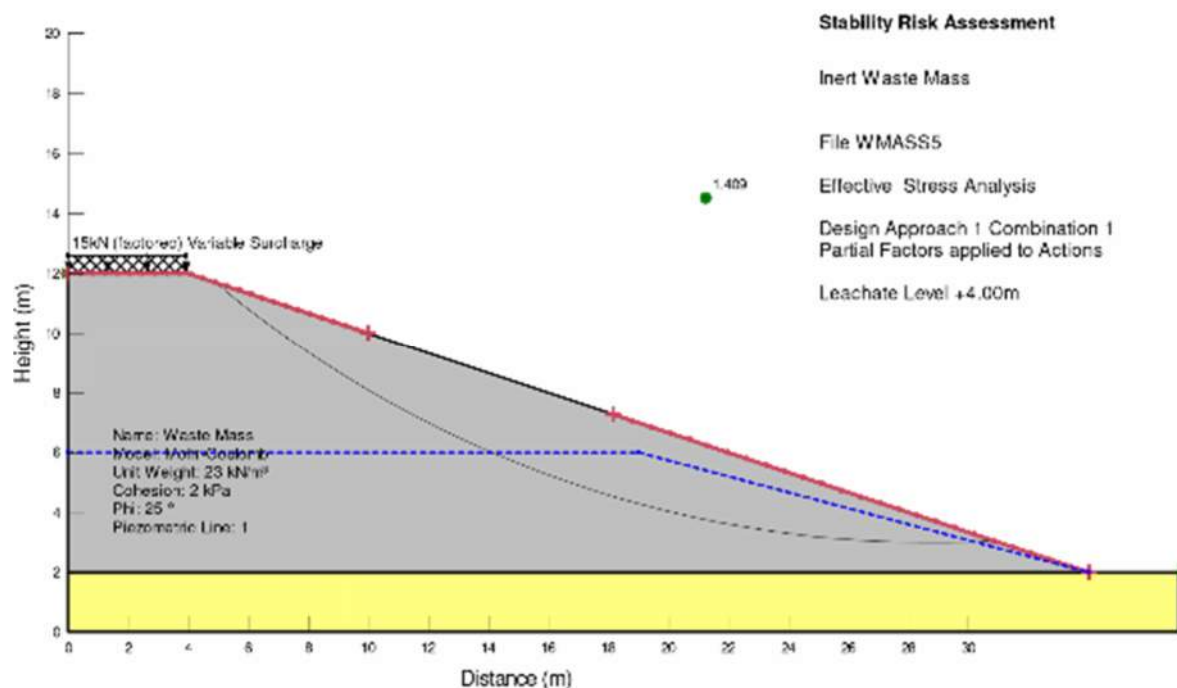
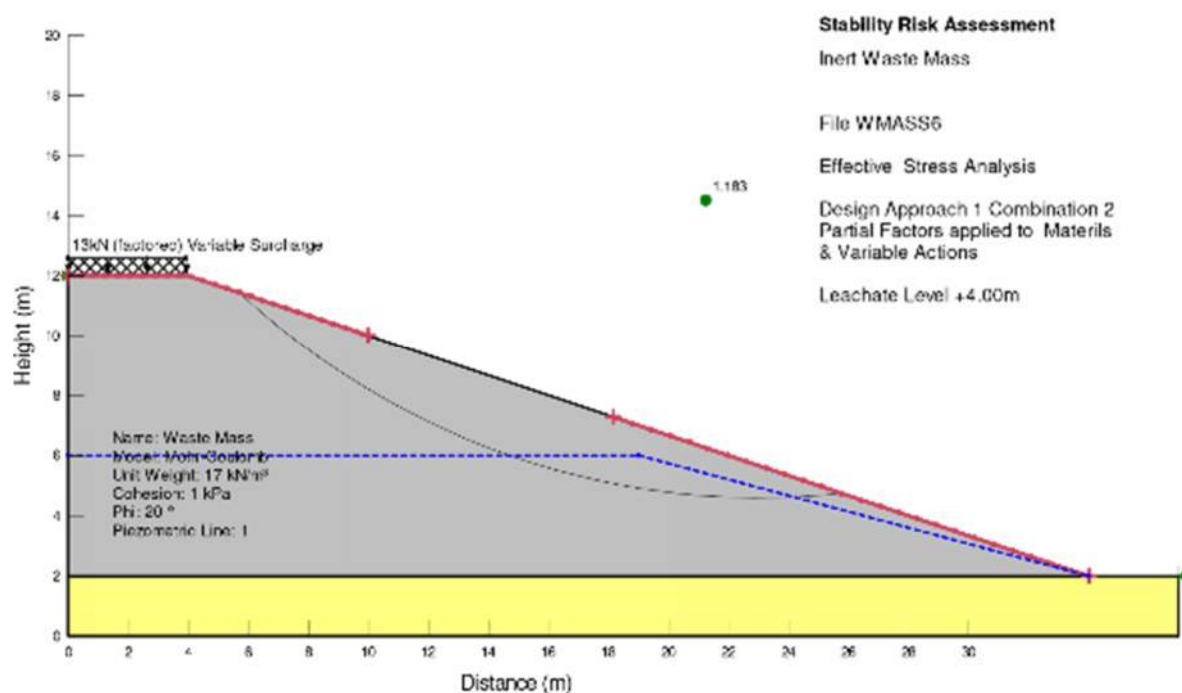
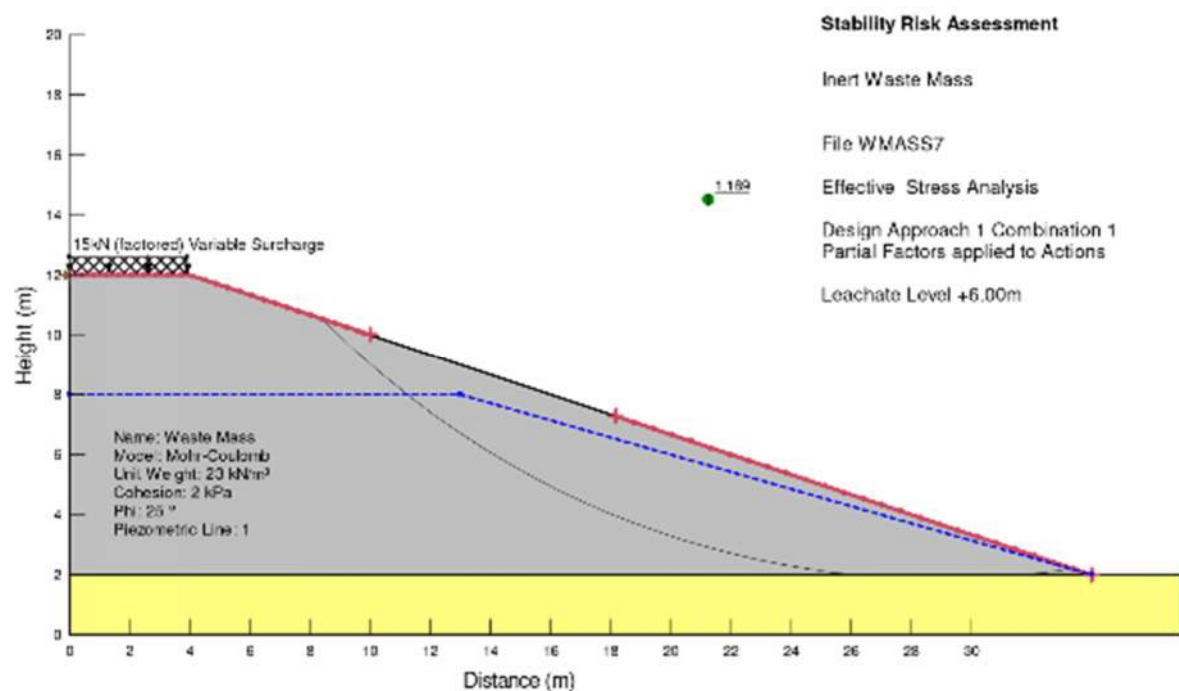
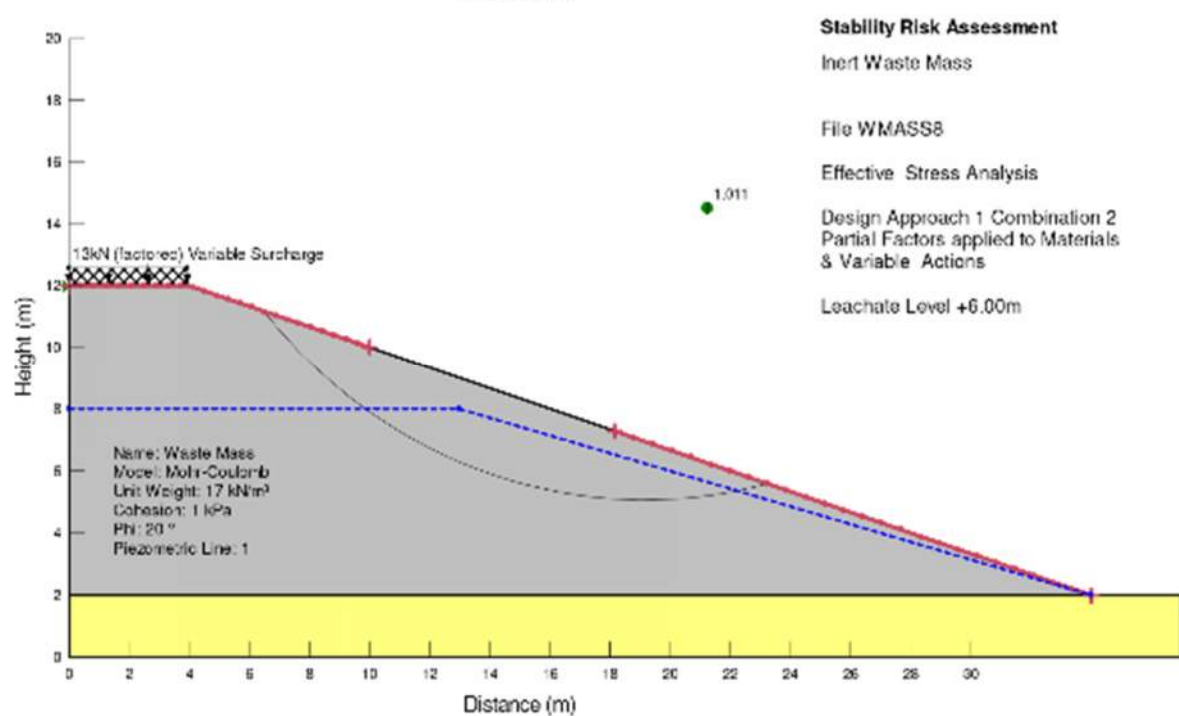
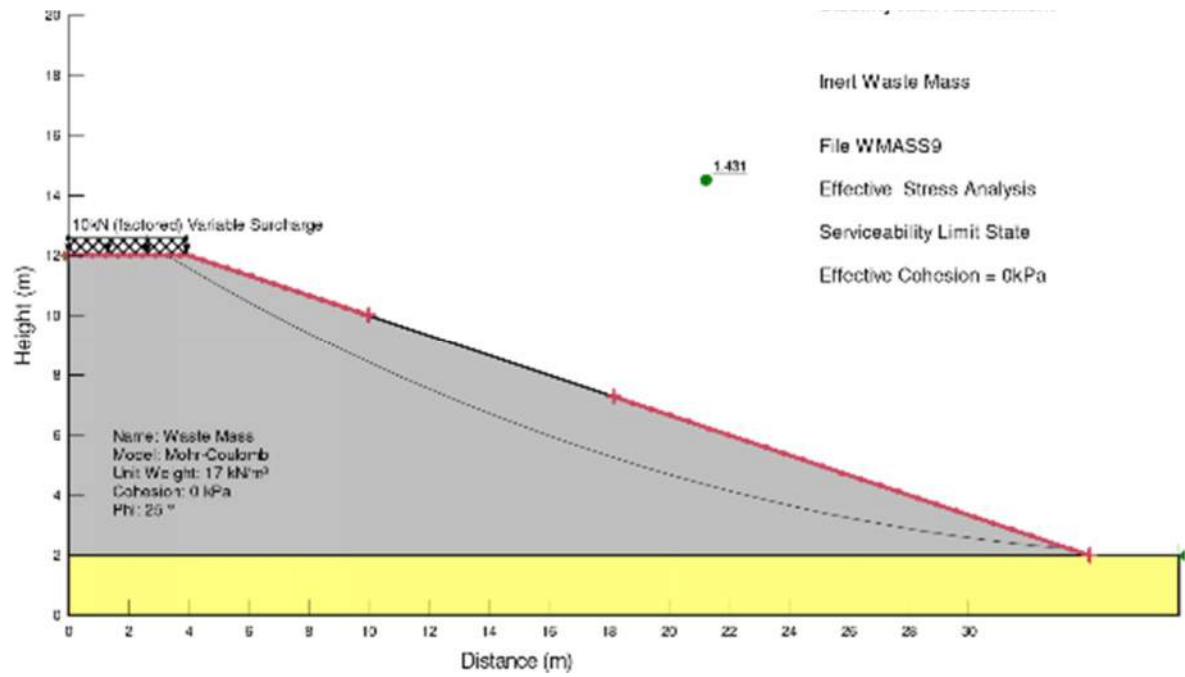
SlopeW Worksheets – Waste Mass

- 2.29 Slope/W has been used to undertake the investigation into failures wholly within the waste mass for both total and effective stress conditions.
- 2.30 The effects of variations in leachate pressure were modelled by investigating the effects of increased leachate levels on the factor of safety against instability within the waste body.
- 2.31 Results of the analyses are presented in Appendix 1 and can be summarised as follows:

Run	File Name	Waste Strength	Leachate Level	Degree of Utilisation		Notes
				C1	C2	
1	WMass1	Total	Dry	0.59		Short term waste mass parameters
2	WMass2				0.54	
3	WMass3	Effective	1.00m	0.63		Increasing leachate level measured from base of waste mass
4	WMass4				0.72	
5	WMass5		4.00	0.71		
6	WMass6				0.80	
07	WMass7		8.00	0.70		
08	WMass8				0.76	
09	WMass9		Not Present	1.39 (FoS)		Cohesion = 0kN/m ²

- 2.40 The stability of the temporary waste face was analysed using the computer programme SLOPE/W to calculate the factor of safety against failure through the waste body for a range of circular failure surfaces using Morgenstern and Price's method.
- 2.41 The importance of different leachate levels within the waste and their effect on overall stability were assessed. The effect of reduction of shear strength from peak to residual values has also been investigated.

- 2.42 The waste slope has a degree of utilisation < 1 for all leachate levels up to 6.00m from the base of the waste body. As the thickness of the unbuttressed inert waste is 12.00m a leachate level of 8.00m is extremely unlikely to occur under normal operating conditions.
- 2.43 The waste slope has a factor of safety of 1.39 even if the value of the cohesion intercept of the waste reduces from 5kN/m^2 to 0kN/m^2 .
- 2.44 It is concluded that a 1(v) : 3(h) waste slope will be stable for the range of leachate levels anticipated.
