Environmental Permit EPR/XP3092NX
Sidegate Lane Battery Recycling Facility
Site Condition Report

Document title	Sidegate Lane Battery Recycling Facility Site Condition Report
Version	Version 1.0
Date	July 2025
Prepared by	Daniel Reeves – Environment and Industrial Risk Advisor – Technical Hydrogeology
Reviewed by	Geraldine Guiguet-Doron - Permit Manager
Approved by	Chris Dussek – National Hydrogeology Manager
Distribution	SUEZ Environment Agency

Appendix A Sidegate Lane Landfill. Materials Recycling Facility and Transfer Station. Geoenvironmental Assessment Report. Hyder. Report 5001-BM01213-BMR-01. February 2008.

Appendix B Sidegate Lane Landfill, Wellingborough, Northamptonshire. Phase 1 Site Investigation Report for Proposed RDF Facility. Terraconsult. Ref: 1601/01. May 2012

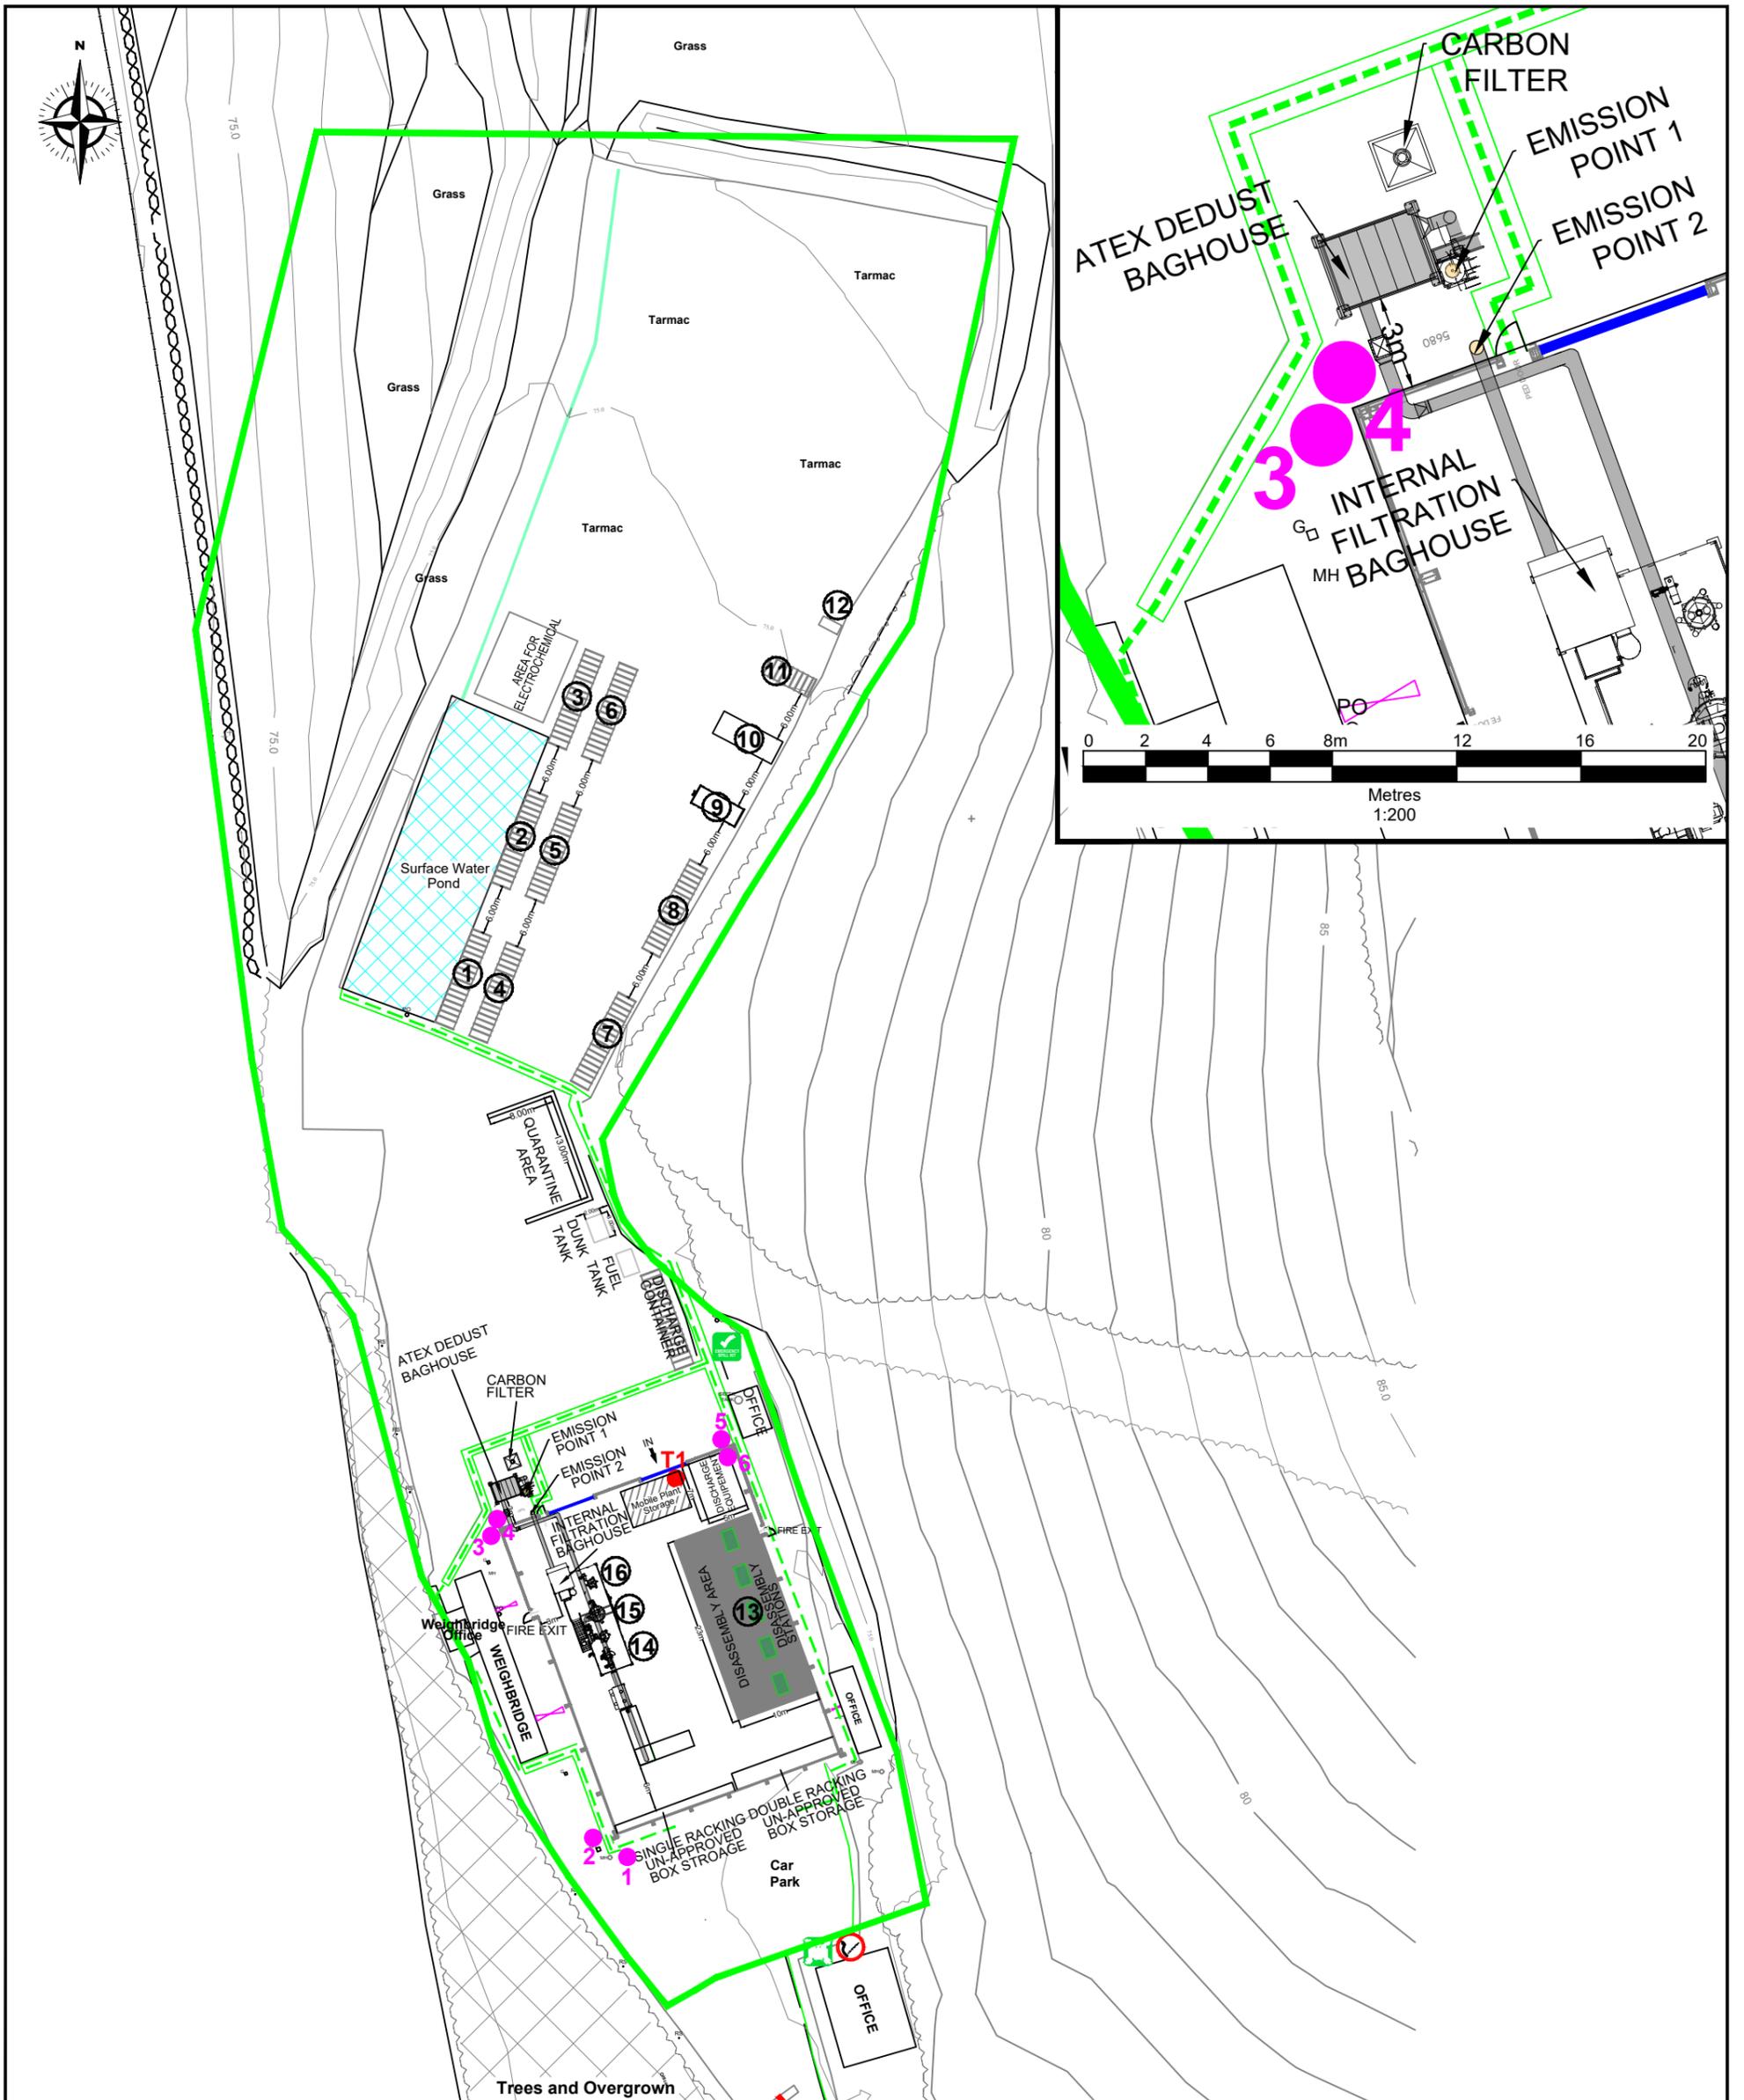
Figure 2

Site Layout Plan

- Permit Boundary
- CCTV
- Thermal Camera
- Safe Walkway
- + Fire Assembly Point
- Smoking Area
- Spill Kit

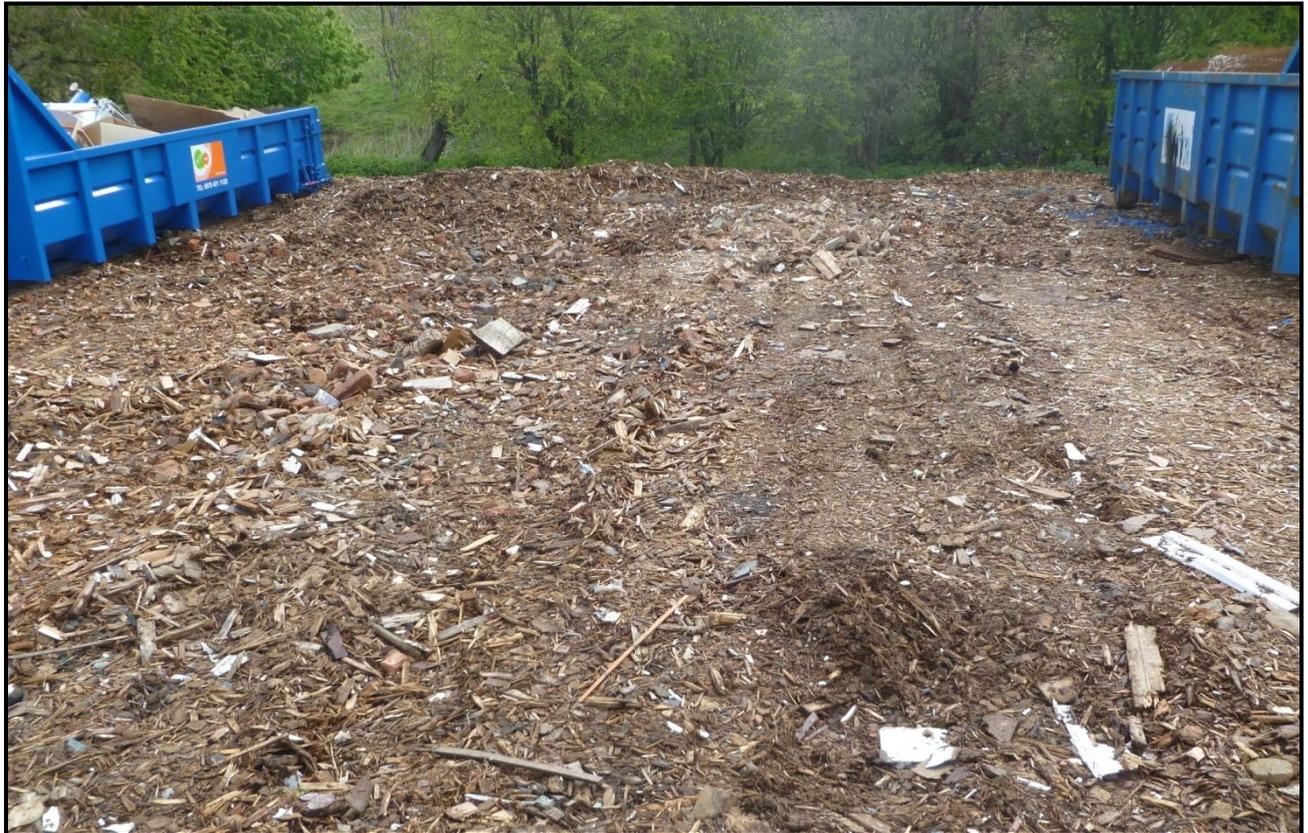
Photograph 9: Unmade Ground of Woodchip and Hardcore in Centre of Site

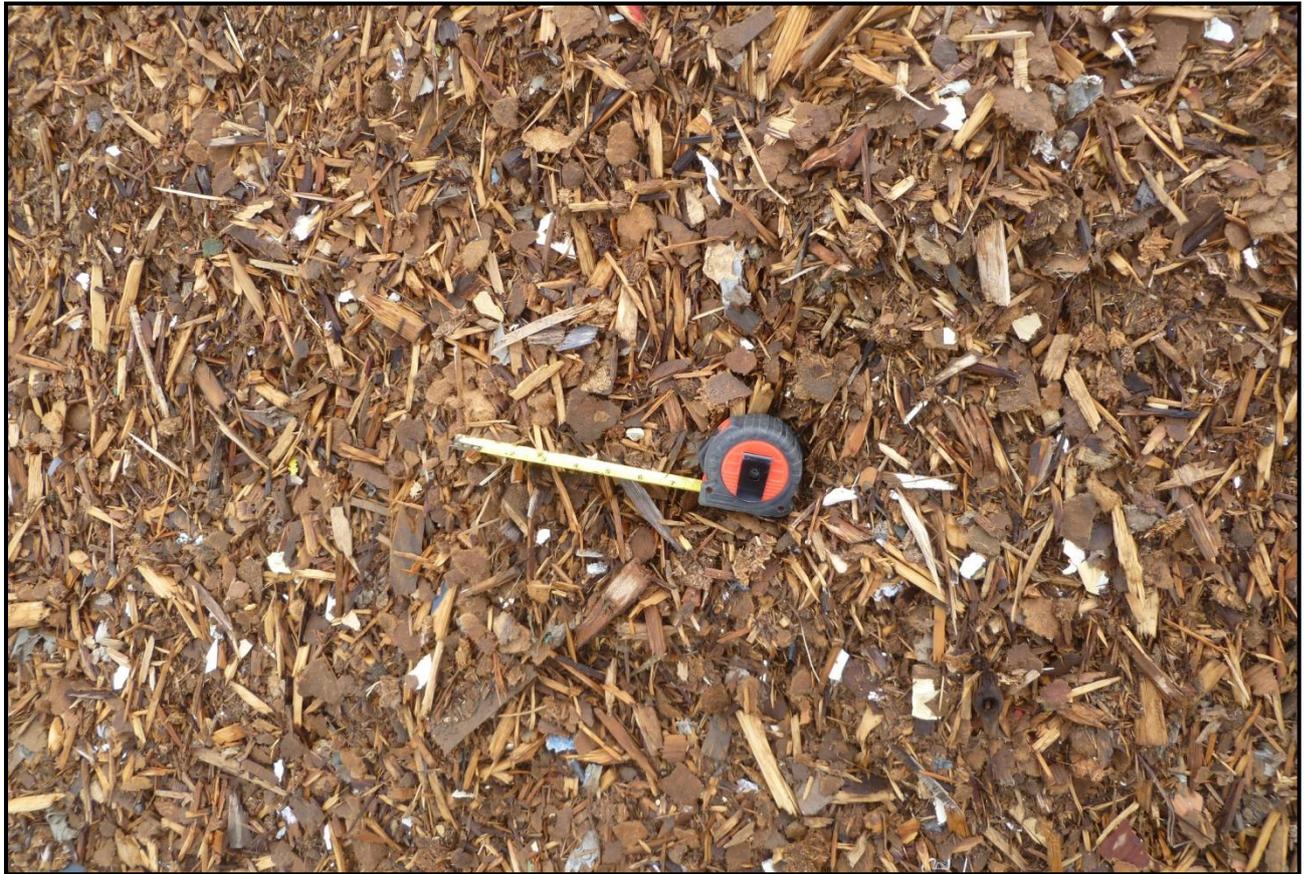
Photograph 13: Fine Grade Woodchip (tape measure extended 0.20 m)

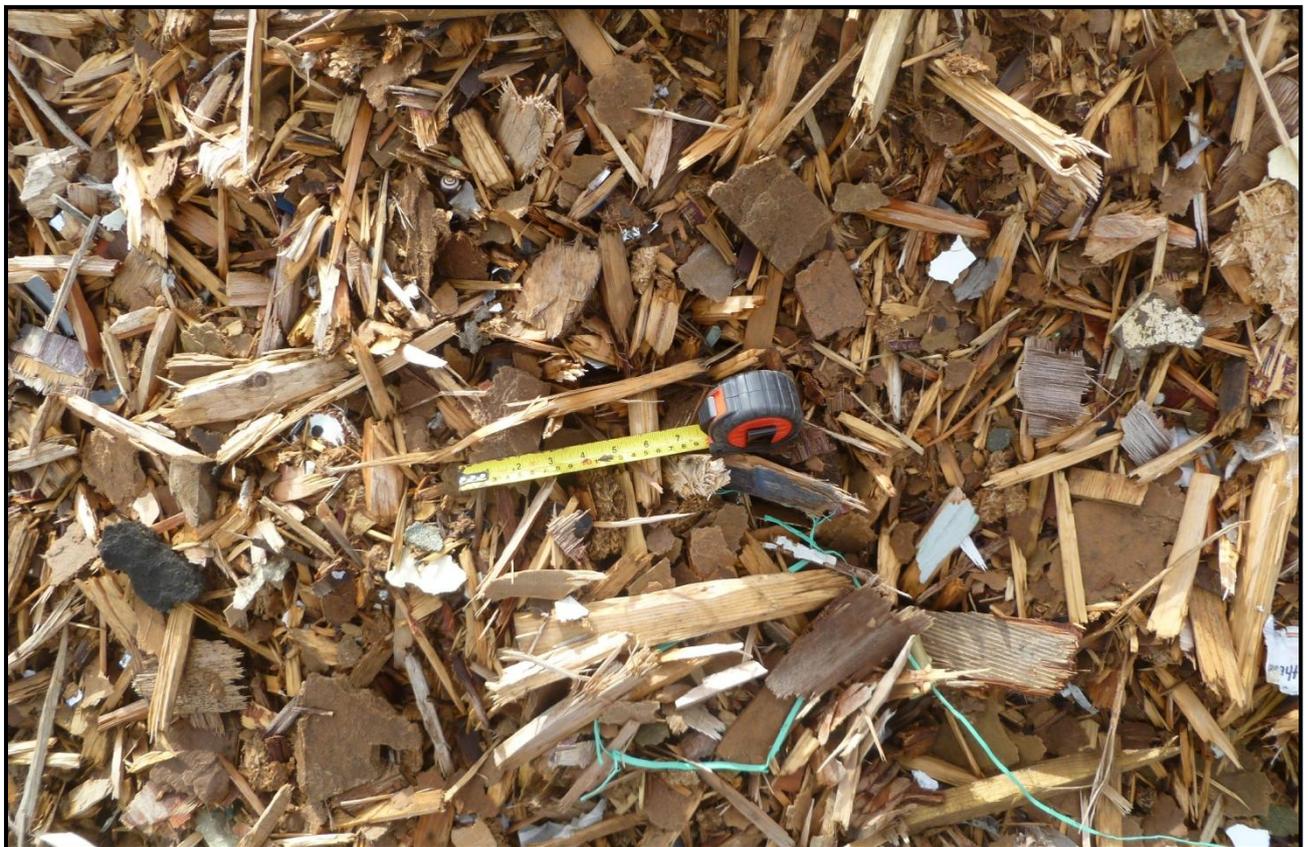
Photograph 14: Coarser Grade Woodchip (tape measure extended 0.20 m)

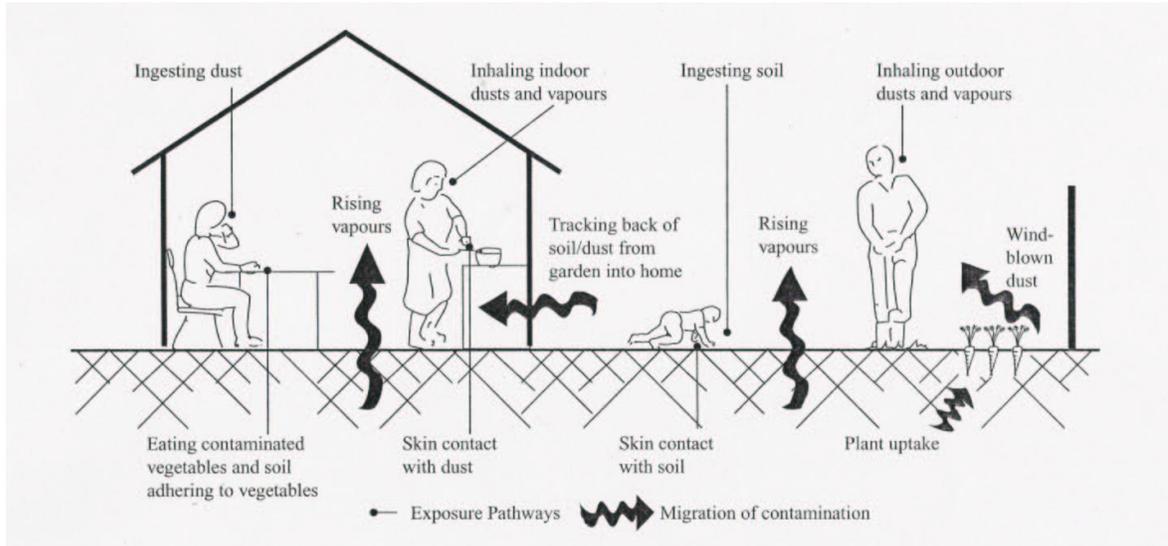
The CLEA model has been developed to calculate an estimated tolerable daily soil intake (TDSI) for site users given a set 'default' exposure pathways. Ten human exposure pathways are covered in the CLEA model as presented below:

- **Ingestion**
 - ingestion of outdoor soil;
 - ingestion of indoor dust;
 - ingestion of home grown vegetables;
 - ingestion of soil attached to home grown vegetables.
- **Dermal Contact**
 - dermal contact with outdoor soil;
 - dermal contact with indoor dust.
- **Inhalation**
 - inhalation of outdoor dust;
 - inhalation of indoor dust;
 - inhalation of outdoor soil vapour;
 - inhalation of indoor soil vapour.

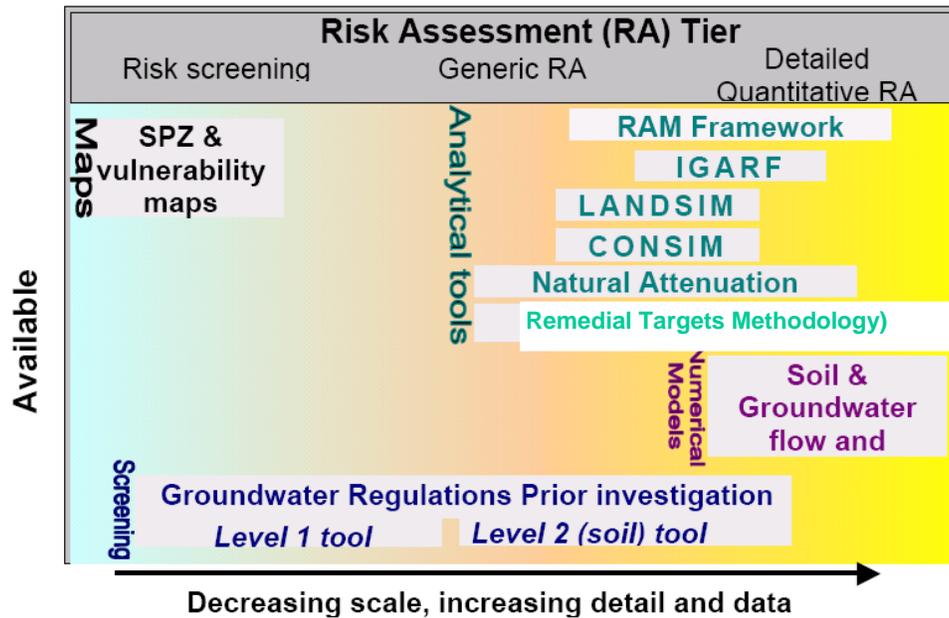
Figure 1-1 Environment Agency groundwater assessment tools, mapped against the different levels of risk assessment.

The process is summarised below (Taken from the Environment Agency GP3 draft consultation document, 2006):

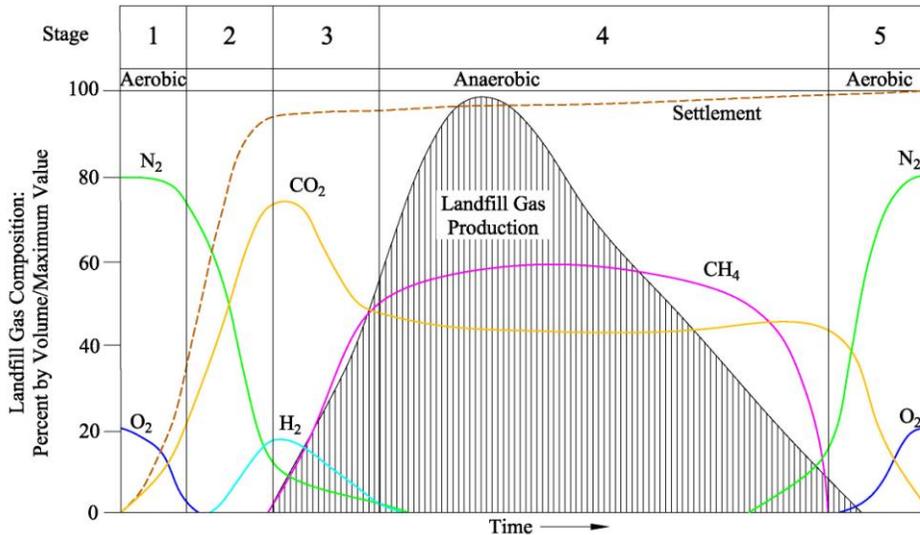
Figure G2. Idealised Representation of Landfill Gas Generation.

Figure G2 is taken from EA guidance document LFTGN 03 illustrates typical ground gas generation curves from biodegradable materials:

The production of methane and carbon dioxide at a landfill site may be expected to be considerable and ongoing. Concentrations of methane will eventually decrease, followed by concentrations of carbon dioxide, but the duration and rate of gas production can vary markedly between sites. Five distinct phases of gas production occur during the process which are, in order of event (as marked on Figure G2), as follows:

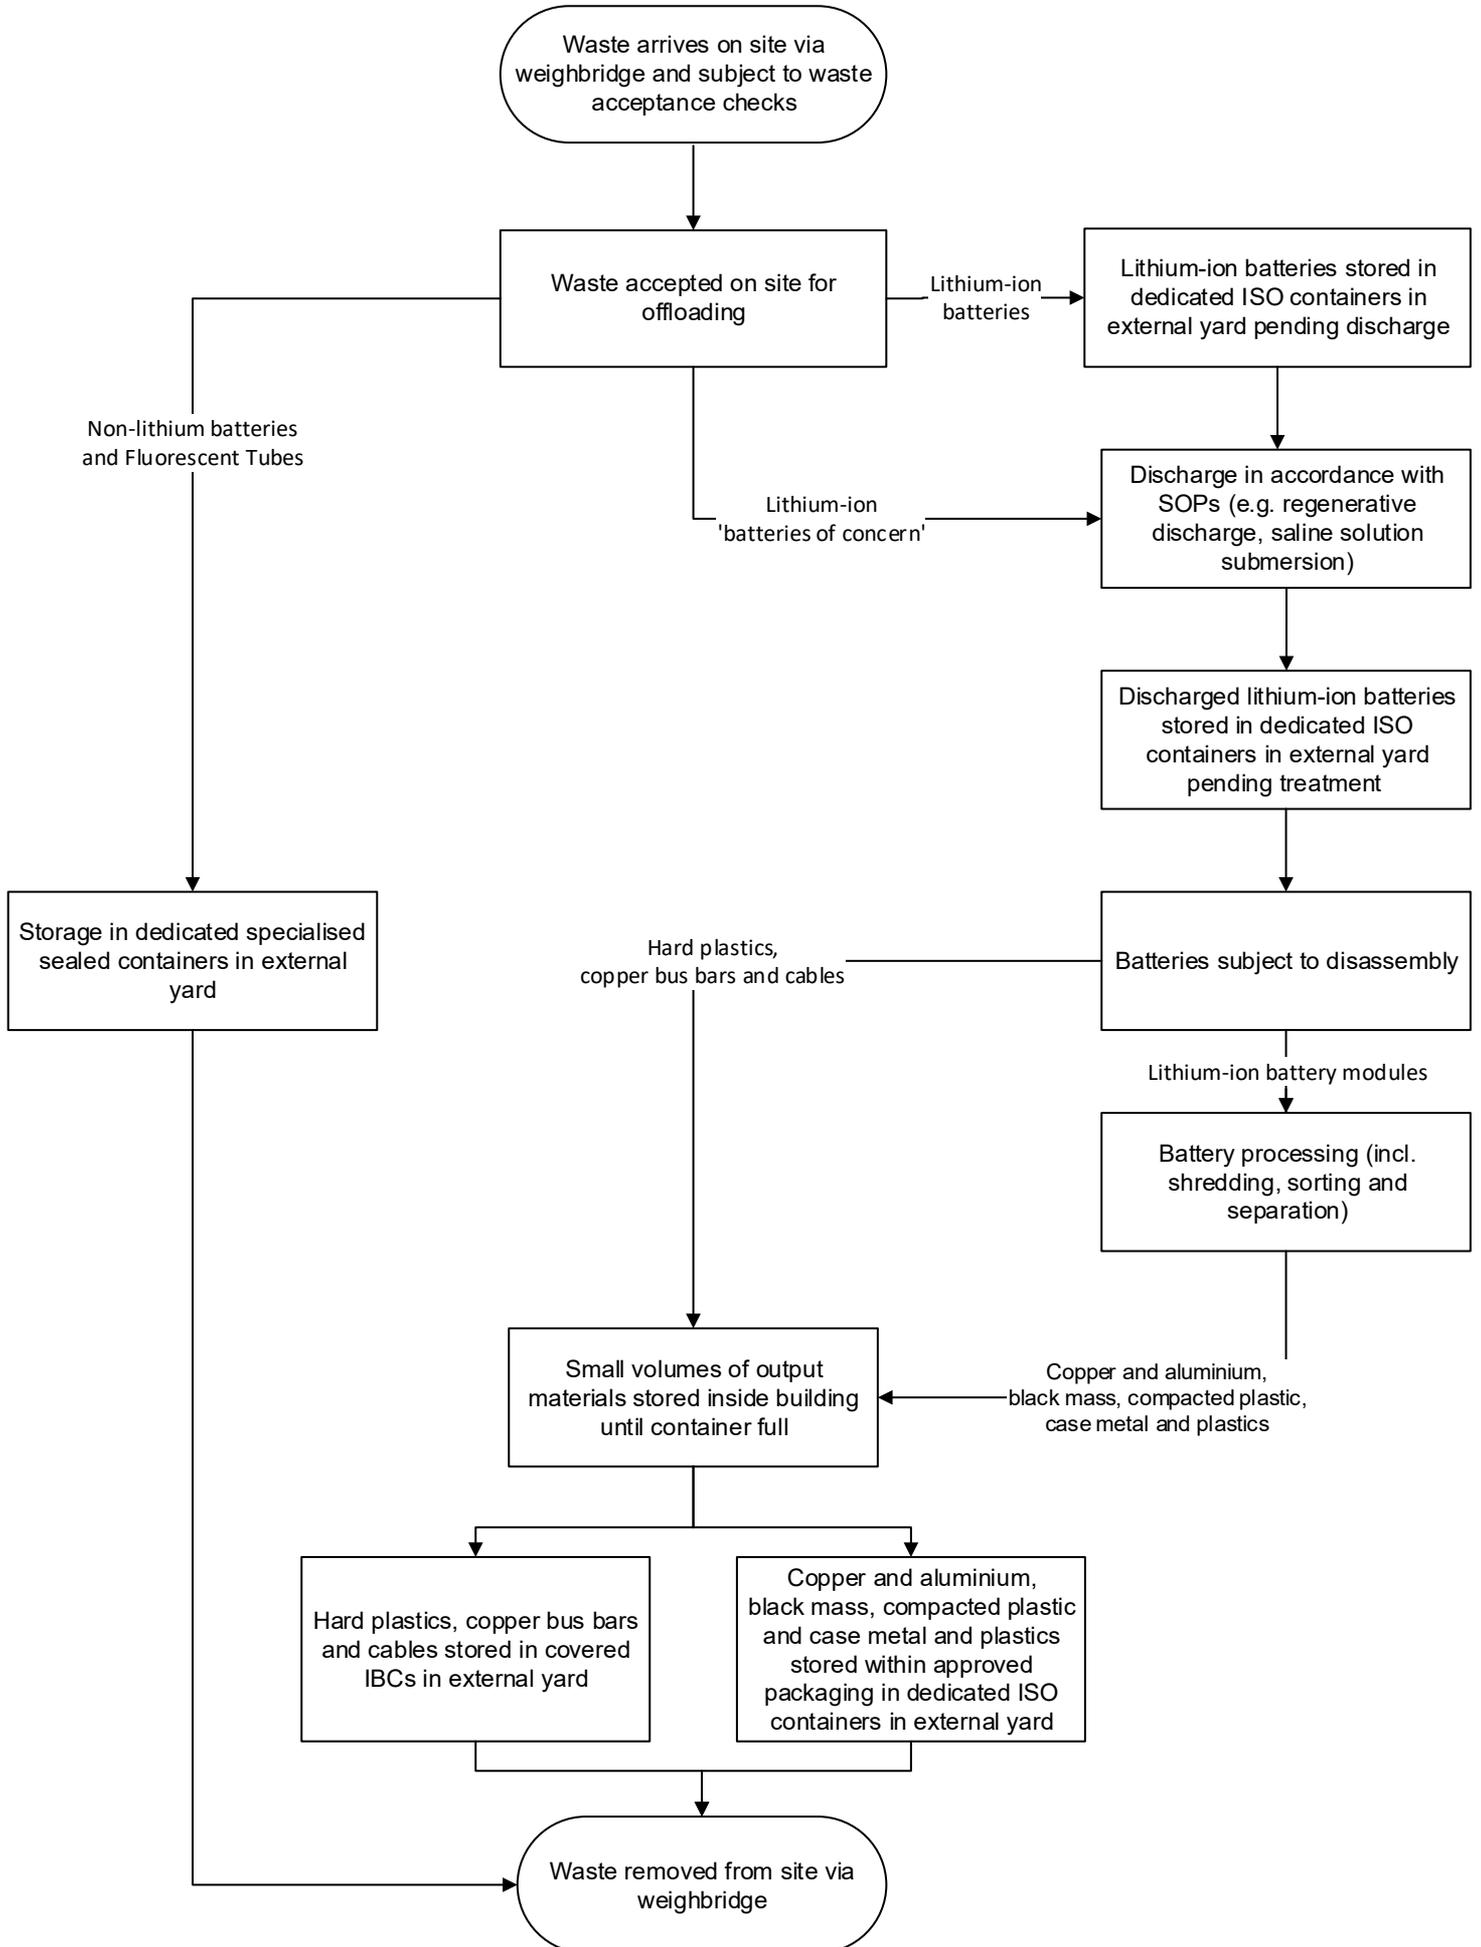
Figure 1: Process Flow

With regards to the discharge of “batteries of concern” within saline fluid, this is performed outside in the yard area, on hardstanding near the lagoon within the permit boundary. Primary containment is performed by the container, with secondary containment by the bunded pallet, and tertiary containment by the drainage system into the surface water lagoon.

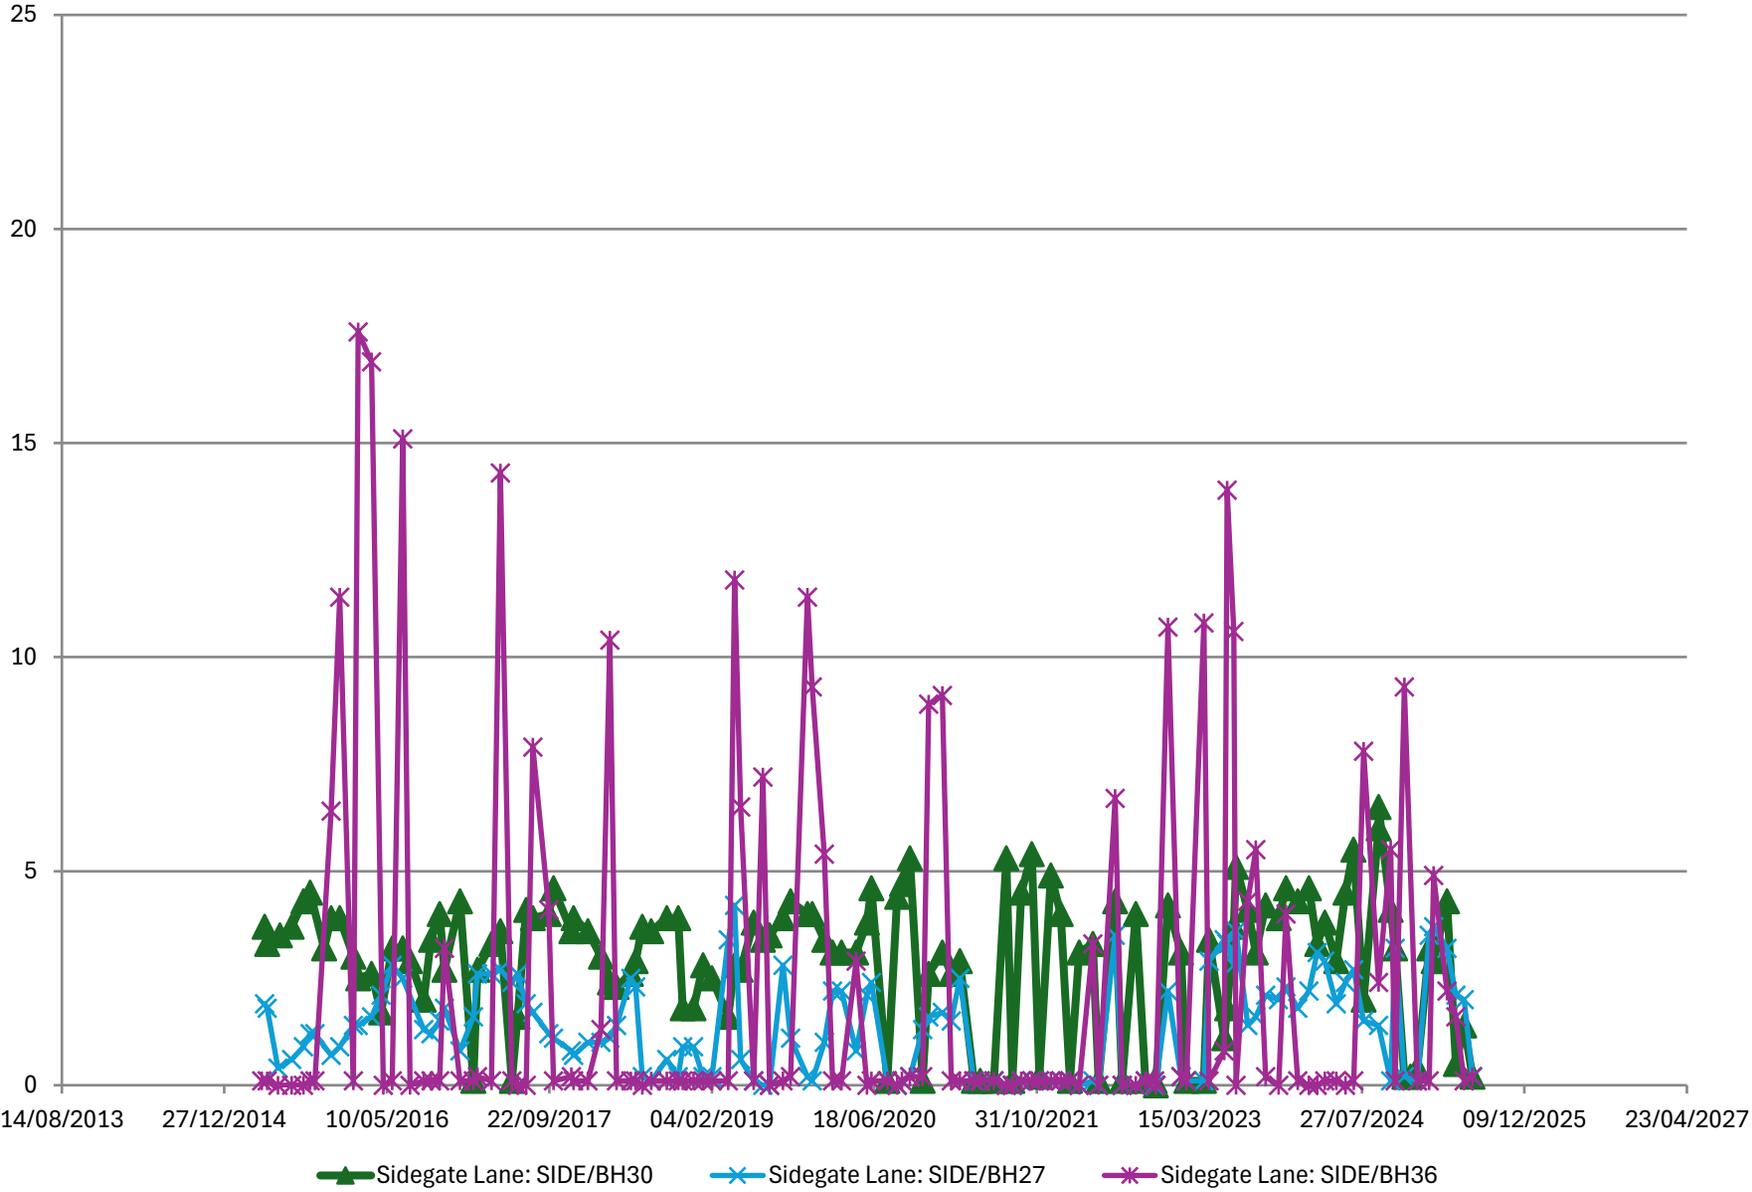
Sidegate Lane Transfer Station: Ground Gas Summary

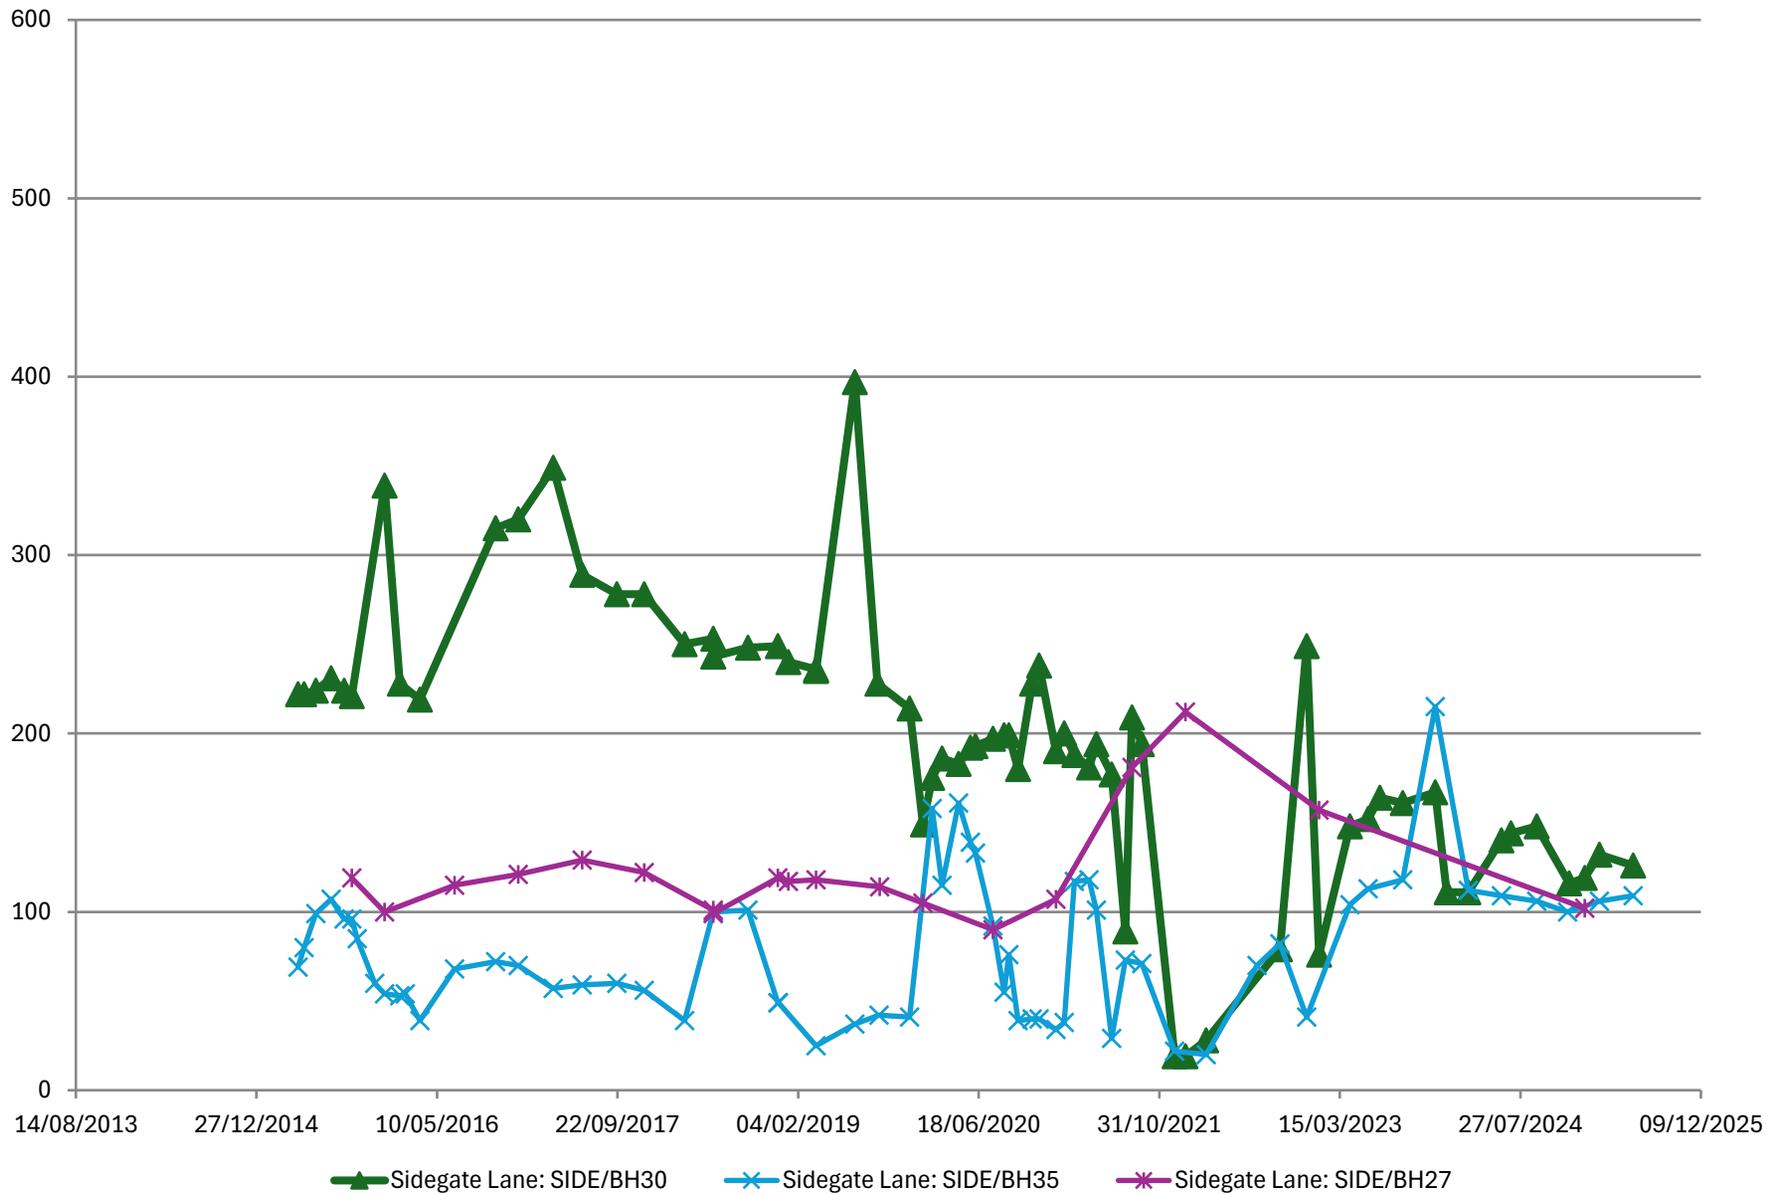
Sidegate Lane Transfer Station: Summary of Groundwater Quality Data

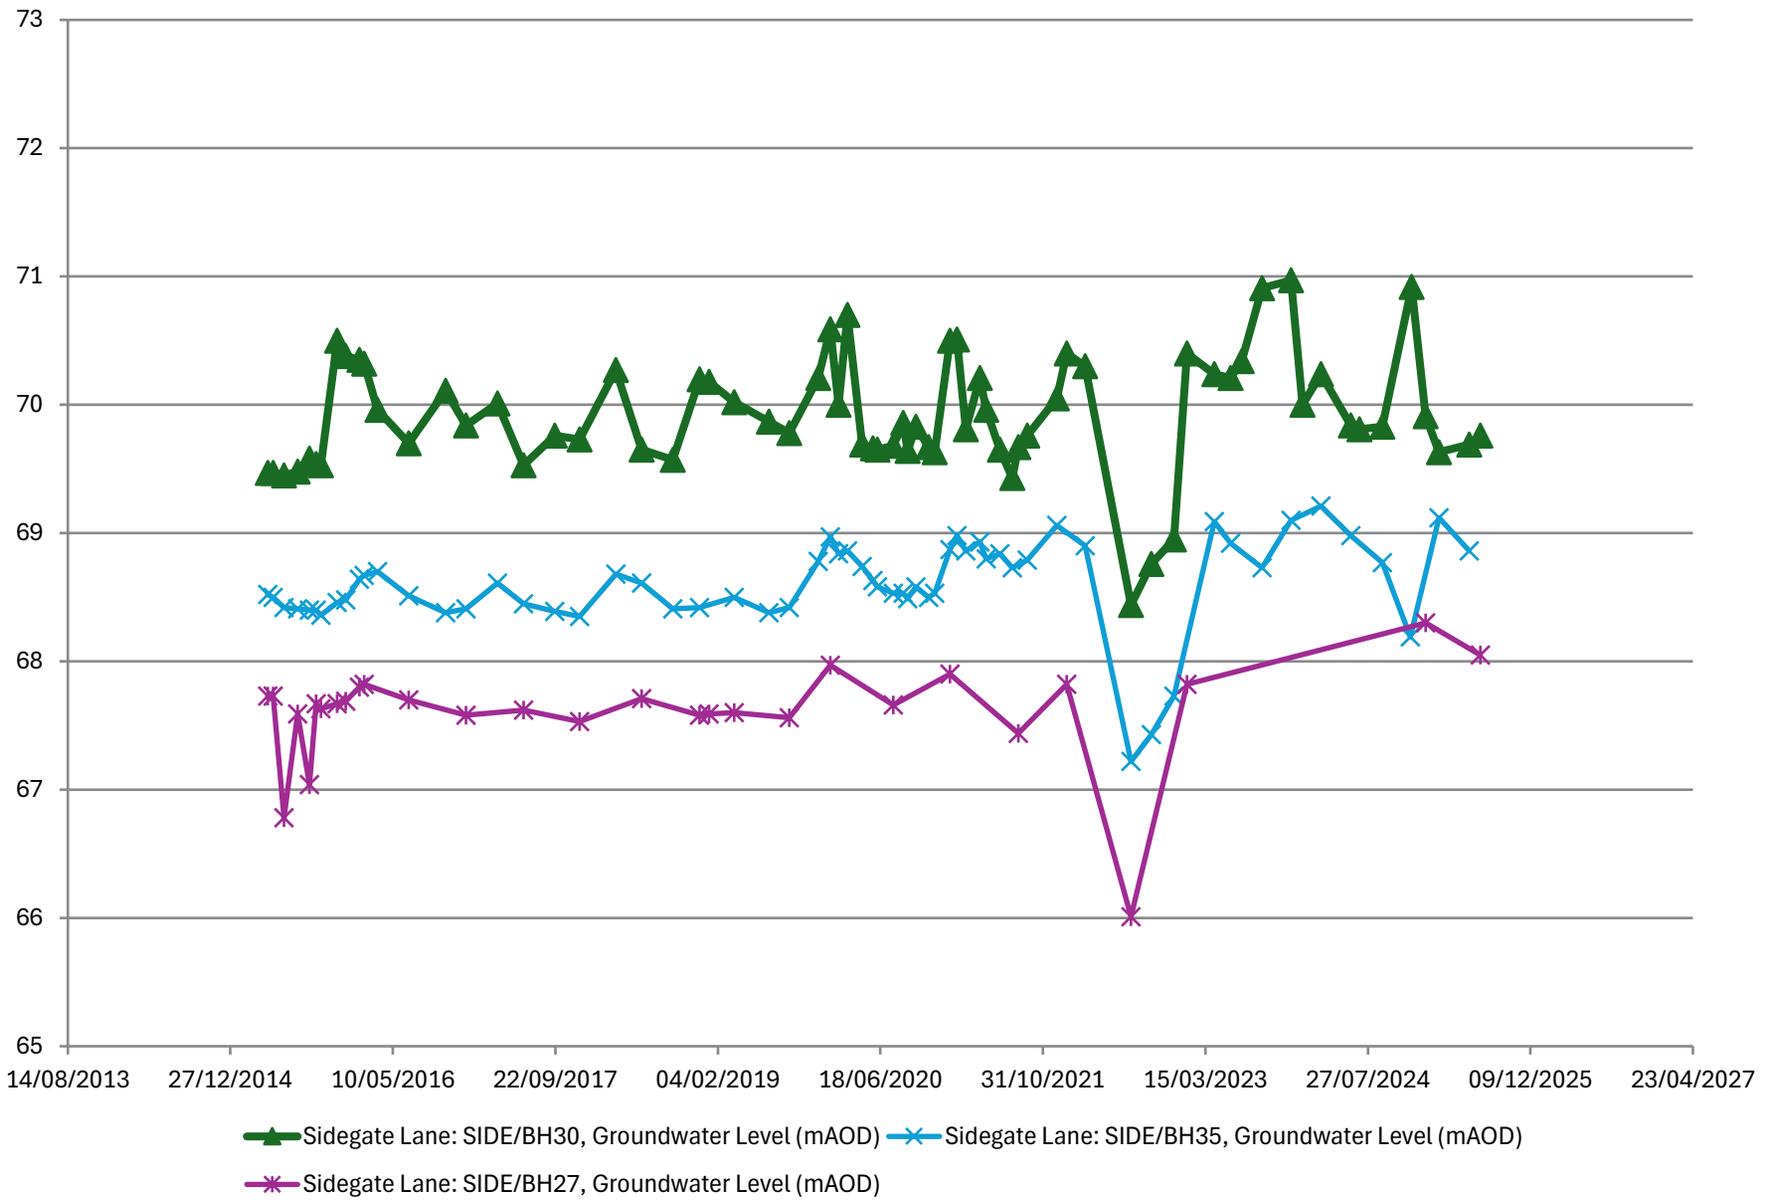
Sidegate Lane Transfer Station: Summary of Groundwater Level Data
