**SITE CONDITION REPORT FOR GAP Group
Limited - Tanker Emptying Facility - Skye House,
Peachman Way, Broadland Business Park,
Norwich, Norfolk, NR7 0WE.**

1.0 SITE DETAILS	
Name of the applicant	GAP GROUP Limited
Activity address	Skye House, Peachman Way, Broadland Business Park, Norwich, Norfolk, NR7 0WE.
National grid reference	TG 28276 09427

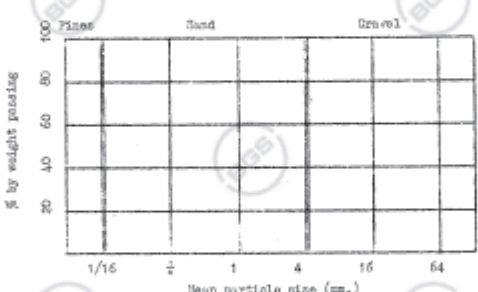
Grading Curve (from Sampling Analysis Sheet)	Grading percentages:	Fines	Sand	Gravel

Institute of Geological Sciences
Mineral Assessment Unit
Sand and Gravel Survey
BOREHOLE RECORD SHEET

Borehole Reg. No.: TG 20 NE/34
Temporary designation:
Nat. Grid Ref.: 28360947
Locality: St. Andrews Hosp. Annexe Norwich
Date: 12.9.69
Recorded by: A.R. Clayton

Drilled by: Ground Engng Drill Type: S/A Hole diameter: 8" Ground level (O.D.): c.45 Water struck at (O.D.): Nil	Horizon	Thickn. in ft.	Nature
	Overburden	3	Soil
	Mineral	24	Sand & Gravel
	Base rock	3	Chalk

Remarks: 100% sand, med. to coarse, c. 12% gravel.

Description of Strata	Depth to base (ft.)	Thickn. (ft.)	Sample Nos.
Topsoil	3	3	
Clayey med sand with med. co. gravel Sand med. SA clayey w. co SA flint, brown Gravel med. and co. SA-SR flint with fine SA flint and ls. fine-med. SR off LPS 35.	9	6	N1013-1014
Med and co sand with fine-med gravel, ls Sand co and med. SA brown & SA-SR granule. Gravel, fine and med. w co SA or SR flint w fine-med SR off LPS 40.	15	6	N1015-1016
Med and co sand and fine-med gravel Sand } As N1016 Gravel }	21	6	N1017-1018

Boreholes show that the area has layers sand and gravel.

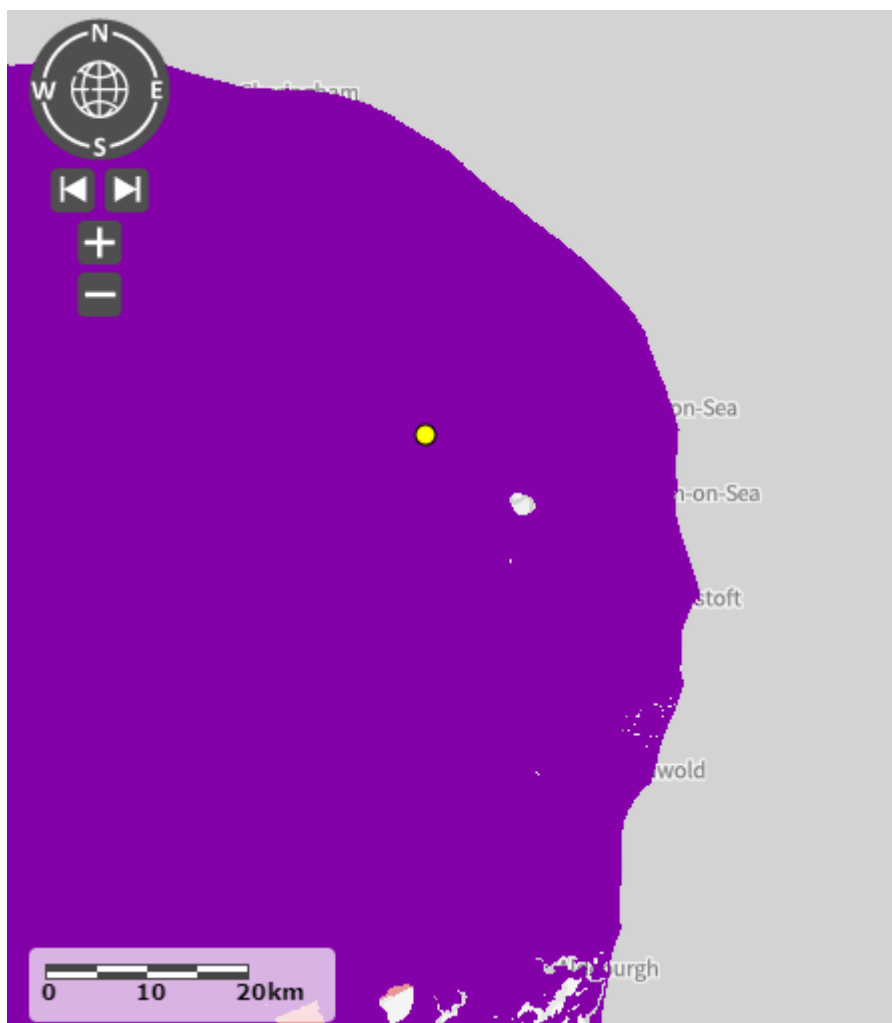
Secondary (B) aquifer - Source Magic Map

The site is located within a Principal aquifer.

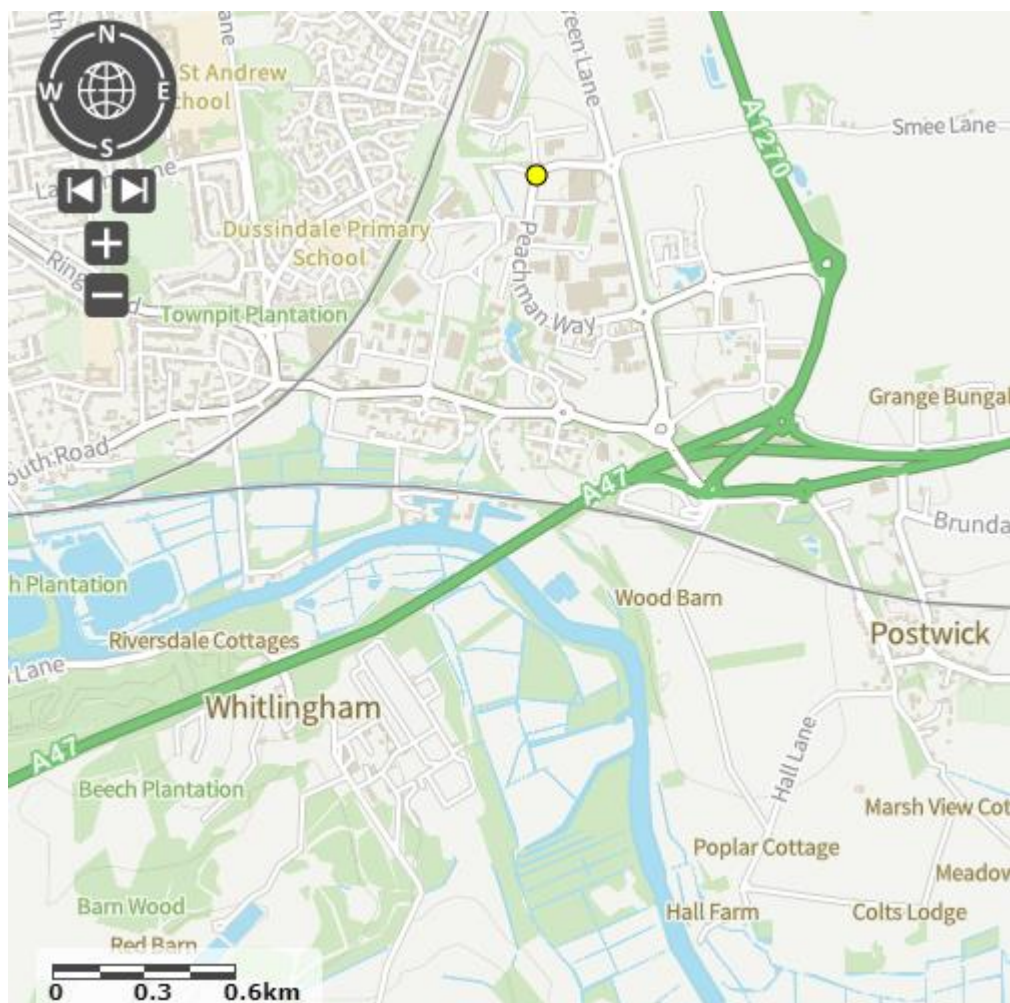
Site location in proximity to the River Yare

The site is located within the Yare (Wensum to tidal) catchment.

The Broadland Business Park in Norwich has a network of surface water drains that drain to the River Yare to the south.
