Site Condition Report

Environmental Permit Application: Site Condition Report

37-39 North Acton Road, London, NW10 6PF.

Project name LHR21 Environmental Permitting Application

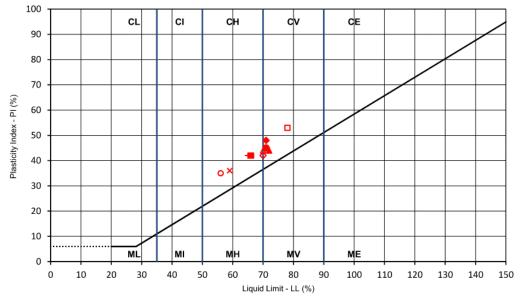
Figure 11.1 Atterberg chart indicating plasticity of London Clay (CH and CV respectively refer to Clay of High and Very High plasticity)

The London Clay was described in the borehole logs as 'CLAY', and locally 'slightly sandy CLAY'. This indicates that the majority of the material comprised of clay particle sizes, with some layers containing subordinate coarser sand particles. The plasticity of the clay was investigated by conducting Plasticity Index tests, and plotting the results on an Atterberg chart. Data plots are included in Appendix 6. The Atterberg chart is reproduced from the GEL factual report as Figure 11.1. The results indicate that the clay is of high plasticity, which is typical for London Clay. The natural moisture content ranged from 15 - 36%; typically this was above the plastic limit of the material.

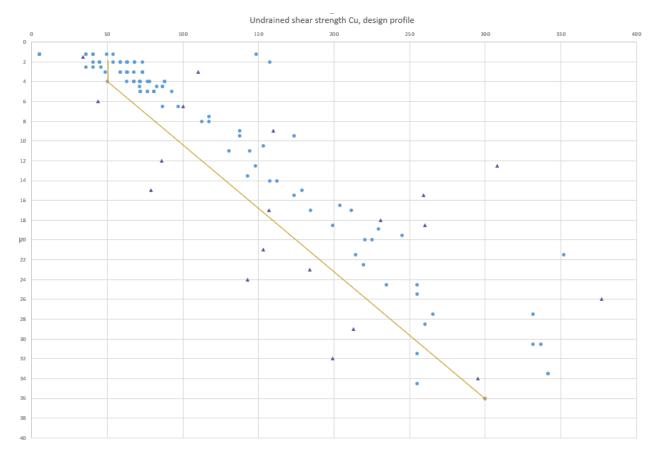
Figure 11.2 Design Cu profile for London Clay used for preliminary pile design.

Legend: triangle = Cu from triaxial (kPa), circle = SPT N value with F1 factor of 4.5 applied to give equivalent Cu (kPa). Vertical axis = depth in metres.

Based on pile design practice in accordance with the London District Surveyors Association (LDSA) publication 'Guidance Notes for the Design of Straight Shafted Bored Piles in London Clay', undrained shear strength (Cu) data for the London Clay is required throughout and beneath the depth profile of proposed foundation piles. Triaxial strength tests and SPTs from both the GEL GI and the JOMAS GI were combined for this purpose, to provide increased data population and coverage across the site. Triaxial tests directly report the design parameter Cu, whereas for SPTs a correlation factor 'F1' is used. The F1 factor relates to the plasticity index of the material. Through consideration of the plasticity index results, and through plotting the SPT and triaxial results from both investigations together, an F1 correlation factor of 4.5 has been derived. The design Cu profile is indicated in Figure 11.2.

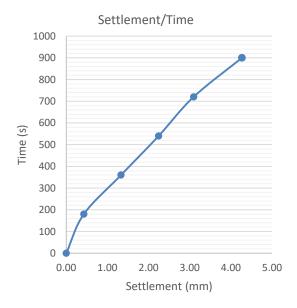
Maximum Applied Stress (kPa):	84
Maximum Settlement (mm):	4.27
Equivalent CBR Value (%):	1
Modulus of Subgrade Reaction, k ₇₆₂ (MN/m ² /m):	17

Settlement/Stress 90 80 70 60 Stress (kPa 50 40 30 20 10 0 1.00 2.00 3.00 0.00 4.00 5.00 Settlement (mm)

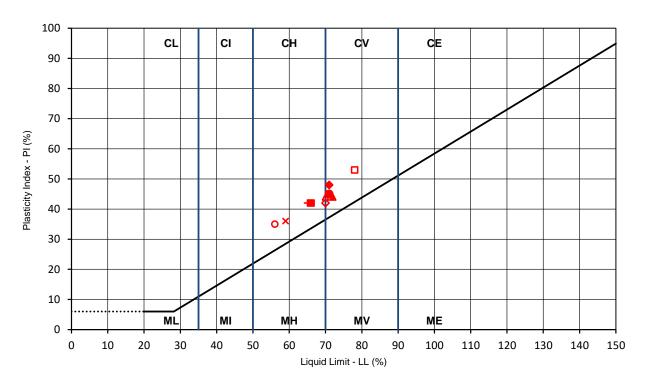
BH/TP No.	depth (m)	LL	PL	PI	remarks
	BH01	4.00	78	25	53	
\$	BH01	14.50	70	28	42	
Δ	BH01	25.50	70	26	44	
×	BH02	10.50	59	23	36	
+	BH02	21.00	65	23	42	
0	BH02	31.00	56	21	35	
	BH03	1.20	66	24	42	
•	BH03	4.00	71	23	48	
•	BH03	15.50	72	28	44	
•	BH03	24.50	71	26	45

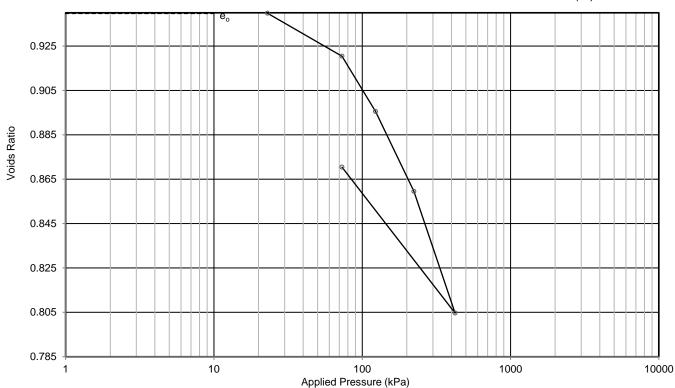
DESCRIPTION Brown CLAY with rare selenite SAMPLE DEPTH (m) 5.50

test and sample details			test results				
			pressure	voids	laboratory c	oefficients of	
specimen diameter	mm	63.28	stage	ratio	compressibility	consolidation	
specimen height	mm	18.75	(kPa)		mv	Cv	
initial moisture content	%	36.4	(KFa)		(m2/MN)	(m2/yr)	
final moisture content	%	37.7					
initial bulk density	Mg/m3	1.90	23	0.940			
initial dry density	Mg/m3	1.39	73	0.920	0.2	1	
initial voids ratio		0.940	123	0.895	0.26	0.6	
initial degree of saturation	%	105	223	0.859	0.19	0.76	
particle density	Mg/m3	#2.70	423	0.805	0.15	0.48	
swelling pressure	kPa	23	73	0.870	0.1		
P'o to P'o +100 kPa		-					
laboratory temperature	оС	20 ± 2					
method of time fitting		root time					
	2.1.1						
remarks # denotes particle der	•	signed an assumed v	value		CONTRACT	CHECKED	
Load sequence added to swelling	37013	ТВ

DETERMINATION OF ONE-DIMENSIONAL CONSOLIDATION PROPERTIES BS EN ISO 17892 - 5 : 2017 : 6

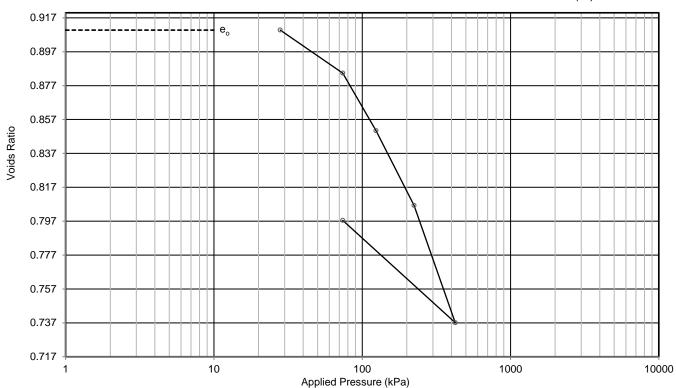
DESCRIPTION Brown mottled grey CLAY with rare selenite SAMPLE DEPTH (m) 3.50

test and sample details			test results				
			pressure	voids	laboratory c	oefficients of	
specimen diameter	mm	63.34	stage	ratio	compressibility	consolidation	
specimen height	mm	18.69	(kPa)		mv	Cv	
initial moisture content	%	33.5	(Ki a)		(m2/MN)	(m2/yr)	
final moisture content	%	35.2					
initial bulk density	Mg/m3	1.89	28	0.910			
initial dry density	Mg/m3	1.41	74	0.884	0.29	1.6	
initial voids ratio		0.910	124	0.850	0.36	1.4	
initial degree of saturation	%	99	224	0.806	0.24	0.82	
particle density	Mg/m3	#2.70	424	0.737	0.19	0.61	
swelling pressure	kPa	28	74	0.797	0.099		
P'o to P'o +100 kPa		-					
laboratory temperature	оС	20 ± 2					
method of time fitting		root time					
remarks # denotes particle de	noity has been one	ianad an accumad	volue			OUEOKEE	
·	•			CONTRACT	CHECKED		
Peak swelling pressure 28kPa be pressure.	37013	ТВ

DETERMINATION OF ONE-DIMENSIONAL CONSOLIDATION PROPERTIES BS EN ISO 17892 - 5 : 2017 : 6

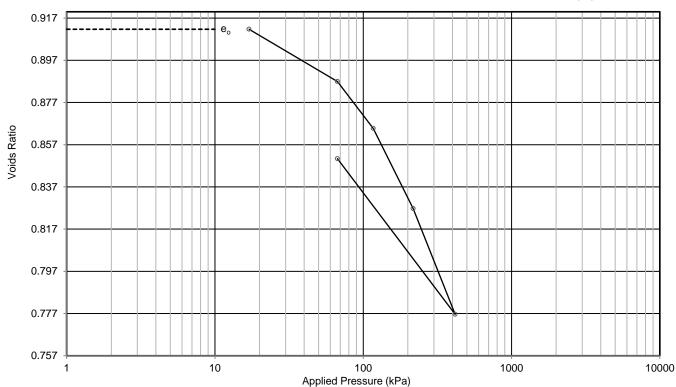
DESCRIPTION Brown mottled orange CLAY with rare selenite SAMPLE DEPTH (m) 5.50

test and sample details			test results			
			pressure	voids	laboratory c	oefficients of
specimen diameter	mm	63.38	stage	ratio	compressibility	consolidation
specimen height initial moisture content	mm %	18.82 33.8	(kPa)		mv (m2/MN)	Cv (m2/yr)
final moisture content	%	35.0				
initial bulk density	Mg/m3	1.89	17	0.912		
initial dry density	Mg/m3	1.41	67	0.887	0.26	0.63
initial voids ratio		0.912	117	0.865	0.24	0.5
initial degree of saturation	%	100	217	0.827	0.2	0.51
particle density	Mg/m3	#2.70	417	0.777	0.14	0.65
swelling pressure	kPa	17	67	0.850	0.12	
P'o to P'o +100 kPa		-				
laboratory temperature	оС	20 ± 2				
method of time fitting		root time				
remarks # denotes particle de	nsity has been assi	igned an assumed	d value		CONTRACT	CHECKED
Load sequence added to swellin	g pressure.				37013	ТВ

DETERMINATION OF ONE-DIMENSIONAL CONSOLIDATION PROPERTIES BS EN ISO 17892 - 5 : 2017 : 6

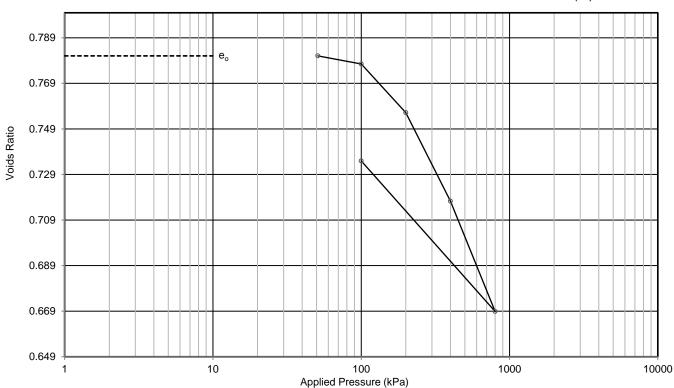
DESCRIPTION Brown CLAY with rare selenite SAMPLE DEPTH (m) 8.00

test and sample details			test results			
			pressure	voids	laboratory c	oefficients of
specimen diameter	mm	63.33	stage	ratio	compressibility	consolidation
specimen height	mm	18.46	(kPa)		mv	Cv
initial moisture content	%	29.1	(KFa)		(m2/MN)	(m2/yr)
final moisture content	%	29.3				
initial bulk density	Mg/m3	1.96	51	0.781		
initial dry density	Mg/m3	1.52	100	0.778	0.041	0.82
initial voids ratio		0.781	200	0.756	0.12	0.29
initial degree of saturation	%	101	400	0.717	0.11	0.28
particle density	Mg/m3	#2.70	800	0.669	0.071	0.25
swelling pressure	kPa	51	100	0.735	0.057	
P'o to P'o +100 kPa		-				
laboratory temperature	оС	20 ± 2				
method of time fitting		root time				
remarks # denotes particle der	•	· ·			CONTRACT	CHECKED
Load sequence amended due to s	swelling pressure	exceeding the first s	scheduled load.		37013	ТВ

DETERMINATION OF ONE-DIMENSIONAL CONSOLIDATION PROPERTIES BS EN ISO 17892 - 5 : 2017 : 6
