# **Site Condition Report**

**Bespoke Environmental Permit Application**

**JVC Business Park, Staples Corner, London,  
NW2 7BA**

Report Reference: **SP/SCR18**

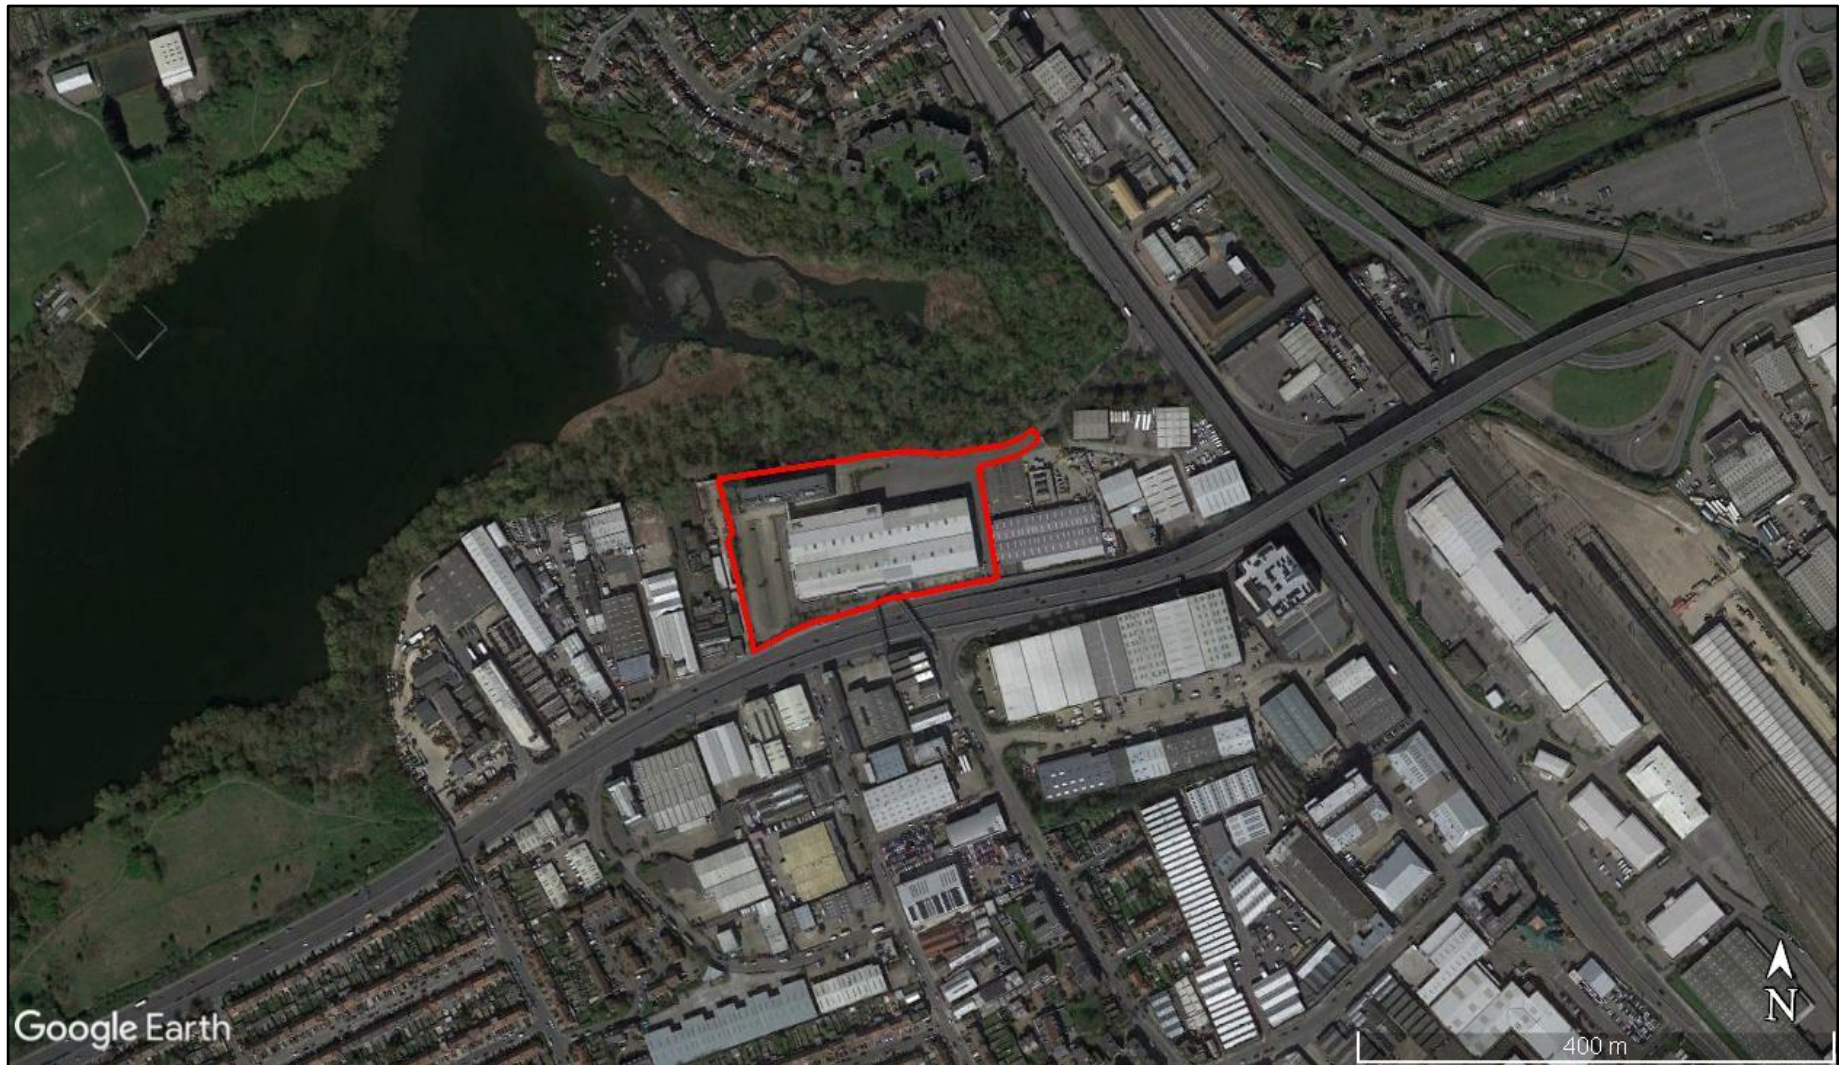
**Drawing 02: Site Boundary and Area Covered by SCR**

Note: Red line boundary shown is indicative and relates to the SCR and not land ownership

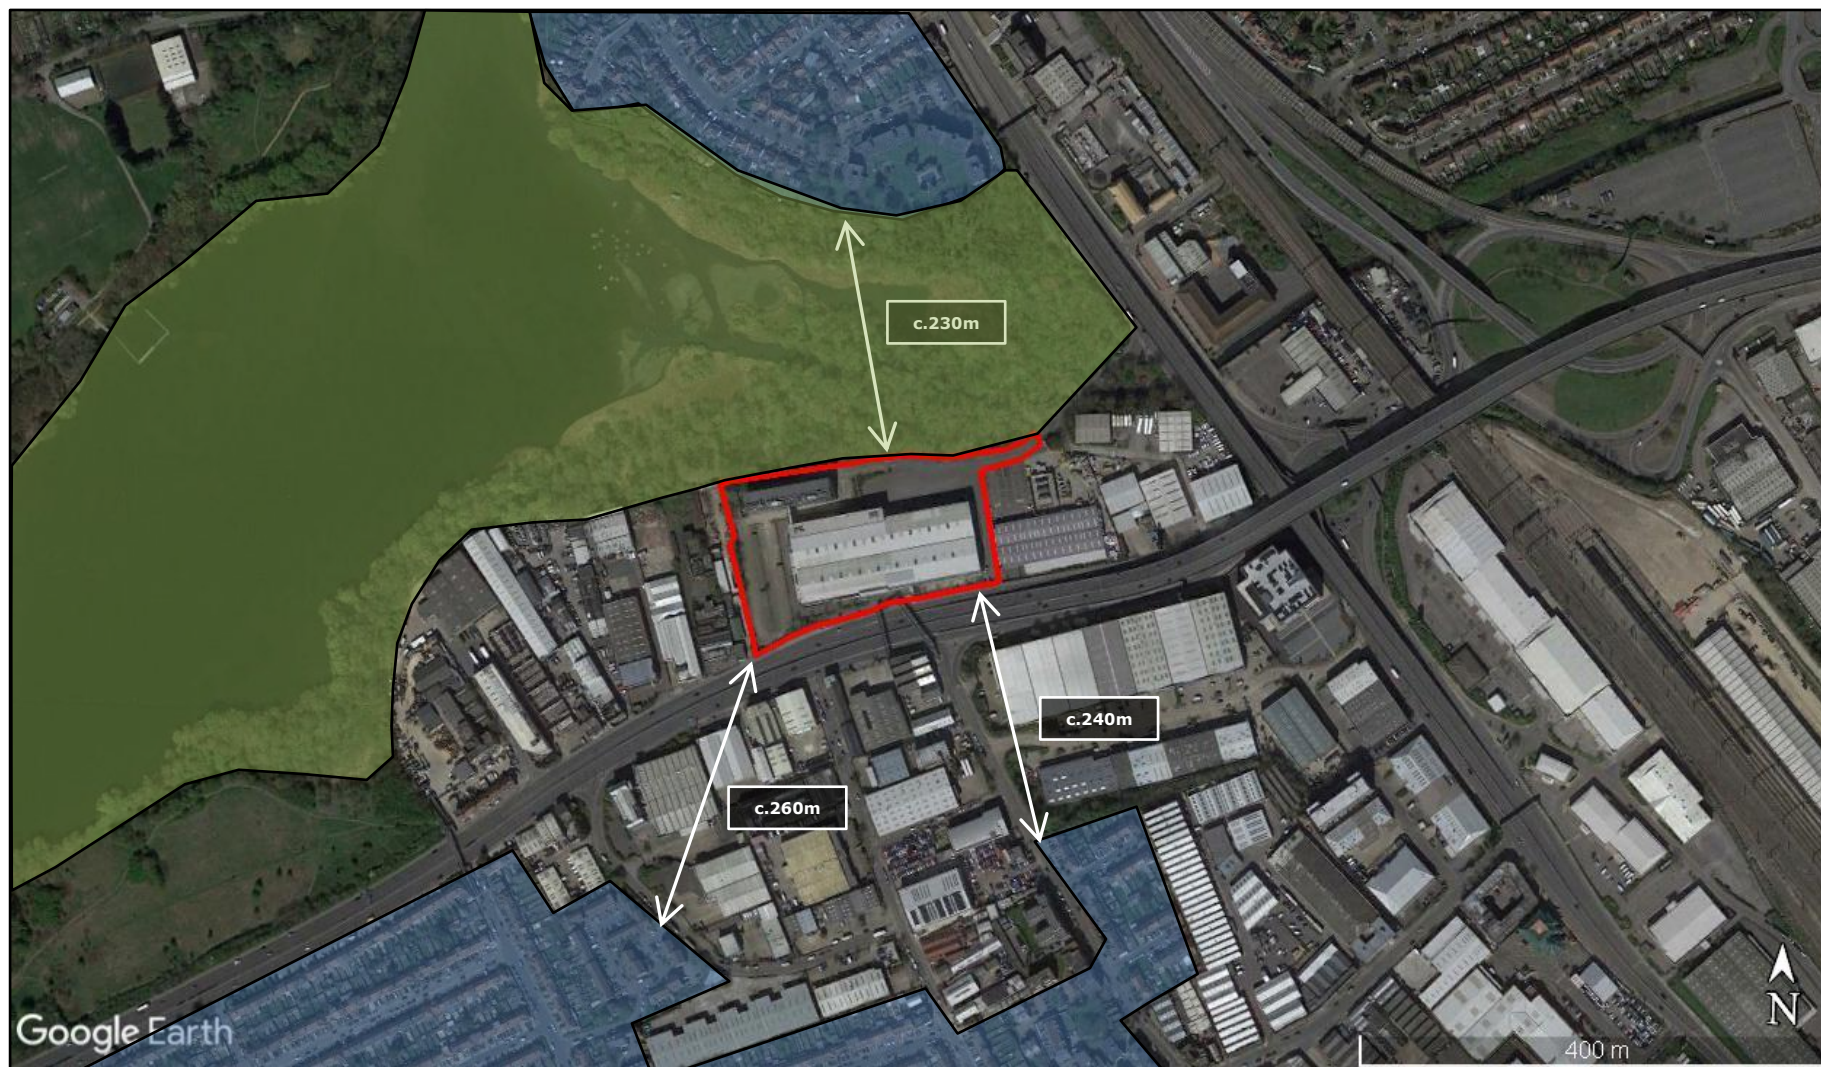
**Drawing 03:** Receptor Locations

- Areas predominantly used for residential
- Brent Reservoir Site of Special Scientific Interest
