RAF CATAPULT PIT	TR/051700/016 Issue B October 2002 J Armitage
Title: Land Quality Statement

The purpose of this document is to provide evidence that the site has been remediated and that it does not present a risk to health and safety or the environment nor that it will not represent a potential legal liability.

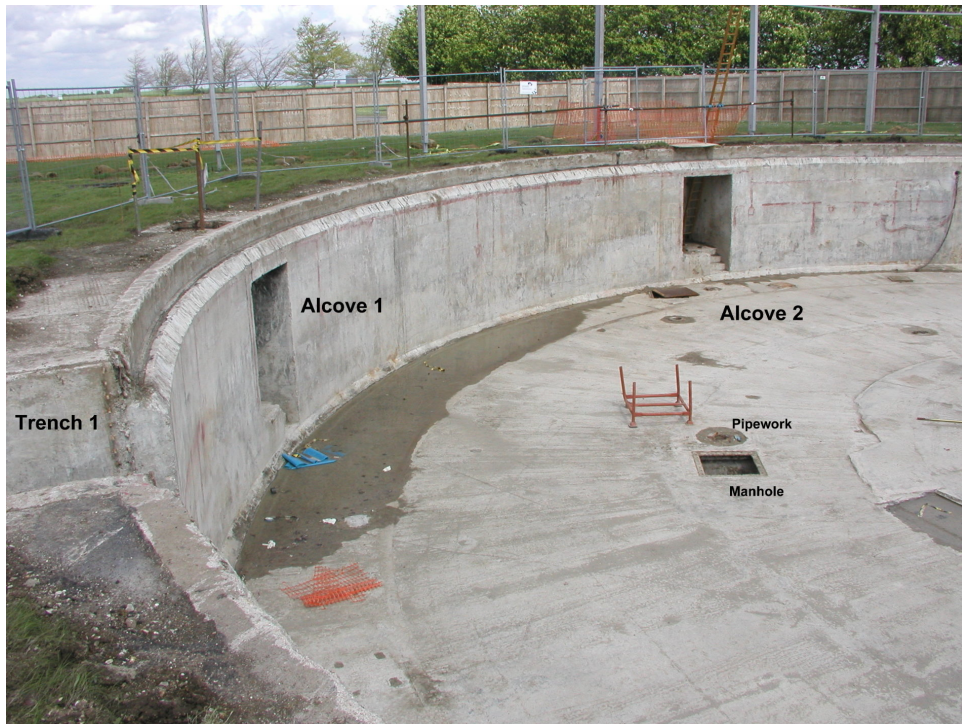
(Note the pit did contain other features such as: entry alcoves to allow personnel to access the structure, a 2.8m deep 1.5m diameter central bearing housing in the centre of the pit base, a small chamber immediately adjacent to the main pit and the pit base contained a network of cast iron pipes and inspection holes shown in Figure 4.2).

Figure 4.2. The Catapult Pit interior. Note the additional features: Alcove 1 and 2, manhole and pipework.

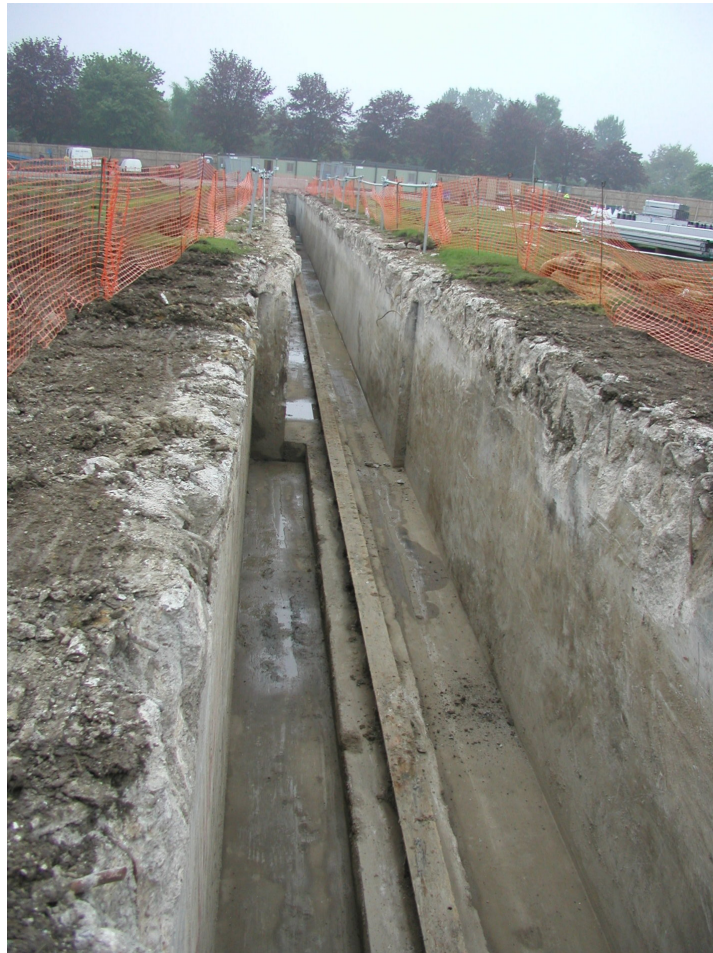
Trench 1 and 2 (Figure 4.3)

Length	82m
Width	2.1m (at pit end), 1.5m (at distal end)
Depth	2.85m
Volume	340m ³

Figure 4.3. A view of the interior of Trench 2.

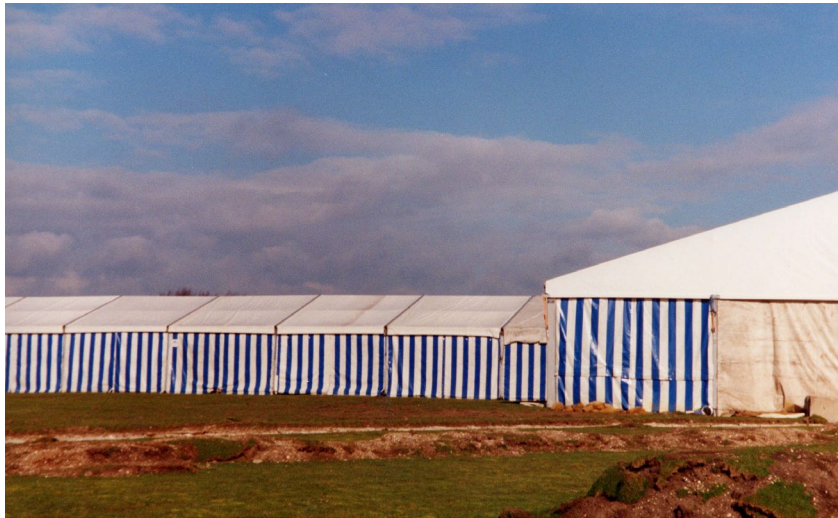
Figure 6.1. The Tents (WPFs) in which excavations were undertaken.

The process of remediation involved the complete removal of waste from the whole structure (the concrete structure was left *in-situ*). The excavation work was undertaken within large tents (Weather Protection Facilities, WPF) to minimise the impact of dust etc. to the surrounding area.

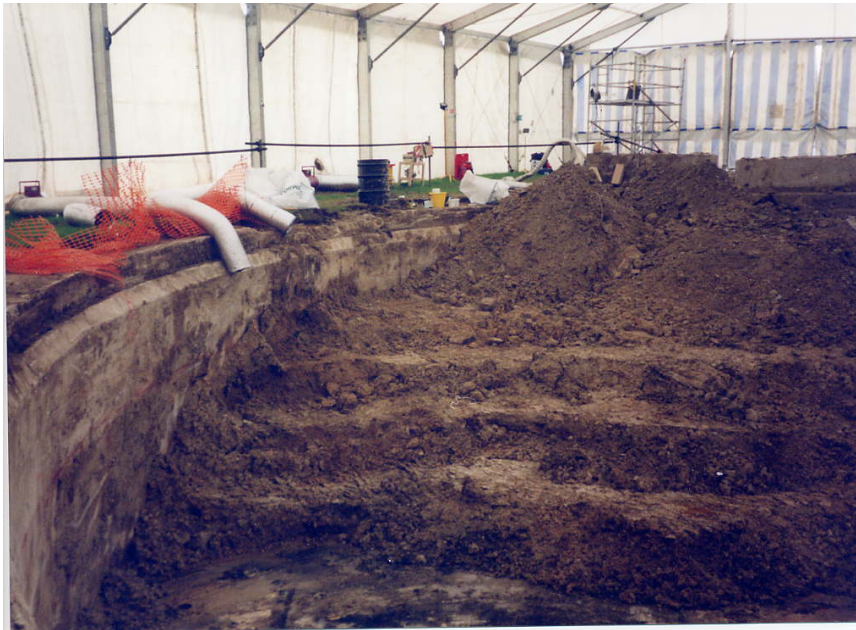
Figure 6.2. The Catapult Pit during excavation. Note the waste was excavated in layers and benched for safety purposes.

Excavators drove onto pit surface and carefully excavated the pit contents in shallow layers to the concrete base. As the excavation got deeper the waste in the pit was benched for safety purposes and a small ramp was left at one part of the Pit to allow the excavator to leave the pit. The excavated surfaces were monitored by Health Physics personnel to detect the presence or absence of radioactive contamination and samples were collected at regular intervals for further analysis at the on site laboratory. Some of these samples were also sent to a UKAS accredited laboratory to provide extra reassurance. Excavated waste was loaded into lorries and removed from site to landfill only when the sample results demonstrated that it was acceptable.

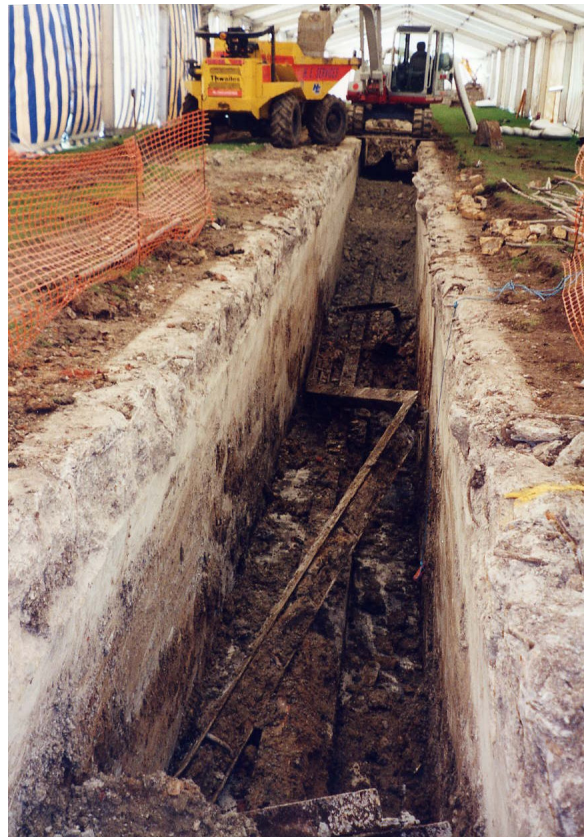
Figure 6.3. Excavations in the Trench. Note the small excavator in the distance straddling the trench and loading waste into a dumper.

In the trenches the excavator straddled the narrow structure and dug waste again, in shallow layers and loaded the waste into a dumper which transported the waste to the lorry loading area. The same monitoring and sampling methodology was used during the trench excavations.

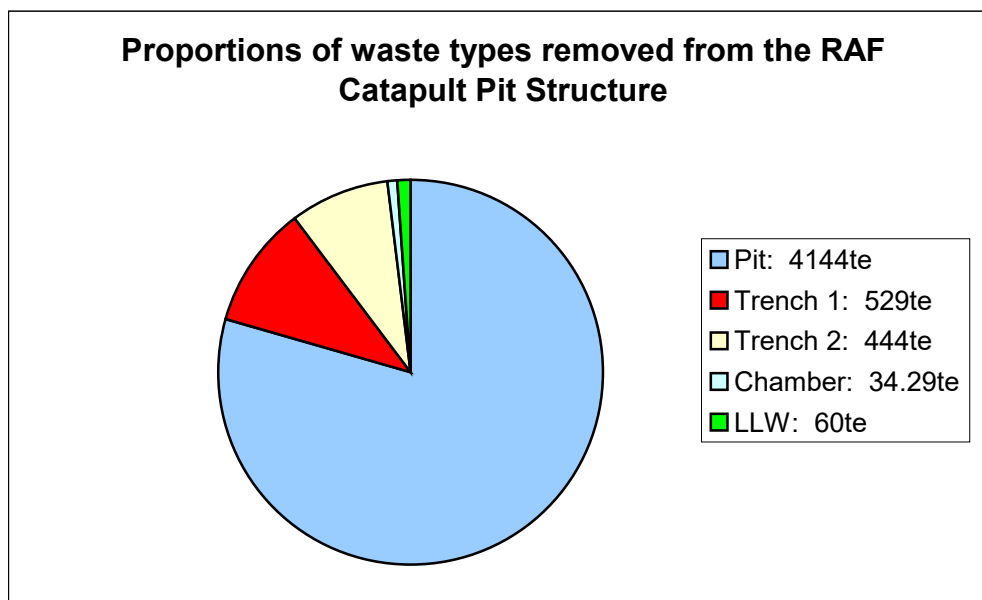
Figure 6.1 summarises the weights and types of waste removed from the Catapult Pit and trenches.

Figure 6.1. Pie chart of the proportion of waste types removed from the RAF Catapult Pit.

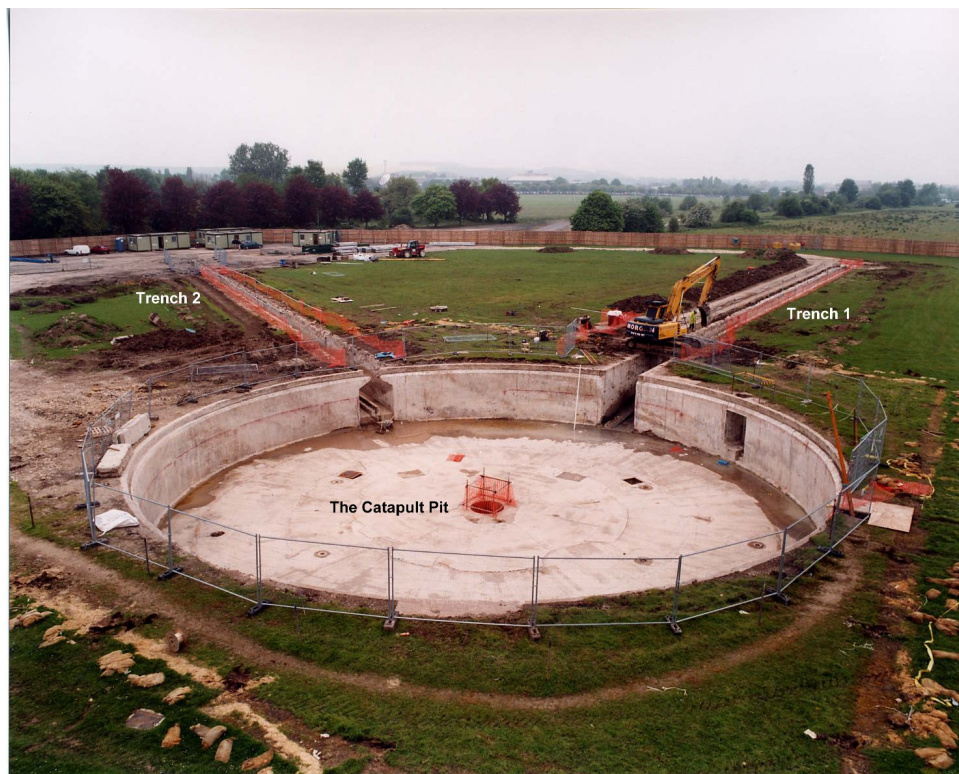
A series of validation surveys were undertaken on the empty Catapult Pit structure in order to demonstrate that the remediation process was successful. The results are outlined below. The empty structure is shown in Figure 6.1.

Figure 6.1. The empty RAF Catapult Pit structure. (Photograph courtesy of Harwell UKAEA Image Resources).

Smear surveys of the exposed surfaces were taken for gross alpha/beta counting, and beryllium analysis. A total of 191 smears were taken and all found to be lower than the clean up target of $<0.4 \text{ Bq/cm}^2$ (α) and $<4.0 \text{ Bq/cm}^2$ (β).

All accessible surfaces within the Catapult Pit structures were monitored for any residual radiological activity using a 1667 low energy beta probe. The monitoring demonstrated that the concrete surfaces of the structure were not radiologically contaminated as the clean up target of $<0.4 \text{ Bq/cm}^2$ (α) $<4.0 \text{ Bq/cm}^2$ (β) had been met.

Dose rate surveys were undertaken using an environmental dose rate meter on all empty structures. No readings above background ($0.15 \mu\text{Sv/hr}$) were detected throughout.
