# GEO-ENVIRONMENTAL & GEOTECHNICAL ASSESSMENT (GROUND INVESTIGATION) REPORT

Zone 5 & ESA Harwell Campus  
Didcot  
OX11 0FD

**Report Title:** Geo-environmental & Geotechnical Assessment Ground Investigation Report for Zone 5 & ESA Harwell Campus, Didcot, OX11 0FD

**Job No:** P4397J2609/SC

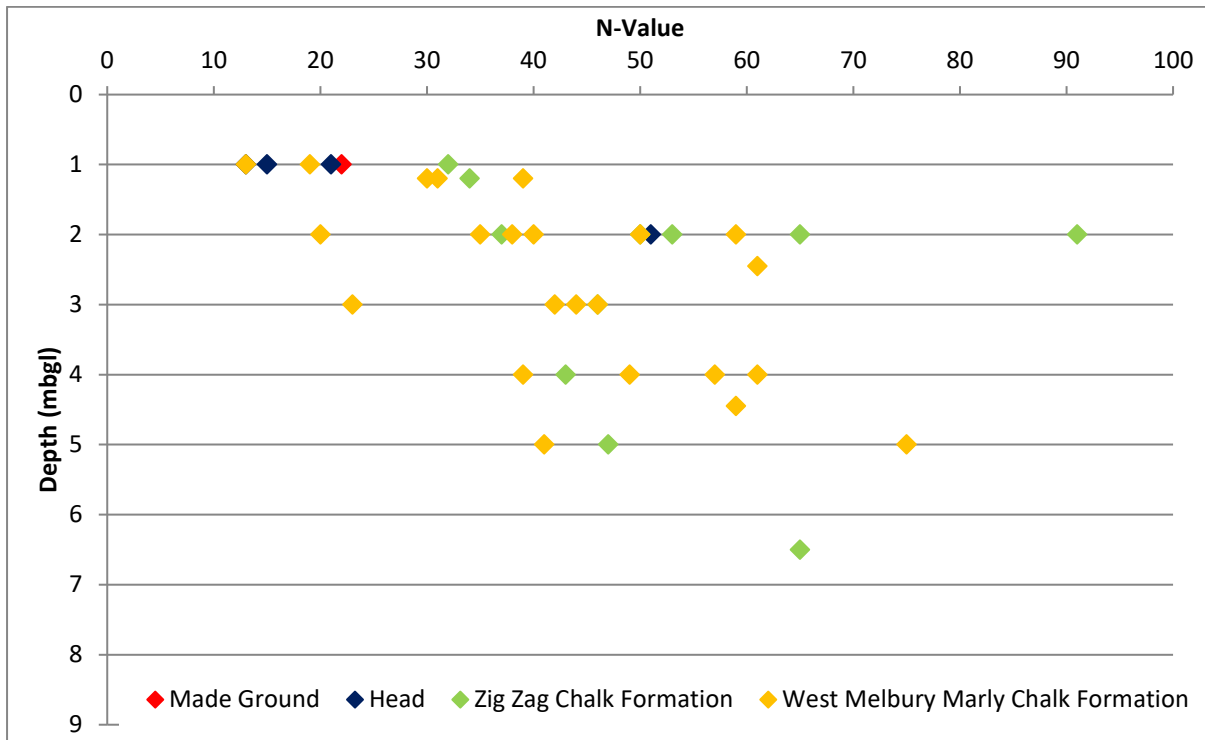
Figure 10.2: SPT 'N' Value v Depth

10.3.3 The results show a general trend of increasing N value with depth.

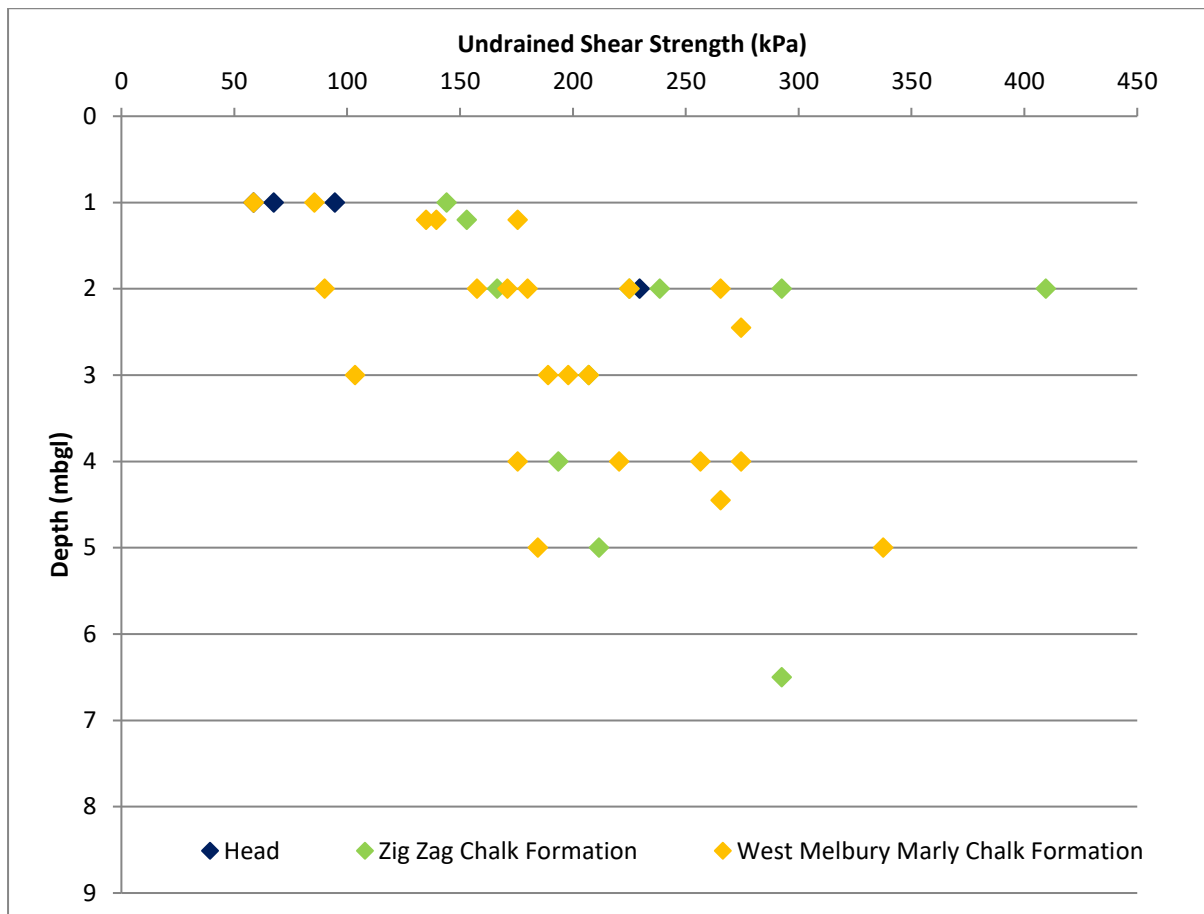
Figure 10.3: Undrained Shear Strength v Depth

10.4.4 It should be pointed out that the correlation between SPT 'N' value and undrained shear strength of weathered chalk is based on the material being recovered as structureless, stiff to very stiff clay. In reality, correlation can vary greatly, as pointed out in CIRIA R143, and therefore the results should be treated with some circumspection.

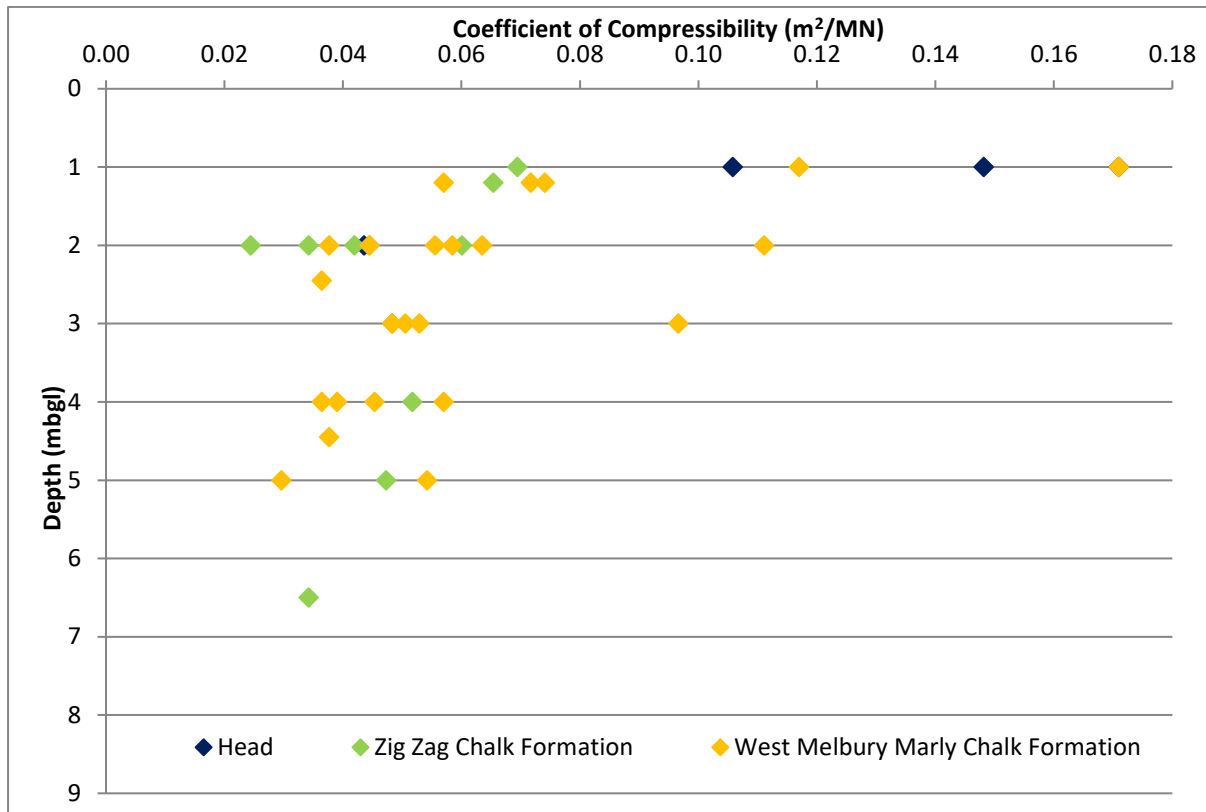
**Figure 10.4: Coefficient of Volume Compressibility ( $m_v$ ) v Depth**

10.5.3 At shallow depth, the results indicate soils of low to medium compressibility, becoming soils of very low compressibility with increasing depth.
