Medworth CHP Ltd

Medworth Energy from Waste Combined Heat and Power Facility Permit Application

Site Condition Report

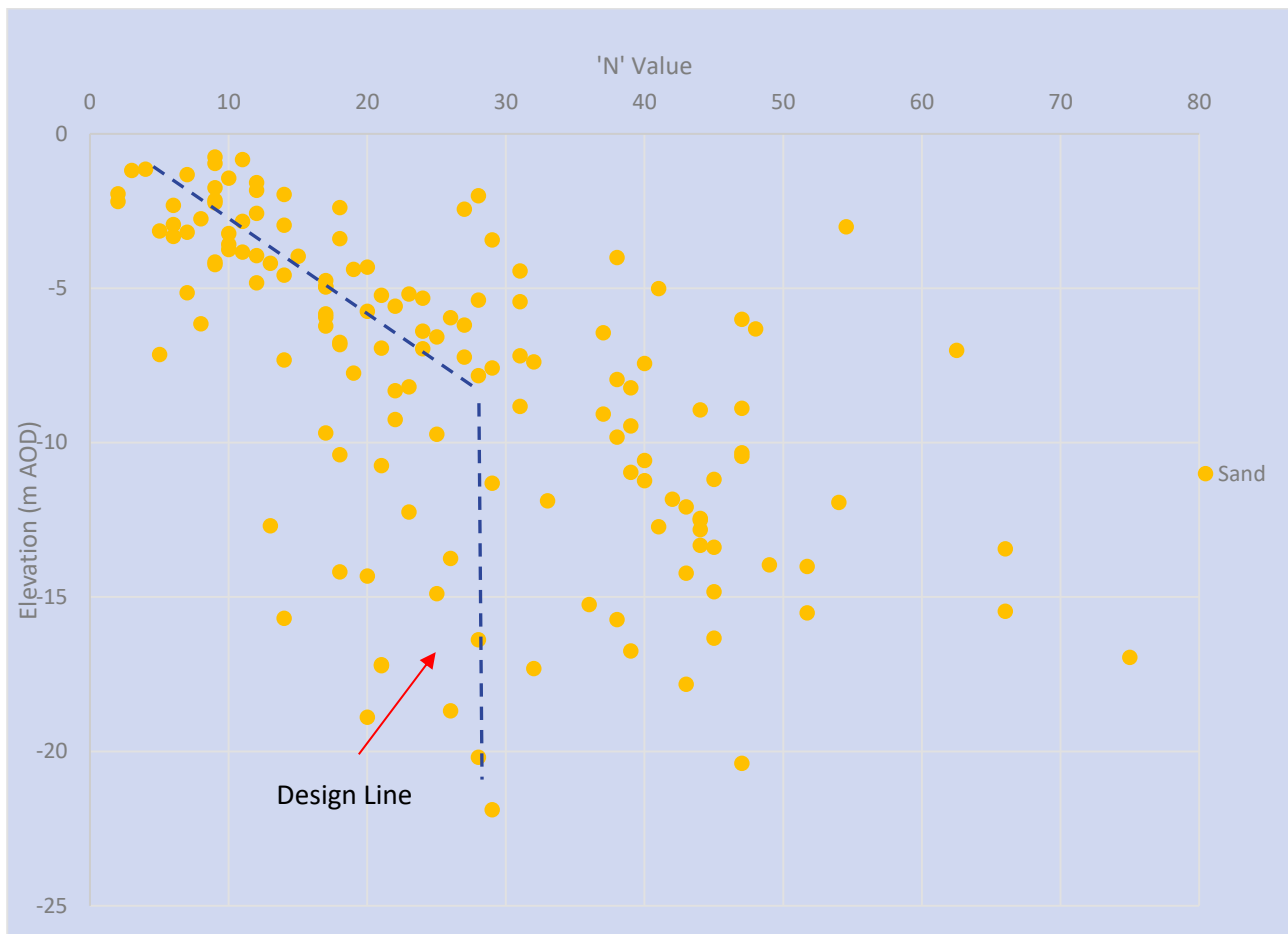
Graphic 11.7 SPT Results for Tidal Flat Sand

11.5.2 As **Graphic 11.7 SPT Results for Tidal Flat Sand** shows, there is a general trend of increased SPT N value with depth, to an elevation of approximately 8m below OD, beyond which there is no discernible trend. This is illustrated by the design line showing the change in representative values with depth, which are as follows:

- $N = 5 + 3.3z^*$ (Between -1.0m AOD and to - 8.0mA OD).
- $N = 28$ (from -8.0m AOD to base of Stratum).

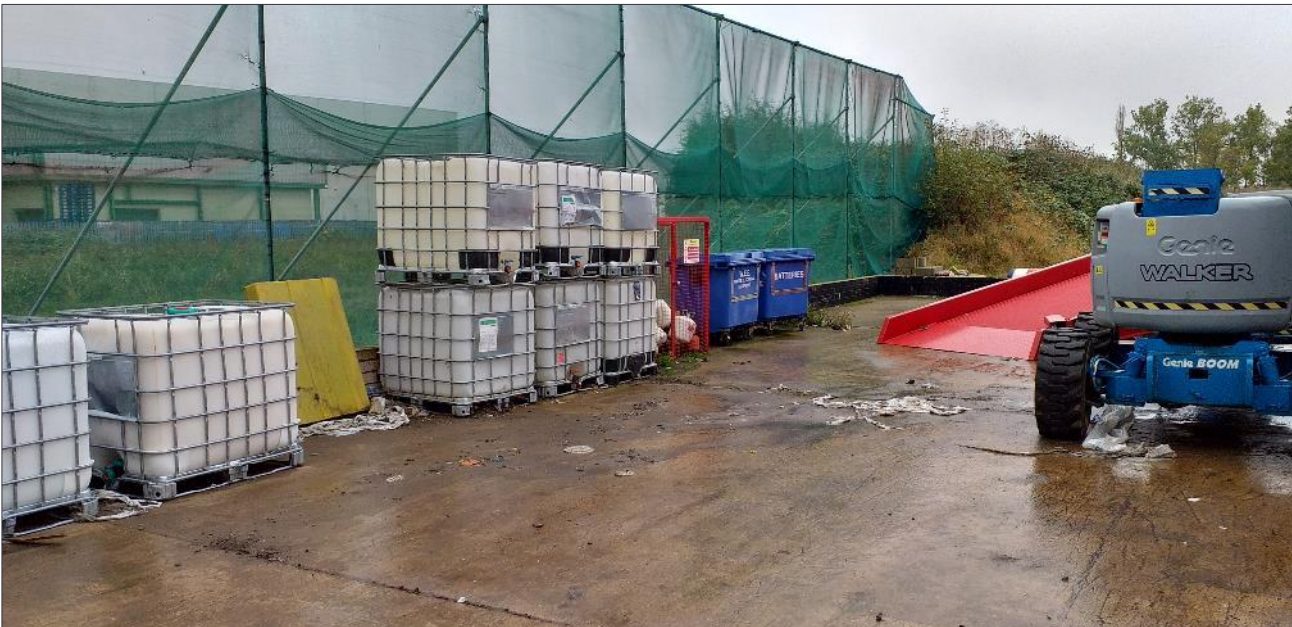
Plate 14

Looking south adjacent to the south-east corner of the WRW. Storage containers for batteries, gas cylinders and other hazardous items which are picked from the receiving household waste.
