**DSL 11 - SITE CONDITION REPORT FOR -
DATASHREDDERS LIMITED - 44, Hostmoor
Avenue, March Trading Park, March,
Cambridgeshire, PE15 0AX**

1.0 SITE DETAILS	
Name of the applicant	Datashredders Limited
Activity address	44, Hostmoor Avenue, March Trading Park, March, Cambridgeshire, PE15 0AX
National grid reference	TL 40820 98052

Document reference and dates for Site Condition Report at permit application and surrender	V2 25.05.2021
--	---------------

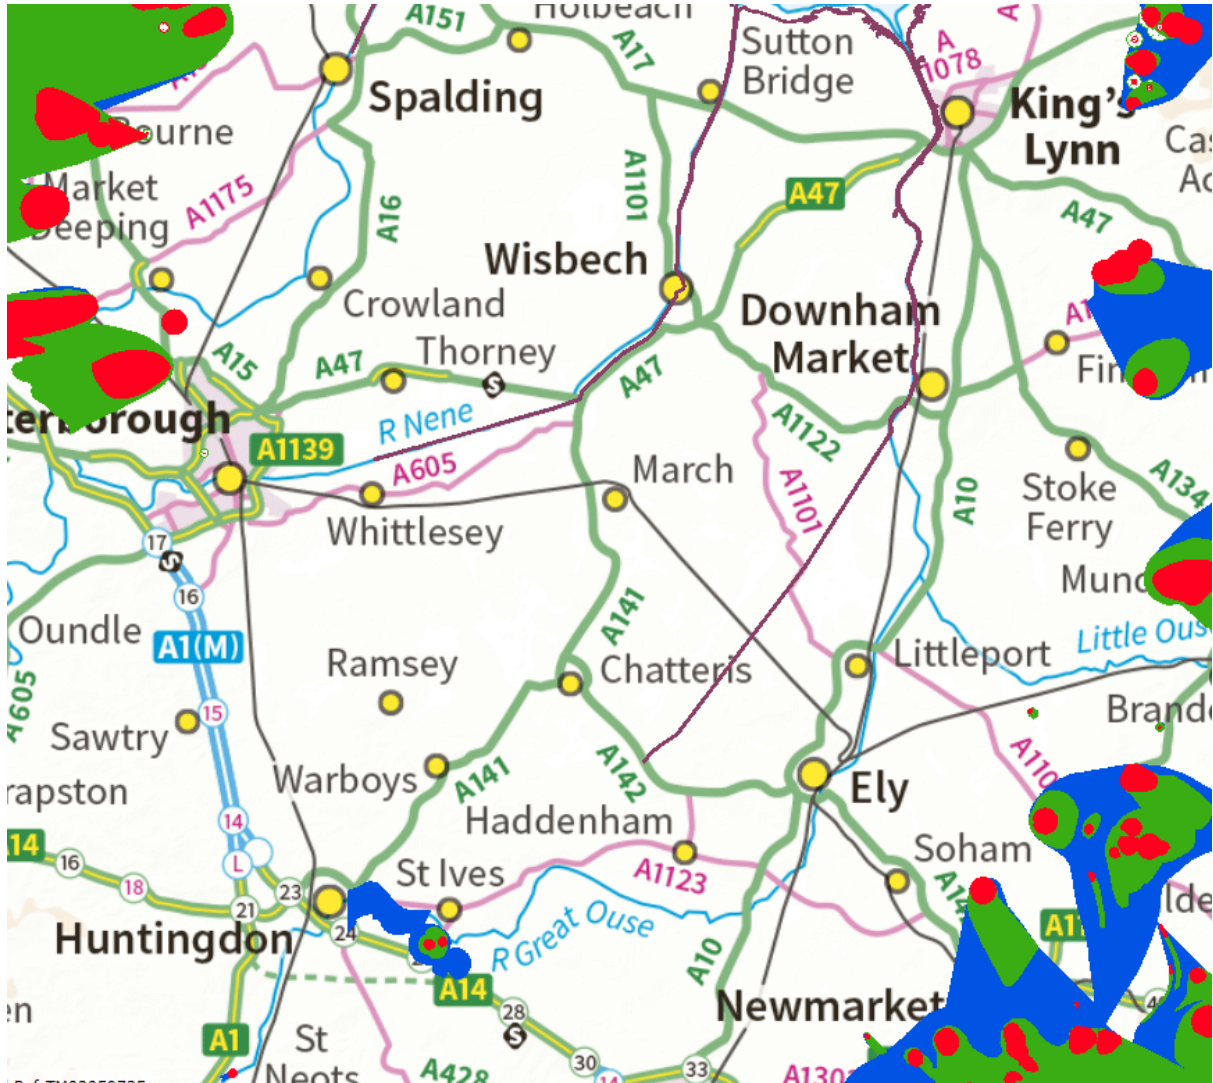
Map showing source protection zones, with the site being located outside of any source protection zones.

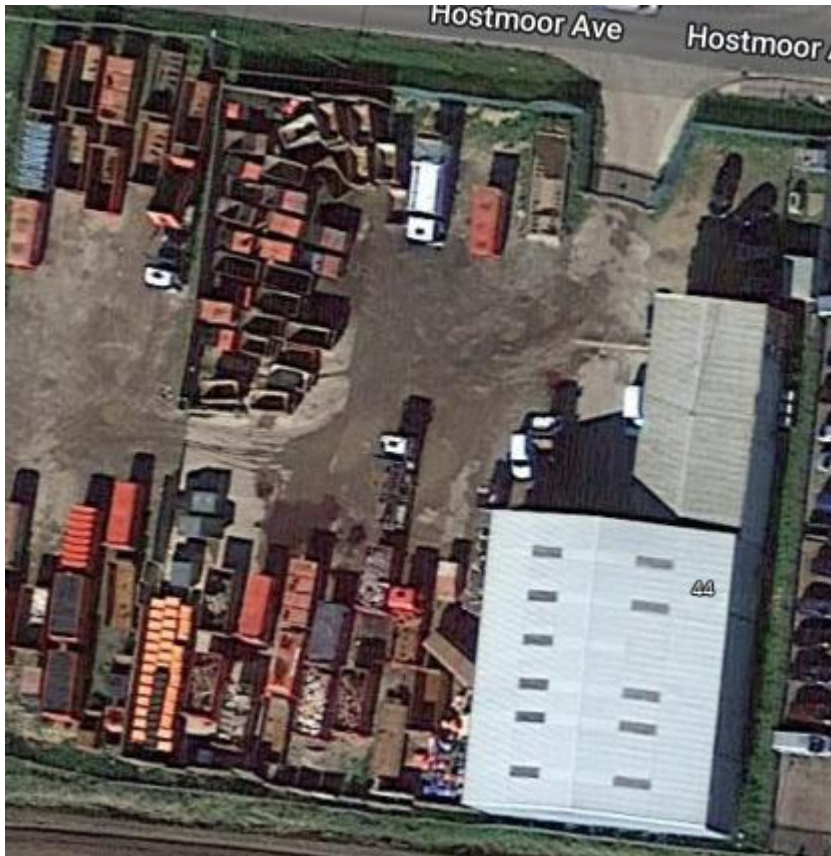
Aerial photograph of the existing waste transfer operation.

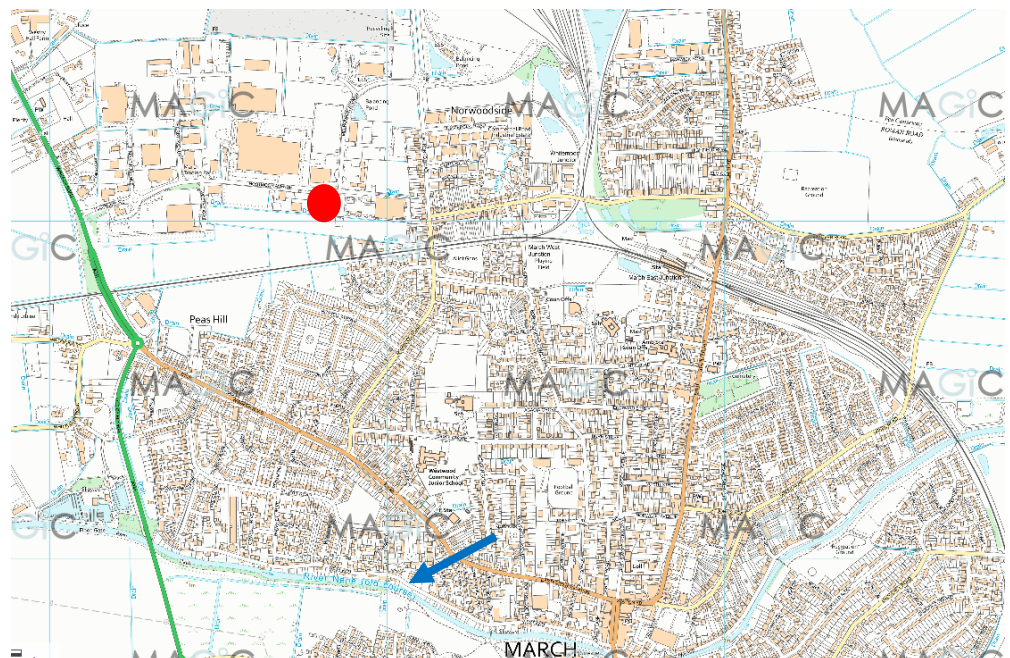
Site location in proximity to the River Nene
