Maxey Crossing Extension

Environmental Risk Assessment

Report No. K6036-ENV-R004

May 2024

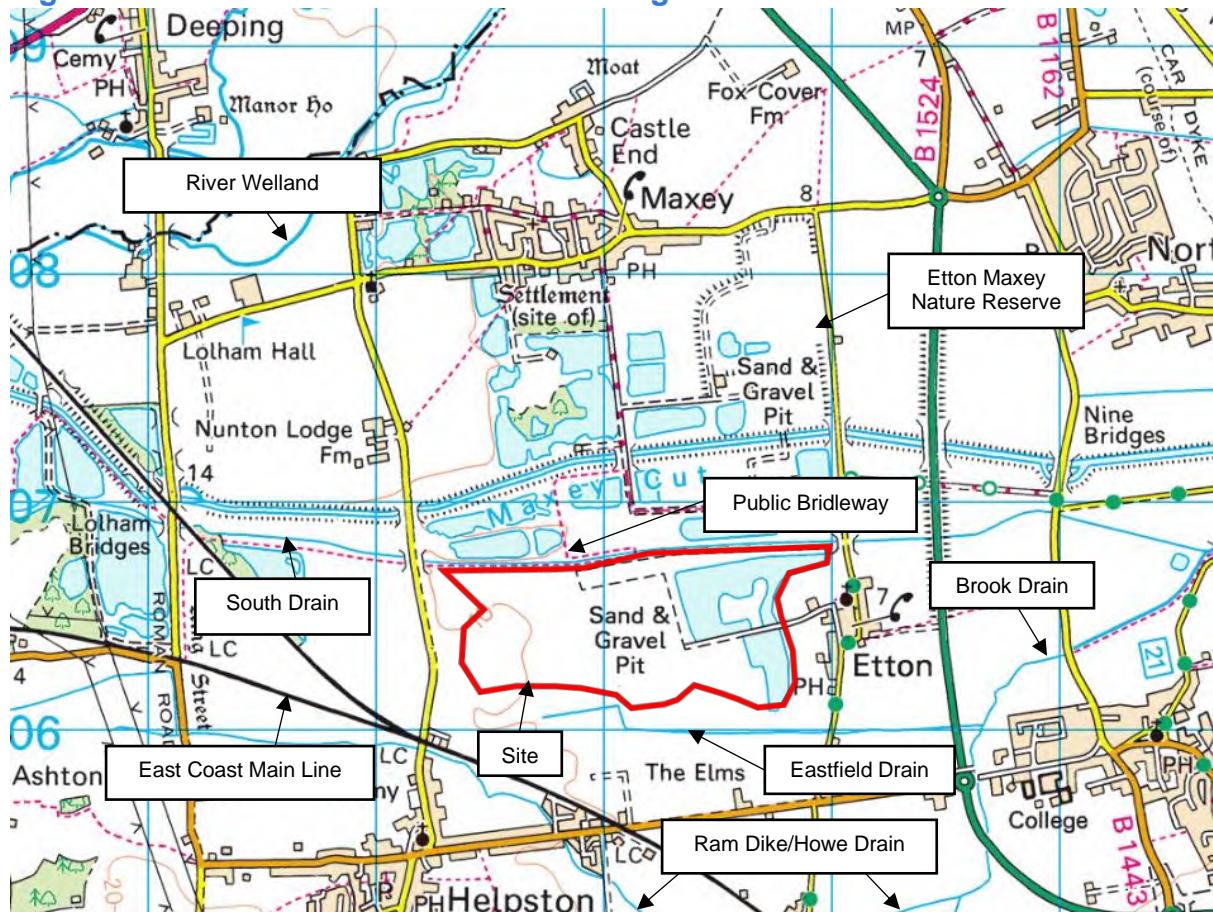
Figure 1 Site Location and Surrounding Features

The Site is bound to the north by an artificial watercourse known as the South Drain. The South Drain is a drainage channel that runs west to east past the Site and separates the Maxey Crossing Extension from previously worked areas of the Maxey Quarry which have been restored to a mixture of grassland and wetland habitats. To the east, west and south, the site is bound by agricultural fields. Maxey Road is positioned some 100m to the west of the site. Beyond the agricultural fields to the east, lies the village of Etton, where the closest residential properties are located at approximately 250m east of the site.

The Maxey Crossing Extension is surrounded by several surface water features as shown on Figure 1 including a number of manmade flood alleviation channels. The site is located within the Welland and Deepings Internal Drainage Board (IDB) district with the River Welland (designated by the Environment Agency as a 'Main River') located approximately 2.6km to the north east of the site at its closest point. All artificial surface water channels drain to a confluence with the River Welland 4km to the west.

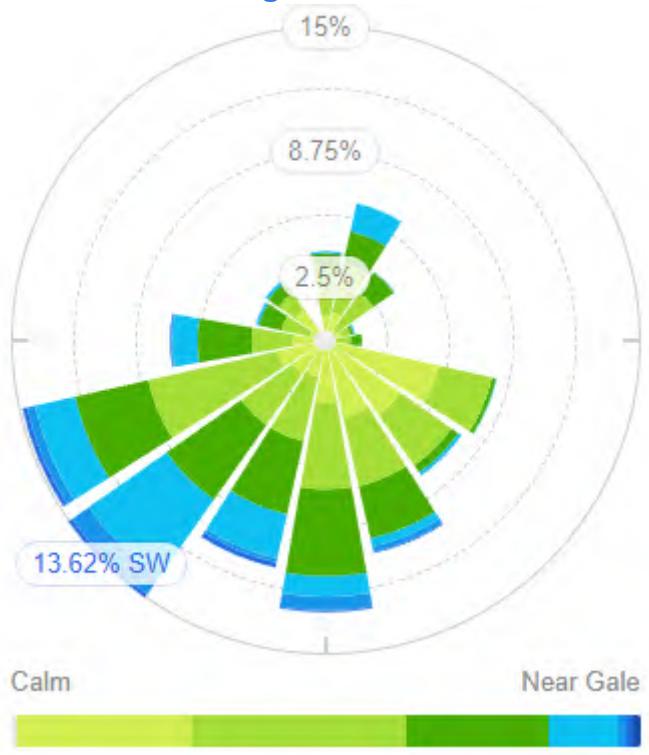
Figure 2 Wind Rose for Wittering weather station

The probability of exposure is determined by distance of the receptor to the site and the likelihood of the hazard reaching the receptor i.e. frequency of prevailing wind in that direction. The probability of exposure is irrespective of the type of hazard presented.

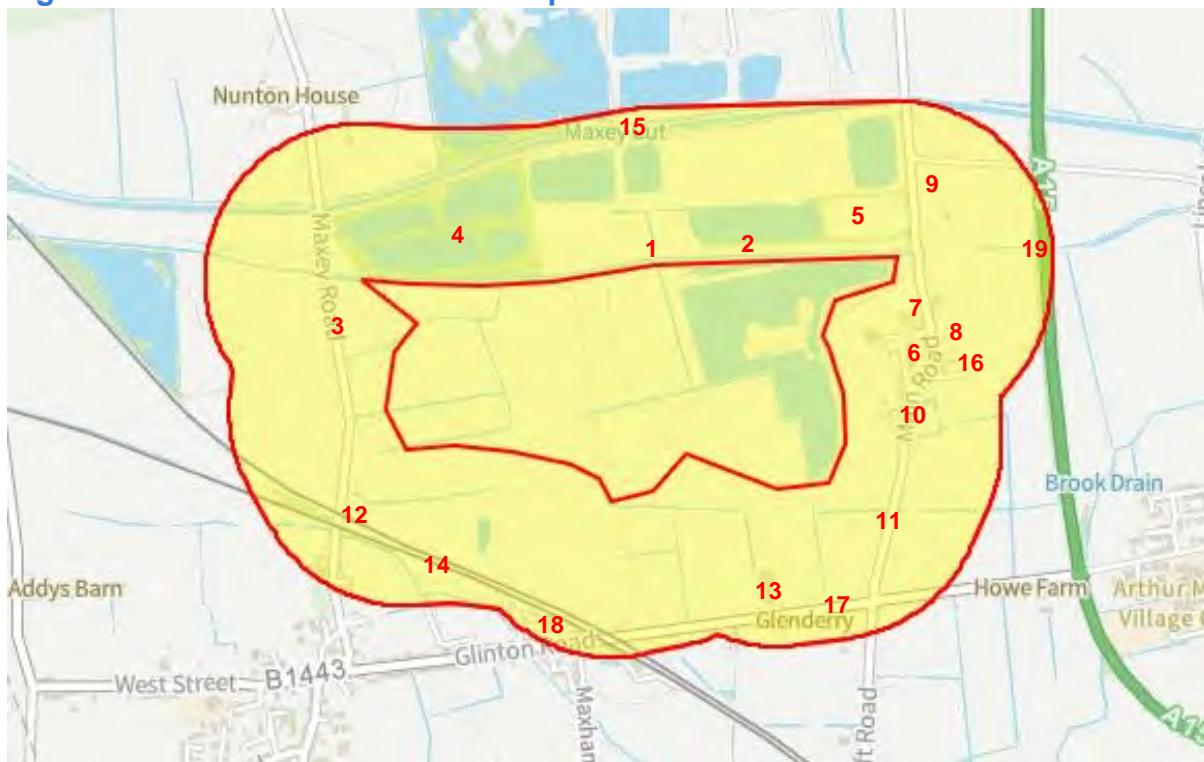
Figure 3 Location of Sensitive Receptors⁴

The site is surrounded by agricultural land, residential buildings, restored quarry (the majority of which has been converted into waterbodies, woodland and nature reserves) and Grade II listed properties in the villages of Etton and Maxey. The dominant land use is sand and gravel quarrying and agriculture.

The closest receptor is the South Drain manmade flood alleviation channel, which bounds the Site on its northern perimeter. Adjoining the South Drain are the Etton 1 and 9 footpaths (*Environmental Statement, David L Walker Ltd, July 2022*). Both the South Drain and these public rights of way are intersected by the Site's access haul road. The closest ecological receptors are the restored previously quarried areas to the North of the site including Vergette Wood Meadow and associated wetland. The closest residential properties are Rectory Farm and adjacent properties located in the village of Etton to the East of the site. St Stephen's Church is a Grade II listed property 170m from the site and further residential properties and the Golden Pheasant pub are also located in the village of Etton within 250m of the Site. Further residential properties exist on the edge of the village of Helpston to the South and South- West of the site within 330m and further East within Etton village (430m).

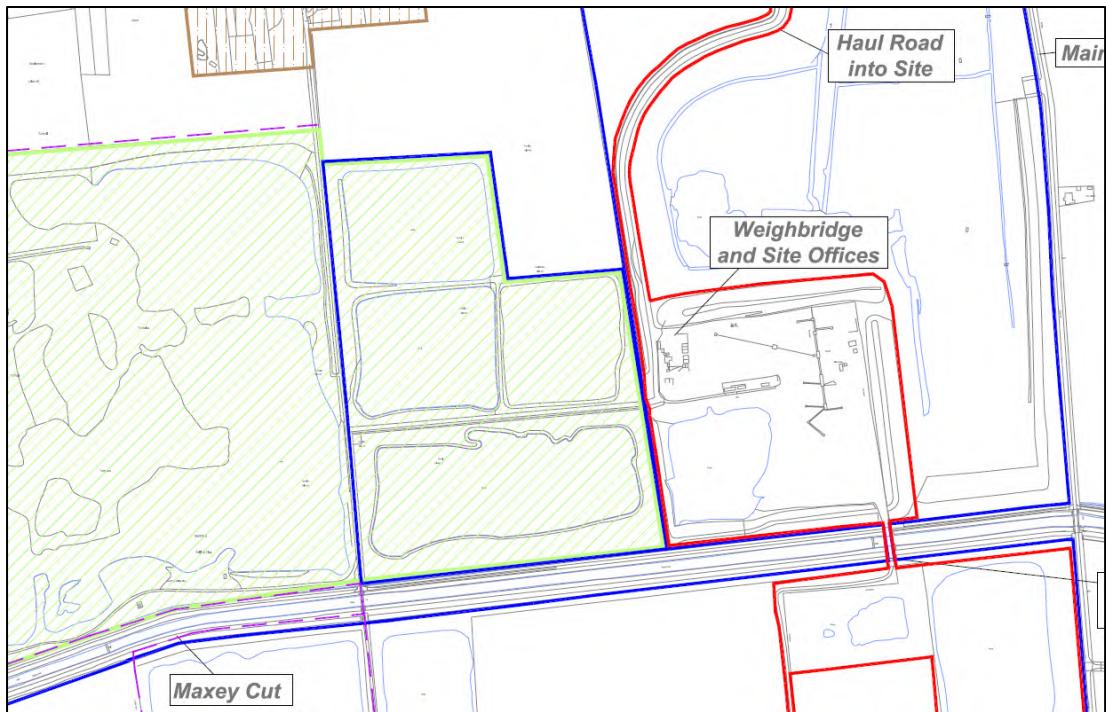
3.1.8. Maxey Quarry County Wildlife Site lies adjacent to the northern section of the survey area. This is shown in green hatching on the map below with the survey area within the red line.

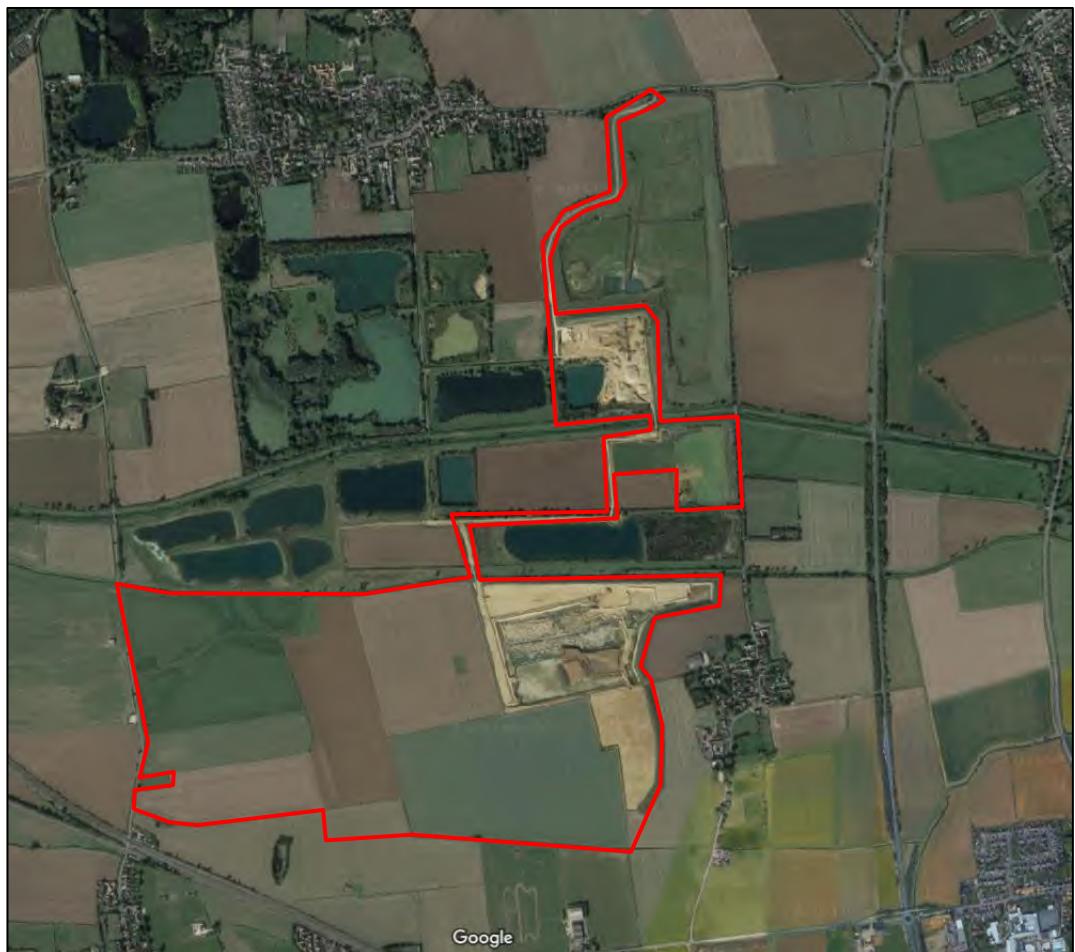
3.2.2. The aerial photograph below shows the survey area.

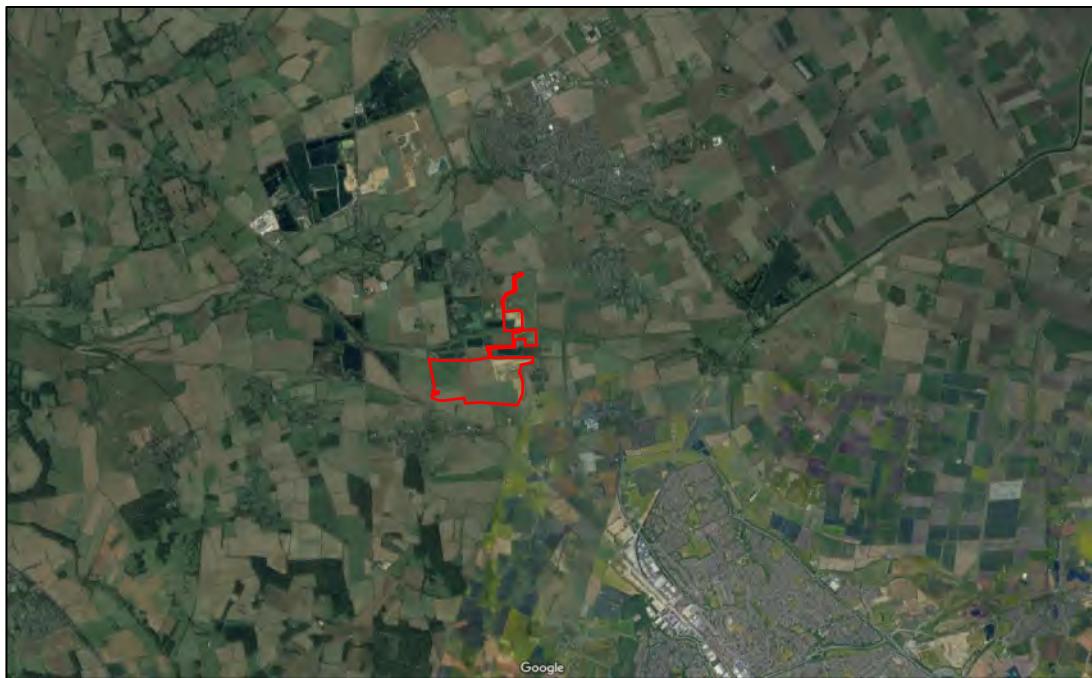
3.2.3. The aerial photograph below shows the survey area and wider surrounding area.

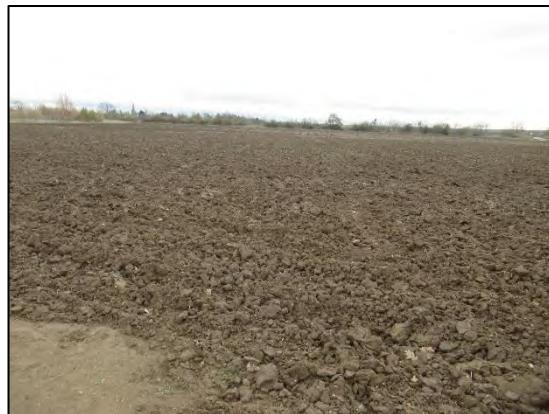
3.3.2.1. Within the central section of the site there is a freshly ploughed arable field, half of which is within the survey area. This field did not appear to have an arable margin.

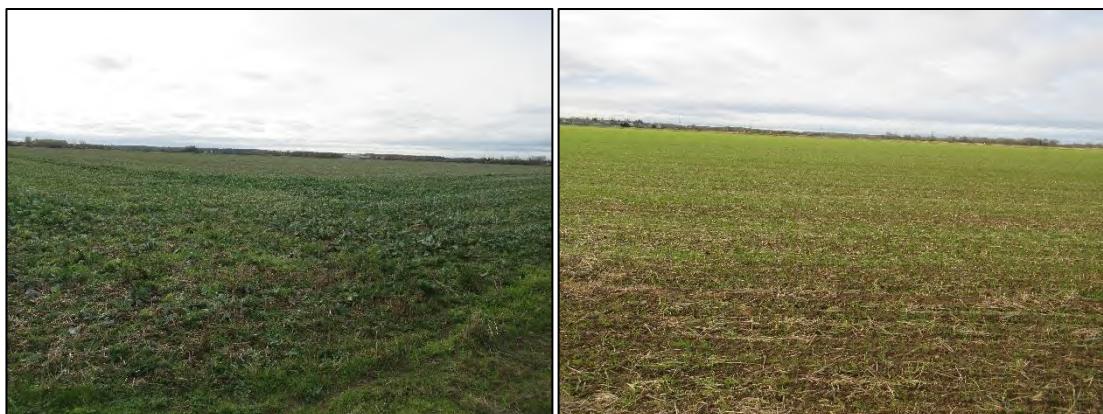
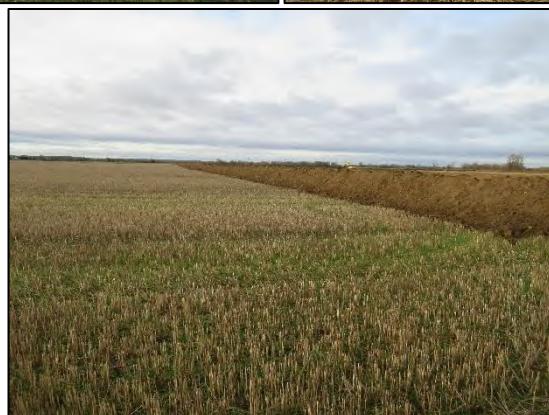
3.3.2.2. Within the southern section of the site there are large open arable fields separated by dry drainage ditches, which are improved grassland with a narrow margin of improved grassland along the tops of the banks. All the banks are mown short. These fields did not appear to have arable margins.

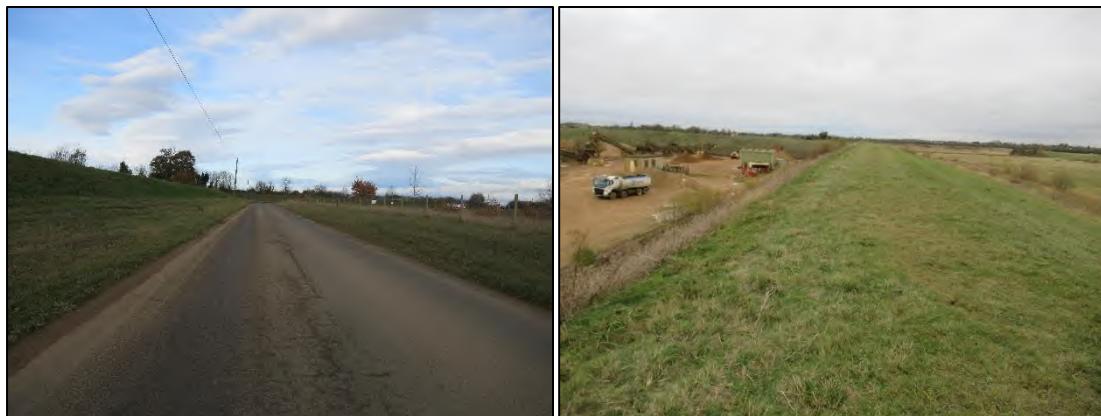
3.3.3.1. Within the northern section of the site there are bunds along each side of the access road to the quarry and bunds around the northern and eastern sides of the working area. These are all covered with improved grassland with a short sward.

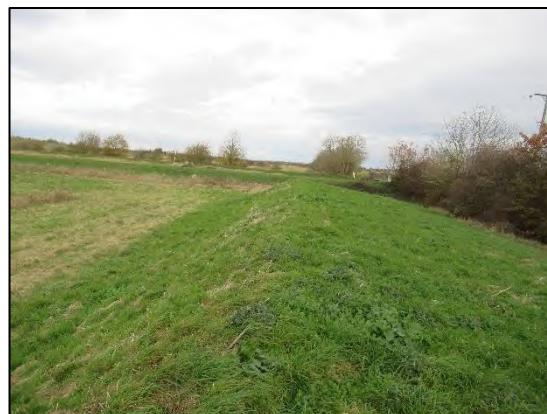
3.3.3.2. Within the central section of the site there is a bund along the eastern side of the lagoon, which is covered with improved grassland with a short sward. The banks of Maxey Cut, which flows between the northern and central sections of the site are also improved grassland with a short sward.

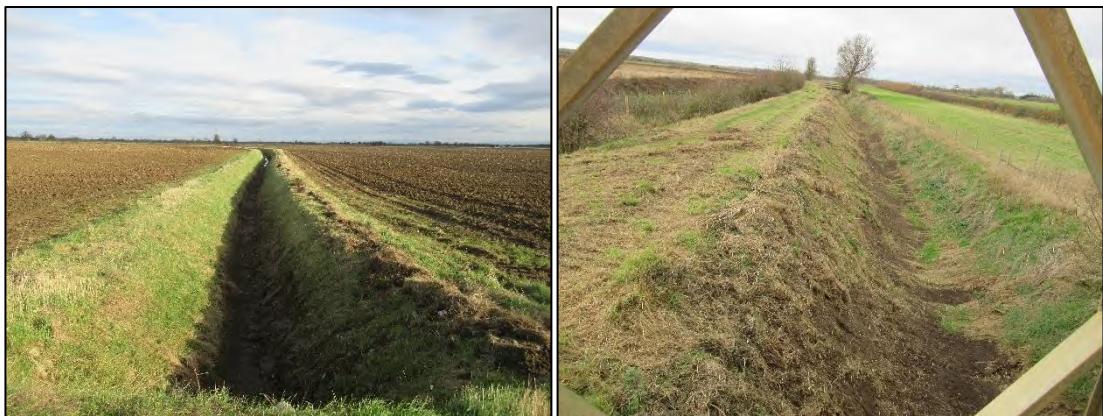
3.3.3.3. Within the southern section of the site there are numerous areas of improved grassland including along the bund along the northern boundary. There are a number of dry ditches within the southern section separating the arable fields, which are improved grassland with a narrow margin along the tops of the banks. The western half of the northern dry ditch is also improved grassland.

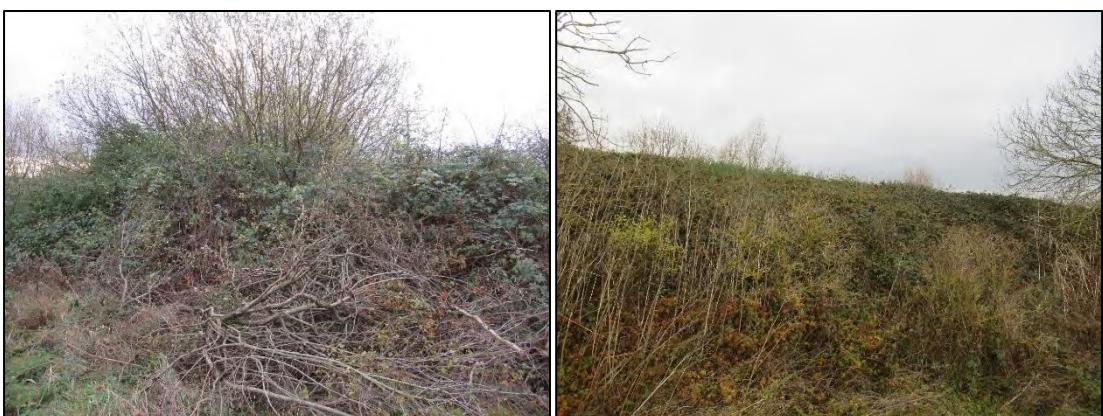
3.3.5.1. Within the northern section of the site there is a margin of dense scrub around three sides of the lagoon. The main species present are bramble (*Rubus fruticosus*), blackthorn (*Prunus spinosa*), elder (*Sambucus nigra*), teasel (*Dipsacus sylvestris*), hogweed (*Heracleum sphondylium*), nettle (*Urtica dioica*), goat willow (*Salix caprea*), crack willow (*Salix fragilis*) and hawthorn (*Crataegus monogyna*).

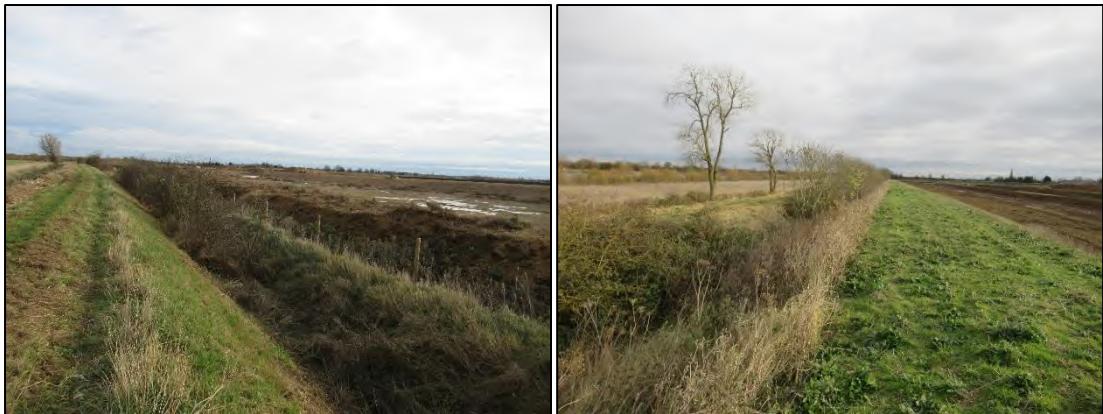
3.3.5.2. Within the southern section of the site there is a dry ditch along the northern side. The eastern half of this ditch is full of dense scrub, mainly bramble (*Rubus fruticosus*), blackthorn (*Prunus spinosa*), elder (*Sambucus nigra*), dog rose (*Rosa canina*) and hawthorn (*Crataegus monogyna*).

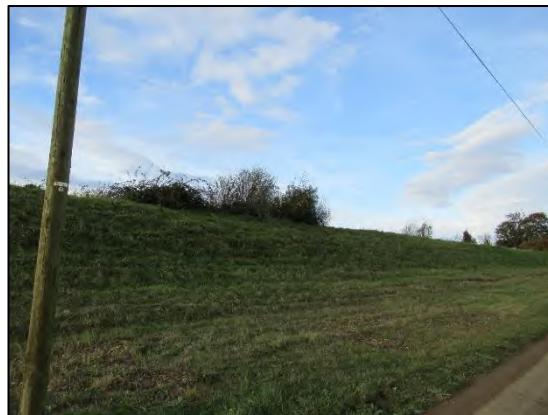
3.3.6.1. Along the western side of the bund, along the western side of the access road to the quarry there is occasional scattered scrub, including bramble (*Rubus fruticosus*), blackthorn (*Prunus spinosa*) and sapling hawthorn (*Crataegus monogyna*) and elder (*Sambucus nigra*).

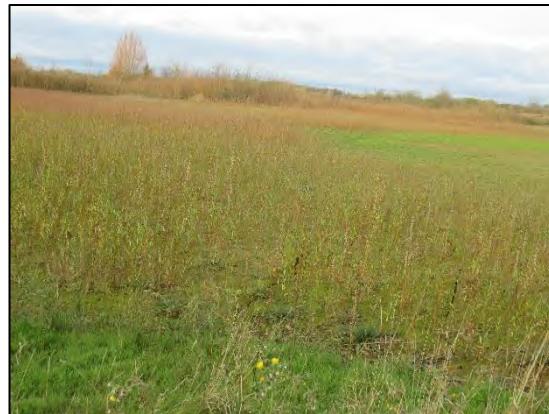
3.3.6.2. Within the central section of the site there is a large lagoon, which at the time of the survey only contained water in the northern half. The southern half of the lagoon was silt becoming overgrown with large numbers of sapling crack willow (*Salix fragilis*) and some phragmites (*Phragmites australis* (Cav.)).

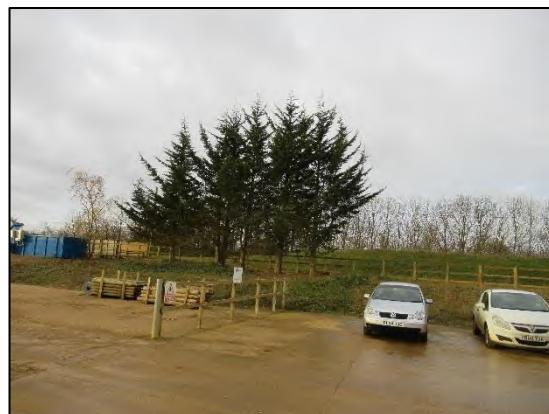
3.3.7.1. There are few trees on the site. Adjacent to the car park within the northern section of the site there are three semi-mature pine (*Pinus sp.*) trees.

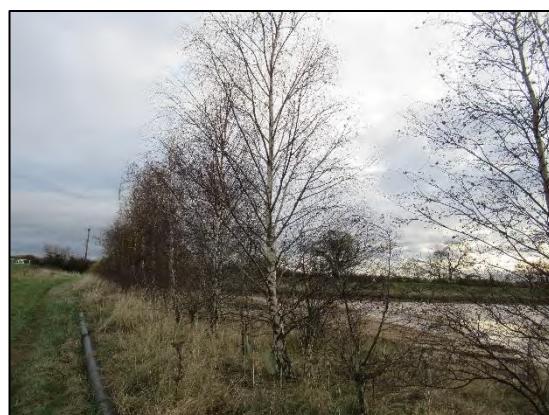
3.3.7.2. Within the central section of the site there is a row of small semi-mature trees along the northern side of the lagoon. The main species present are oak (*Quercus sp(p)*), alder (*Alnus glutinosa*), silver birch (*Betula pendula*) and crack willow (*Salix fragilis*).

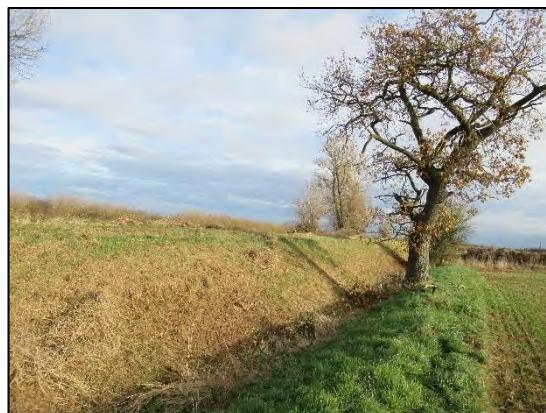
3.3.7.3. Within the southern section of the site there are three trees along the northern boundary. Two large ash (*Fraxinus excelsior*) are just outside the site boundary on the bank of South Drain. One semi-mature oak (*Quercus sp(p)*) is within the site boundary on the southern side of the dry ditch.

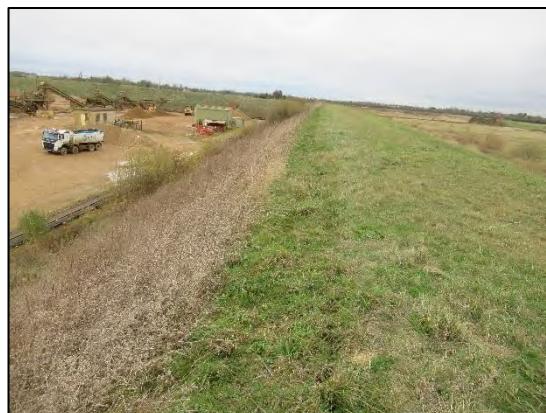
3.3.8.1. Along the eastern bund, within the northern section of the site, there is tall ruderal vegetation on the western side of the bund with improved grass covering the top and eastern side of the bund. The main species present are teasel (*Dipsacus sylvestris*), sow thistle (*Sonchus oleraceus*), thistle (*sp(p)*), nettle (*Urtica dioica*), sapling elder (*Sambucus nigra*), sapling goat willow (*Salix caprea*), sapling hawthorn (*Crataegus monogyna*), buddleia (*Buddleia davidii*) and bramble (*Rubus fruticosus*).

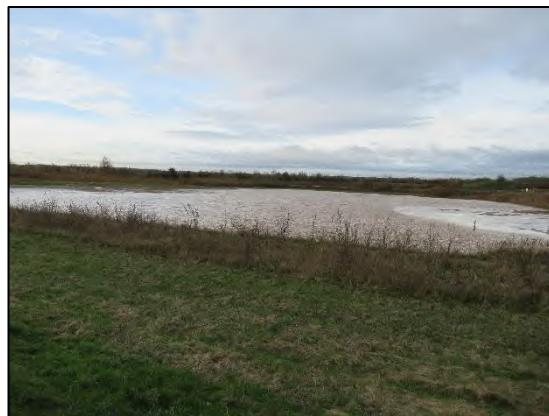
3.3.8.2. Within the central section of the site there is a small strip of tall ruderal habitat along the eastern bank of the lagoon, including nettle (*Urtica dioica*), sapling crack willow (*Salix caprea*), thistle (*Cirsium sp(p)*) and sow thistle (*Salix caprea*).

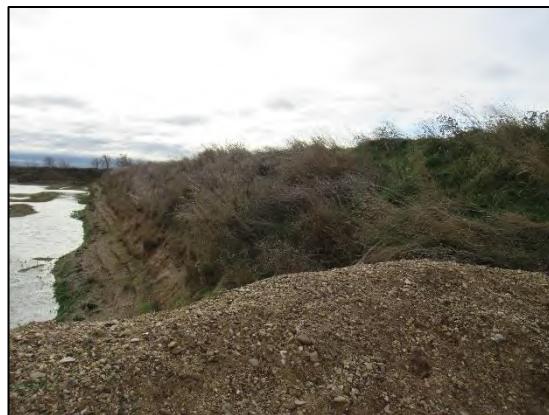
3.3.8.3. Within the southern section of the site there is a bund along the western side of the southern lagoon, which is covered with thistle (*sp(p)*), nettle (*Urtica dioica*), dock (*Rumex sp.*), sow thistle (*Sonchus oleraceus*), comfrey (*Symphytum officinale*), chickweed (*Stellaria media*), white dead nettle (*Lamium album*), coltsfoot (*Tussilago farfara*), annual meadow grass (*Poa annua*) and cocks foot (*Dactylis glomerata*).

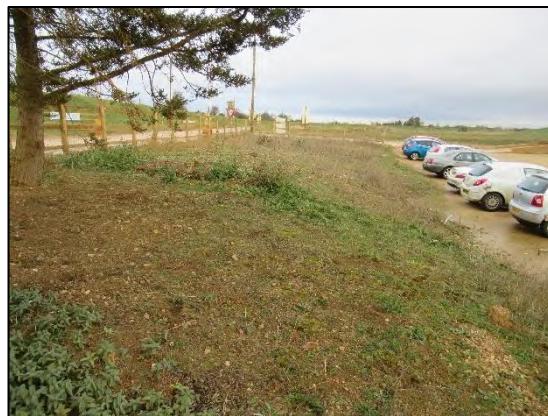
3.3.9.1. Within the northern section of the site along the western side of the car park there is an area of sparse short ephemeral species growing between the car park and the access track, including teasel (*Dipsacus sylvestris*), creeping buttercup (*Ranunculus Repens*), bugle (*Ajuga reptans*), white clover (*Trifolium repens*), common daisy (*Bellis perennis*), ragwort (*Senecio jacobaea*), thistle (*Cirsium sp(p)*), ribwort plantain (*Plantago lanceolata*) and small sapling buddleia (*Buddleia davidii*).

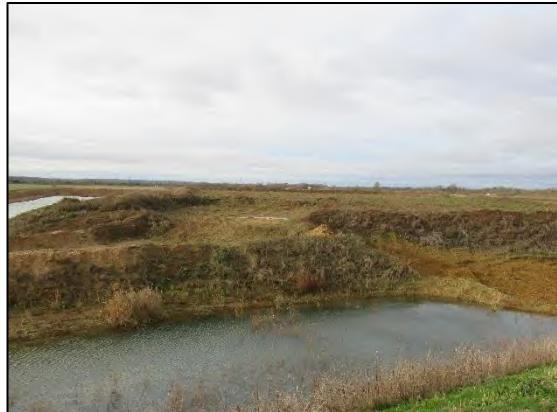
3.3.9.2. Within the southern section of the site within the areas of lagoons there is a series of sand bunds, which are becoming vegetated with nettle (*Urtica dioica*), thistle (*Cirsium sp(p)*), sow thistle (*Sonchus oleraceus*), dock (*Rumex sp.*), coltsfoot (*Tussilago farfara*) and cocks foot (*Dactylis glomerata*).

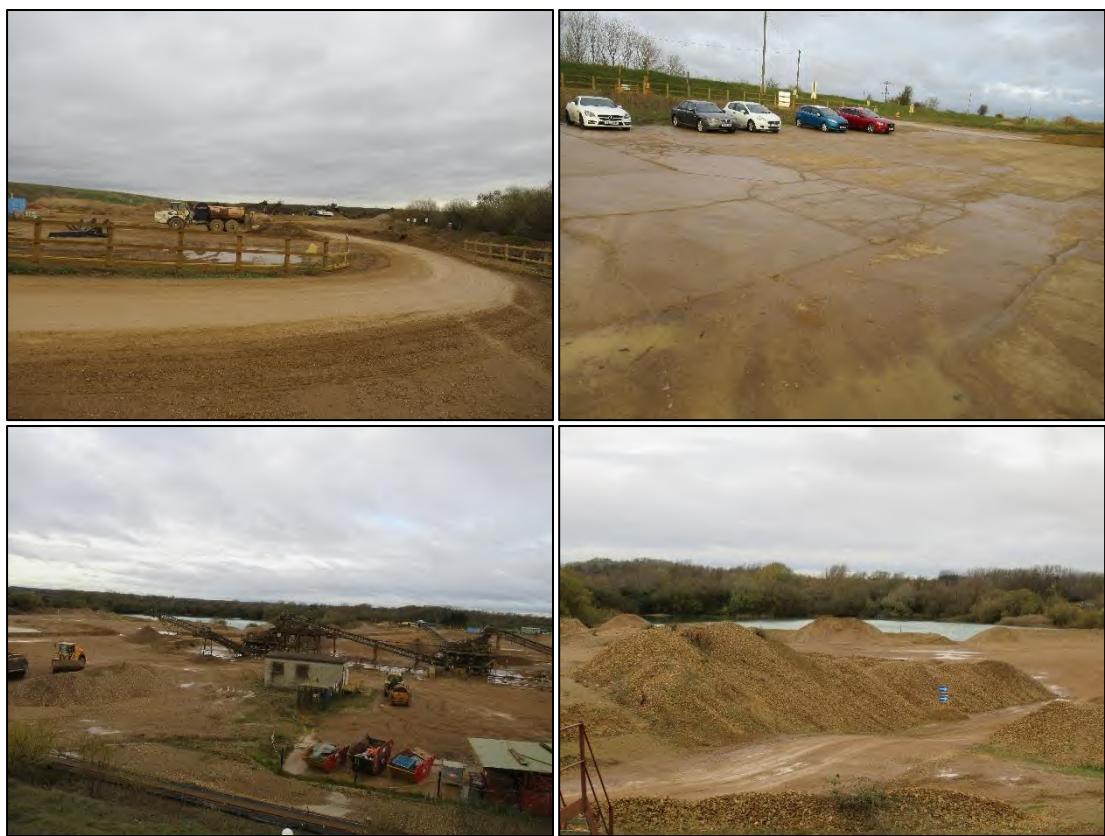
There are large areas of bare ground within all sections of the site, which are mainly bare sand and topsoil within the operational areas of the quarry. There is also a concrete car park, a tarmac access road and two metal bridges.

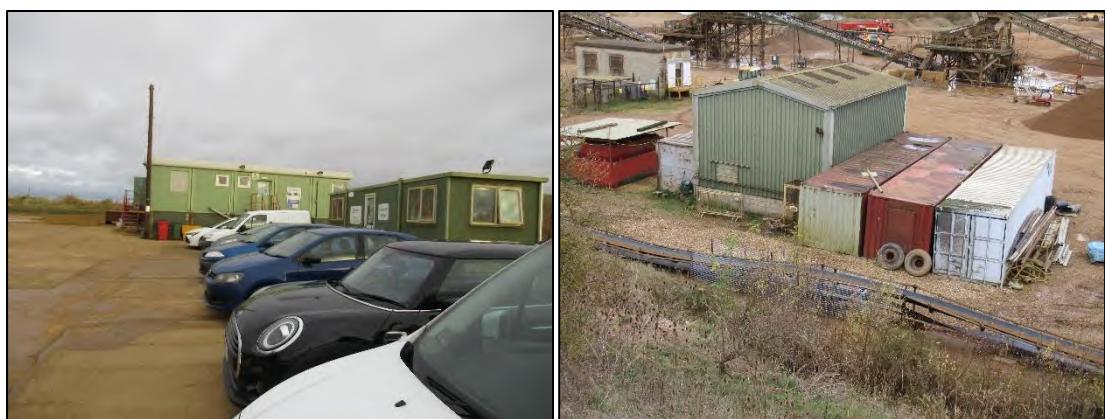
There are a number of buildings within the northern section of the site included the site office and weighbridge portacabins and a series of metal workshops and metal storage containers.

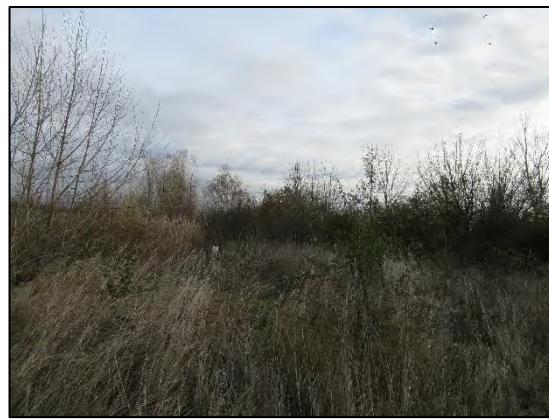
3.3.12.1. Within the central section of the site there is a hedgerow along the southern boundary, which is mainly sapling hawthorn (*Crataegus monogyna*) with sapling oak (*Quercus sp(p)*), alder (*Alnus glutinosa*), silver birch (*Sambucus nigra*) and elder (*Sambucus nigra*).

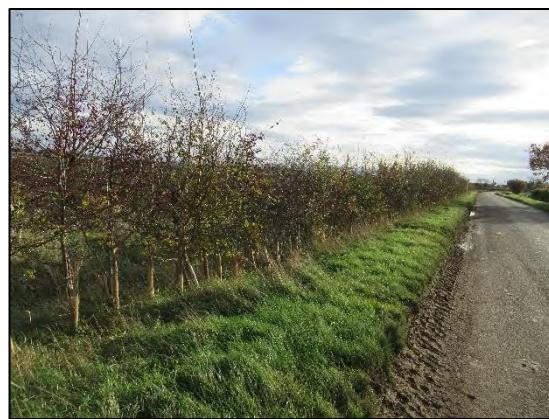
3.3.12.2. Along the western side of the southern section of the site between the arable fields and adjacent road there is a newly planted hedgerow of young trees, mainly hawthorn (*Crataegus monogyna*) with occasional sapling oak (*Quercus sp(p)*).

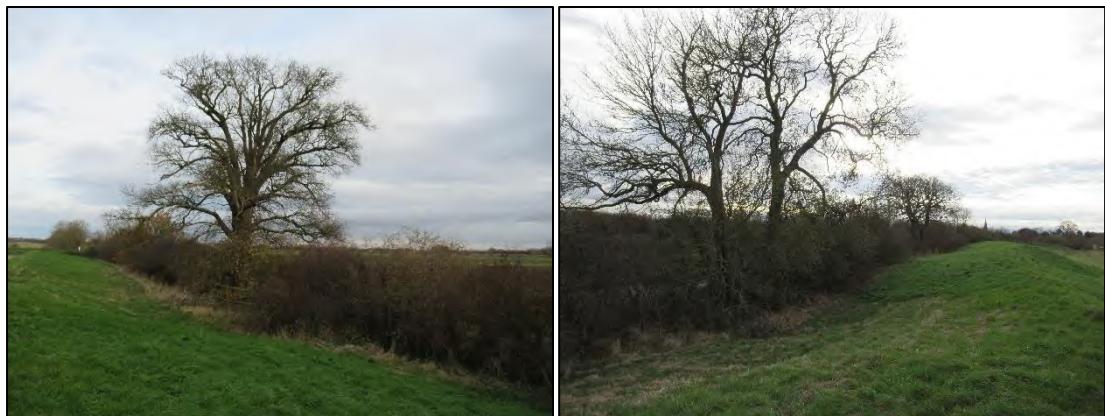
Along the eastern boundary of the central section of the site there is a hedgerow containing semi-mature and mature trees, between the site and the adjacent road. The main species present are hawthorn (*Crataegus monogyna*), elder (*Sambucus nigra*) and sapling ash (*Fraxinus excelsior*) with mature oak (*Quercus sp(p)*) and semi-mature ash (*Fraxinus excelsior*).

4.4.7. There are two ash trees and a mature oak tree that lie just outside the eastern site boundary of the central area that overhang the site boundary that may provide suitable roosting bat opportunities with broken limbs and lifted bark that provide roosting potential. Therefore, if these trees will be affected by the works, there may be an impact on bats roosting within the trees.

5.4. It is recommended that the trees along the eastern site boundary that provide roosting bat potential are left undisturbed during the proposed works to avoid having any impact on roosting bat if they are present.

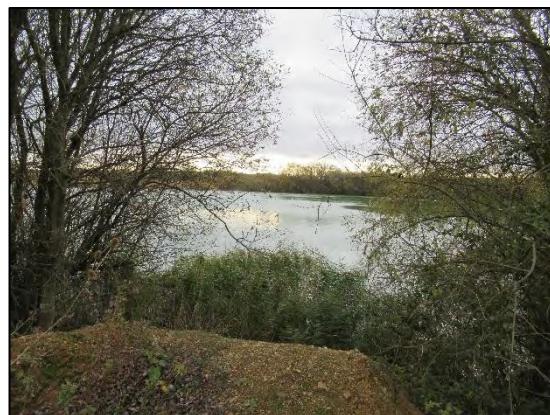
3.3.14.1. Within the northern section of the site there is a large lagoon with scrub around three sides and bare ground on the eastern side. There are a number of large pipes both taking water from the lagoon and putting water into the lagoon as part of the working quarry.

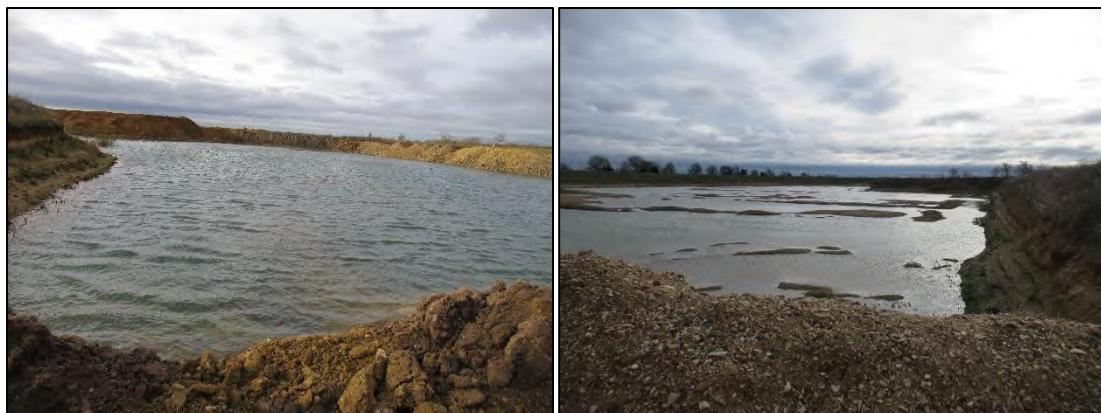
3.3.14.3. Within the southern section of the site there are two large areas of open water comprised of flooded mineral workings surrounded mainly by bare sand and topsoil. There is an improved grass bund along the eastern side, an area of ephemeral vegetation on a bund in the centre of the water bodies and a section of bund on the western side covered with tall ruderal habitat. The water bodies are within an area of the quarry currently being worked.

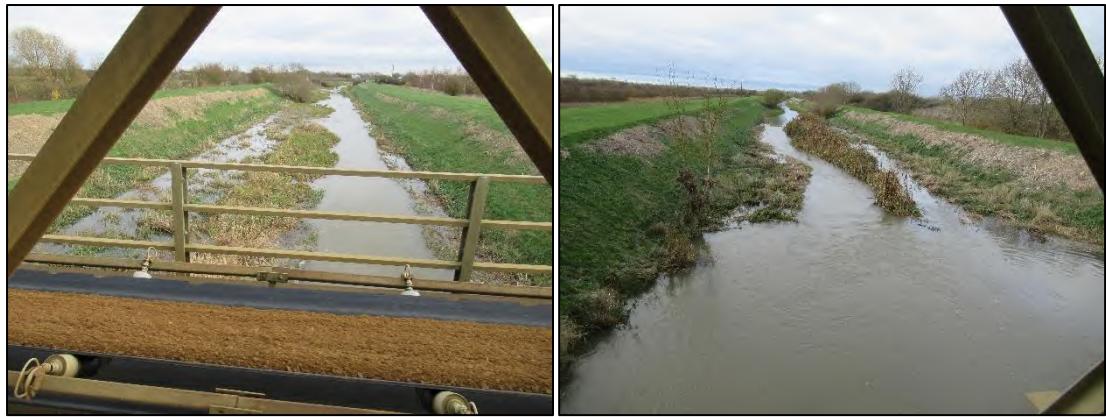
Maxey Cut flows between the northern and central sections of the site with a bailey bridge crossing the watercourse. The watercourse is approximately 10m wide with a moderate flow. The banks are improved grassland with a short sward with a public footpath along the northern bank. There is reed in the water and during the survey water was being pumped into the river from the bridge. This is a manmade drainage feature maintained for that purpose and is as such highly engineered.

3.4.2. Maxey Cut flows through the site from west to east between the northern and central sections of the quarry. This watercourse may provide a suitable habitat for water voles, otters and freshwater white clawed crayfish. However, the proposed works will have no impact on the watercourse as this feature is already crossed by a clear span bailey bridge.

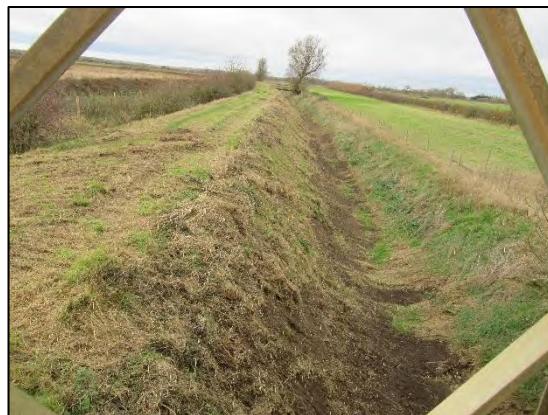
3.3.16.1. South Drain extends between the central and southern sections of the site but this drain is totally dry and the banks and the drain are improved grassland with a short sward. Again, this is a manmade drainage feature.

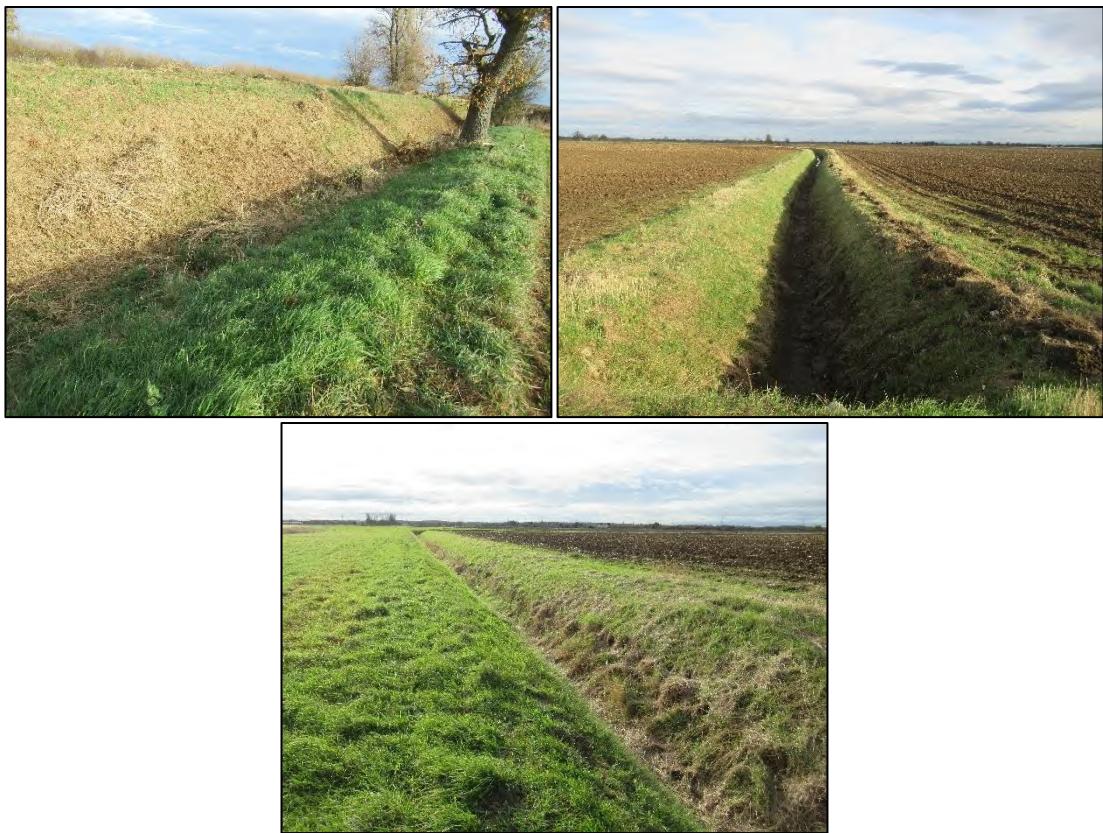
3.3.16.2. Within the southern section of the site there are a series of dry ditches and drains along the northern boundary and separating the arable fields. The banks, the drains and a narrow margin each side of the banks are improved grassland with a short sward. These were all found to be dry at the time of the survey.

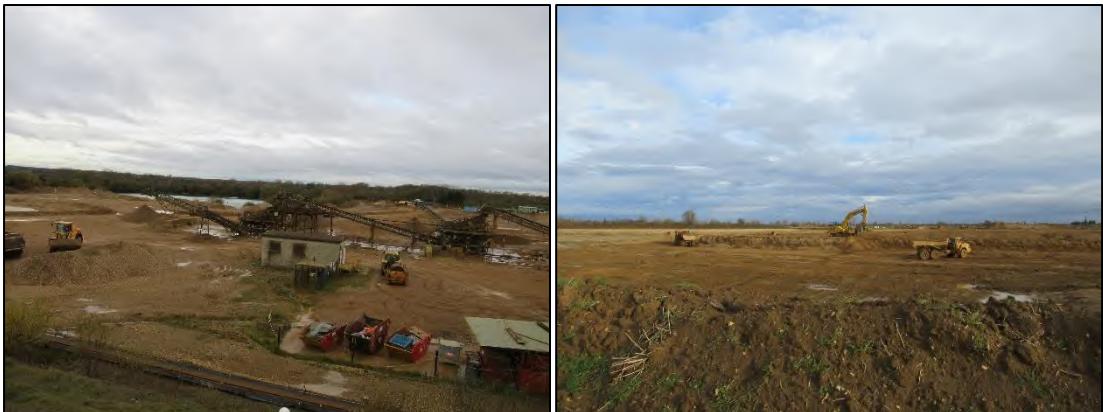
These areas are the working areas of the existing quarry with regular vehicle movements and extraction works.

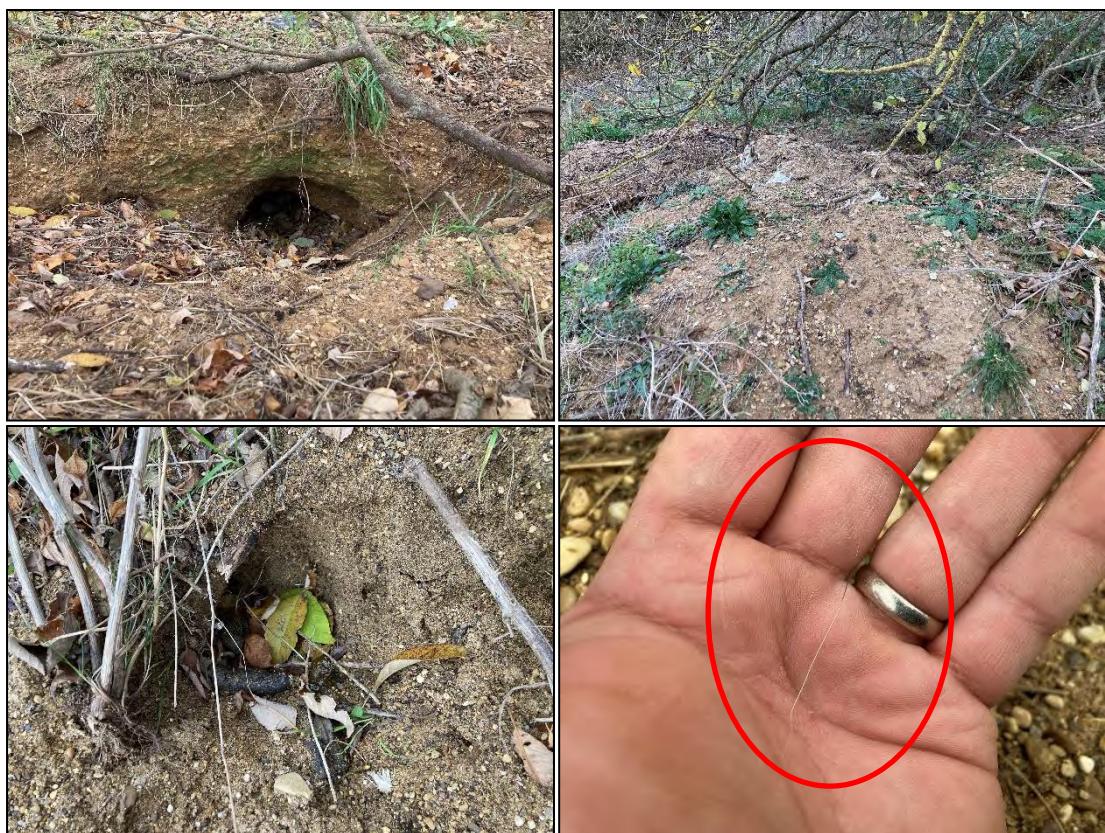
3.4.1. During this survey, a badger sett was identified at the bottom of the western side of the eastern bund behind the quarries workshop. The sett consists of five entrances with small to medium spoil heaps. Three of the entrances were full of leaf debris and two entrances had old bedding blocking the entrances. There was old bedding in the spoil heaps with badger hairs also found in the spoil. A fresh badger dung pit was located between two of the entrances and there was a clear path leading south at the bottom of the bund. The badger sett has been assessed as a currently active outlying sett. The photographs below show one of the entrances, a spoil heap, the dung pit and a badger hair.

4.4.1. During this survey a badger sett was identified at the bottom of the western side of the eastern bund behind the quarries workshop. The sett consists of five entrances with small to medium spoil heaps. Three of the entrances were full of leaf debris and two entrances had old bedding blocking the entrances. There was old bedding in the spoil heaps with badger hairs also found in the spoil. A fresh badger dung pit was located between two of the entrances and there was a clear path leading south at the bottom of the bund. The badger sett has been assessed as a currently active outlying sett. Therefore, the current works will have no impact on the badger sett. However, if the bund will be affected by future works, there will be a high impact on badgers and their setts.

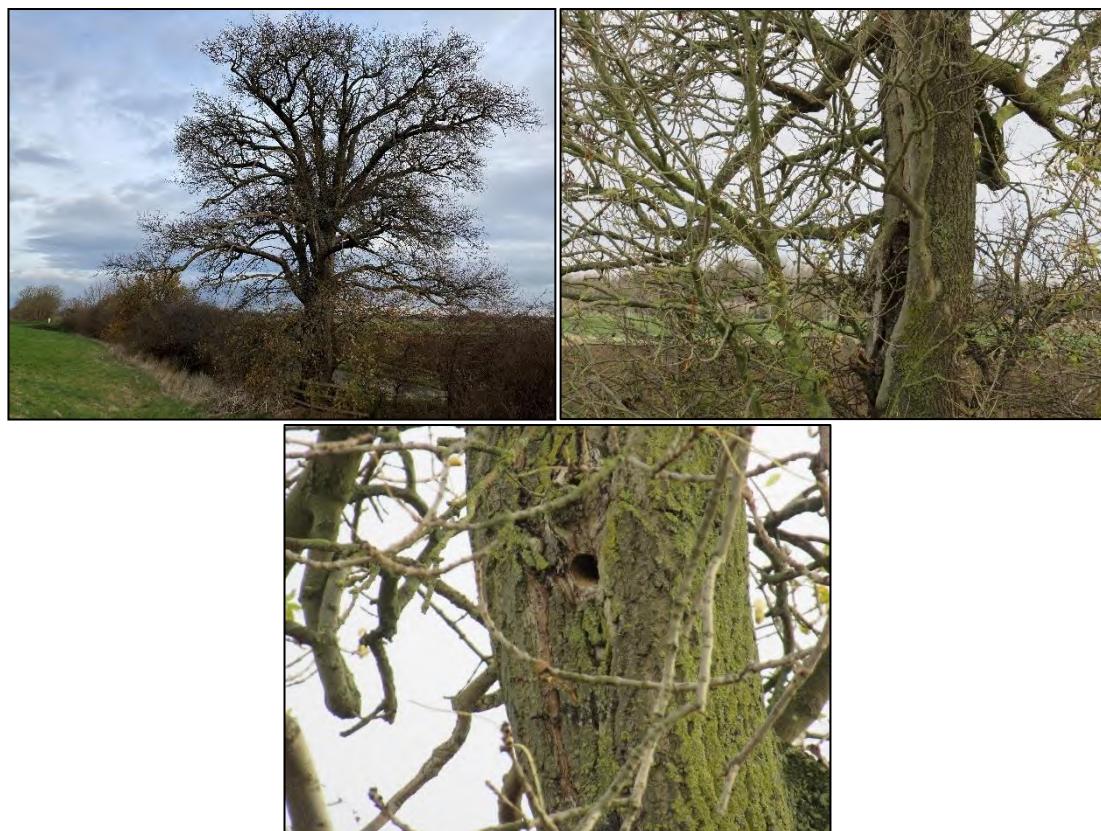
3.4.4. There are two ash trees and a mature oak tree that lie just outside the eastern site boundary of the central area within the hedgerow with trees. The trees overhang the site boundary and may provide suitable roosting bat opportunities with broken limbs and lifted bark that provide suitable features for roosting bats. The photographs below show the oak tree and some of the features in the ash trees.
