Stability Assessment of Proposed Stabilisation Buttress

Saxon Pit

East Midlands Waste Management

SLR Project No.: 403.07764.00001

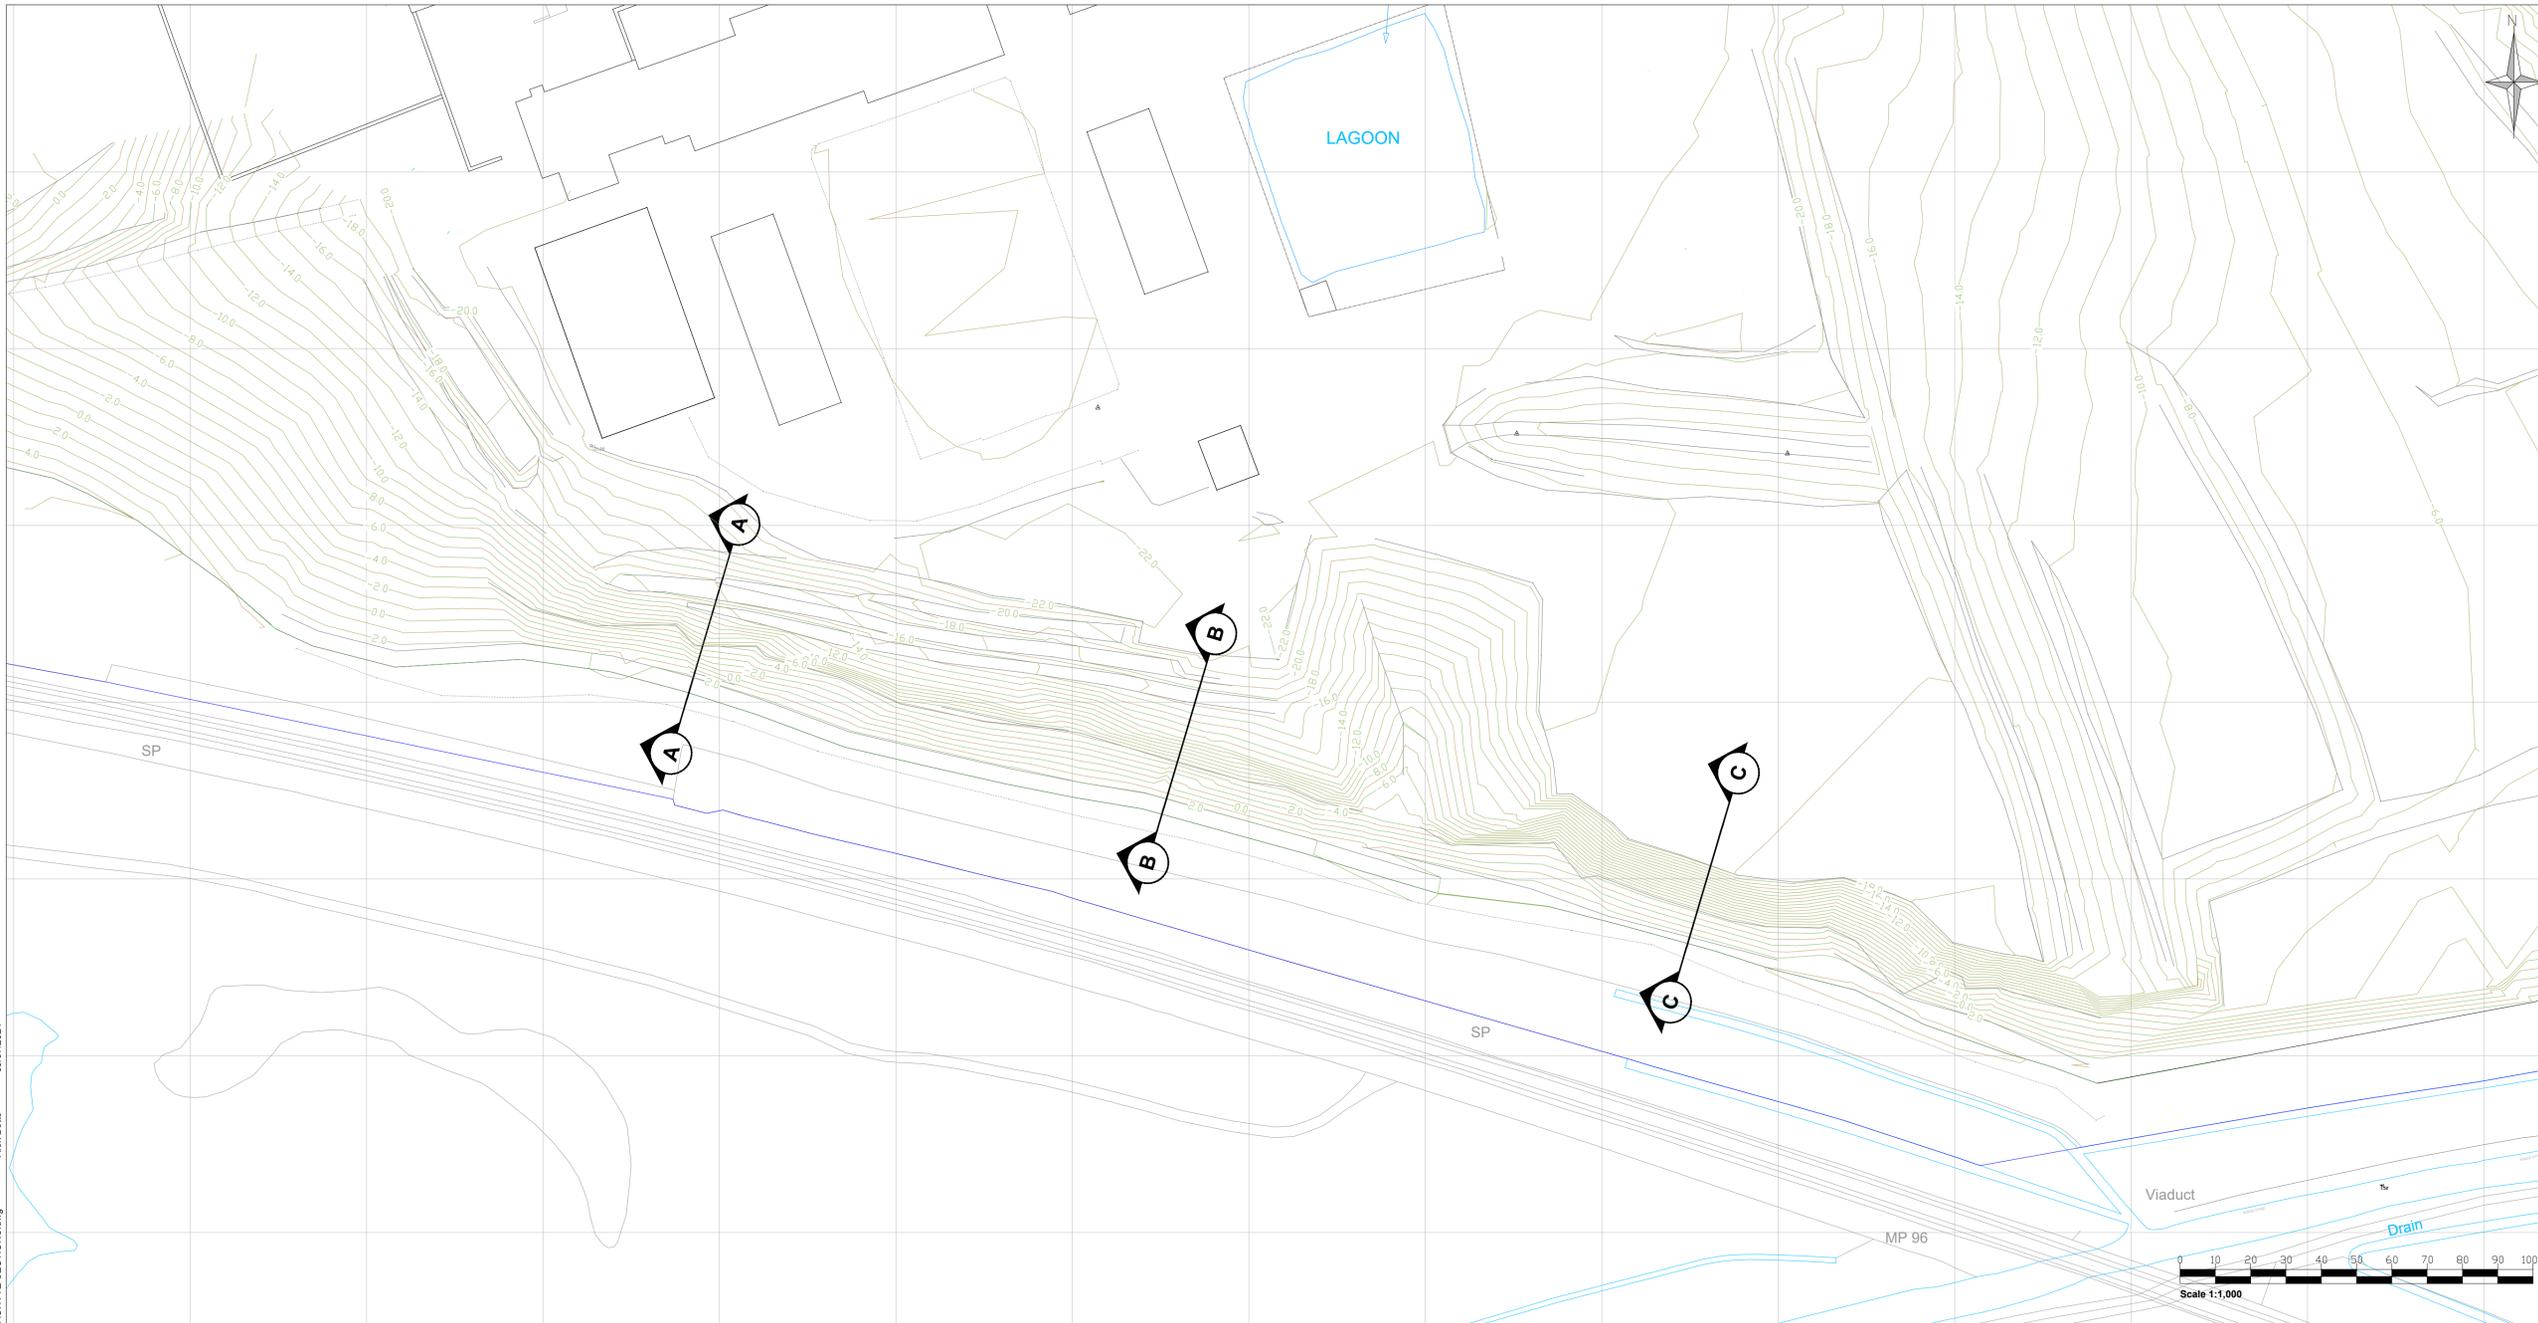
Drawing Title
HISTORICAL SLOPE SECTIONS / PROFILES

Drawing 001 contains historical slope sections showing a comparison between a survey carried out c. 2004 and the 2019 topographic survey. This further confirms that the crest of the southern slope is migrating.

A topographic survey⁴ was provided by EMWM for the purpose of this assessment, Drawing 001 contains the drawing and the cross-sections produced to derive the slope profile. The slope forming the majority of the buttress along the south-western edge of the site has been modelled, as well as the slope adjacent to the existing site buildings. The geometries shall be used throughout the analyses and are solely based on the information provided.

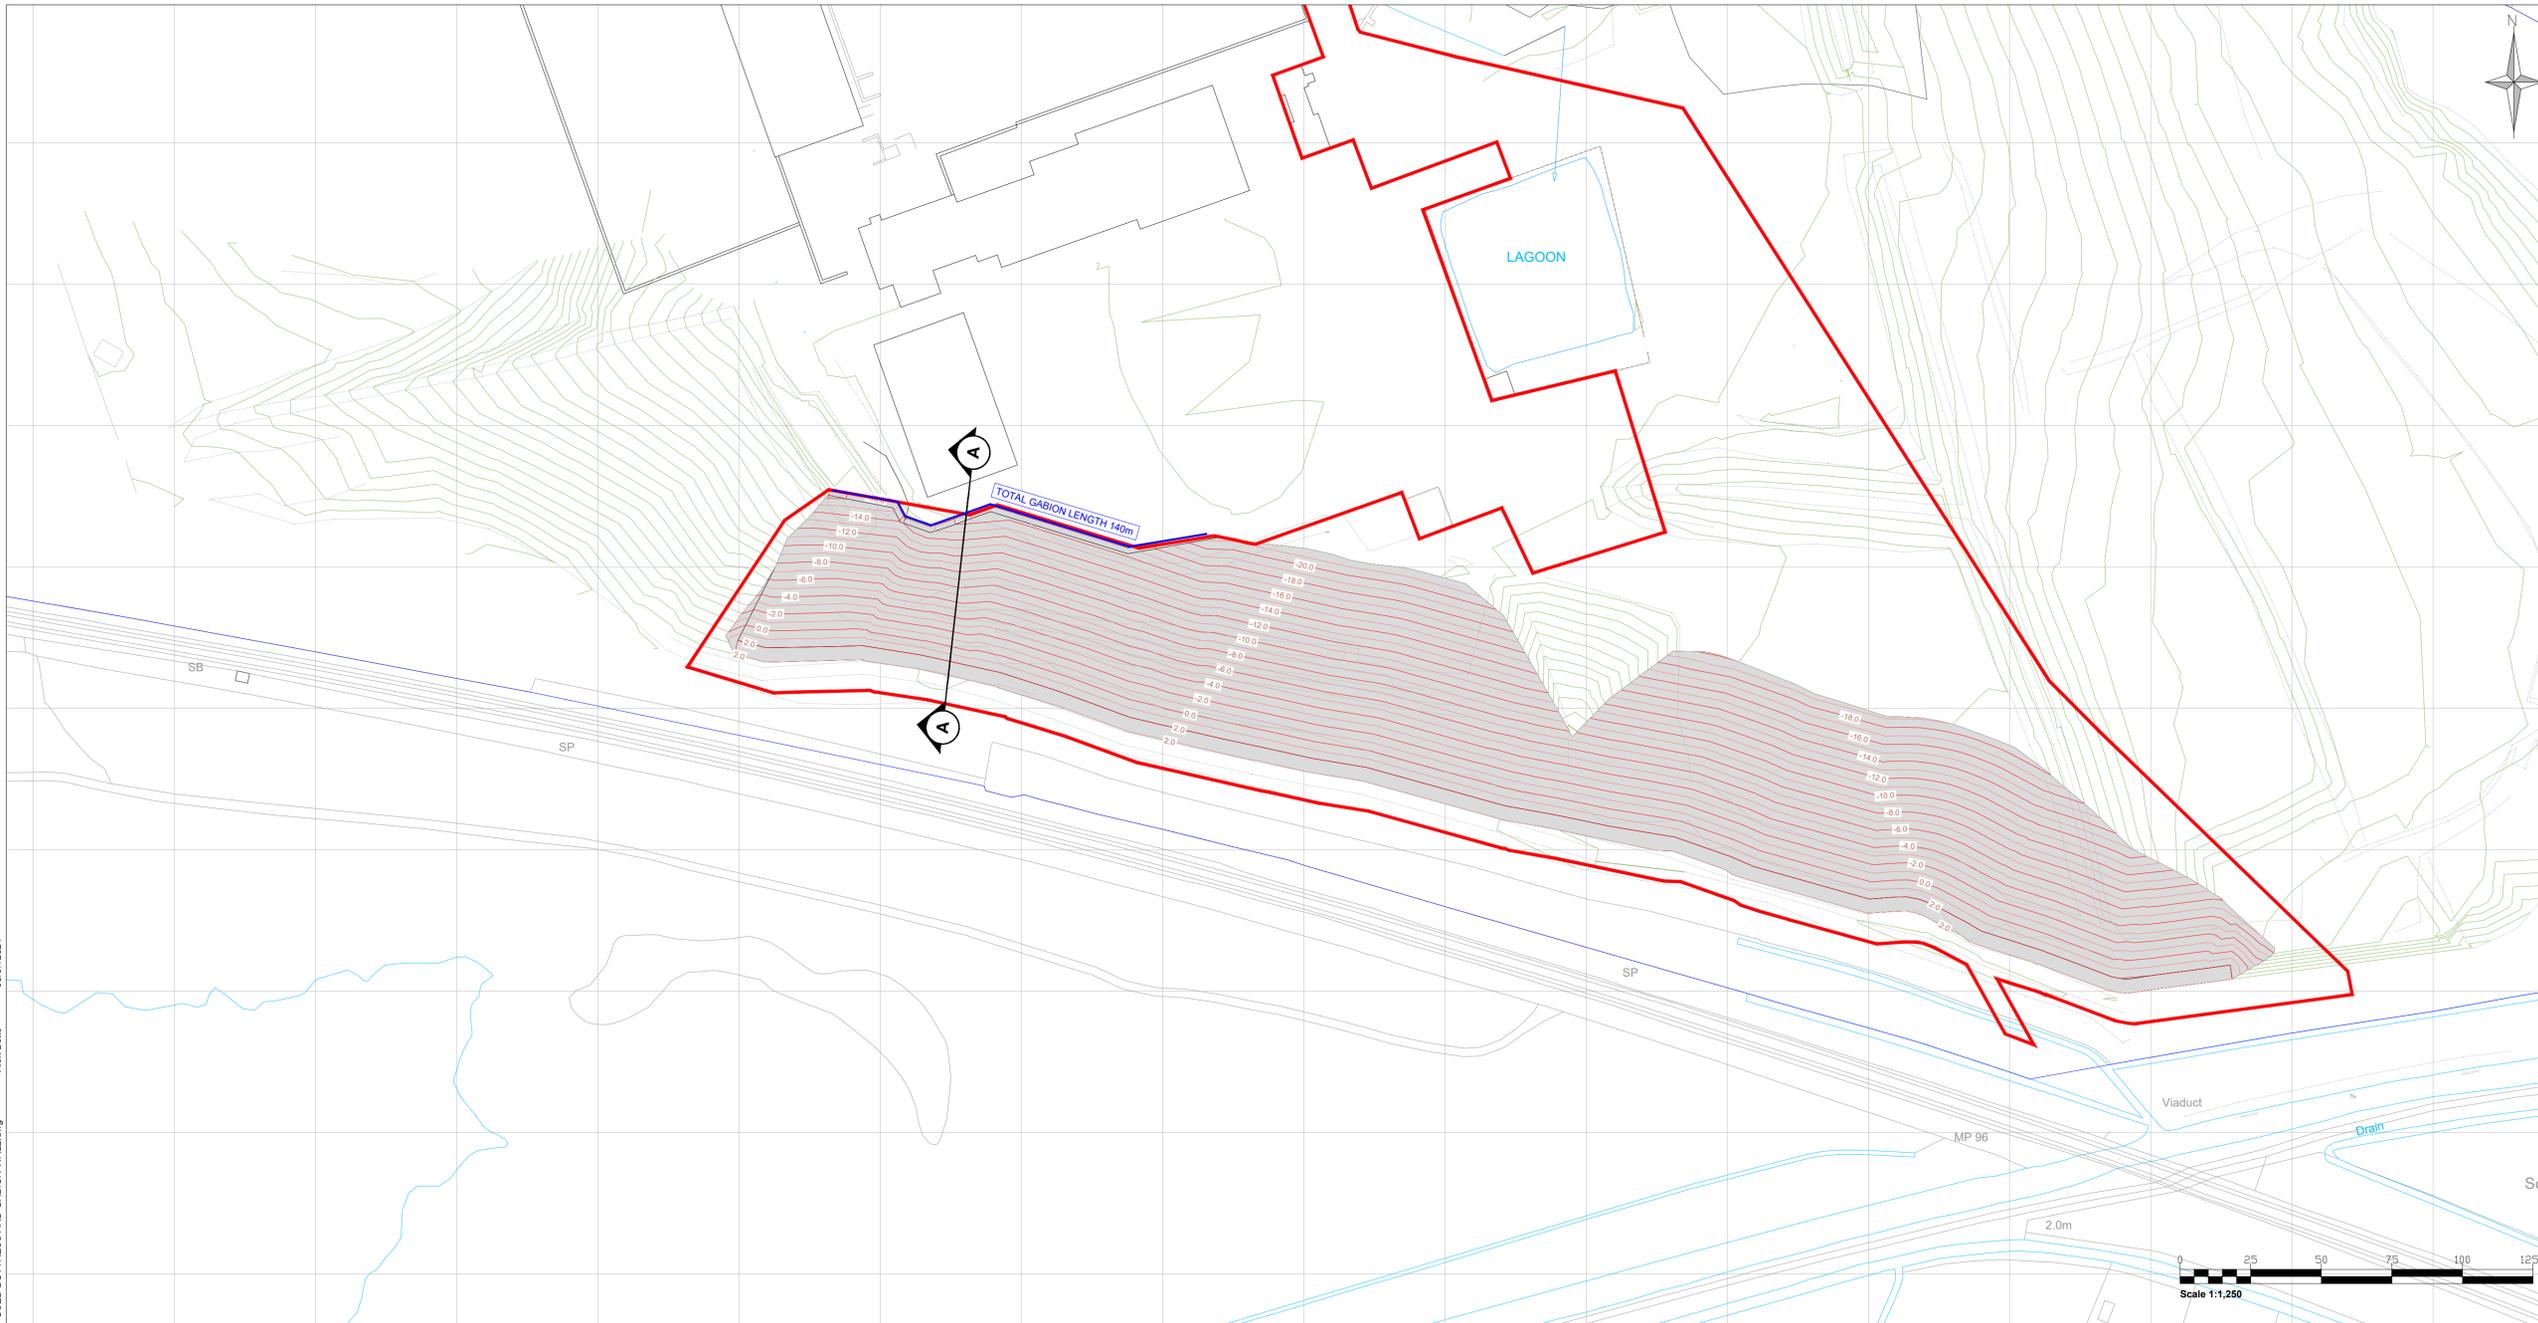
Drawing Title:
PROPOSED BUTTRESS AND GABION WALL

SURVEY 12-02-19
	BUTTRESS AND GABIONS
	PROPOSED PHASE 2 BUTTRESS MAY 2024

The analyses have shown that in order to achieve an acceptable FOS, the gradient of the slope needs to be at least 1V:2.5H. For the existing site buildings to remain in-situ, it may be possible to install a retaining wall, such as a gabion wall, at the toe. Based on preliminary calculations, any retaining wall would need to be approximately 47.0m from the crest of the buttress, retaining an approximate height of 5.0m along a length of 120m (Drawing 002). Initial stability analyses have been assessed which produce an acceptable FOS, however it should be noted that any retaining wall would need to be considered further at detailed design stage, including stability of the wall itself.

The assessment demonstrates that an acceptable gradient for the slope adjacent to the existing site buildings is 1V:2.5H. It is anticipated that the toe of the buttress, when formed at this inclination, would need to be retained at an approximate lateral distance of 47.0m from the crest to enable the site buildings to remain in-situ. The retained height at this distance is estimated at 5.0m, extending an approximately 140m laterally. Further consideration of any potential retaining solution is required and would need to go through detailed design, including stability checks of the solution itself.
