**APPLICATION SITE REPORT
FOR PPC APPLICATION**

Chelson Meadow Leachate Treatment Plant

Plymouth City Council

September 2006

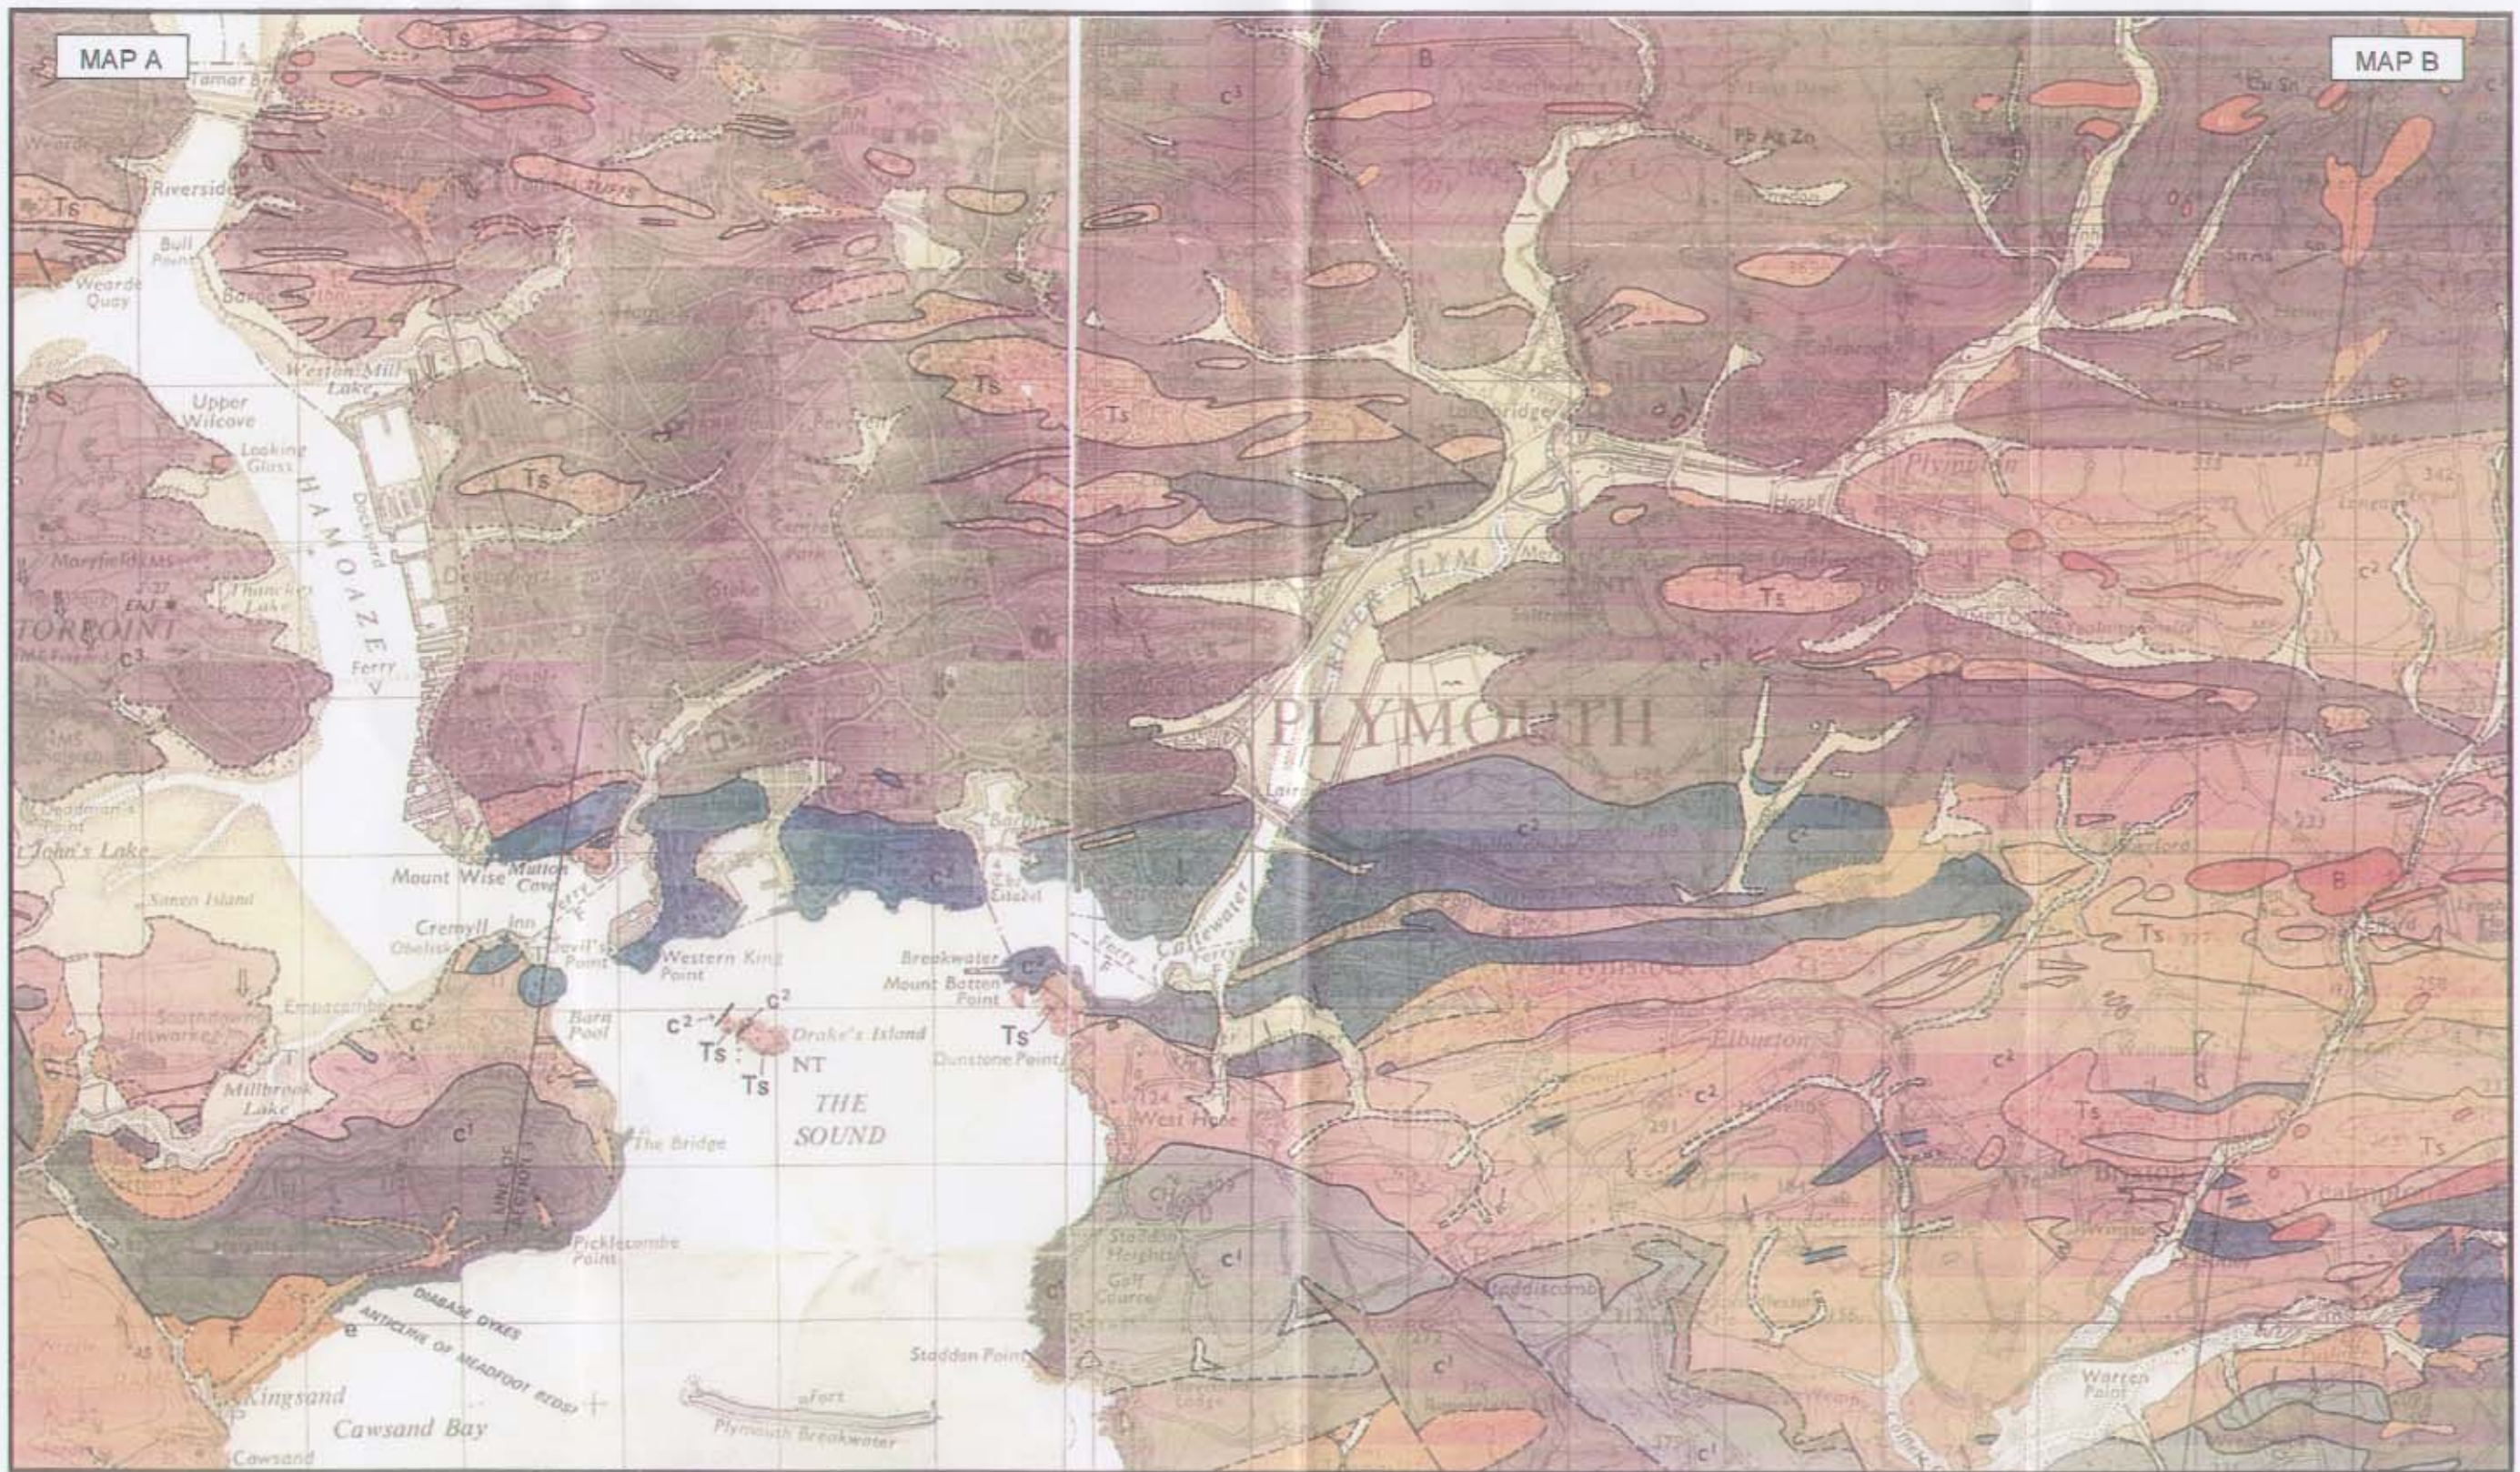
Figure 9(i) shows the maps for the keys above.
 British Geological Survey Maps 1:50,000
 Map A: Plymouth Sheet 348, Drift Edition, 1977
 Map B: Ivybridge Sheet 349, Drift Edition, 1974

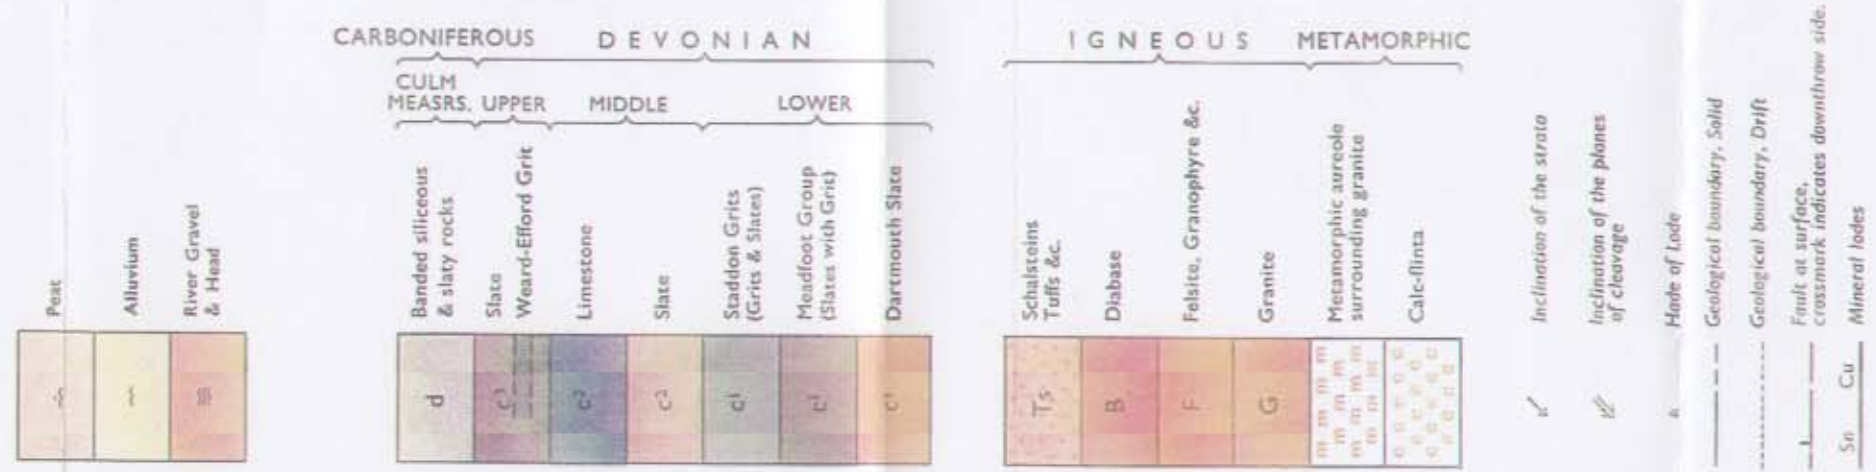
Figure No:
 Figure 9(ii)

EXPLANATION OF GEOLOGICAL SIGNS AND COLOURS

Figure 9(ii) shows the keys for the maps above.

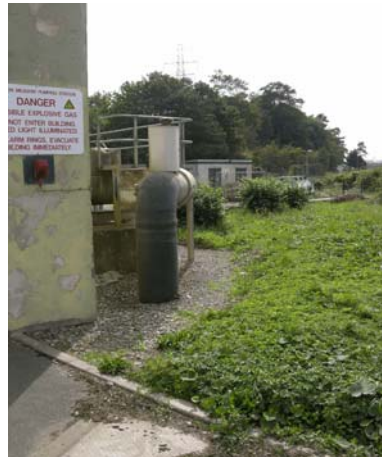
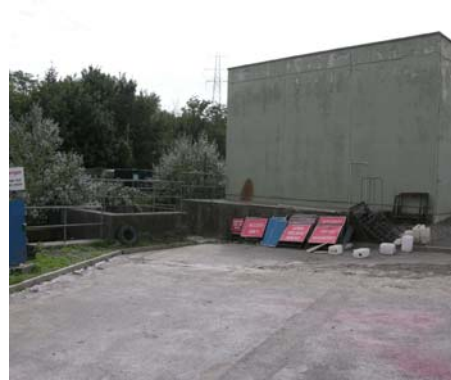
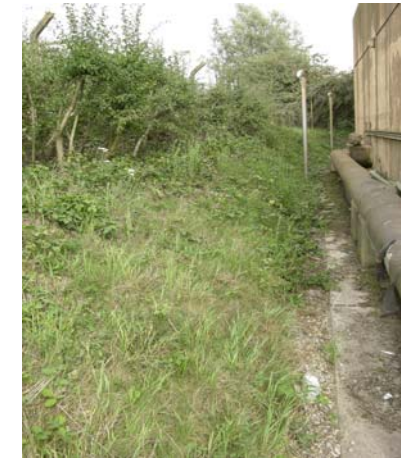
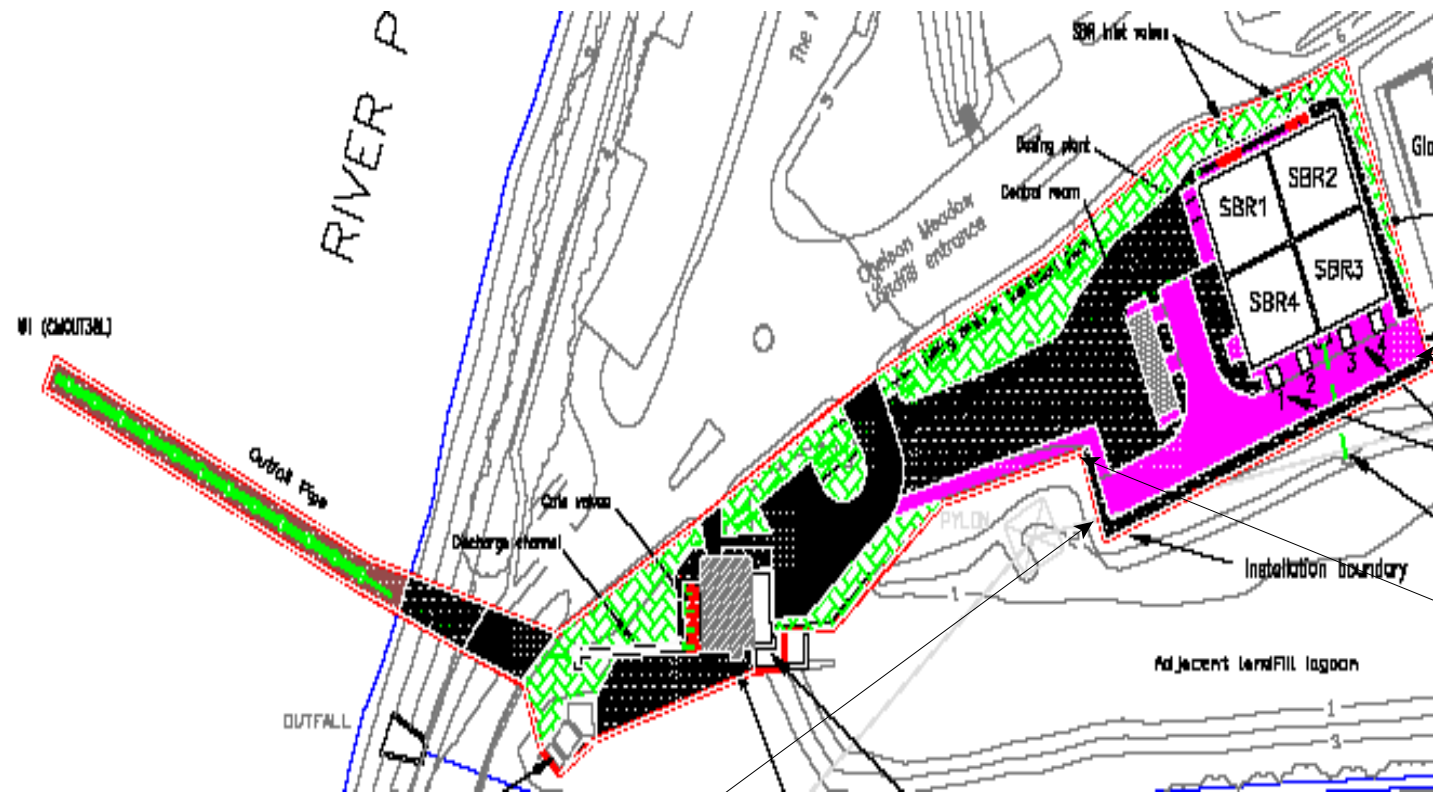
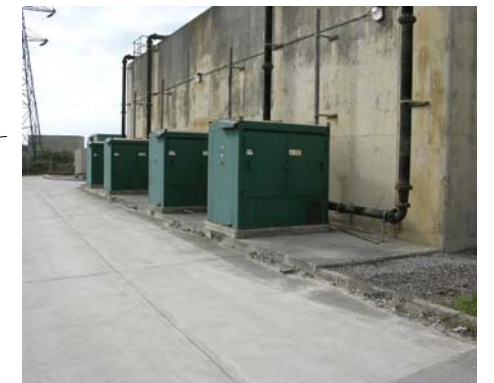
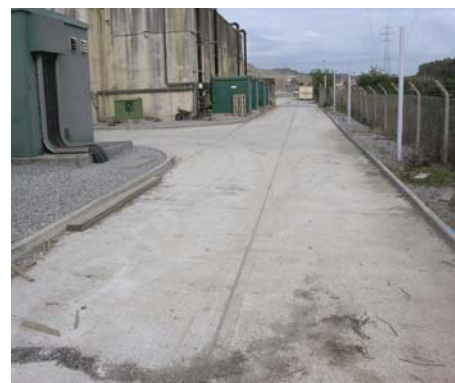
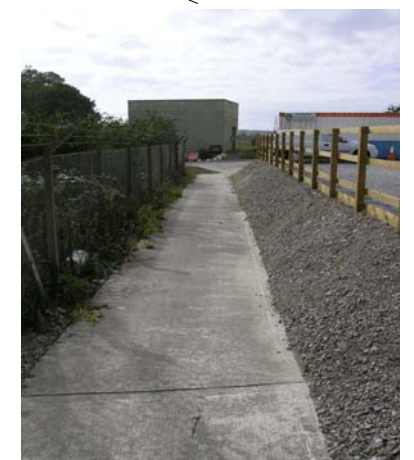
Appendix B1 - Photographs of Surface Areas

Drawing No. WD/W1/476 in Appendix A5 shows the various surface finishes within the LTPI, which are also illustrated by Plates in Appendix B1. The SBRs are surrounded by reinforced concrete, laid in slabs and with sealed joints. There is a gas proof membrane below the SBRs, the concrete service road and the control building. All engineered surfaces are inspected visually on a monthly basis and none have significant areas of cracking or other damage.

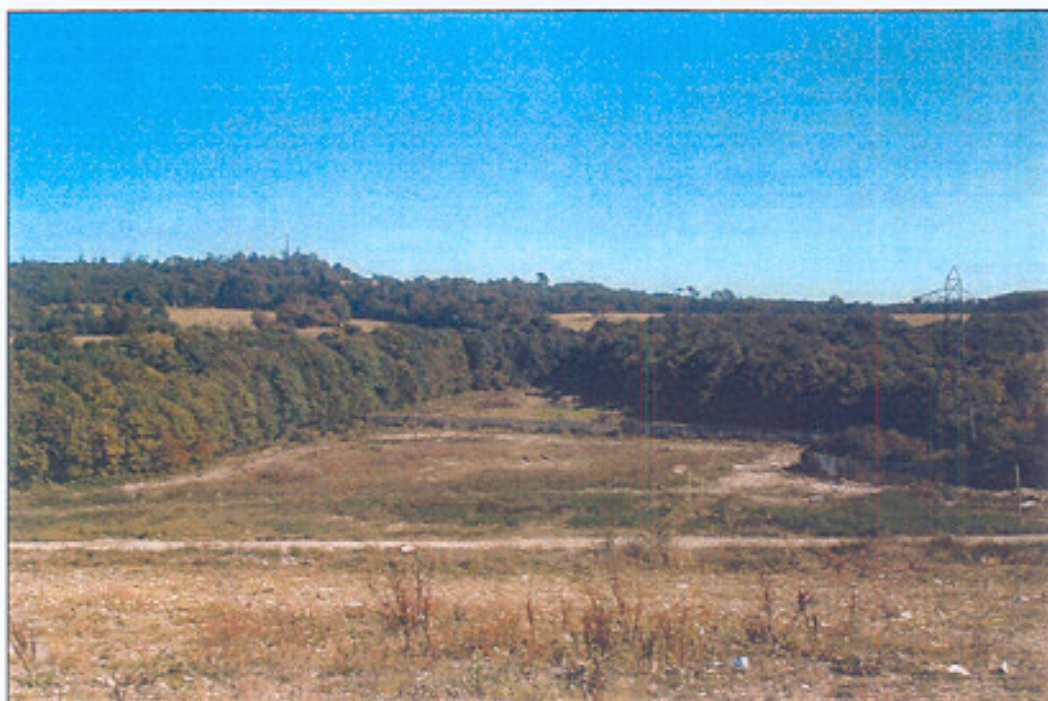
Swallows End is a generally level piece of grassland to the east of the palisade fence which has ground elevation around +9m AOD. The Northern Leat bounds the area to the north and the Southern Leat bounds the area to the South. Despite the drainage afforded by the leats, parts of Swallows End contain shallow pools of surface water throughout the winter seasons and areas of marsh grass exist.

Plate 6 - The plateau area and Swallows End; viewed from the Southern Sector

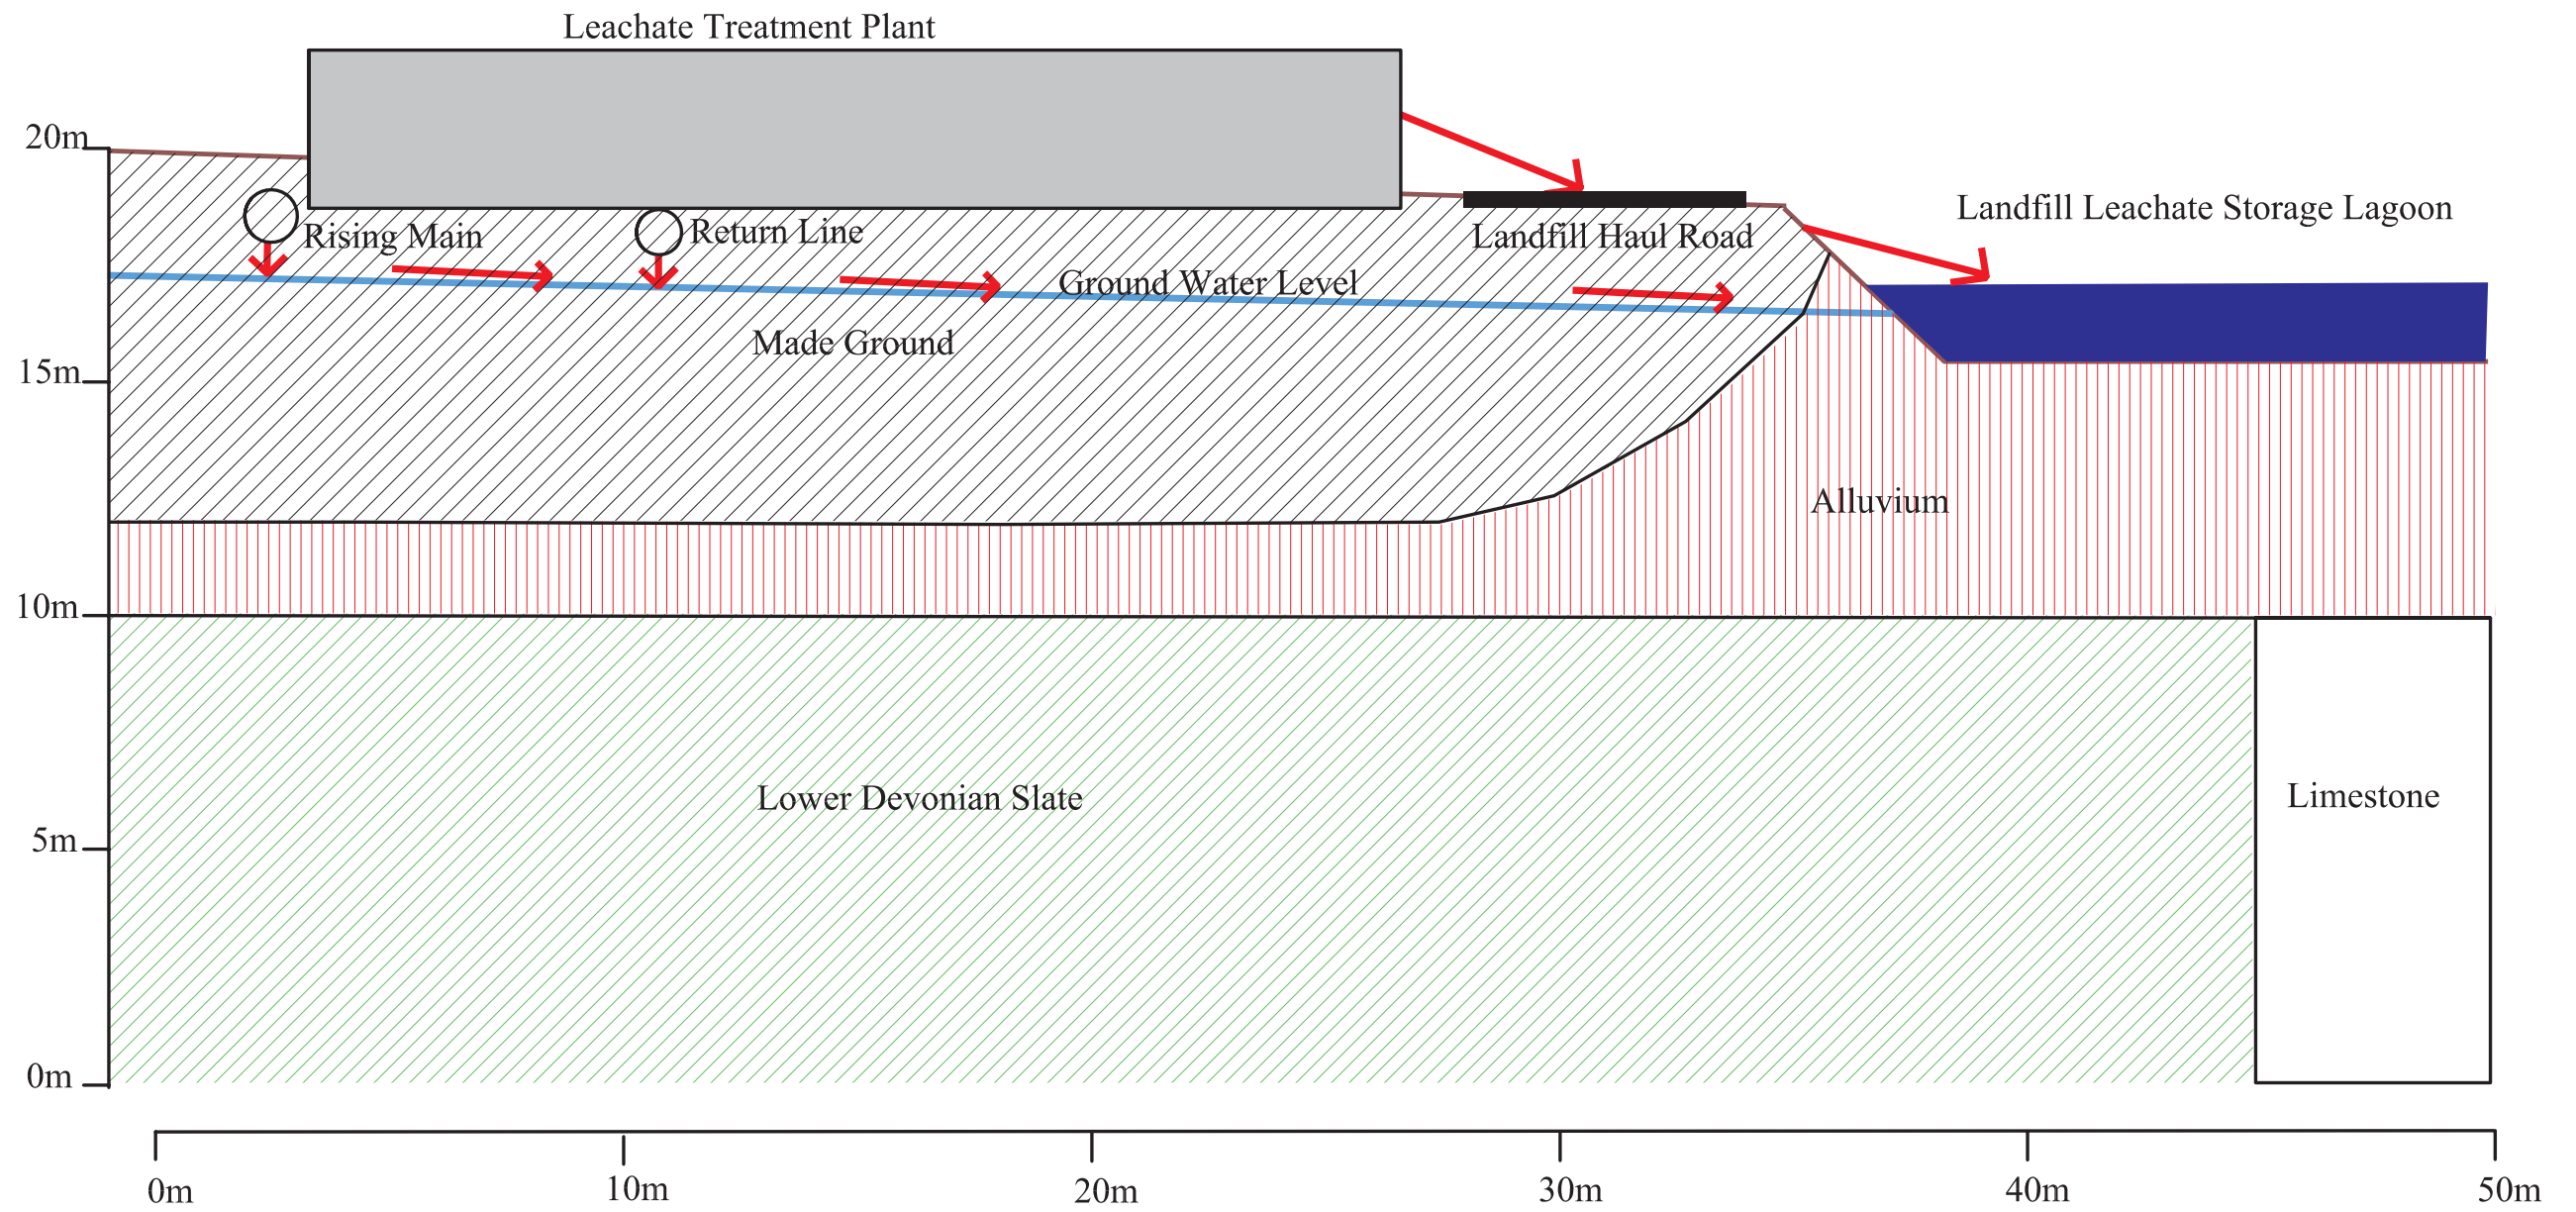
Appendix E1: Graphical Conceptual Site Model for Chelson Meadow Leachate Treatment Plant:

Potential Pollution Pathways arising from Storage & Treatment of Leachate
