Viridis 178 Limited

Red Scar Power plant

Application Site Condition
Report

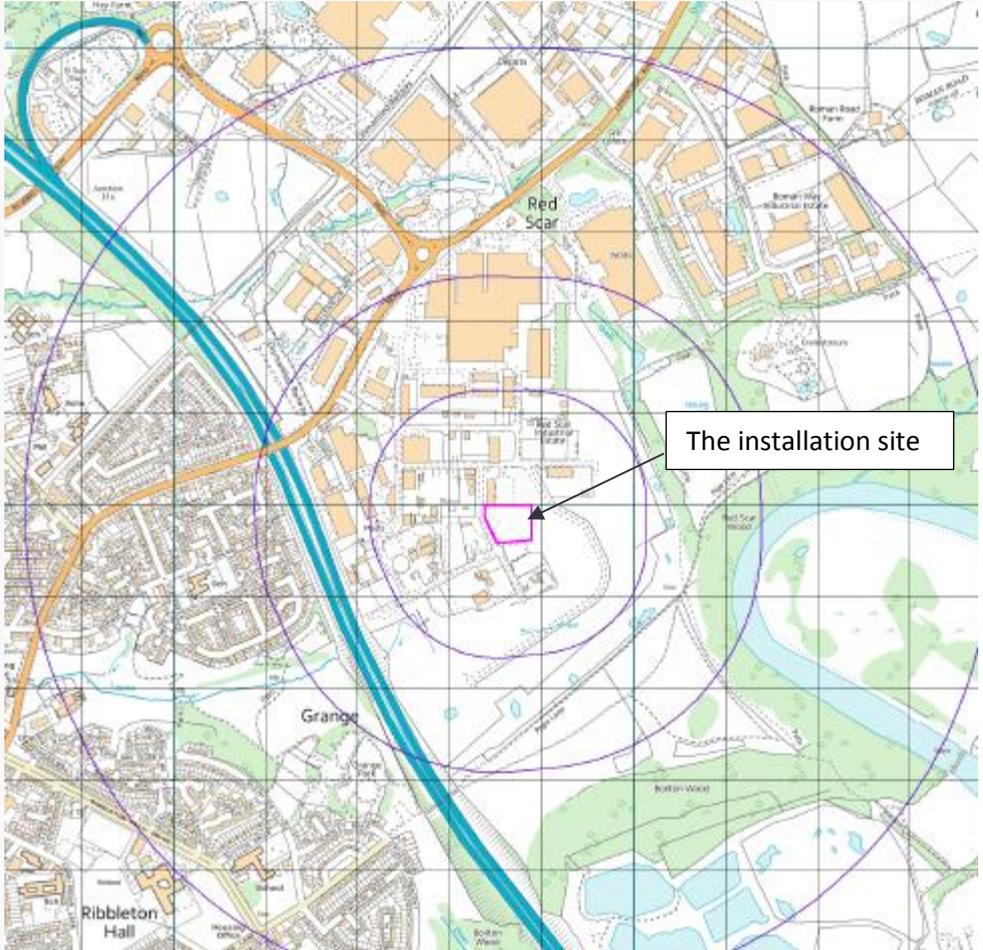
Item	Detail
Name of the Applicant	Viridis 178 Limited
Activity Address	Viridis 178 Limited Red Scar Industrial Estate Preston PR2 5LX
	The site location is shown below.

2018 map extract from the Envirocheck (Appendix A).
