Environmental Management System

Royal Preston Hospital

Sharoe Green Lane, Fulwood, Preston, PR2 9HT.

Ref: RPH.PT.EMS.2307.v2

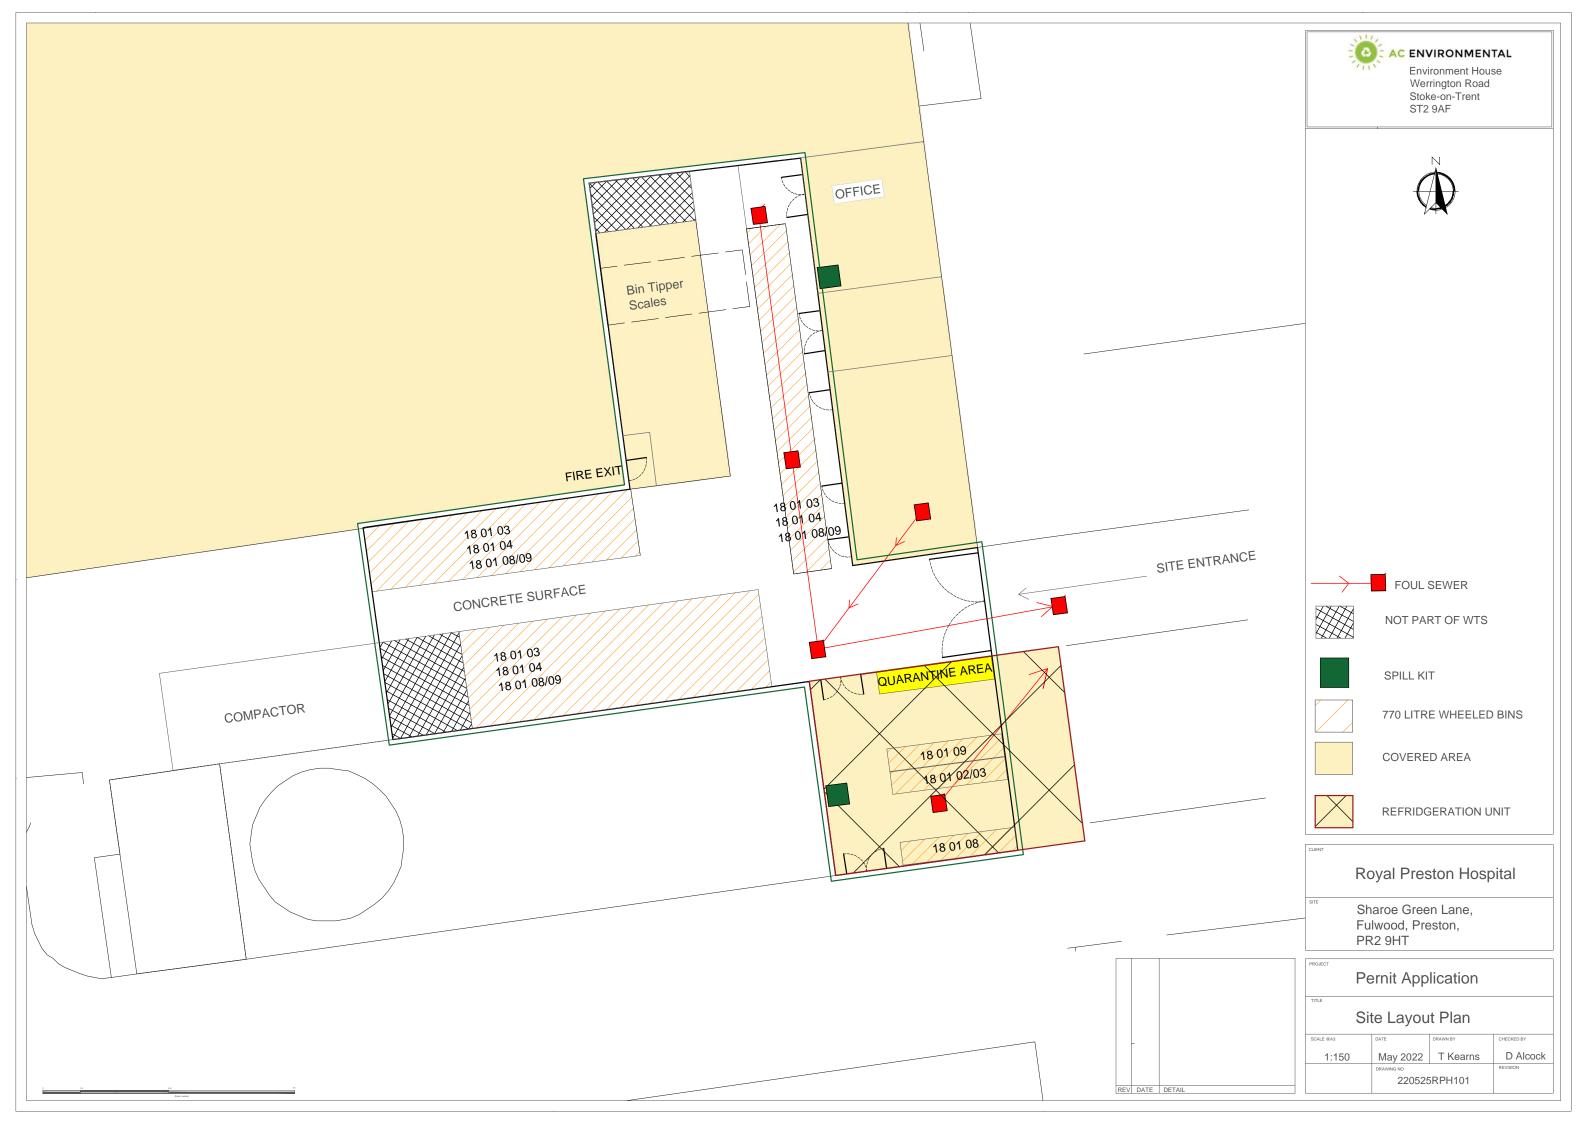
APPENDIX 2 – DRAWING REF: 220525RPH101

There is one UKAS accredited CCTV camera within the permitted area. Further detail on the site layout is shown on Drawing Ref: 220525RPH101.

Any potential spillages will be dealt with appropriately within the permitted area using the spill kit that is provided on site. The location of the foul sewer is shown on Drawing Ref: 220525RPH101.

Once the waste has been accepted, it is weighed on the weigh scales in the north of the permitted area as shown on Drawing Ref: 220525RPH101. The waste is kept segregated at all times in the relevant 770 litre wheeled bin according to waste stream. Some infectious waste, waste containing traces of medicines, and anatomical wastes, are stored within the 770 litre wheeled bins within the refrigerator unit which is indoors and equipped with air conditioning. The remaining 770 litre wheeled bins are stored externally.

weigh scales are a form of fixed plant and the location is shown on Drawing Ref: 220525RPH101. All
