## 1 Changes to the Activity

## 2 Measures Taken to Protect Land

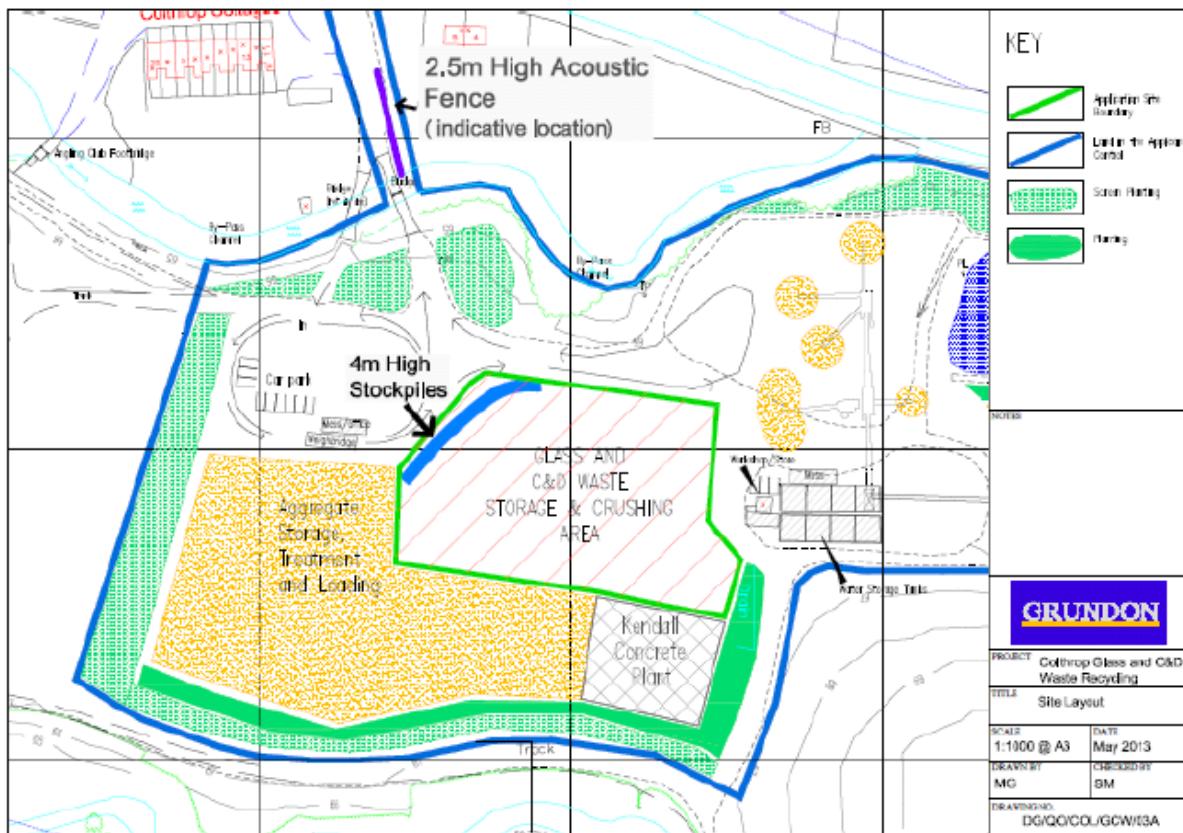
Figure 1: 2014 EP Boundary

The EP for the Kennethholme Quarry Recycling Facility was originally granted on 18 February 2014 (EPR/BB3013MJ). It is a Tier 2 bespoke permit for the treatment of inert waste to produce soil, substitutes and aggregate up to 15,000 tonnes per year. The EP boundary is shown in Figure 1 (Schedule 7 of the EP).

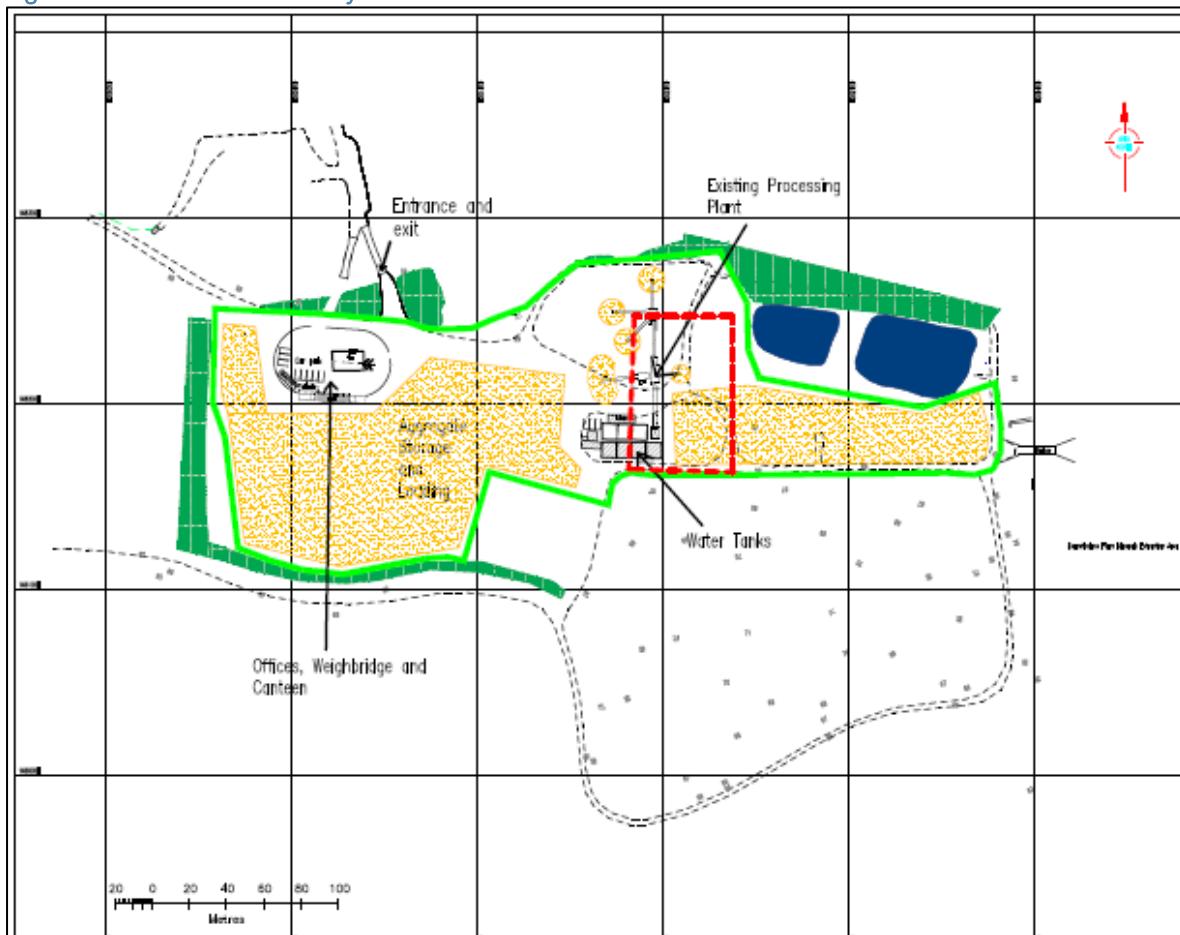
**Figure 2: Revised EP Boundary**

The existing EP boundary is limited to a small area of the land ownership, in the centre portion of the wider site boundary. The addition of the water treatment plant for the wash plant wash waters, and the need for increased storage for incoming (untreated) wastes (up to 10,000 tonnes at any one time), requires the EP boundary to be amended.

The revised/increased EP boundary is shown on Drawing 060/P/003F submitted with the variation application in Appendix 5 and is represented in Figure 2 below by the green line.

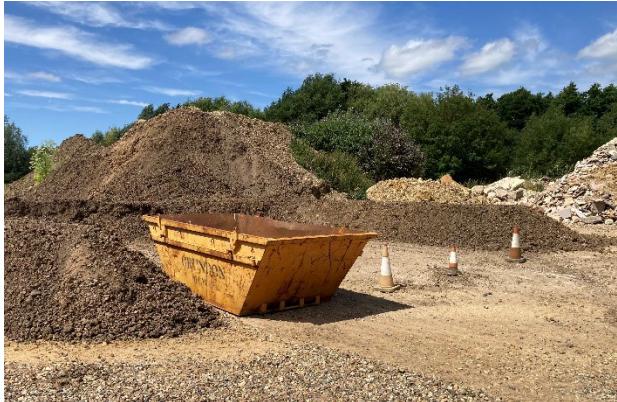
Figure 3: Quarantine Area

➤ Inspection dated 11/06/2024 (ref. 401090/0506592). No non-compliances were found. A note was included regarding the need to provide a designated quarantine area for non-conforming waste. Whilst the expectation is that non-conforming waste is unlikely (due to rigorous waste acceptance procedures) a quarantine area is required. This is recorded as having been followed up, although there is no subsequent CAR form on record to confirm this in writing. Figures 3 and 4 below are recent photographs of the area, showing the signage and the use of a skip to contain any non-conforming materials.
