Busta Triangle, Eversley Deposit for Recovery

Environmental Setting and Site Design

Environmental Permit Application

Collard Group Ltd

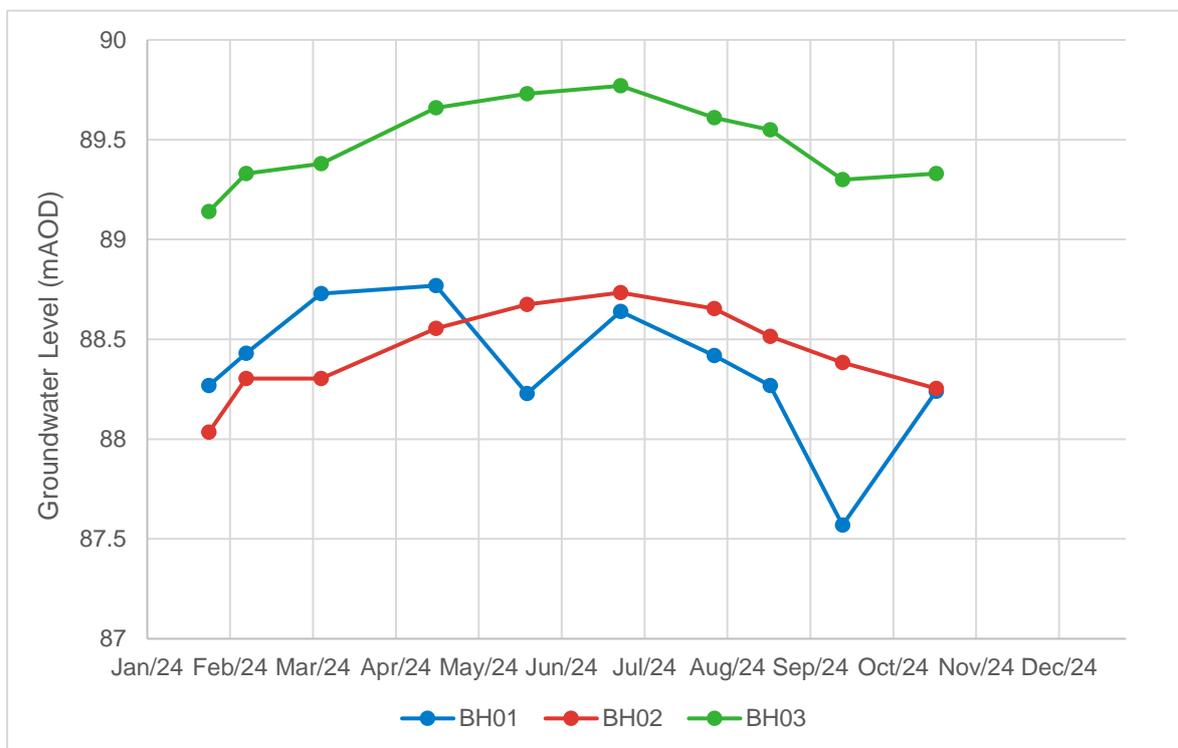
Figure 1: Groundwater Hydrograph, Jan to Oct 2024

- 4.4.12 Groundwater levels display seasonal variation during the monitoring period. Water levels in the boreholes increased by approximately 0.5 metres from the beginning of the year, peaking in the early summer months in June. Following this peak, by October water levels gradually declined to similar levels to those recorded in February.

- 4.4.13 Up until April, groundwater levels in BH01 are higher than those recorded in BH02. However, after April, groundwater levels in BH02 are higher.

- 4.4.14 Groundwater levels are shown to flow towards the northeast in March, and towards the northwest in September. The reason for the change in flow direction is due to the variability in which of BH01 or BH02 demonstrates higher groundwater levels, noted above. However, generally a northwards regional flow direction is assumed, based upon the local topography, and the presence of the River Blackwater 2.7km to the north.

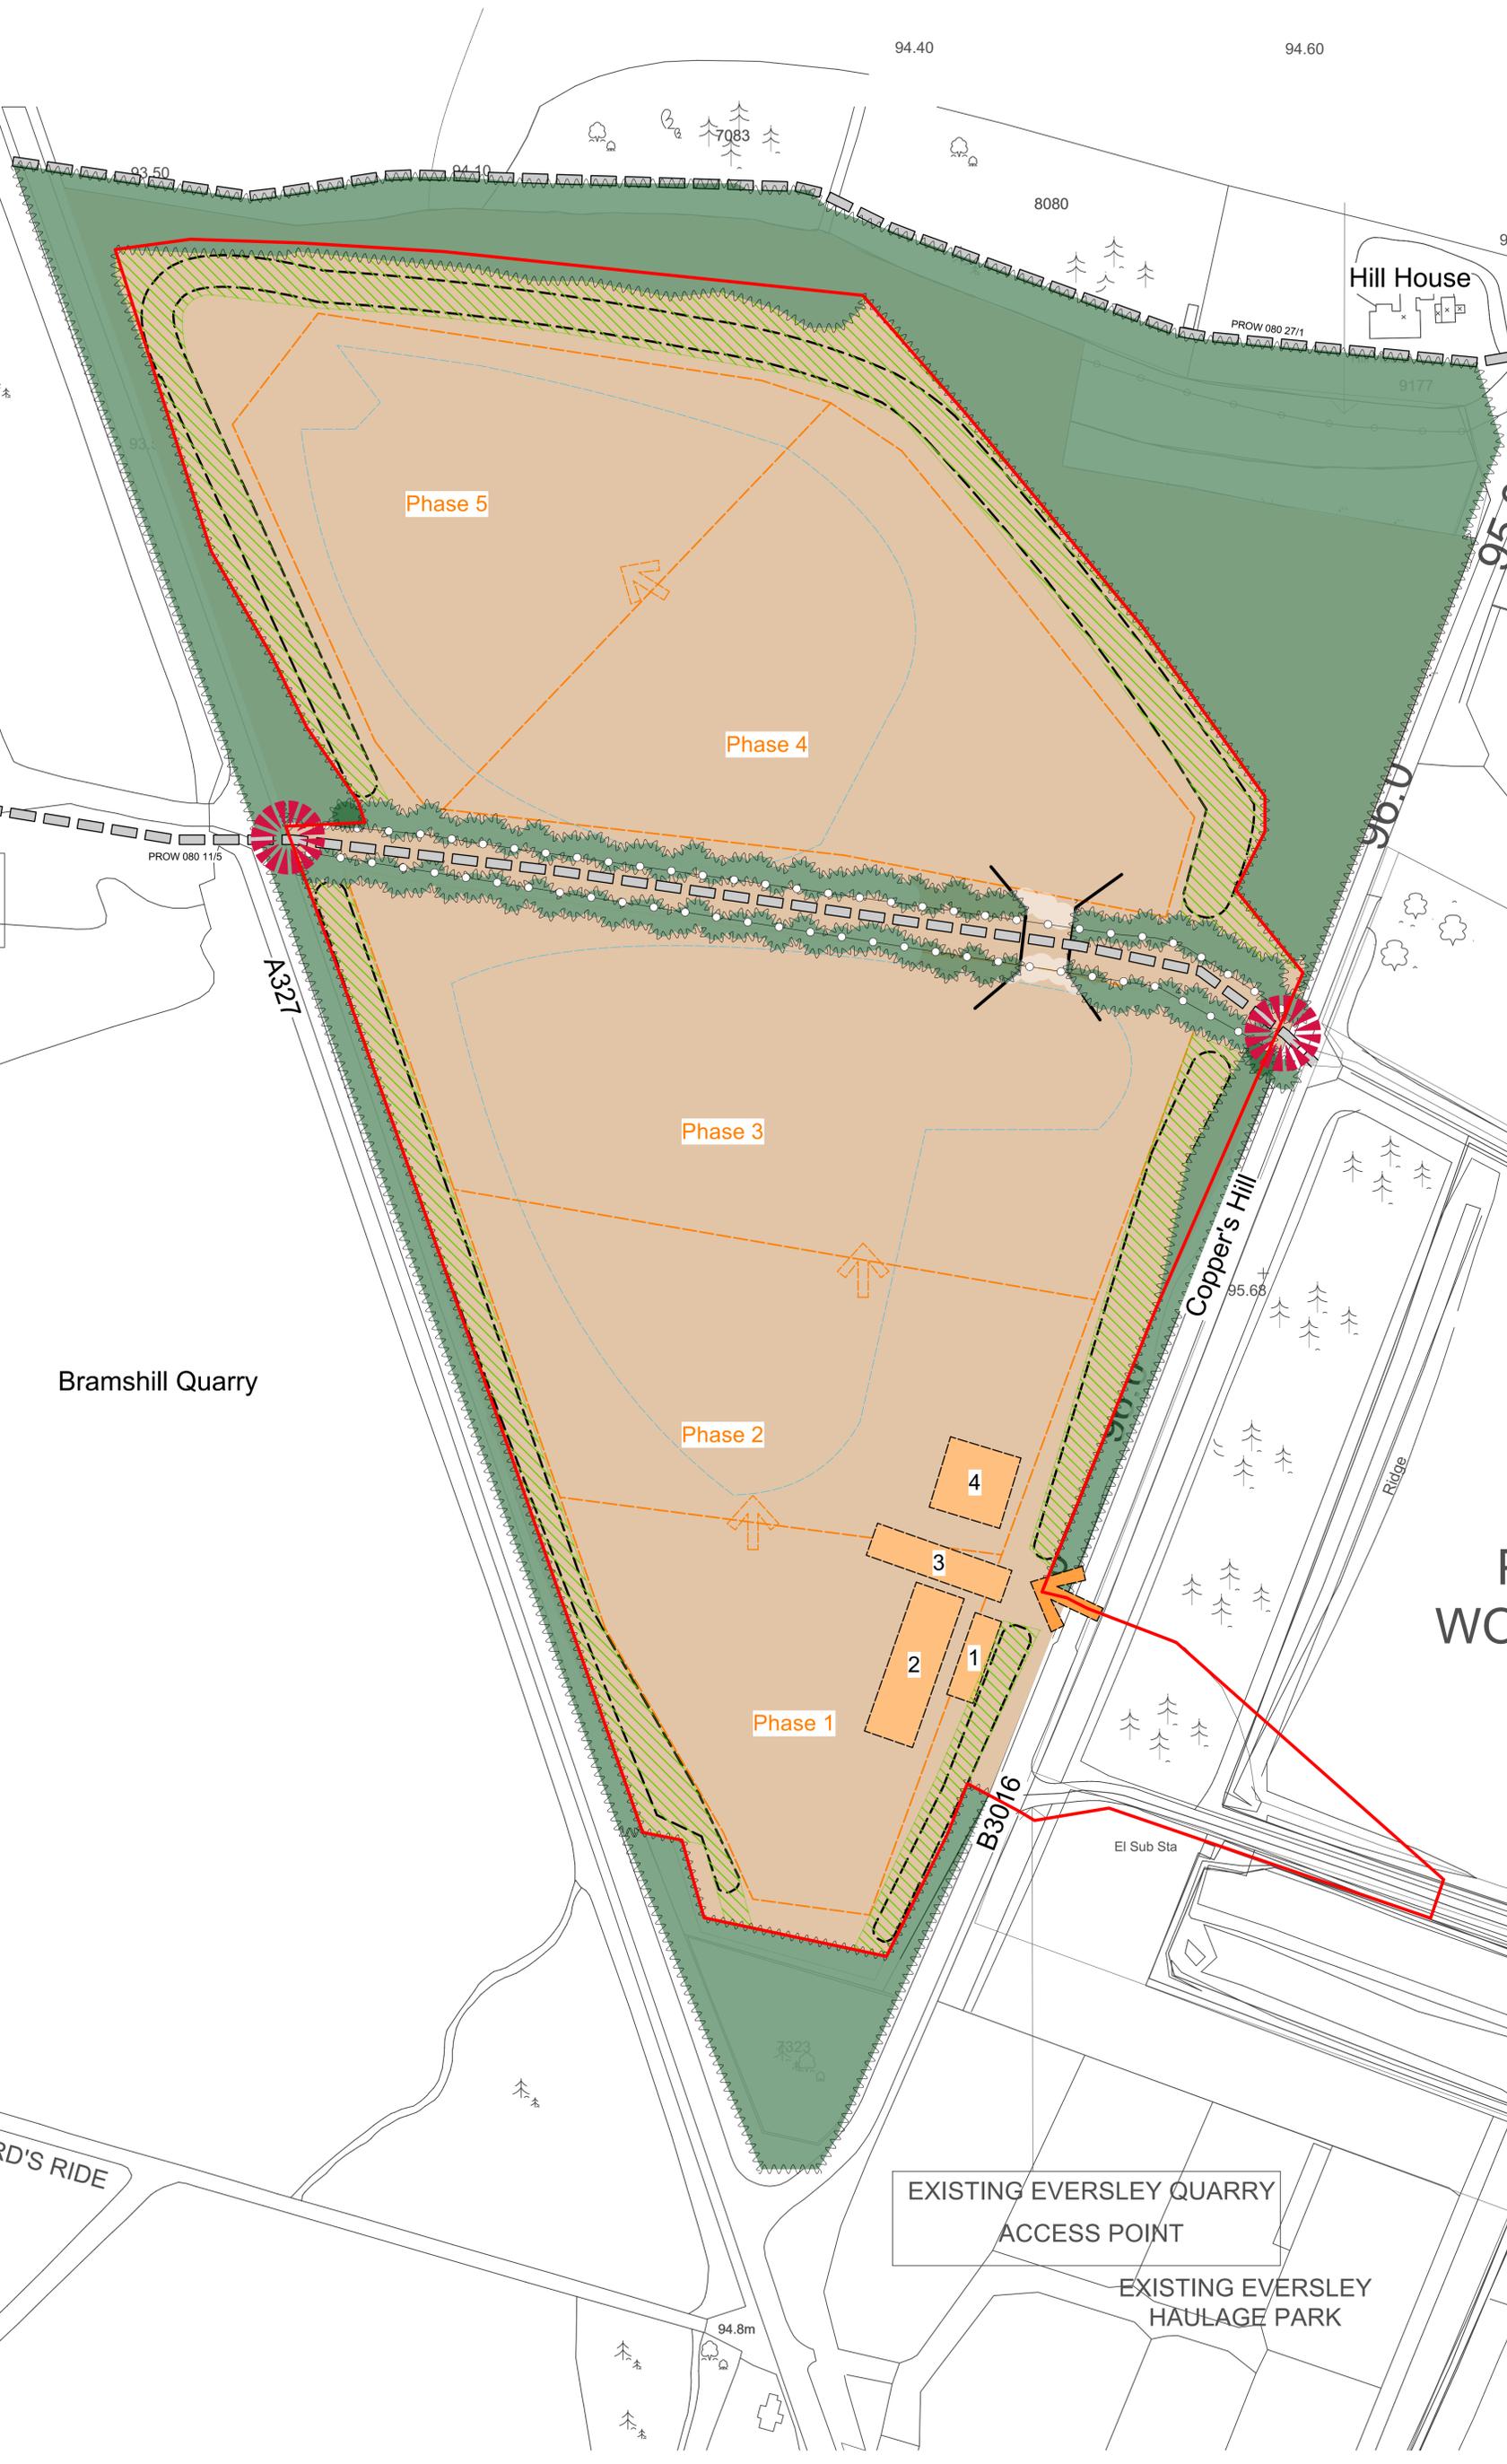
- KEY**
- Site Boundary 12.04h
 - Public Right of Way
 - Retained Woodland & Vegetation
 - Existing Lagoons
 - Existing Swale
 - Restoration Area (Phases 1 to 5)
 - ↑ Directions of Works (Phases 1 to 5)
 - Heras Fencing
 - Proposed Bunding
Proposed 2m high temporary bunding with wild flower meadow mix on top, bunding to hug redline boundary
 - Proposed Wild Flower Meadow Mixture
 - ↑ Site Access - Vehicles
 - ⊙ Site Access - Pedestrian
 - Temporary Crossing
 - Proposed Site Buildings (Indicative Locations)
 - 1 Site Office (two storey stacked cabin)
 - 2 Vehicle Car Parking Area
 - 3 Weigh Bridge + Wheel Wash
 - 4 Quarantine Area

3.5.3 The proposed phasing plan for the proposed site is detailed on Drawing Number 1886-FPCR-XX-XX-DR-L-0001. The works will take place over five phases as shown with Phases 1-3 located to the south of the bridleway and Phases 4-5 located to the north of this. The application site would be worked in a northerly direction, beginning with Phase 1 at the far south.

3.5.4 The importation, landscaping and restoration works in Phases 1-3 located to the south of the bridleway, would be completed within approximately two years and works in Phases 4-5 located to the north of the bridleway would be completed within one year.

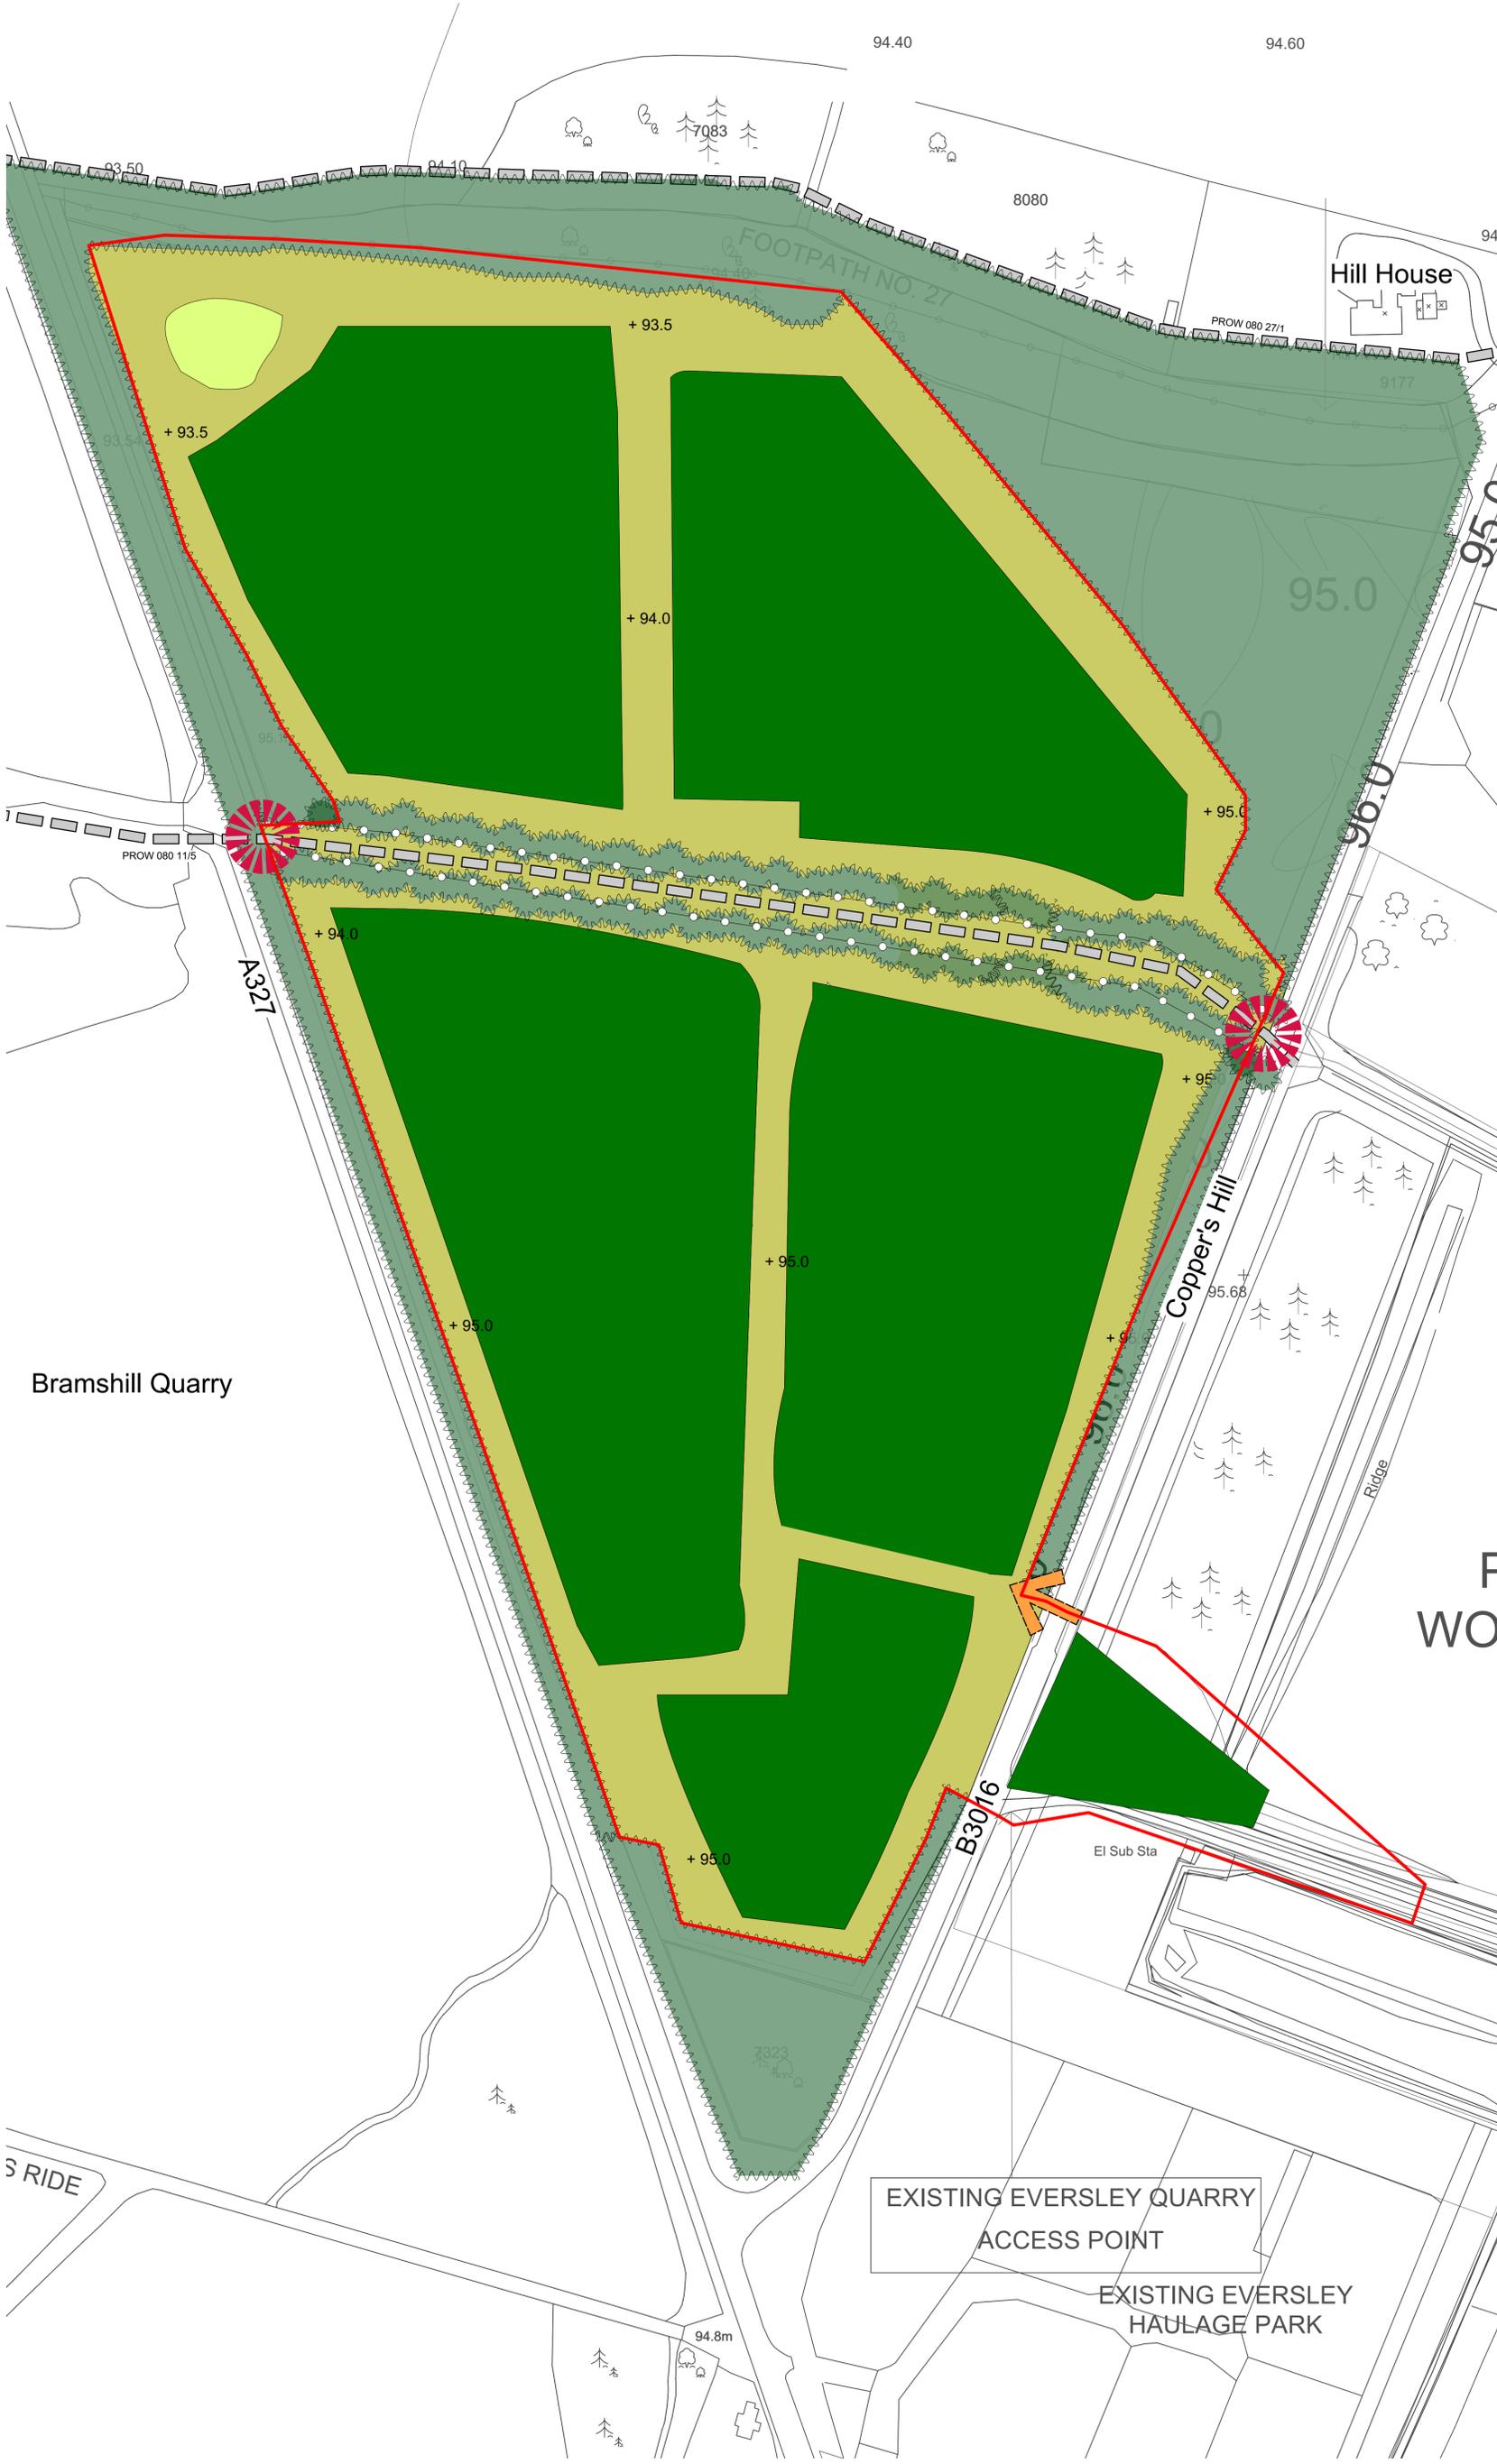
- KEY**
- Site Boundary 12.04ha
 - Public Right of Way
 - Retained Woodland
 - Proposed Coniferous Forestry Plantation 62% of site
 - Proposed Lowland Heathland 18% of site
 - Proposed Wet Heathland
 - Site Access - Maintenance
 - Site Access - Pedestrian PROW
- Other land use including wetland and walk through path 20% of site

- 3.6.1 As detailed in the restoration plan Drawing Number 1886-FPCR-XX-XX-DR-L-0002 the site will be restored to an appropriate balance of habitats and after-uses in accordance with the approved scheme of restoration under Planning Permission 10/01971/CMA dated 03/02/2011 (“the planning consent”), which are a combination of nature conservation and rotational commercial forestry.
