**BUSTA TRIANGLE QUARRY
RESTORATION**

ENVIRONMENTAL PERMIT APPLICATION

Stability Risk Assessment Report

GEC JOB NO: GE250240605

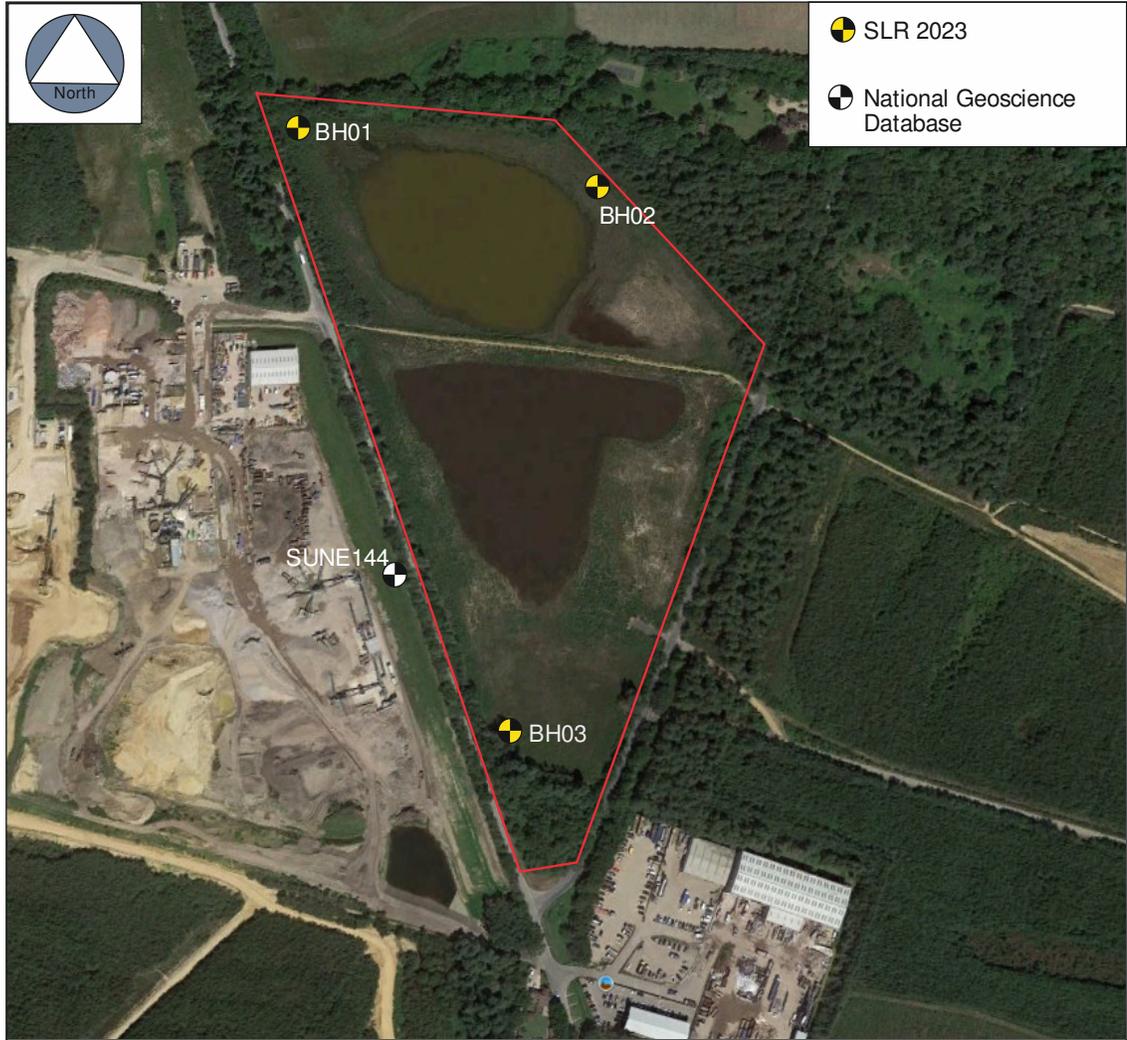
Figure SRA 2 Location of exploratory boreholes

- 1.17 Three (3no.) investigative boreholes were undertaken by SLR in 2023 an additional borehole record held by the National Geoscience Database has been used to enhance the coverage. The locations of these exploratory holes are shown on Figure SRA 2 overleaf.

1.18 The stratigraphy encountered in the 4no. boreholes has been interpreted and presented as Table SRA 1 of this Report.

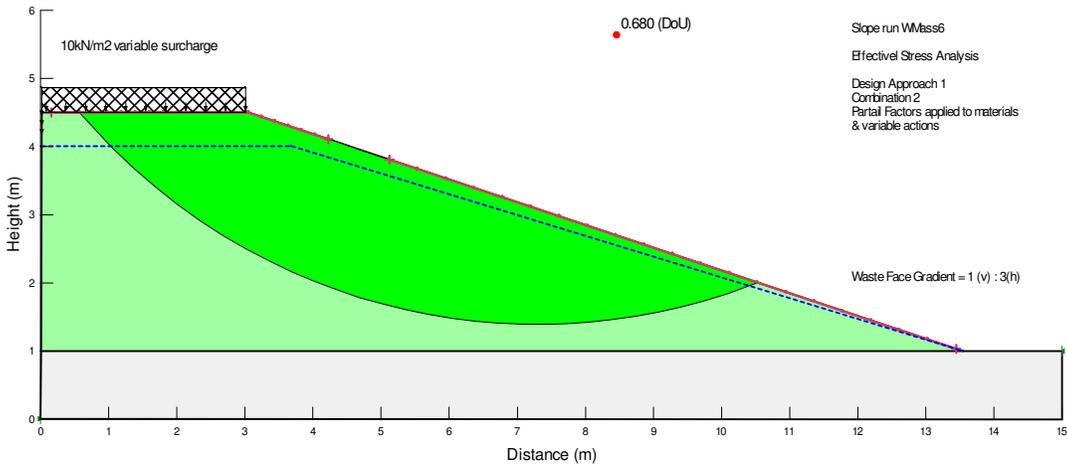
SlopeW Worksheets – Inert Waste Mass

Inert Waste Stability

- 2.34 Slope/W has been used to undertake the investigation into failures wholly within the waste mass for both total and effective stress conditions.
- 2.35 The effects of variations in leachate pressure were modelled by investigating the effects of increased leachate levels on the factor of safety against instability within the waste body.

- 2.46 The stability of the temporary waste face was analysed using the computer programme SLOPE/W to calculate the factor of safety against failure through the waste body for a range of circular failure surfaces using Morgenstern and Price's method.

- 2.48 The waste slope has a degree of utilisation < 1 for all leachate levels up to 3.50m from the base of the waste body. As the thickness of the unbuttressed inert waste is 4.00m a leachate level of 3.50m is extremely unlikely to occur under normal operating conditions.
