Crawley Data Centre Campus – Site Condition Report

Digital Realty (UK) Limited
EPR/UP3604MT/A001

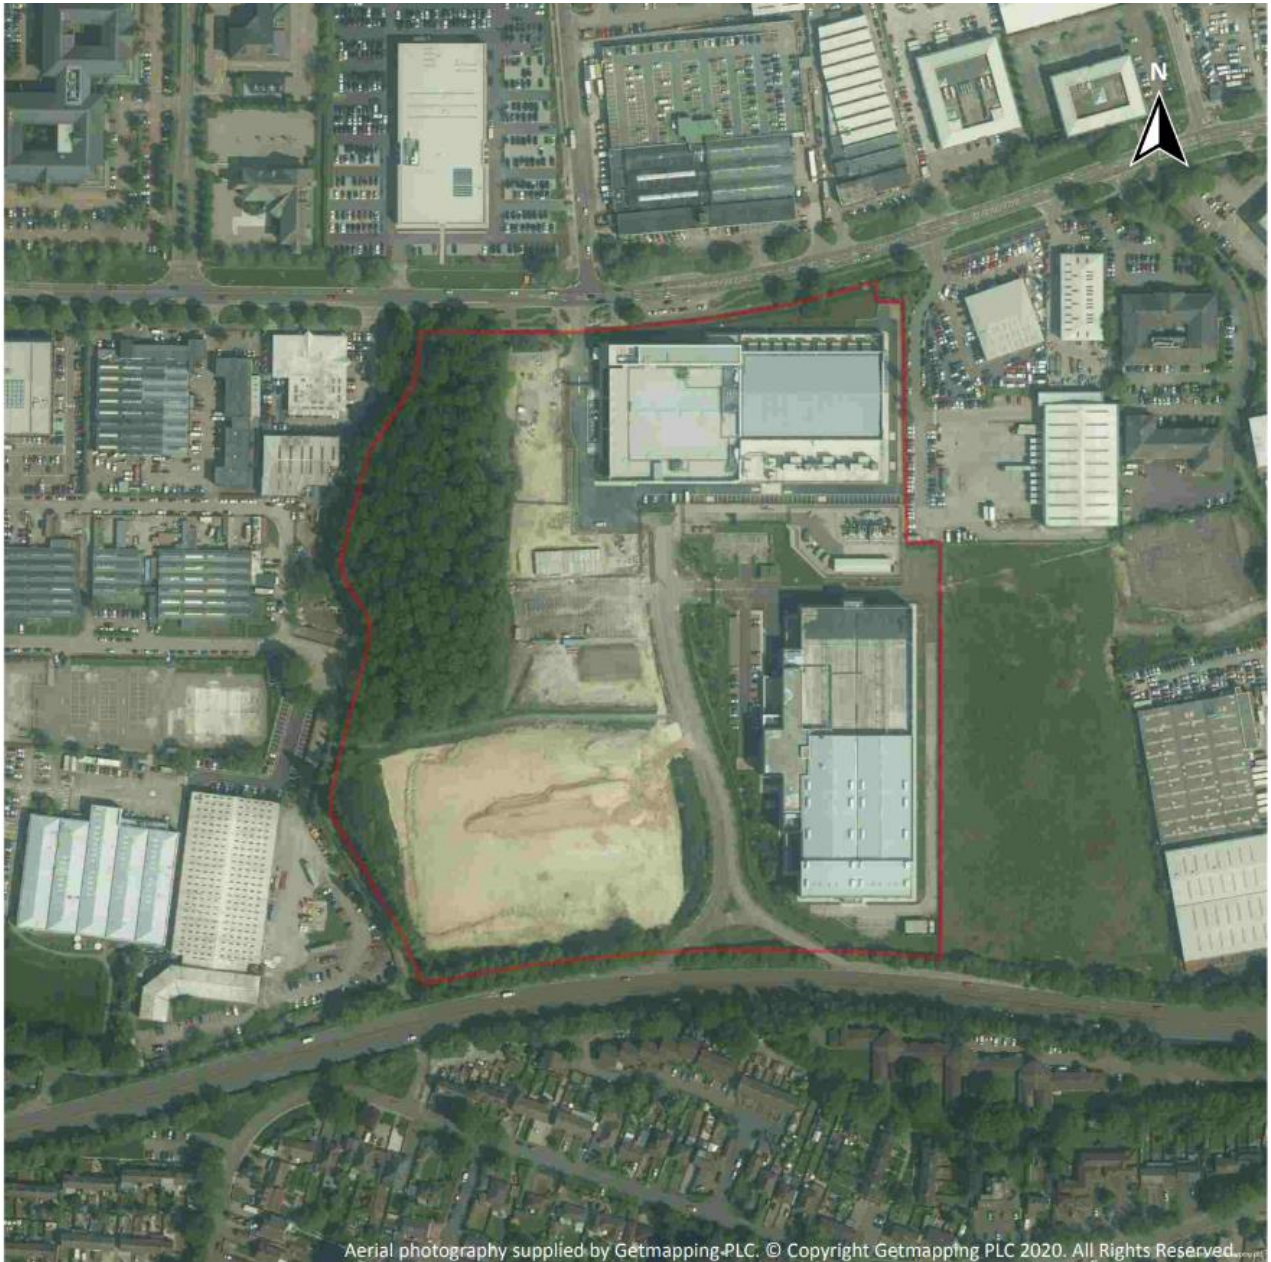
Figure 1: Site Boundary and Location

The whole site is 10.29 hectares in area and is shown in Annex A, Figure 1. The application focuses on the main operation of the site, including the generators and boilers.

The Environment Agency has requested that a permit application be submitted for the area of land identified in Figure 1, Annex A.
